MINERALS PROGRAM INSPECTION REPORT
PHONE: (303) 866-3567

MINE NAME: Juniper Quarry	MINE/PROSPECTING ID#: M-1982-141	MINERAL: Limestone (general)	COUNTY: Moffat
INSPECTION TYPE: Monitoring	INSPECTOR(S): Amy C. Yeldell	INSP. DATE: July 17, 2019	INSP. TIME: 15:15
OPERATOR: Moffat Limestone Company	OPERATOR REPRESENTATIVE: Mike Anson	TYPE OF OPERATION: 112c - Construction Regular Operation	
REASON FOR INSPECTION: Normal I&E Program	BOND CALCULATION TYPE: Complete Bond	BOND AMOUNT: \$154,405.00	
DATE OF COMPLAINT: NA	POST INSP. CONTACTS: None	JOINT INSP. AGENCY: None	
WEATHER: Clear	INSPECTOR'S SIGNATURE:

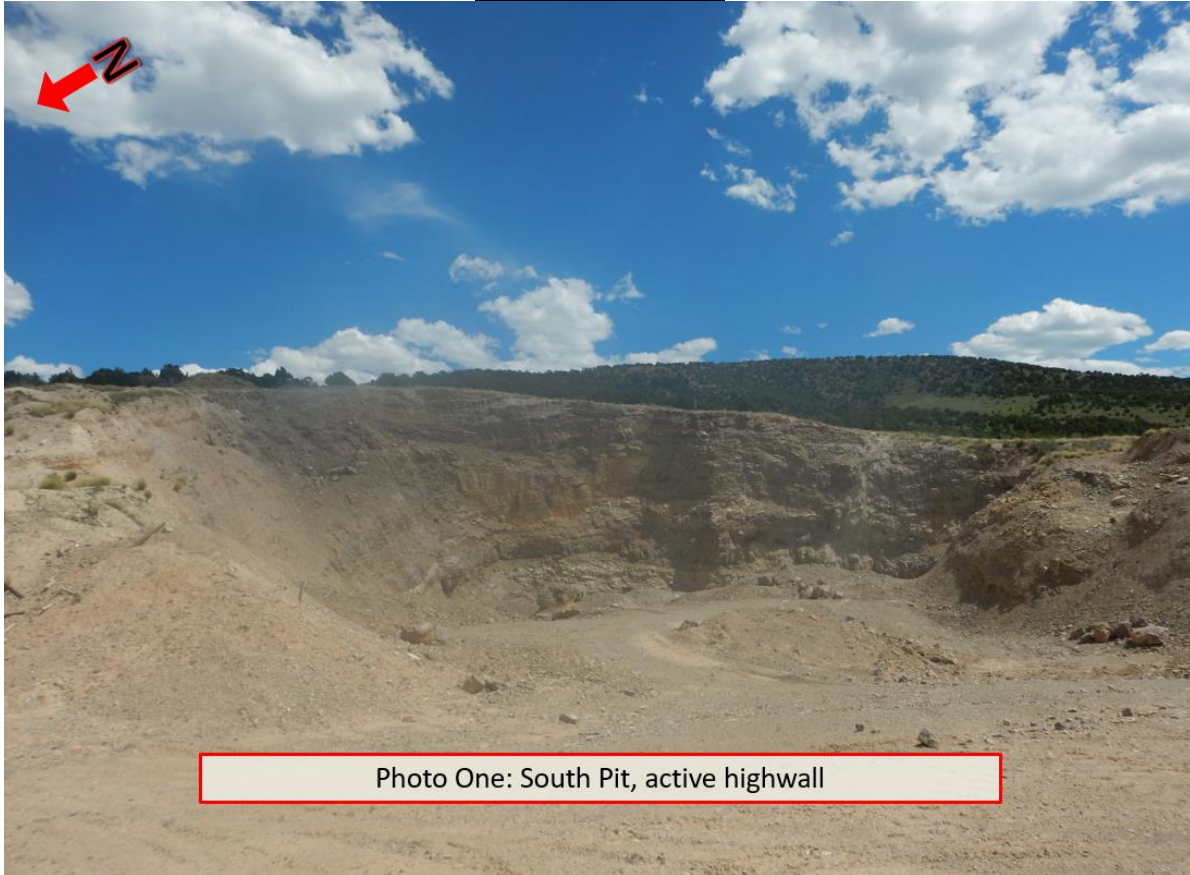
There appears to be no changes to the highwall and over all disturbance footprint since the last inspection. The highwall is approximately 50' tall and sloped 1:1 to near vertical. There is also approximately 200 linear feet of highwall 30' tall sloped 1:1 that will required backfill. The main pit floor has been dropped approximately 10' below original contour and generally follows the permit boundary. Most of the stockpiled metal and other miscellaneous debris has been removed and hauled off site for disposal. There are several stockpiles of various grades of material. All stockpiles are stored neatly and are free of erosion. No fuel or processing equipment is stored at this location.

Photo One: South Pit, active highwall

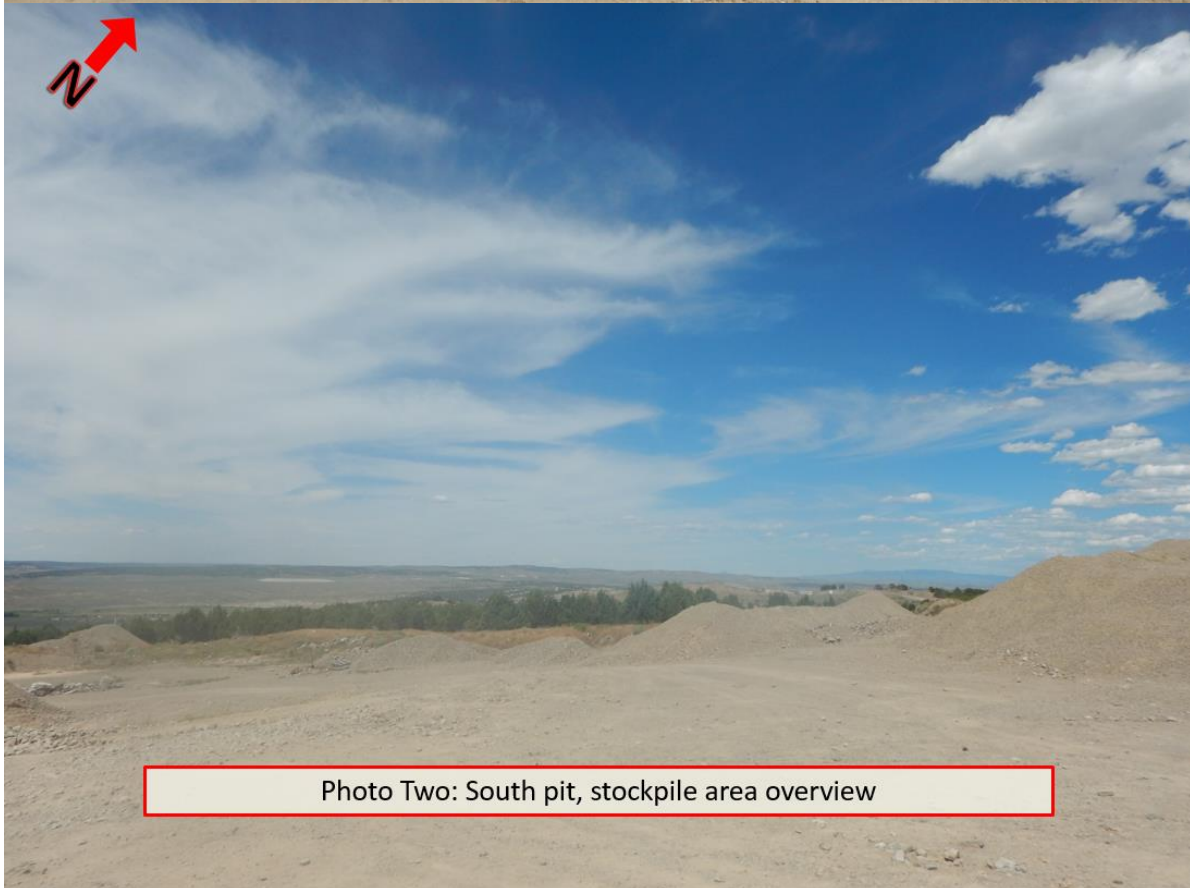
Photo Two: South pit, stockpile area overview

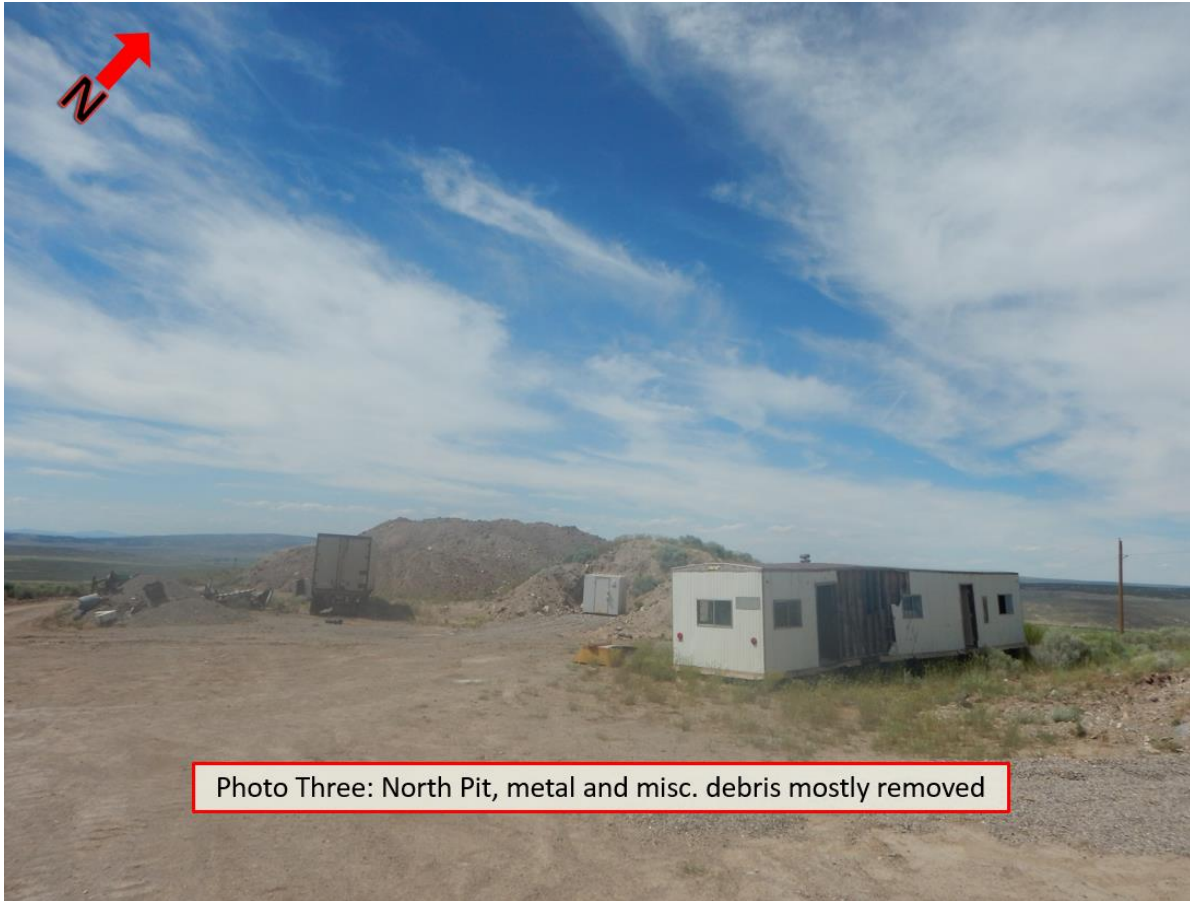
Photo Three: North Pit, metal and misc. debris mostly removed

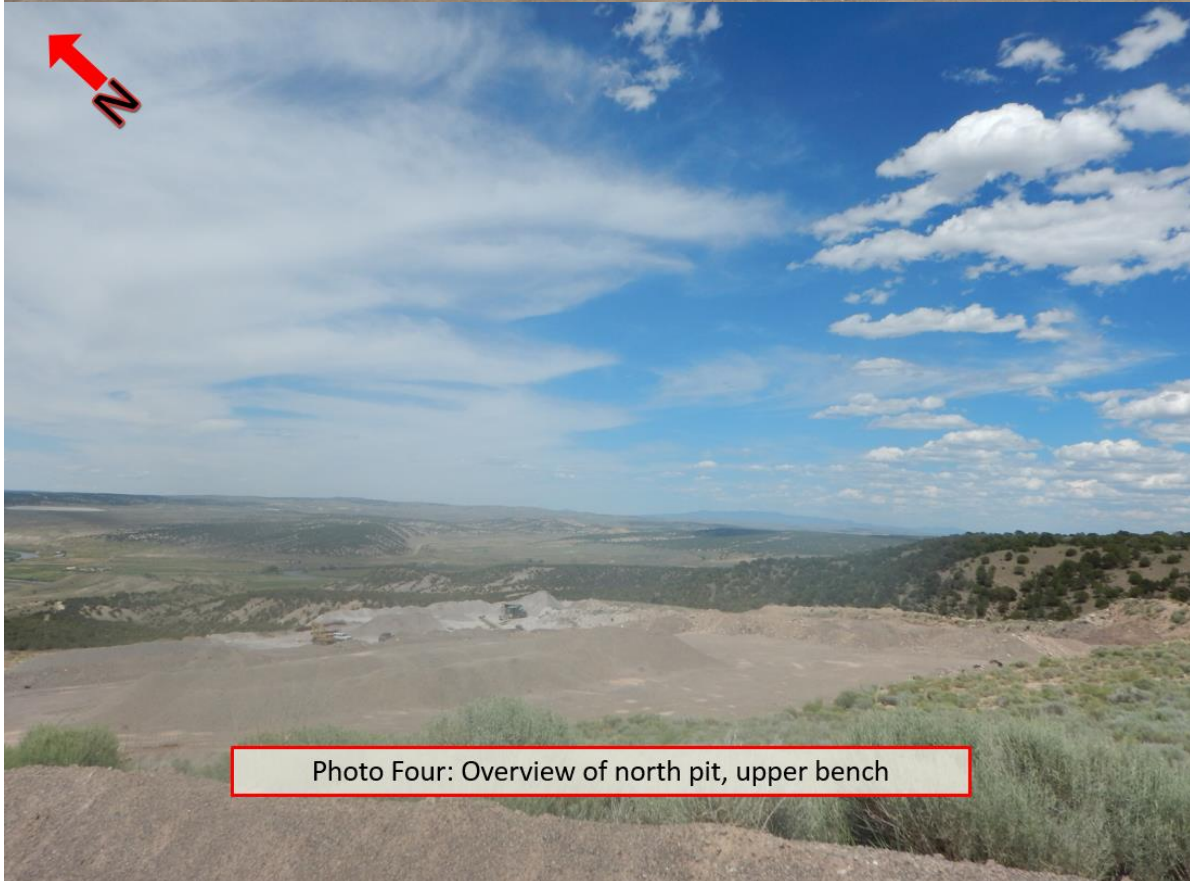
The pre-existing south highwall is approximately 100 linear feet wide, by 50 feet tall and near vertical. A 300 yards wide bench of fines is sloped at a 1H:1V will be graded to 3H: 1V.

Photo Four: Overview of north pit, upper bench

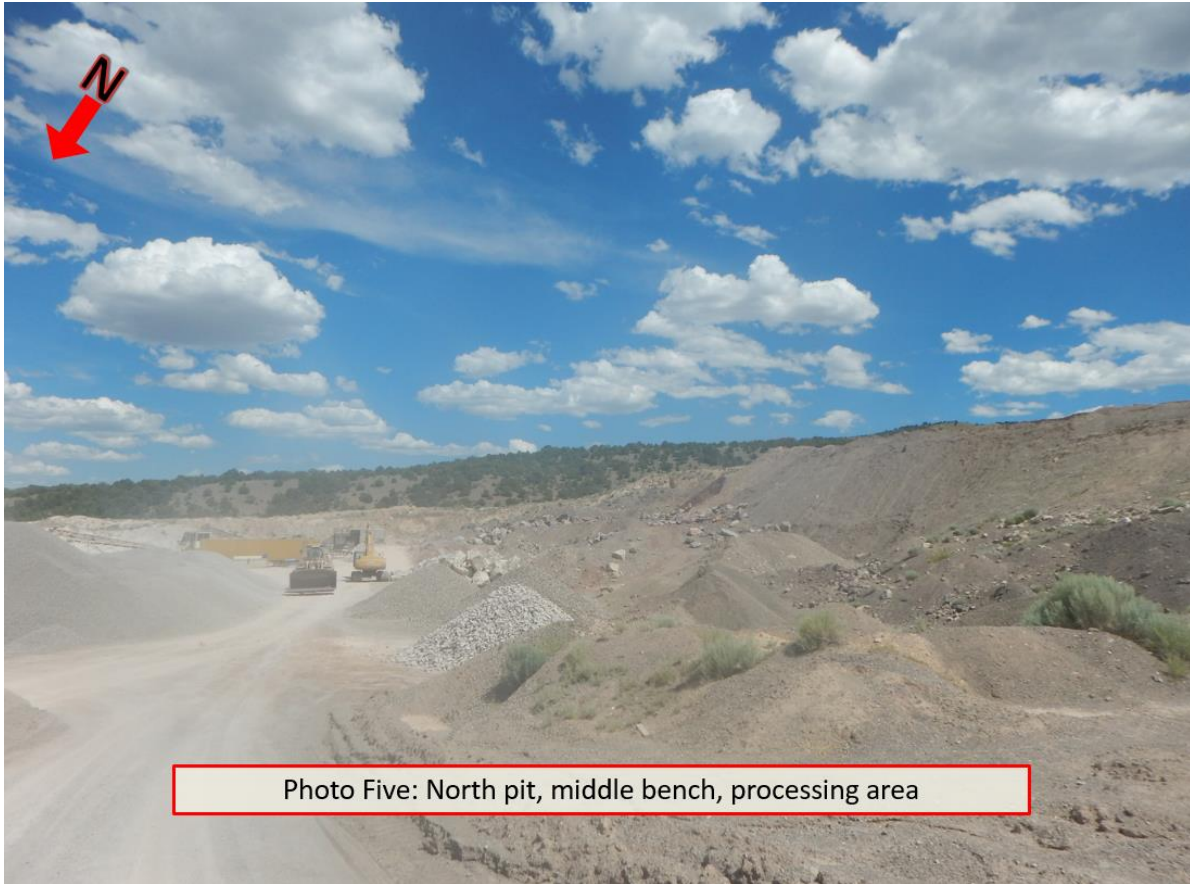
The middle fines bench is 500 linear feet wide by 30 feet high at a 1H: 1V going to a 3H: 1V. Below is vertical rock wall bowl/highwalls. One is 100 linear feet wide vertical 30 feet high. Adjacent is 200 linear feet wide, 40 feet high a 1H: 1V. Some topsoil/overburden is stored north of this highwall to be used for grading.

Photo Five: North pit, middle bench, processing area

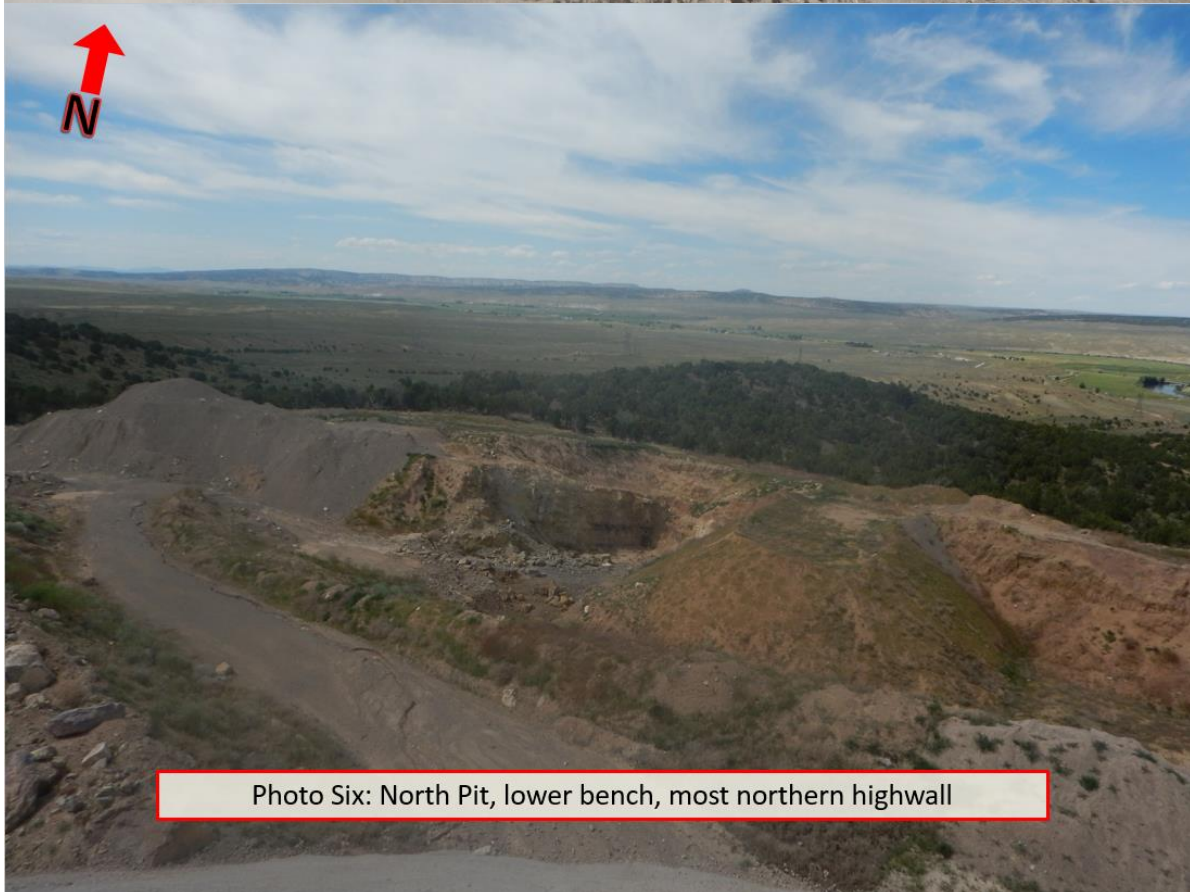
Photo Six: North Pit, lower bench, most northern highwall

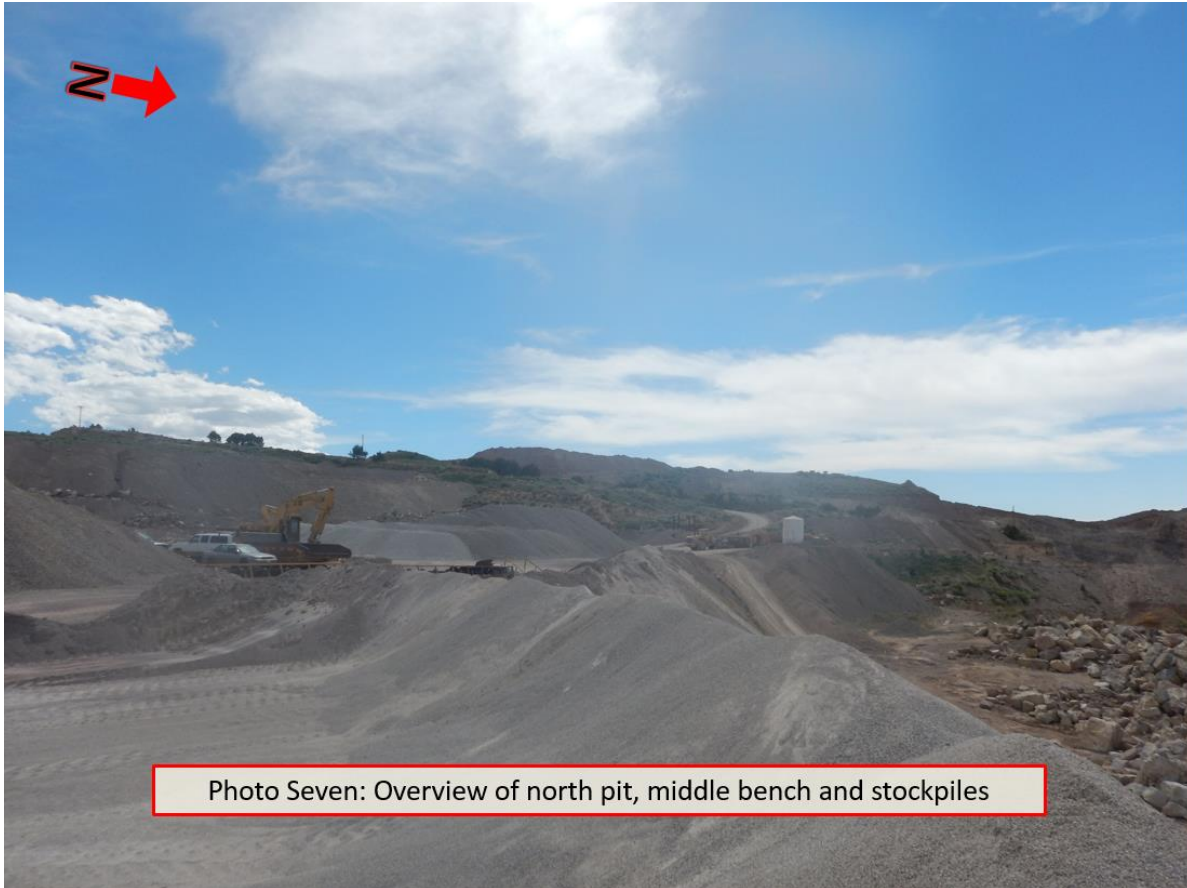
Photo Seven: Overview of north pit, middle bench and stockpiles

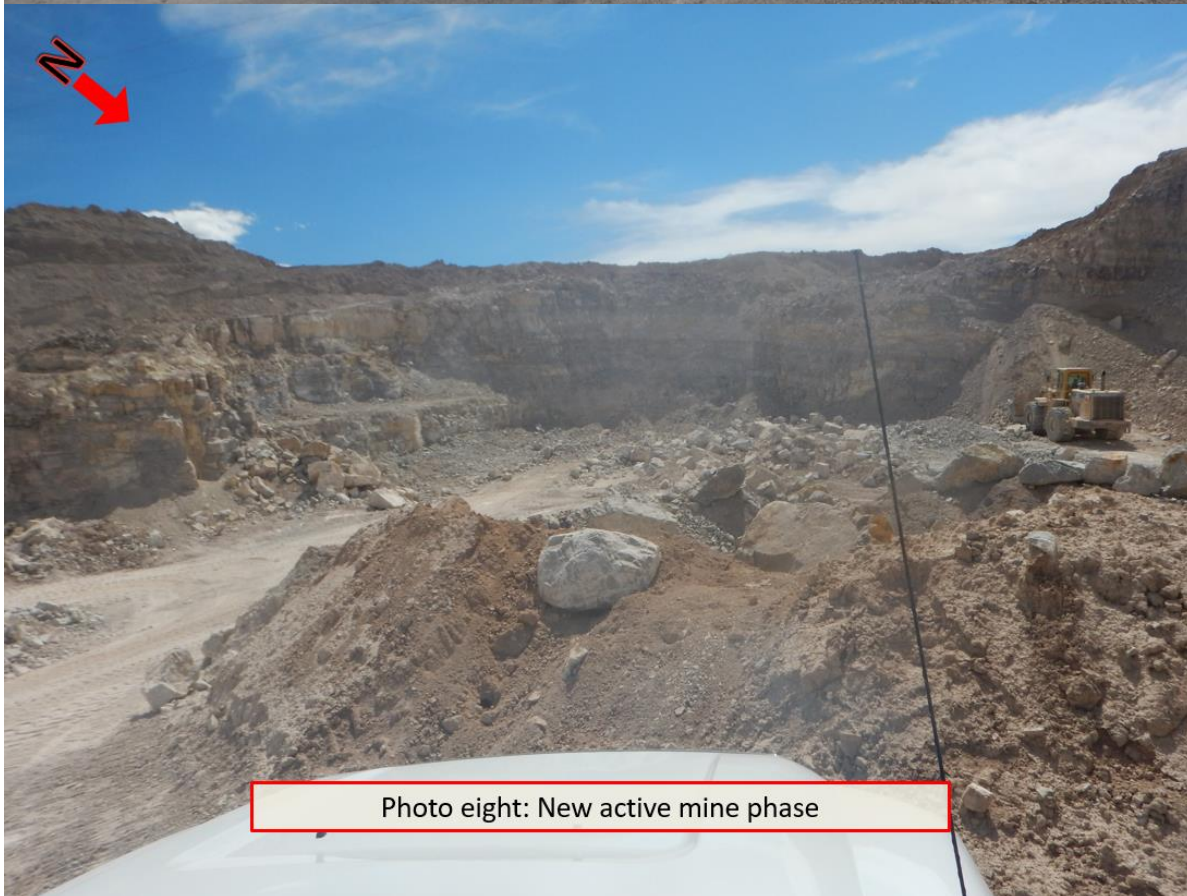
There is a new active highwall area in the northwest corner of the pit that is bowl shaped. The highwall is 300 linear feet wide and 50 feet high near vertical with one bench in the middle. In future mining each bench will be approximately 20-30 foot high (one additional bench is anticipated) and mining will eventually daylight out to the west. There is an overhead electrical line that goes through this area. There is a 50 foot setback from the poles resulting in pillars/islands.

TR-4 updated the maximum disturbance in this area to 25 acres, currently approximately 30 acres are disturbed. This includes roads and storage areas. The Operator is reminded that until reclaimed lands are released they also count towards overall disturbance. Please reclaim additional lands to compensate for the new northwestern mining phase within the north pit.

Photo eight: New active mine phase
