MINERALS PROGRAM INSPECTION REPORT
PHONE: (303) 866-3567

MINE NAME: West Side Placer	MINE/PROSPECTING ID#: M-2016-081	MINERAL: Gold, niobium (colorado), rare earths	COUNTY: Moffat
INSPECTION TYPE: Monitoring	INSPECTOR(S): Amy C. Yeldell	INSP. DATE: July 18, 2019	INSP. TIME: 12:45
OPERATOR: AuPt Industries LLC	OPERATOR REPRESENTATIVE: Peter Freedman	TYPE OF OPERATION: 110(2) - Hard Rock Limited Impact	
REASON FOR INSPECTION: Normal I&E Program	BOND CALCULATION TYPE: Complete Bond	BOND AMOUNT: \$39,160.00	
DATE OF COMPLAINT: NA	POST INSP. CONTACTS: None	JOINT INSP. AGENCY: None	
WEATHER: Clear	INSPECTOR'S SIGNATURE:

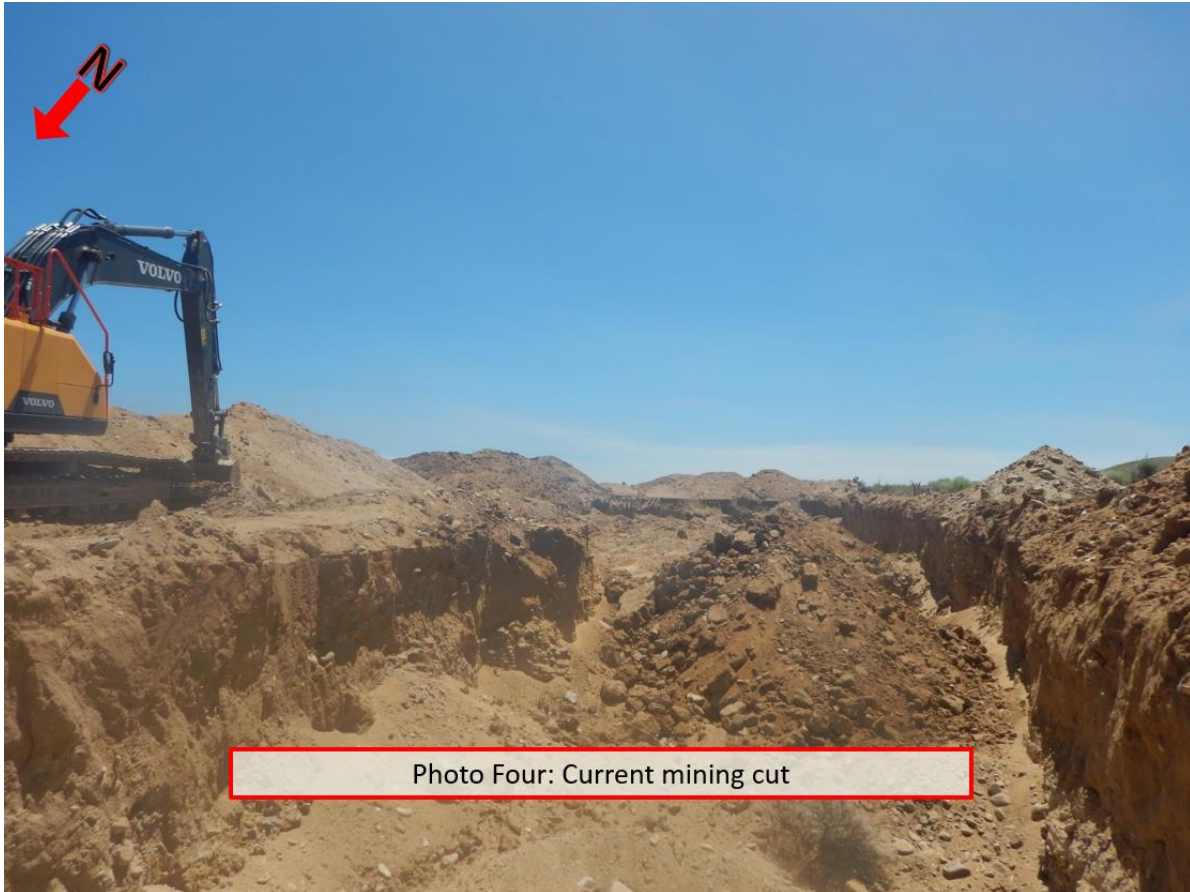
Photo Four: Current mining cut

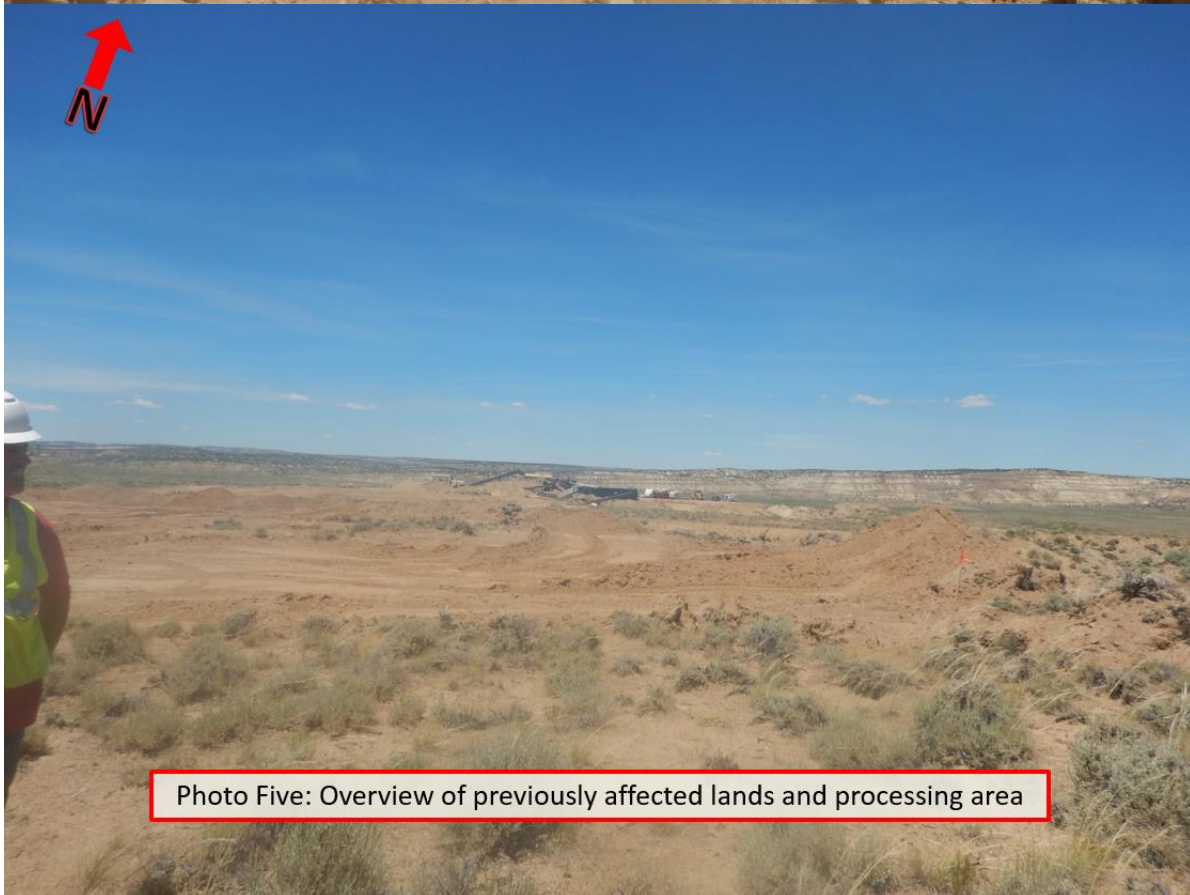
Photo Five: Overview of previously affected lands and processing area
