MINERALS PROGRAM INSPECTION REPORT
PHONE: (303) 866-3567

MINE NAME: Brent Pit	MINE/PROSPECTING ID#: M-2019-032	MINERAL: Borrow material for	COUNTY: Lincoln
INSPECTION TYPE: Monitoring	INSPECTOR(S): Patrick Lennberg	INSP. DATE: August 21, 2019	INSP. TIME: 07:00
OPERATOR: Castle Rock Construction Company of Colorado, LLC		OPERATOR REPRESENTATIVE: Darren Janssen	TYPE OF OPERATION: 111 - Construction by Government Agency
REASON FOR INSPECTION: Normal I&E Program	BOND CALCULATION TYPE: Partial Bond	BOND AMOUNT: \$44,750.00	
DATE OF COMPLAINT: NA	POST INSP. CONTACTS: None	JOINT INSP. AGENCY: None	
WEATHER: Cloudy	INSPECTOR'S SIGNATURE:

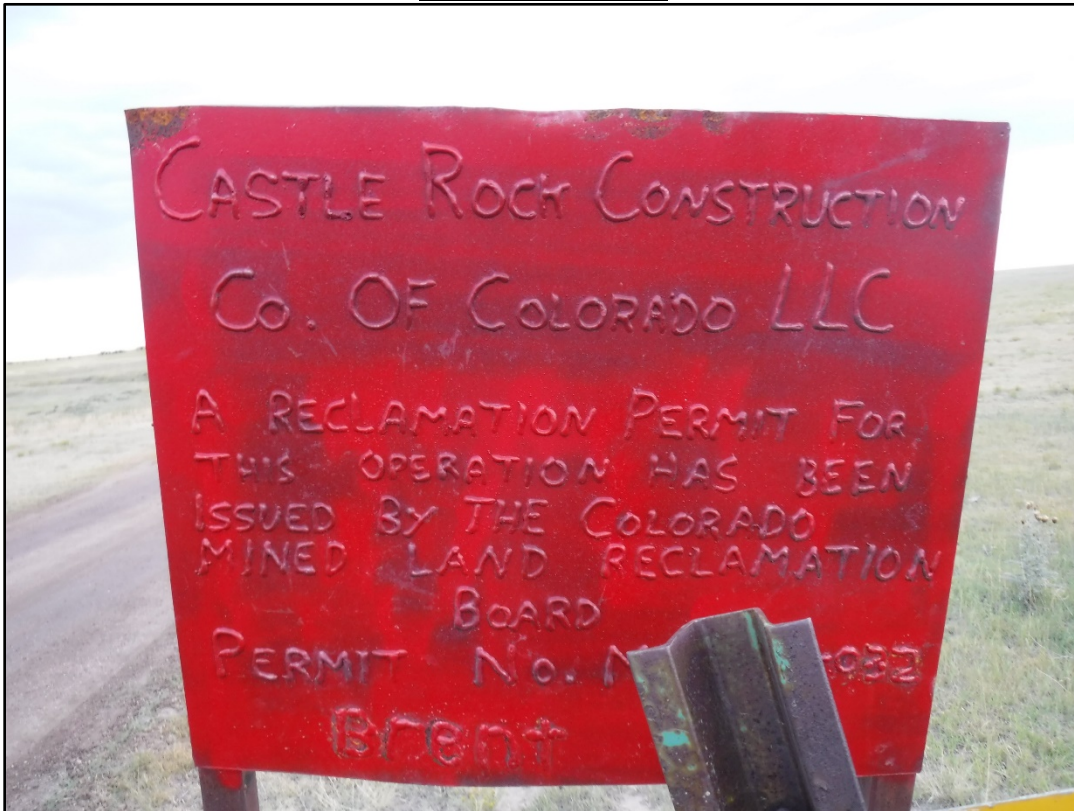
The Brent Pit is located 1.85 miles east of Arriba, CO off of a frontage road that parallels I-70 to the south. The pit is a 111 operation permitted for 15 acres for the removal of sand and gravel for I-70 road construction and maintenance. The site is surrounded by rangeland and the post-mining land use is rangeland. A mine sign was observed as required by Rule 3.1.12.

Photo 1: Mine sign at entrance off of frontage road

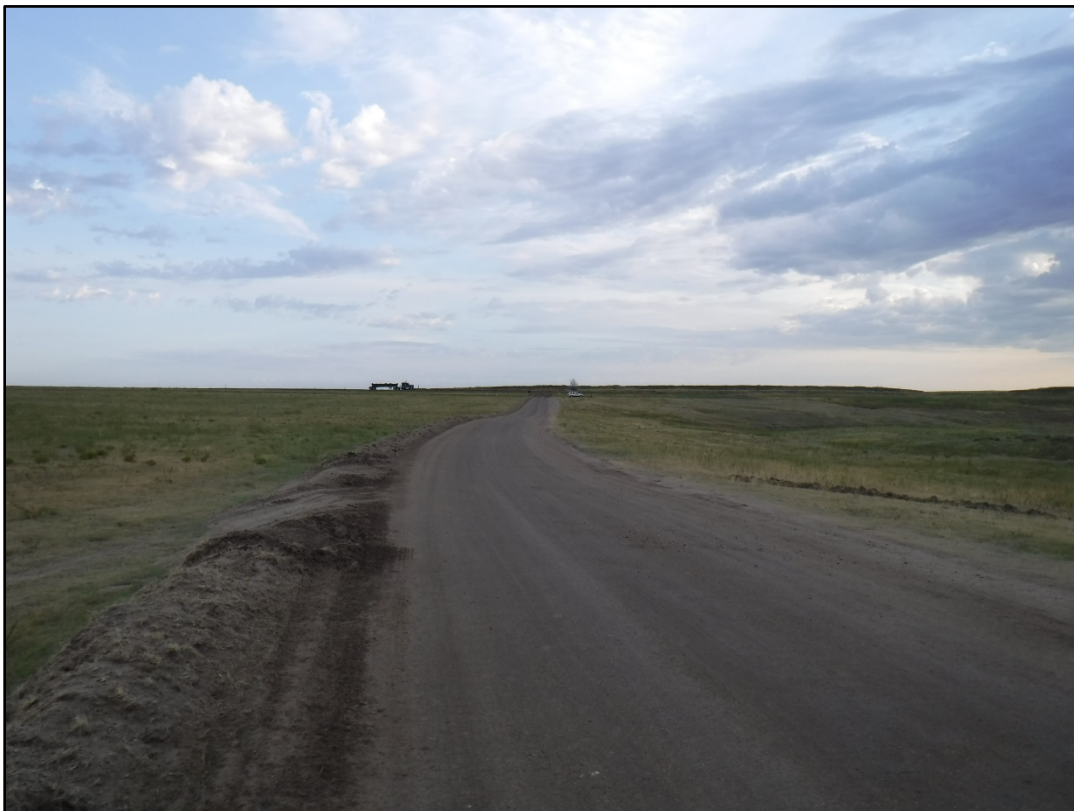
Photo 2: Looking north along the haul toward the mine entrance

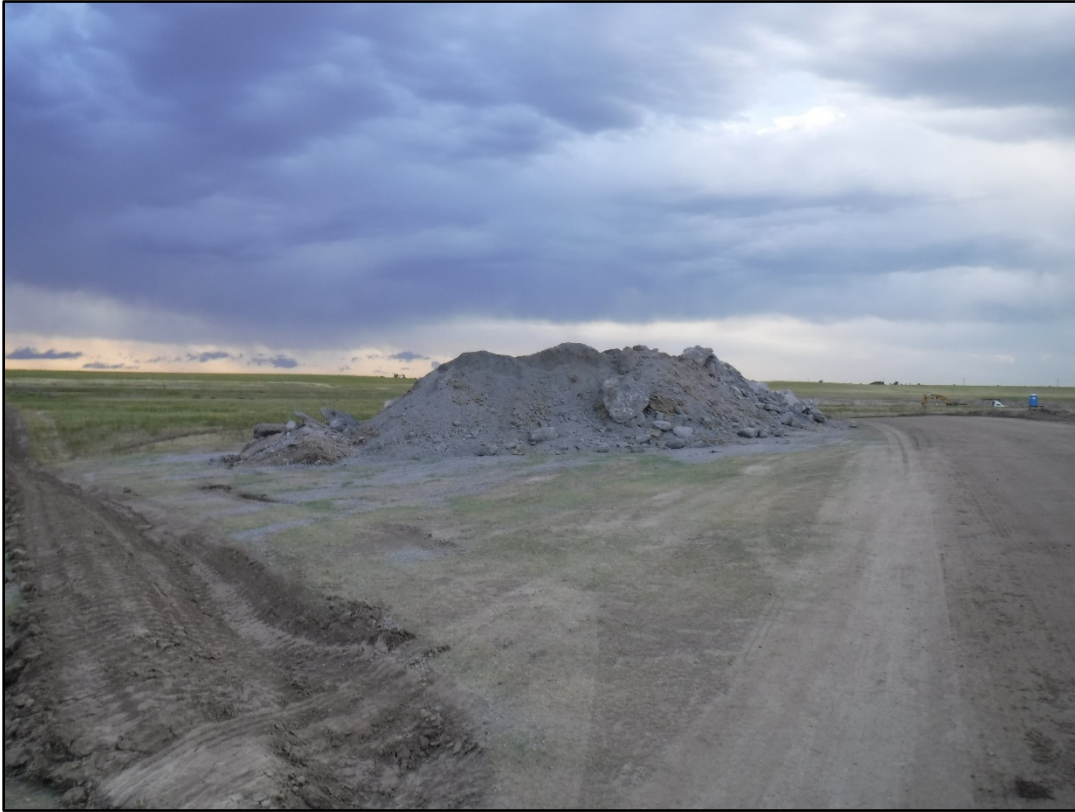
During concrete paving on I-70 it was determined that the paving machine did not spread concrete to the desired specifications and this material had to be removed. The removed concrete had been temporarily stockpiled within the permit boundary. During the inspection the Operator did not know for certain what the plans were for the material, whether they were going to haul off the material or crush it. The Operator was informed that if they wanted to crush the material onsite they would have to submit a Technical Revision (TR) along with the required fee to the Division for approval since crushing material was not part of the approved permit. In addition, the Operator was informed that if they wanted to use the material as backfill they would also have to submit, as part of the TR, an affidavit of clean and inert fill per Rule 3.1.5(9).

Photo 3: Temporary stockpile of concrete debris

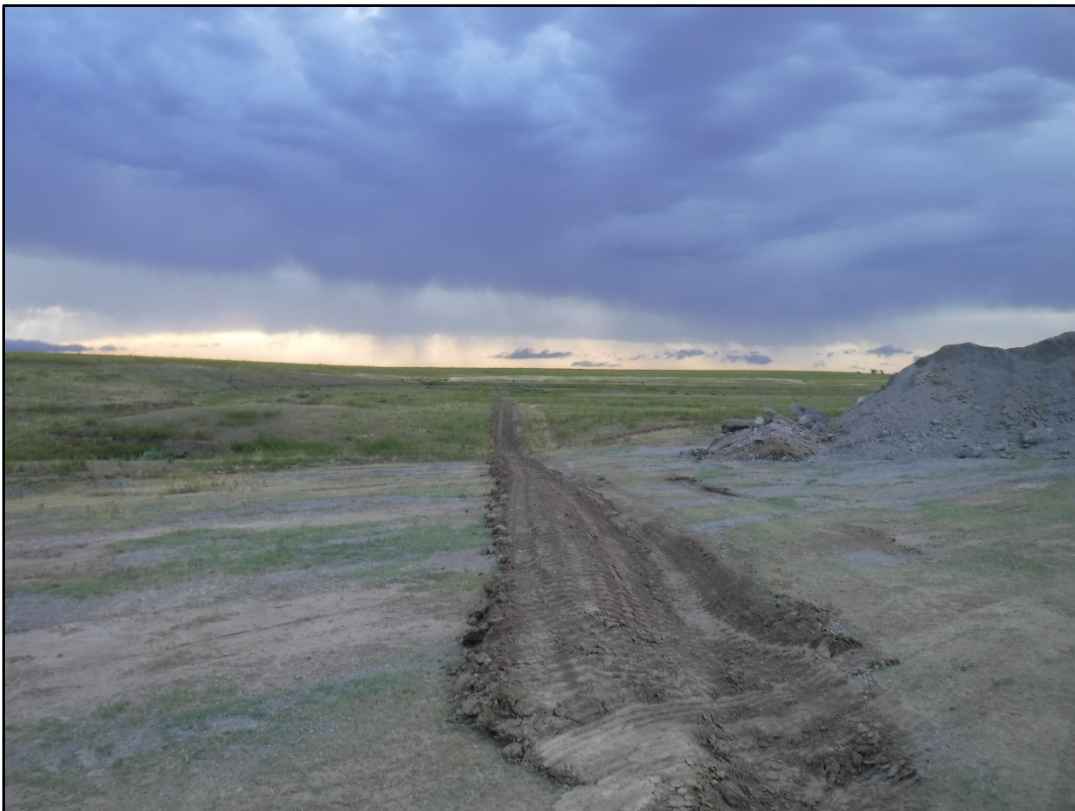
The site was active during the inspection. An excavator was digging material and loading onto haul trucks that then transported the material to active construction locations along I-70. The permit boundaries were clearly marked with wooden stakes and high visibility flagging. A run-on/-off control berm had been cut in parallel to the permit boundary. A topsoil stockpile was adjacent to the excavation area, to the south. Additional topsoil stockpiles have been created at the perimeters of the anticipated excavation area.

Photo 4: Typical section of the run-on/-off control berm that follows permit boundary

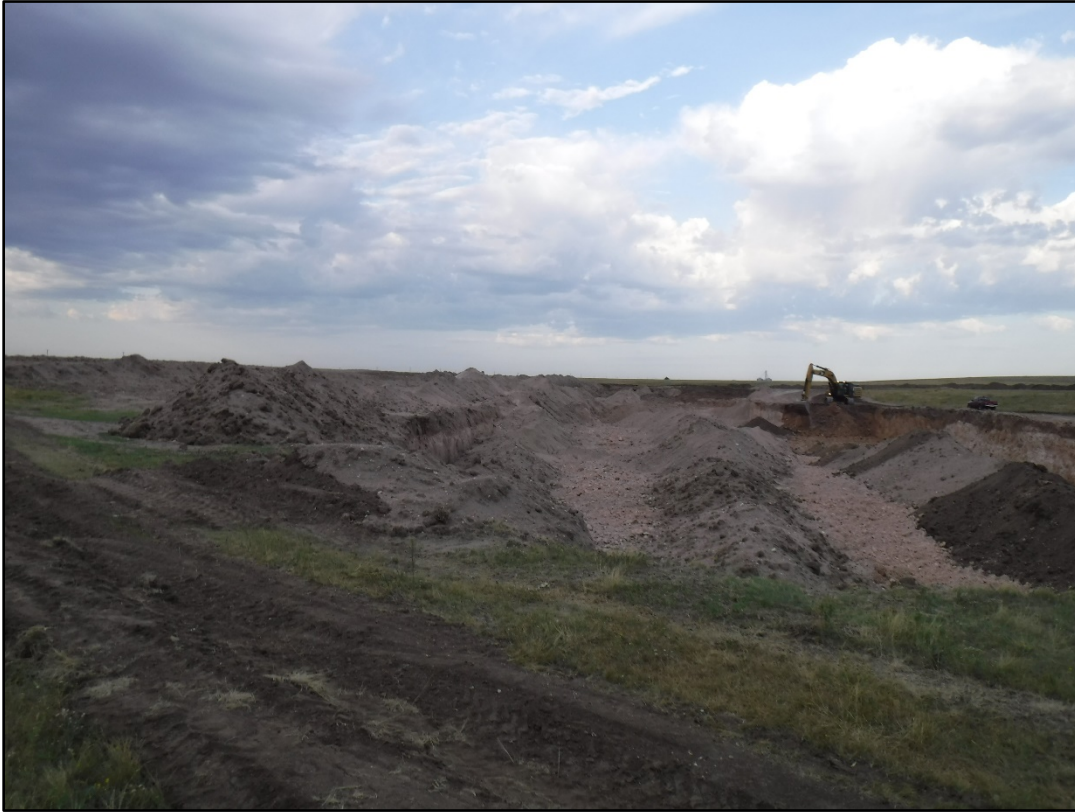
Photo 5: Active excavation area

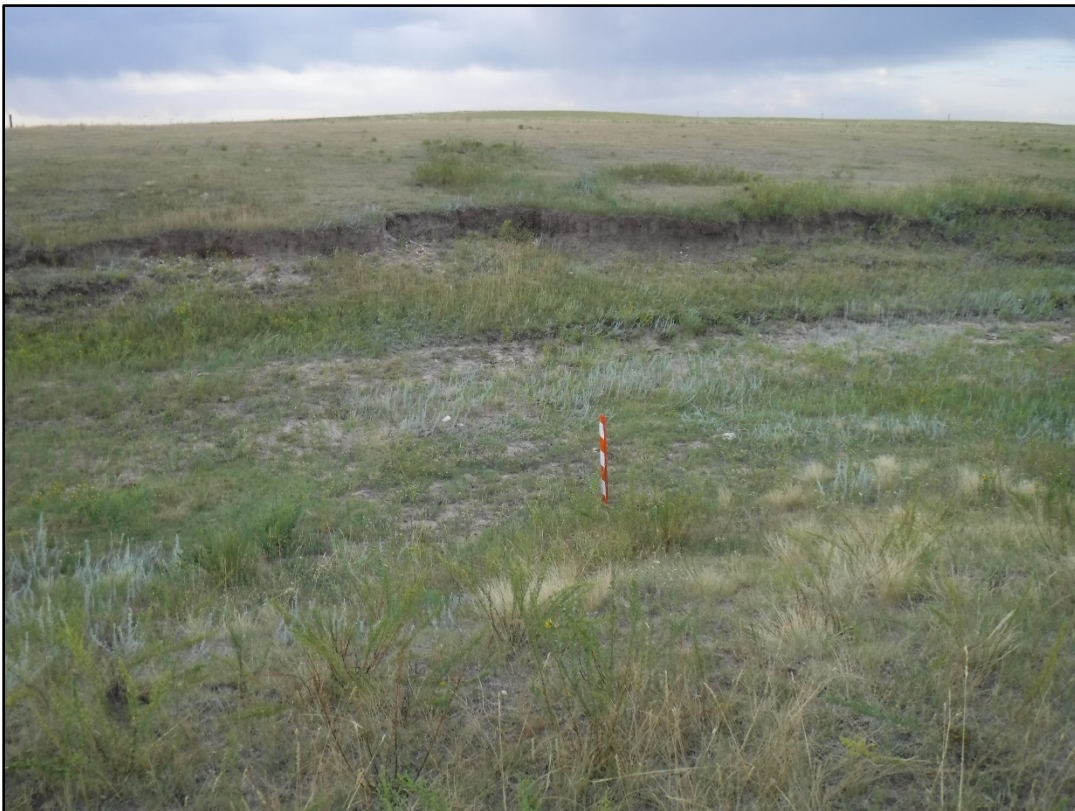
The Division was able to GPS all permit boundary markers. All current mining appears to be within the permit boundaries.

Photo 6: Typical permit boundary marker

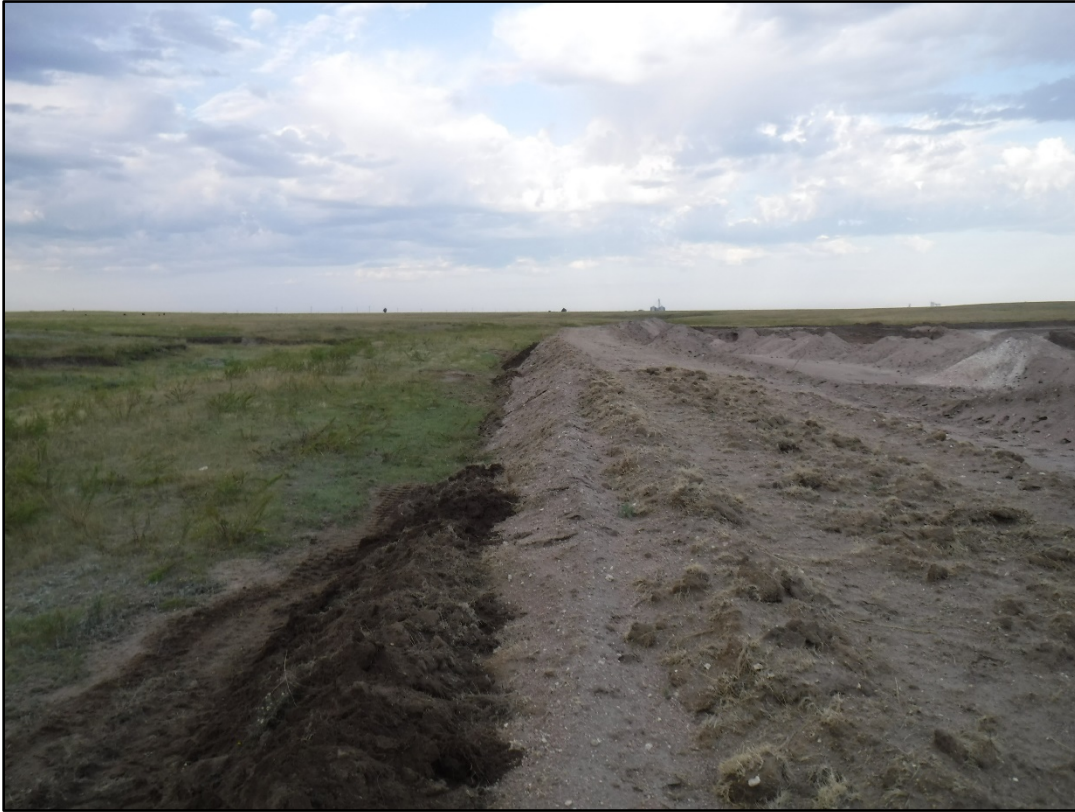
Photo 7: Topsoil stockpile to the south of active excavation

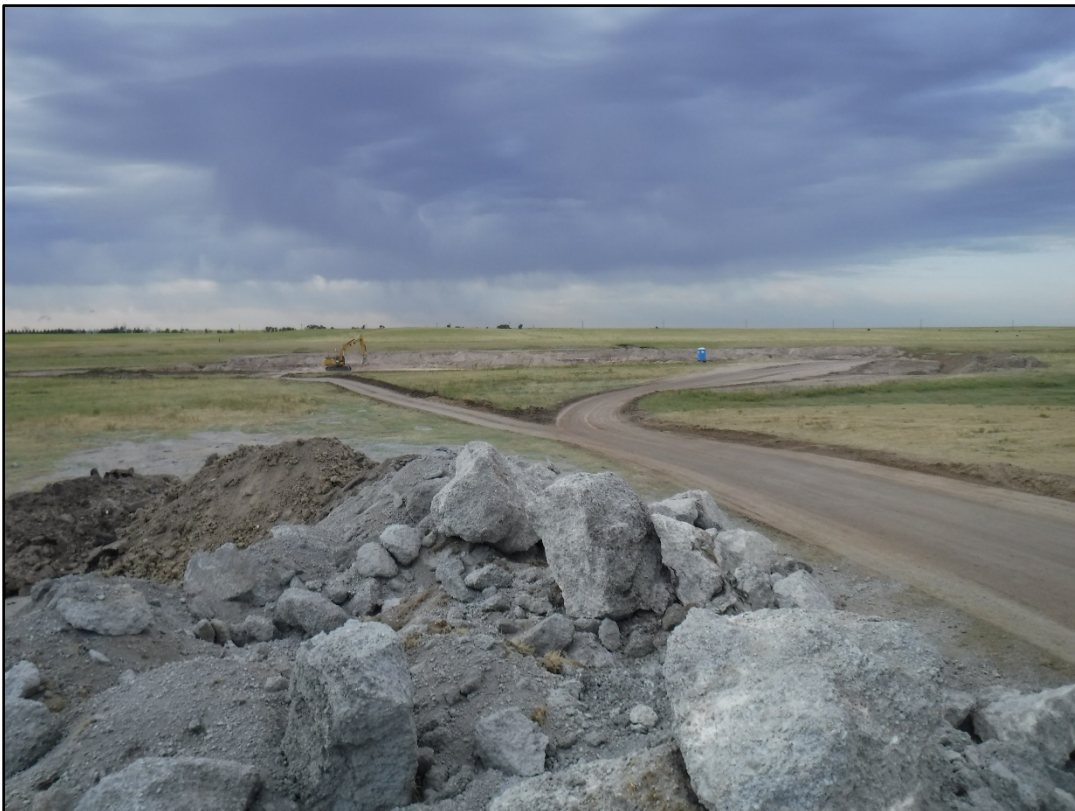
Photo 8: Looking south from the concrete pile towards the active mining area
