MINERALS PROGRAM INSPECTION REPORT
PHONE: (303) 866-3567

MINE NAME: Eikermann	MINE/PROSPECTING ID#: M-2002-108	MINERAL: Sand and gravel	COUNTY: Lincoln
INSPECTION TYPE: Monitoring	INSPECTOR(S): Patrick Lennberg	INSP. DATE: August 21, 2019	INSP. TIME: 09:30
OPERATOR: Lincoln County	OPERATOR REPRESENTATIVE: Fred Lundy	TYPE OF OPERATION: 110c - Construction Limited Impact	
REASON FOR INSPECTION: Normal I&E Program	BOND CALCULATION TYPE: None	BOND AMOUNT: \$0.00	
DATE OF COMPLAINT: NA	POST INSP. CONTACTS: None	JOINT INSP. AGENCY: None	
WEATHER: Clear	INSPECTOR'S SIGNATURE:

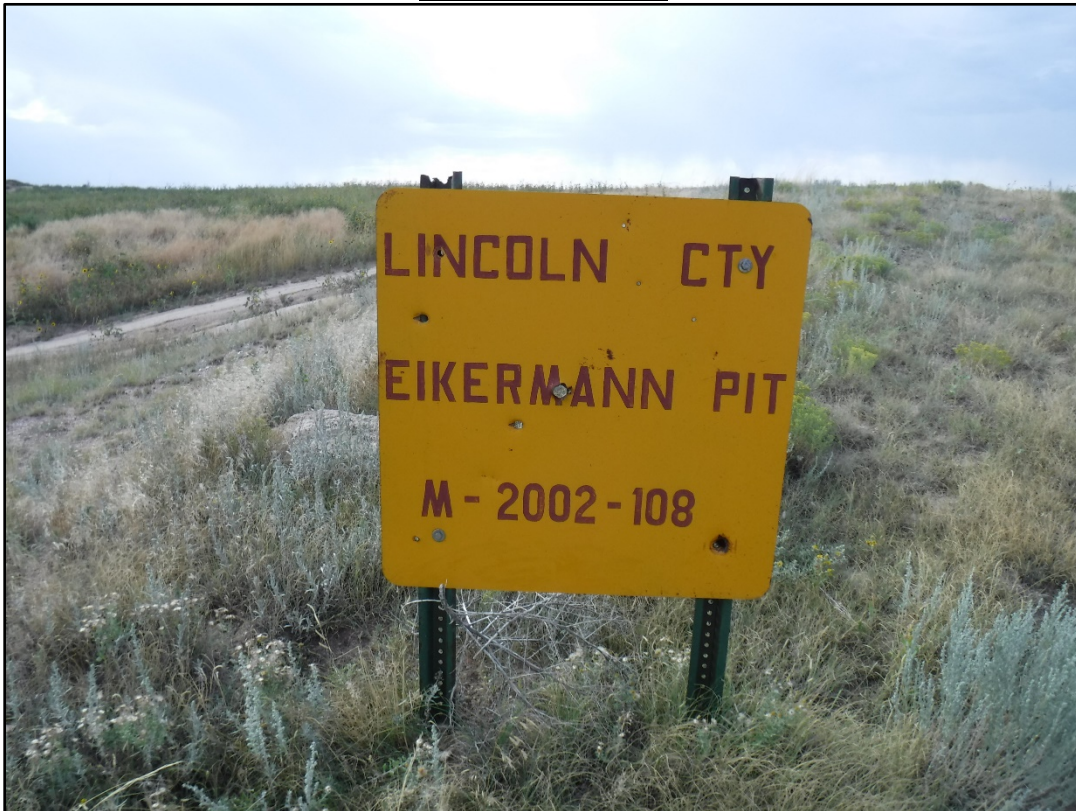
Photo 1: Mine sign at entrance off of County Road 45

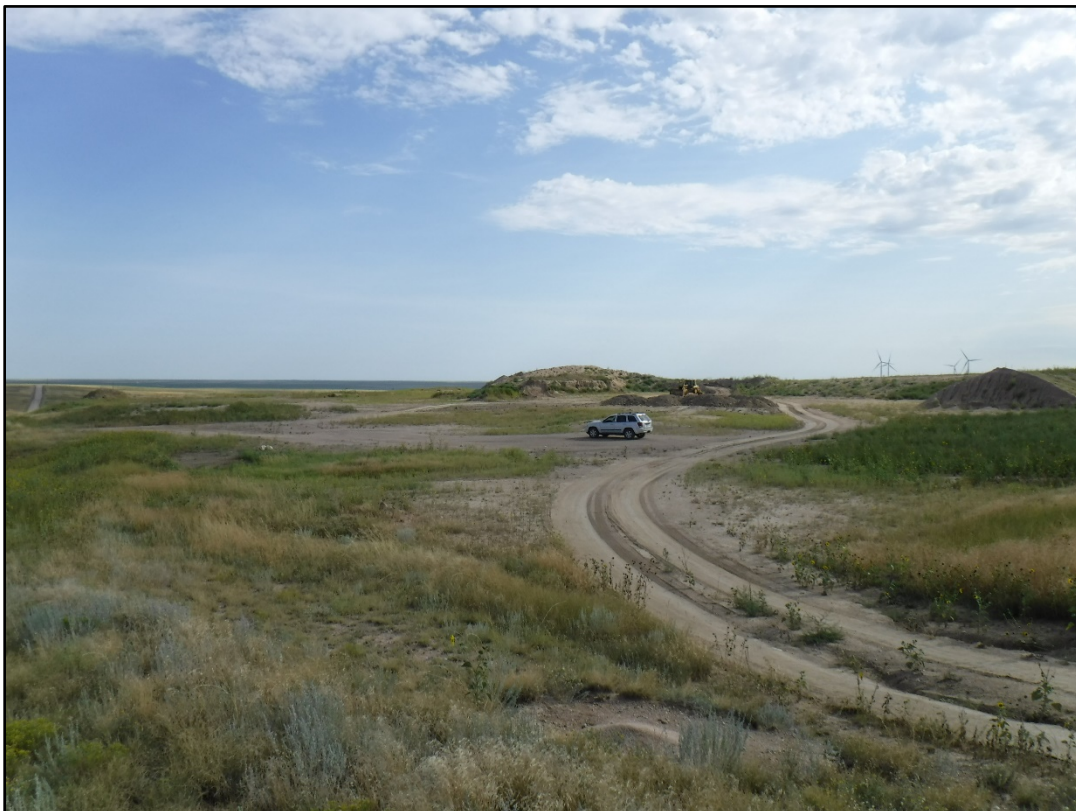
Photo 2: Looking northeast across the site from the southwestern corner

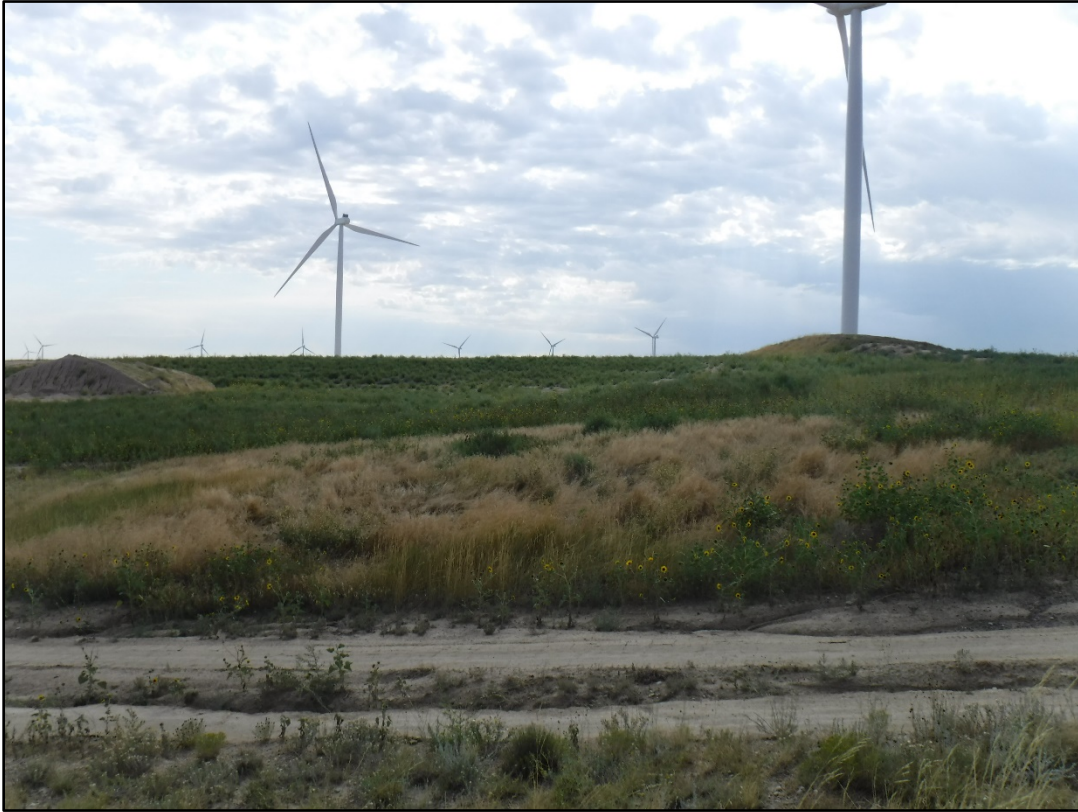
Photo 3: Looking east along the southern permit boundary area, topsoil stockpile center right of picture

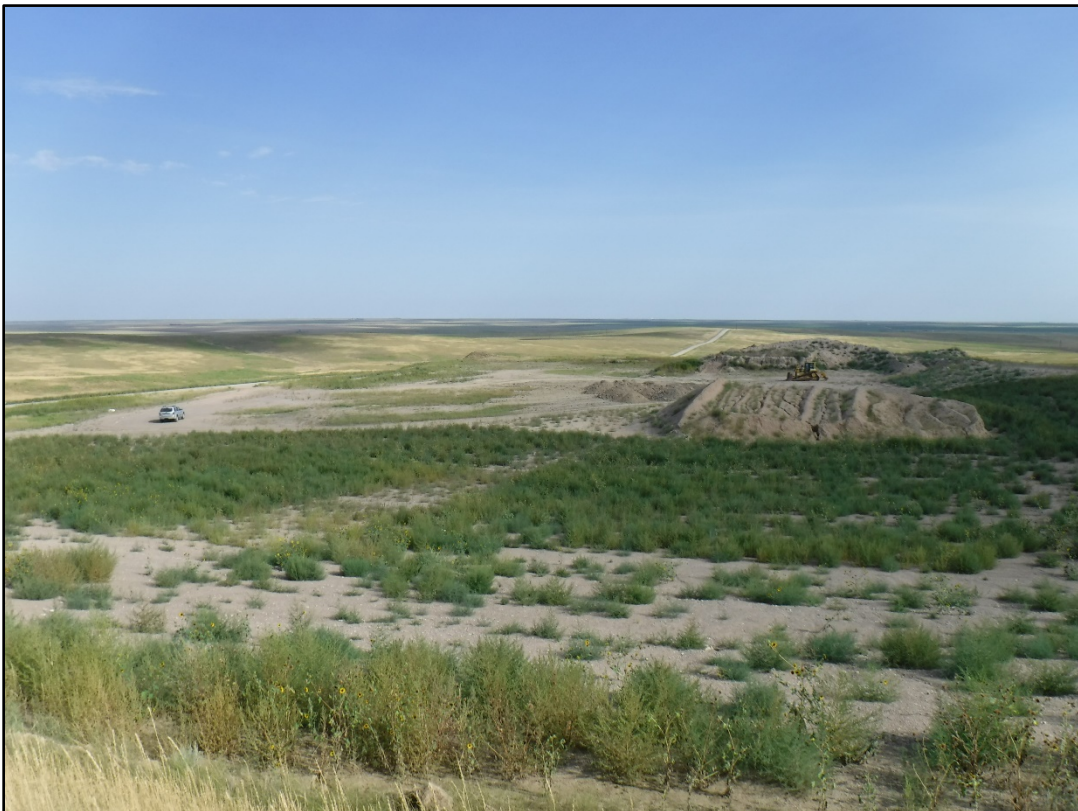
Photo 4: Looking northwest from near the southeastern corner of permit boundary

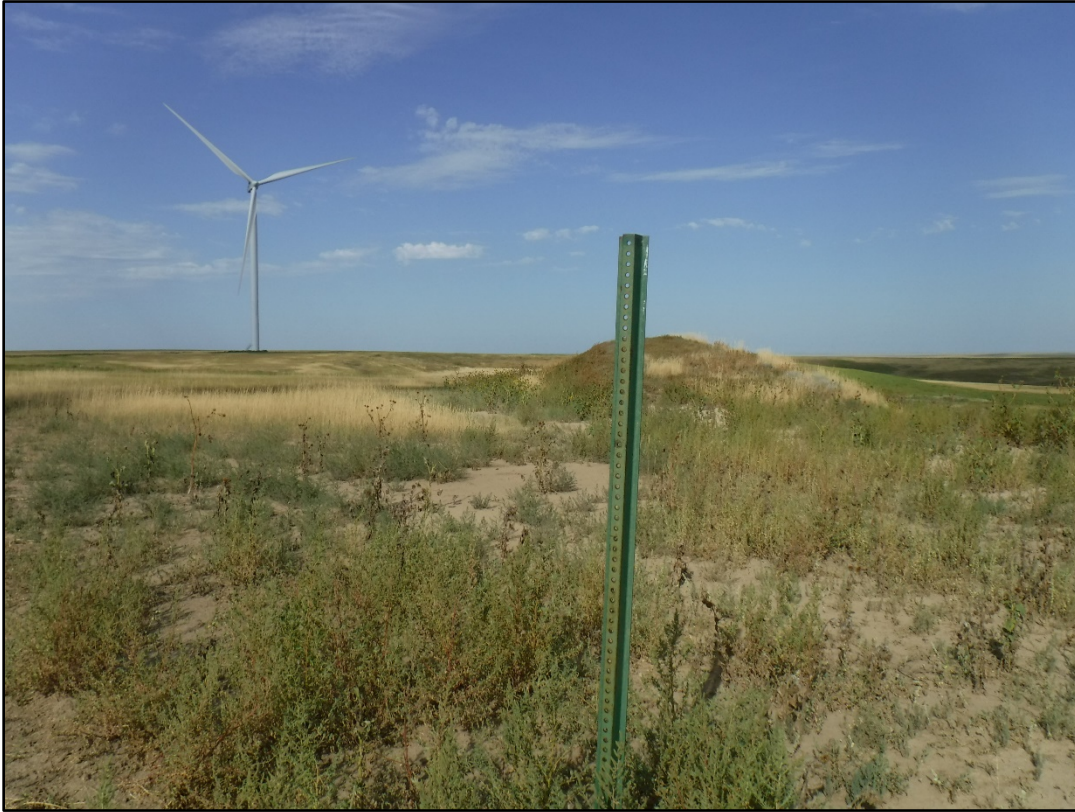
The Division was able to GPS all permit boundary markers. All current mining is within the permit boundaries.

Photo 5: Typical permit boundary marker at the site

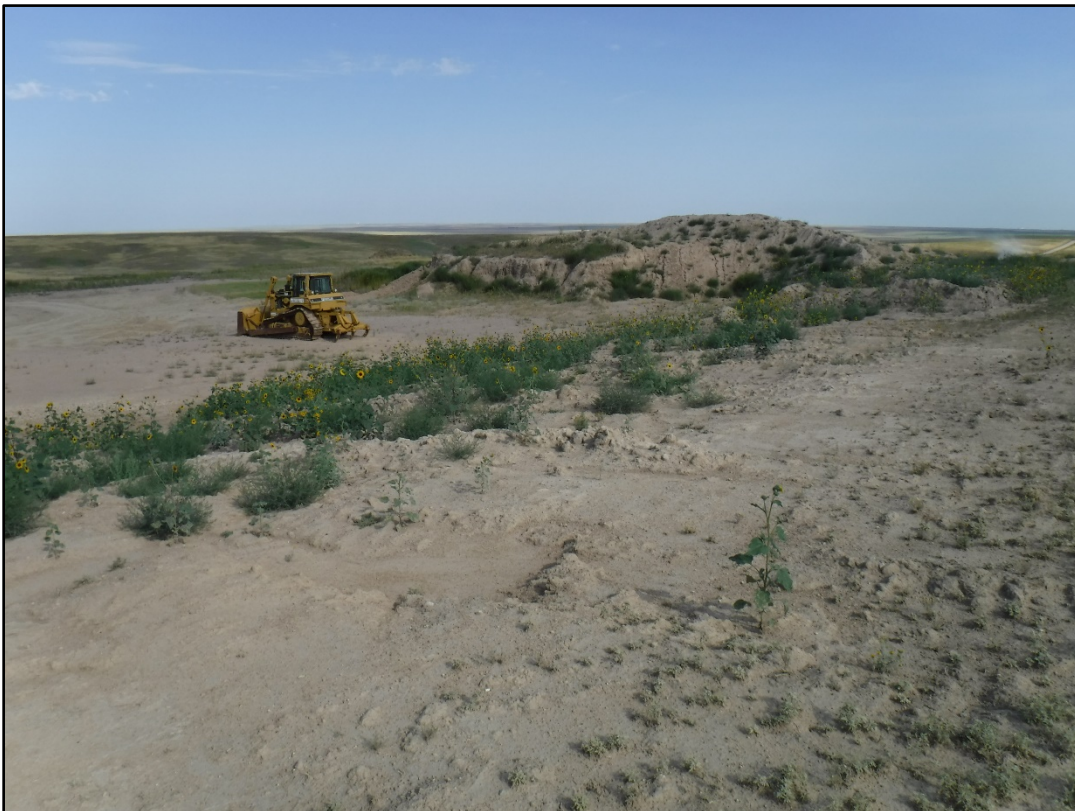
Disturbance at the site includes three short access roads on the western edge, a few topsoil stockpiles stored in the northern half of the site, overburden berms along the eastern and southern edges of the site, several material stockpiles of various sizes and shapes stored on the pit floor. The topsoil stockpiles appeared to be stable with vegetative cover consisting of native grasses mixed with annual weeds. The highwalls appeared to be stable overall, but exhibited some erosional damage in the form of rilling and a few small gullies. Erosion is contained within the permit boundaries.

Photo 6: Highwall, center of picture, showing rilling occurring that is contained on pit floor

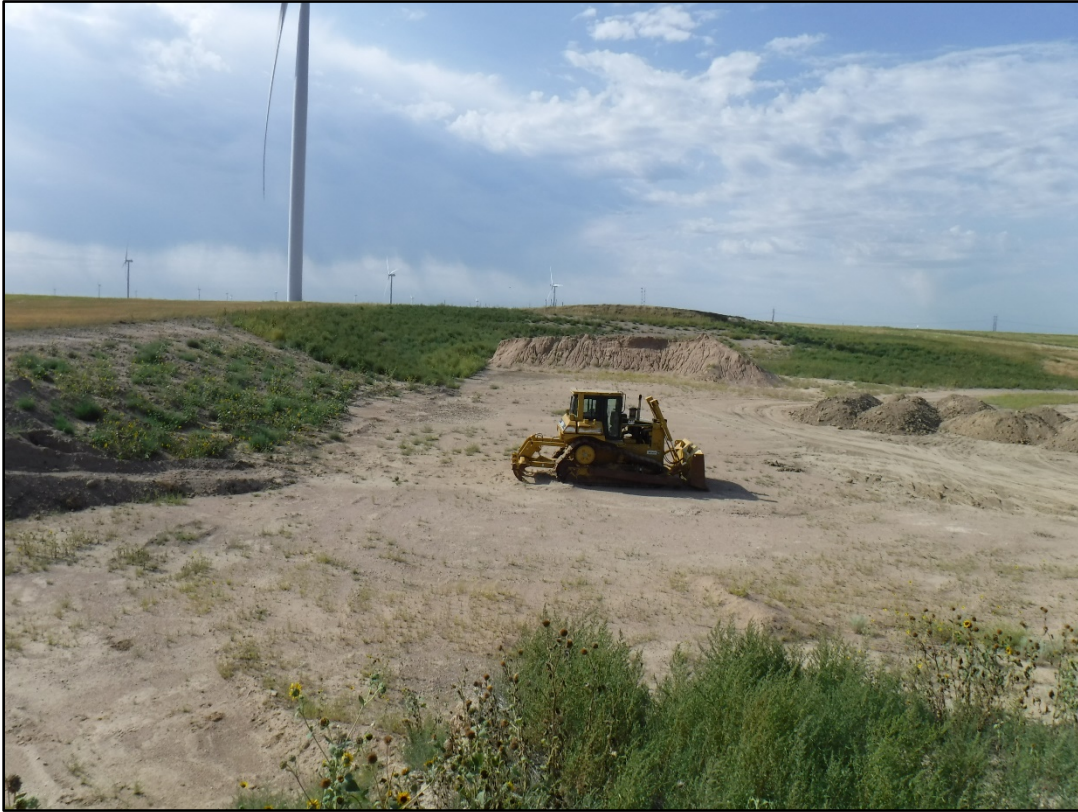
Photo 7: Conditions of the pit floor area

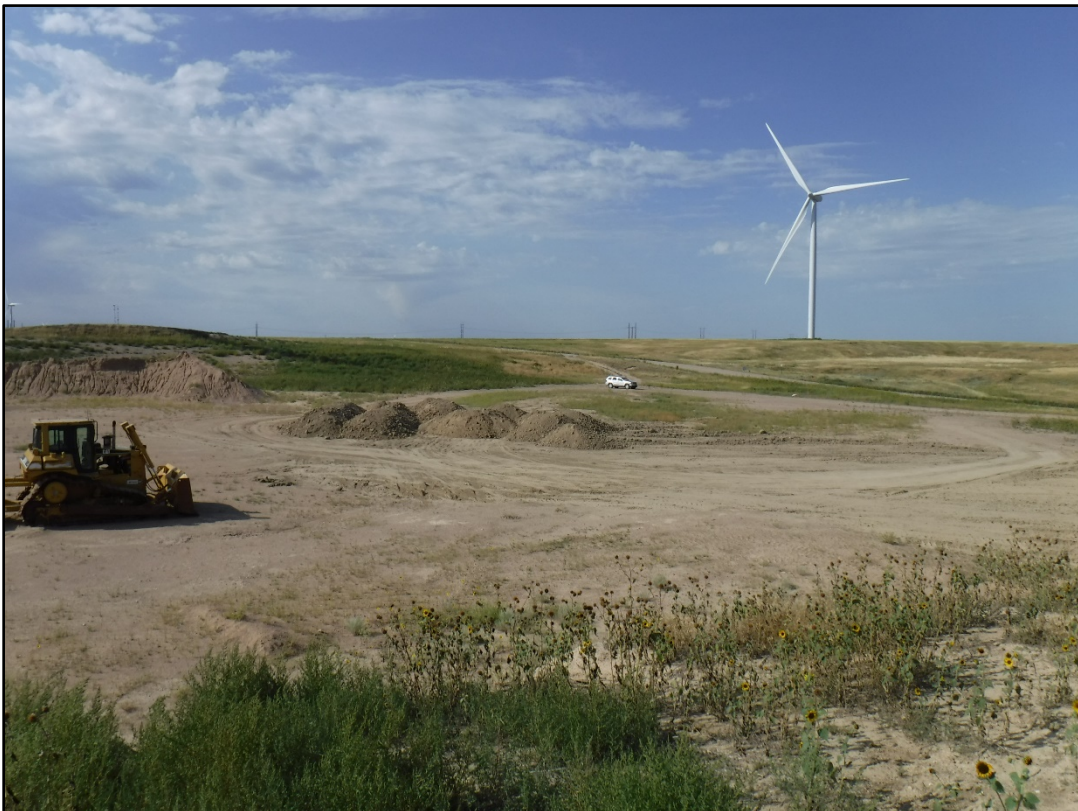
The pit was not active at the time of inspection however the pit has seen some recent activity. There is a large electrical substation that is being developed approximately $\frac{3}{4}$ mile to the south of the pit. As development for that substation, in support of the abundant windmills in the area, a power pole is going to be located within the permit boundaries. A Technical Revision will have to be submitted, with updated Mining and Reclamation maps, and letter from the power company acknowledging that they are installing a structure in an active mine permit boundaries.

Photo 8: The grassy area in the center of picture is the proposed location of the power pole
