MINERALS PROGRAM INSPECTION REPORT
PHONE: (303) 866-3567

MINE NAME: Enderson Pit	MINE/PROSPECTING ID#: M-1979-111	MINERAL: Sand and gravel	COUNTY: Lincoln
INSPECTION TYPE: Monitoring	INSPECTOR(S): Patrick Lennberg	INSP. DATE: August 21, 2019	INSP. TIME: 10:30
OPERATOR: Lincoln County	OPERATOR REPRESENTATIVE: Fred Lundy	TYPE OF OPERATION: 110c - Construction Limited Impact	
REASON FOR INSPECTION: Normal I&E Program	BOND CALCULATION TYPE: None	BOND AMOUNT: \$0.00	
DATE OF COMPLAINT: NA	POST INSP. CONTACTS: None	JOINT INSP. AGENCY: None	
WEATHER: Clear	INSPECTOR'S SIGNATURE:

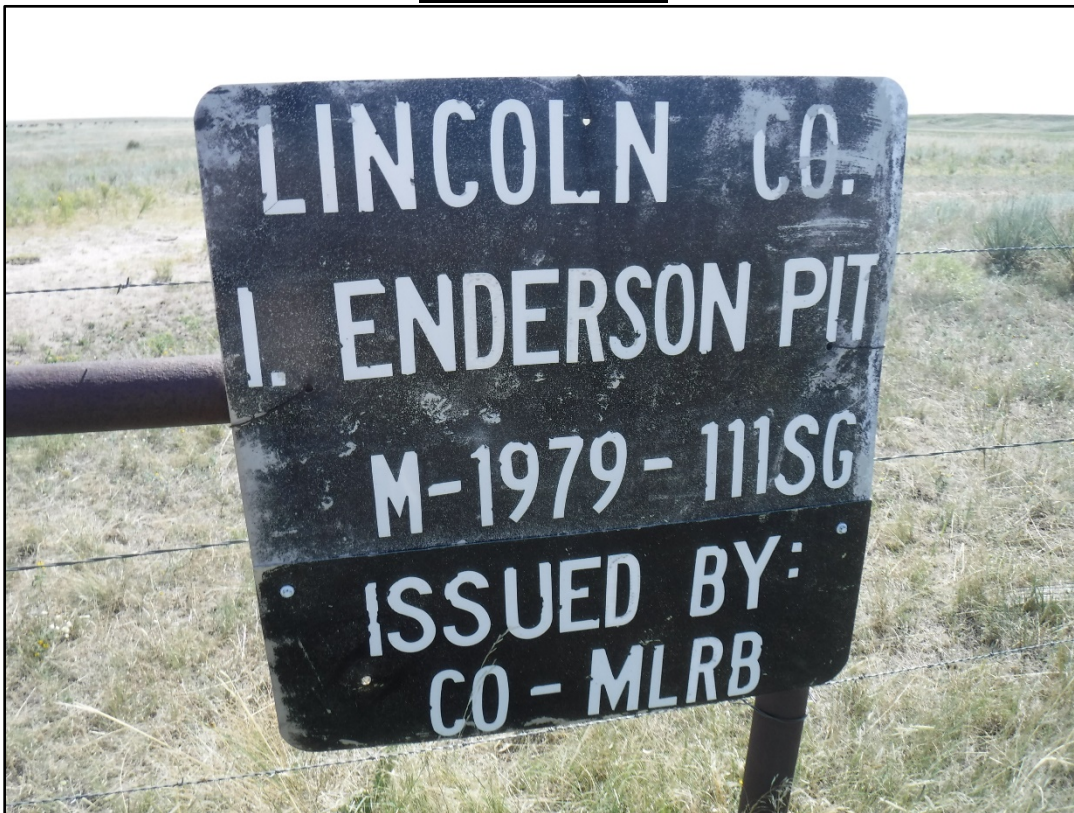
The Enderson Pit is located approximately 25 miles northeast of Genoa, Colorado. Access to the site is off of Co Rd 43. The site is situated on the South Fork of the Arickaree River, which only flows during heavy storm events. When carrying water, the river flows eastward. The affected land is owned by Ivan Enderson. The pit is a 110c operation permitted for 6.3 acres for the removal of sand and gravel for county road maintenance and repair. The site is surrounded by rangeland and the post-mining land use is rangeland. A mine sign was observed as required by Rule 3.1.12.

Photo 1: Mine sign at entrance off of County Road 43

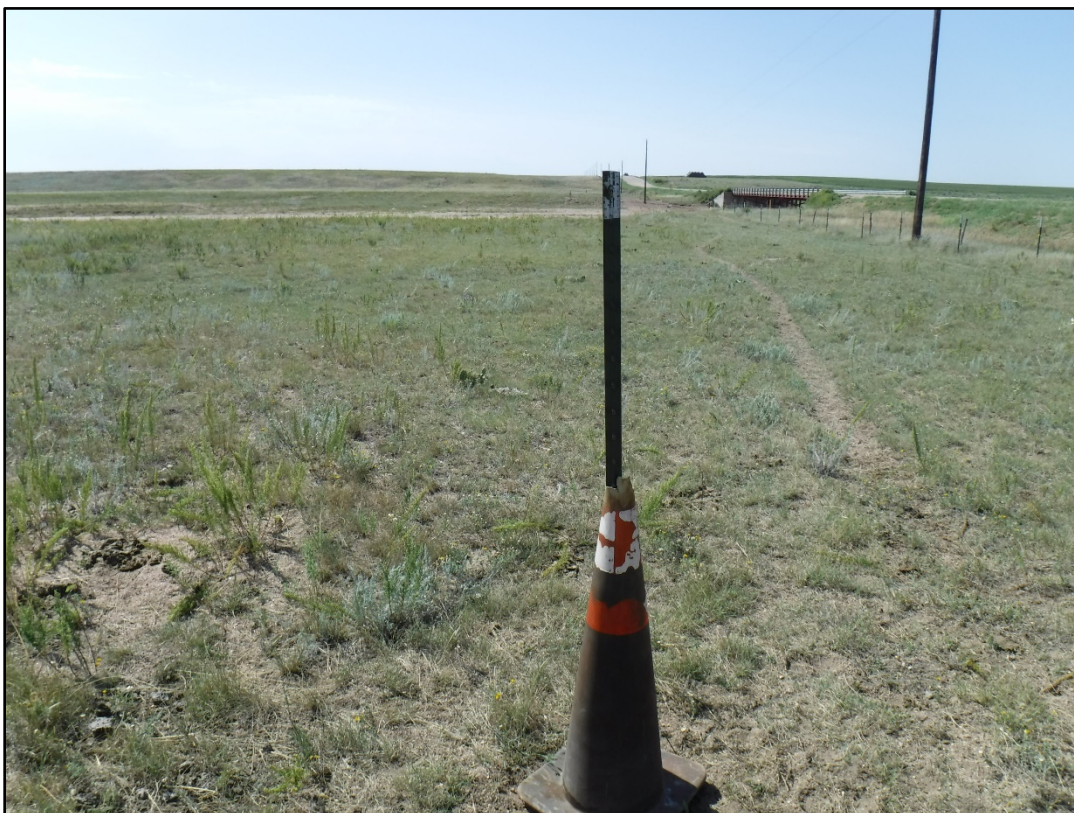
The Division was able to GPS all permit boundary markers. All current mining is within the permit boundaries.

Photo 2: Typical permit boundary corner marker

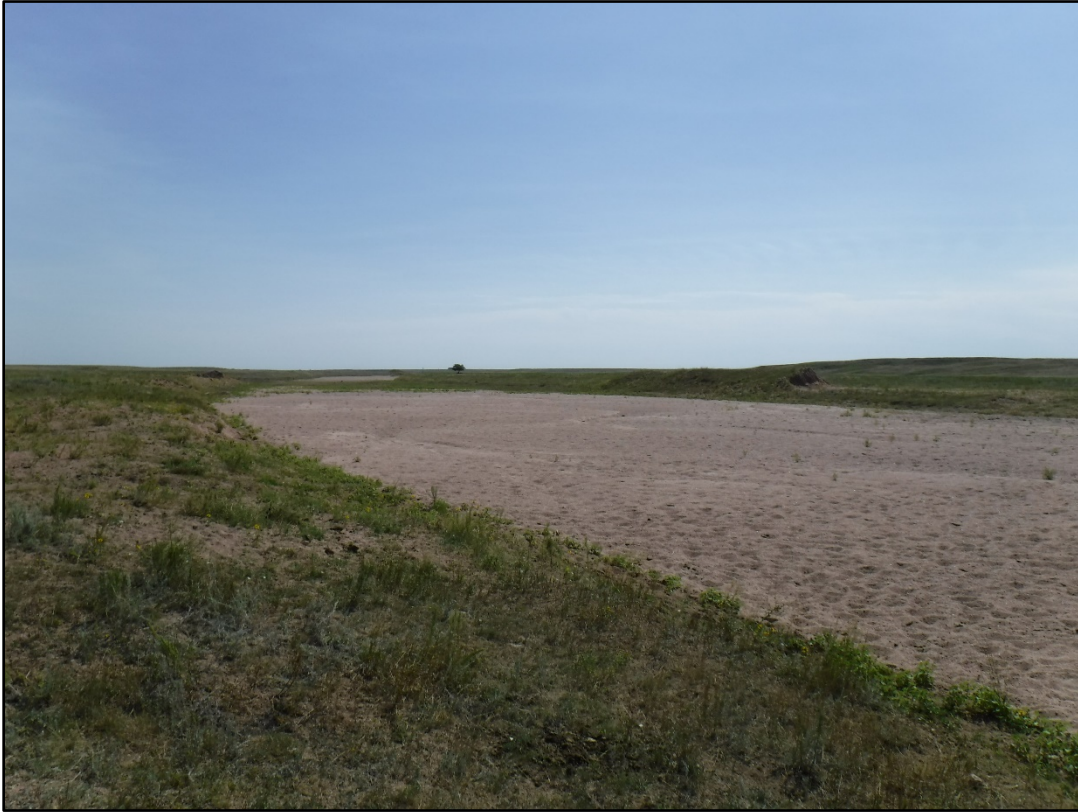
The site was not active at the time of inspection. Mining at the site consists of pushing material up from the riverbed and stockpiling on the northern banks of the river. The material is then loaded onto trucks and transported off-site. It does not appear that the site has been active recently. The northern banks and stockpiling area are relatively flat and native grasses and annual weeds have volunteered into the area. The riverbed appears undisturbed, although this could be due to the high amount of precipitation this year.

Photo 3: Area of the riverbed that was most recently mined but shows little evidence of disturbance, looking SE

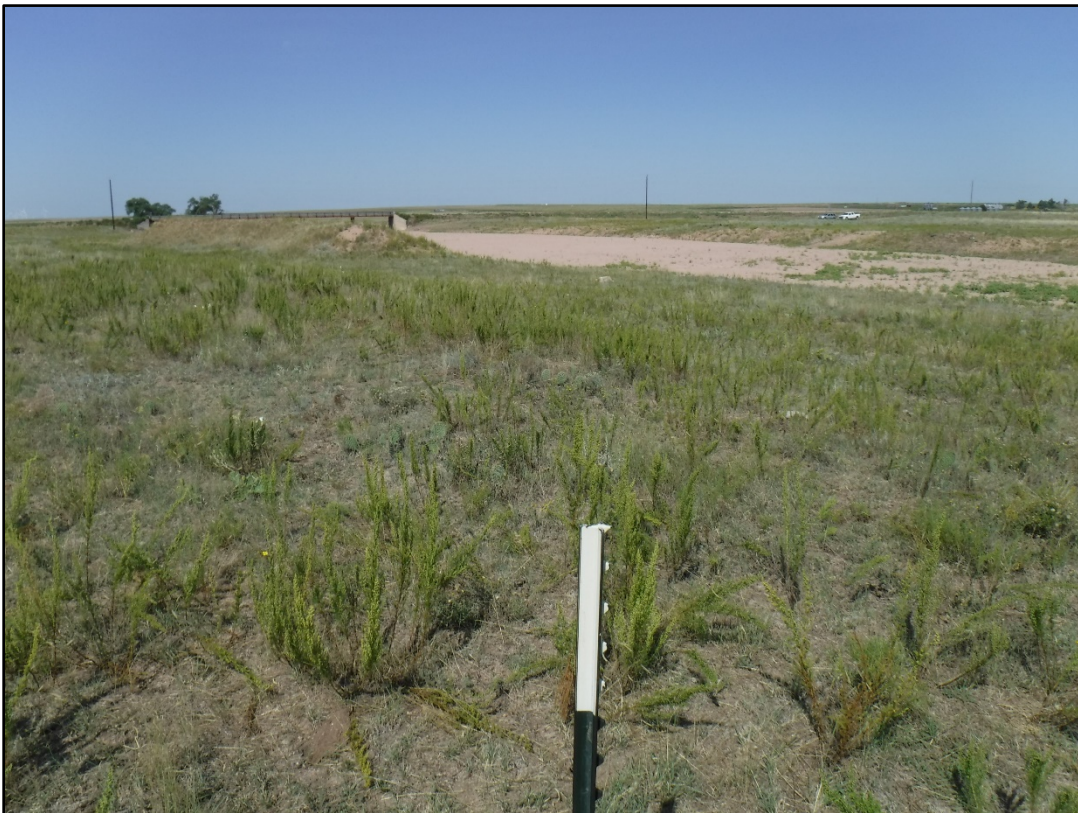
Photo 4: Looking from the southeastern corner across the site to the northwest

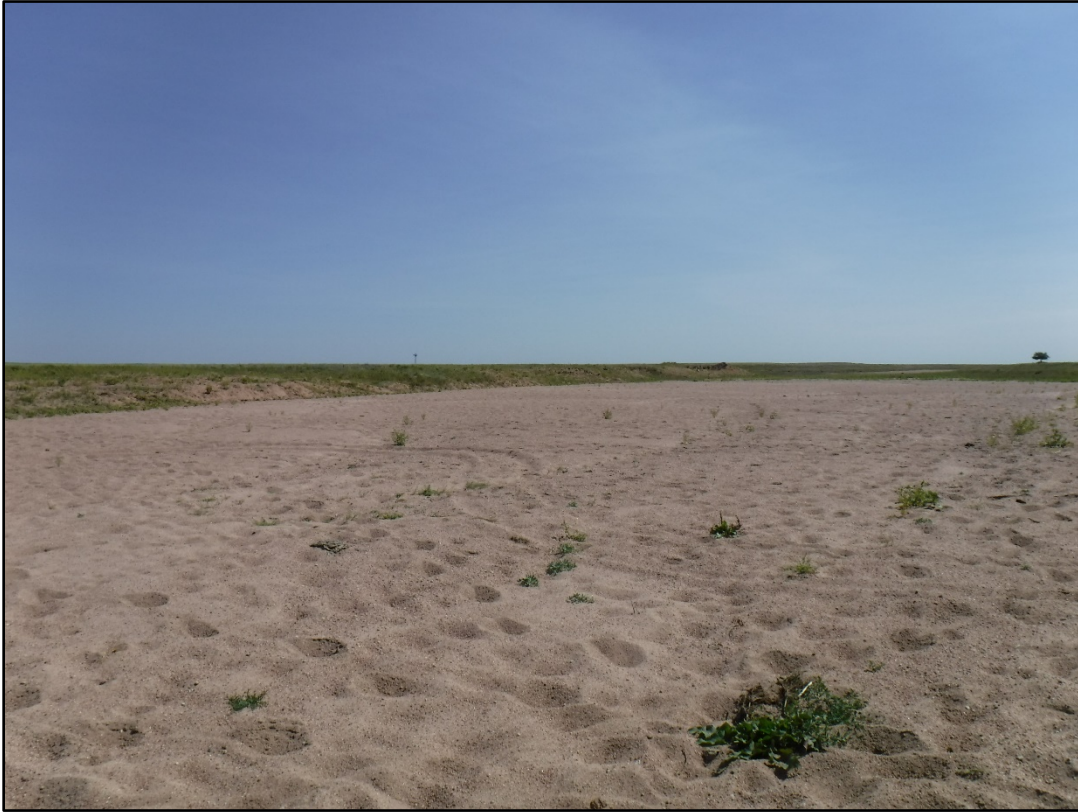
Photo 5: Typical conditions of the riverbed

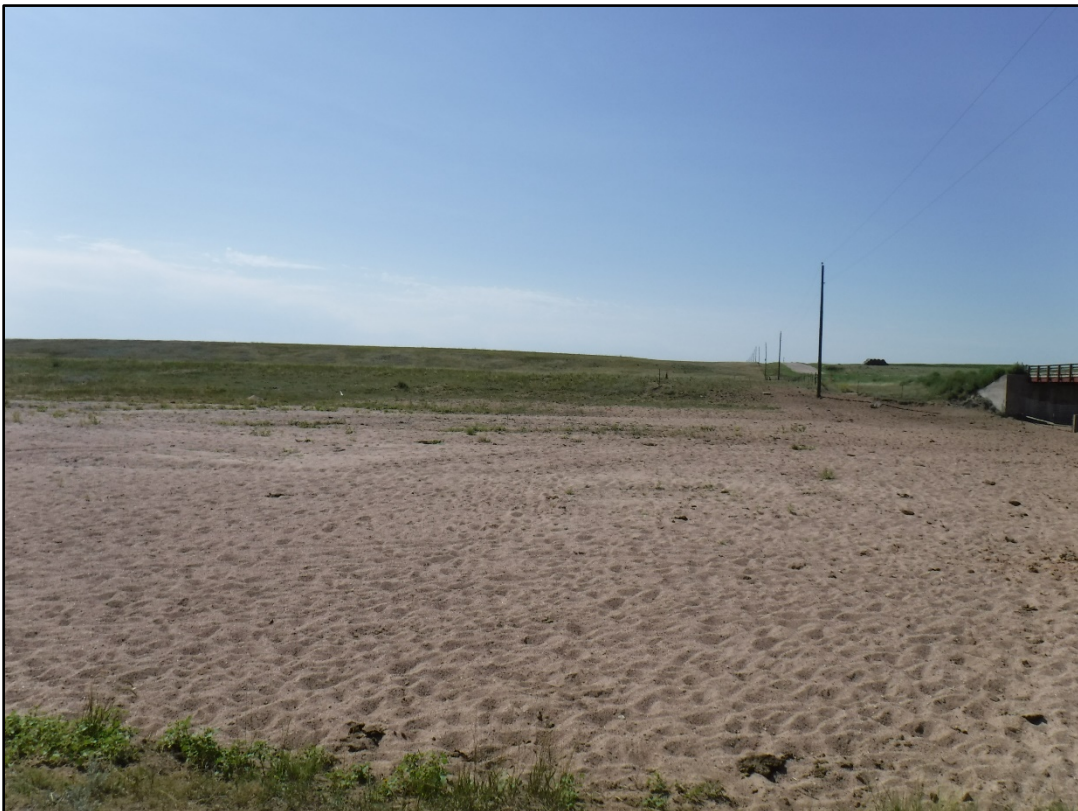
Photo 6: Approximate location of where material would be removed from the riverbed
