MINERALS PROGRAM INSPECTION REPORT
PHONE: (303) 866-3567

MINE NAME: Raymond Enderson Pit	MINE/PROSPECTING ID#: M-2000-066	MINERAL: Sand and gravel	COUNTY: Lincoln
INSPECTION TYPE: Monitoring	INSPECTOR(S): Patrick Lennberg	INSP. DATE: August 21, 2019	INSP. TIME: 11:30
OPERATOR: Lincoln County	OPERATOR REPRESENTATIVE: Fred Lundy	TYPE OF OPERATION: 110c - Construction Limited Impact	
REASON FOR INSPECTION: Normal I&E Program	BOND CALCULATION TYPE: None	BOND AMOUNT: \$0.00	
DATE OF COMPLAINT: NA	POST INSP. CONTACTS: None	JOINT INSP. AGENCY: None	
WEATHER: Clear	INSPECTOR'S SIGNATURE:

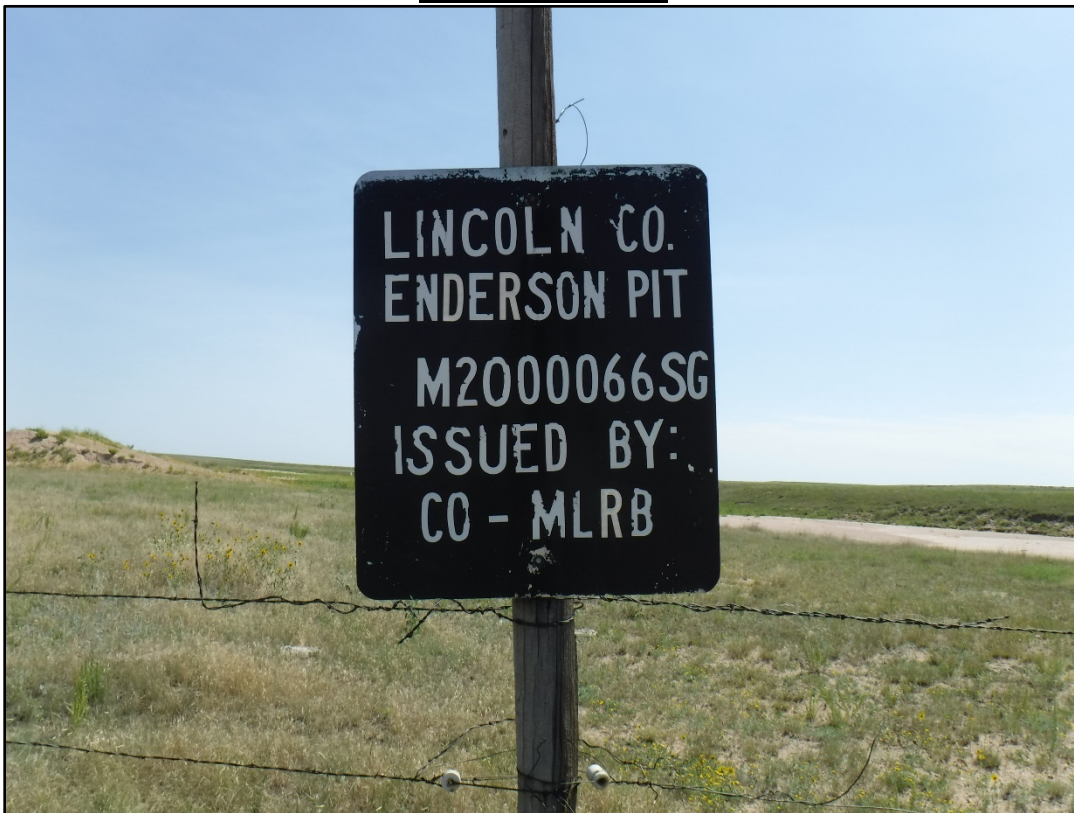
Photo 1: Mine sign at entrance off of County Road 41

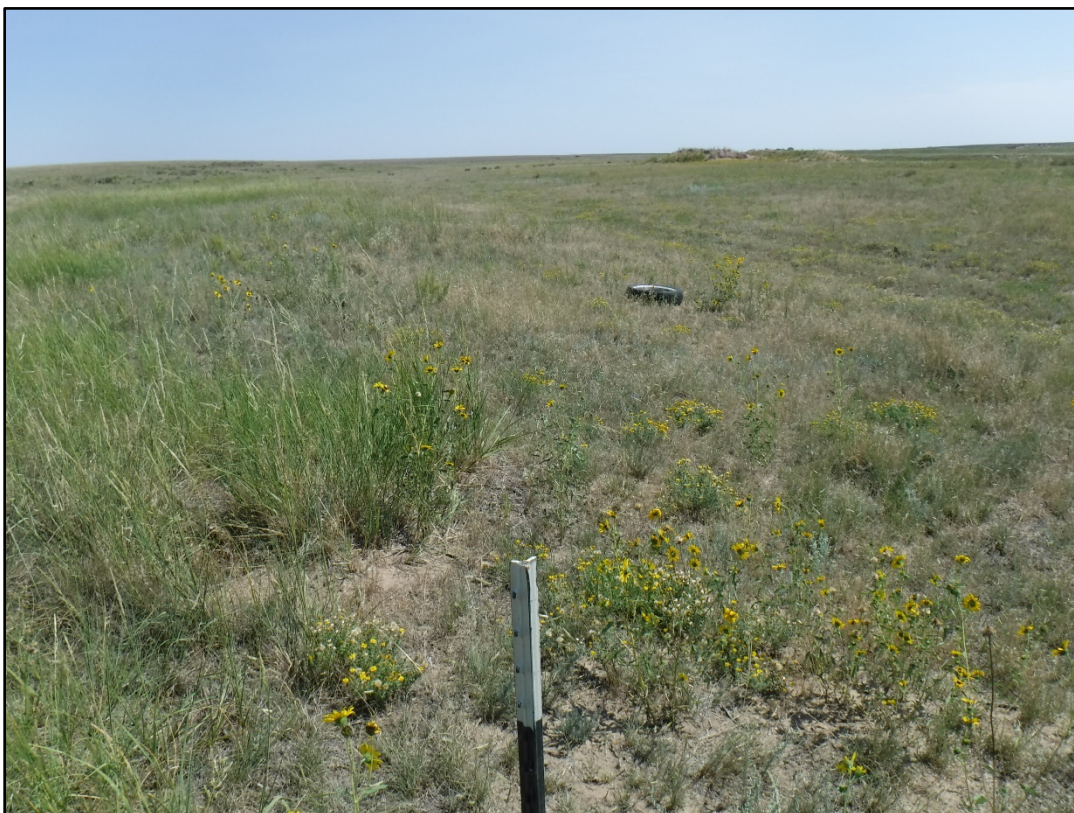
The Division was able to GPS all permit boundary markers. All current mining is within the permit boundaries.

Photo 2: Typical boundary marker in foreground looking east along the northern permit boundary

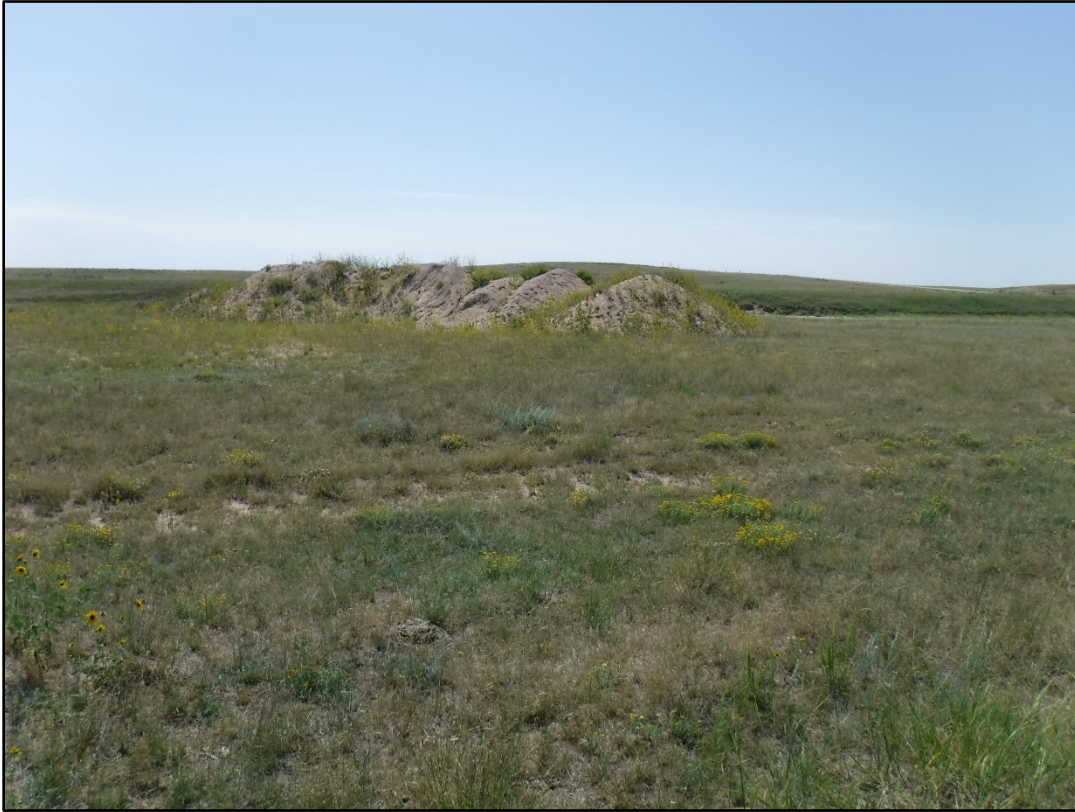
The site does not appear to have been active recently. The riverbed does not show evidence of any recent mining activity and is flat throughout the permit area. On the north banks of the river there is evidence of past stockpiling of material from the riverbed. This area does have vegetation volunteering into the area consisting of native vegetation and annual weeds.

Photo 3: Remaining stockpile of material at the site that has vegetation volunteering on it

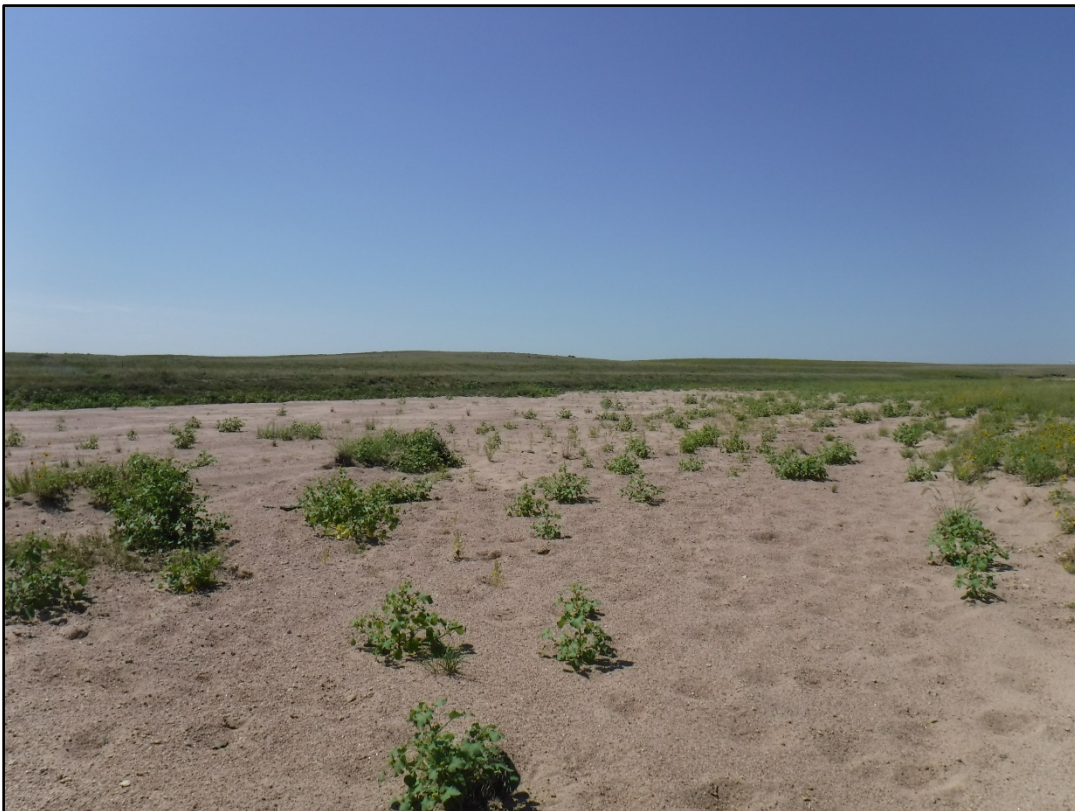
Photo 4: Riverbed area in the permit boundary that has not been mined

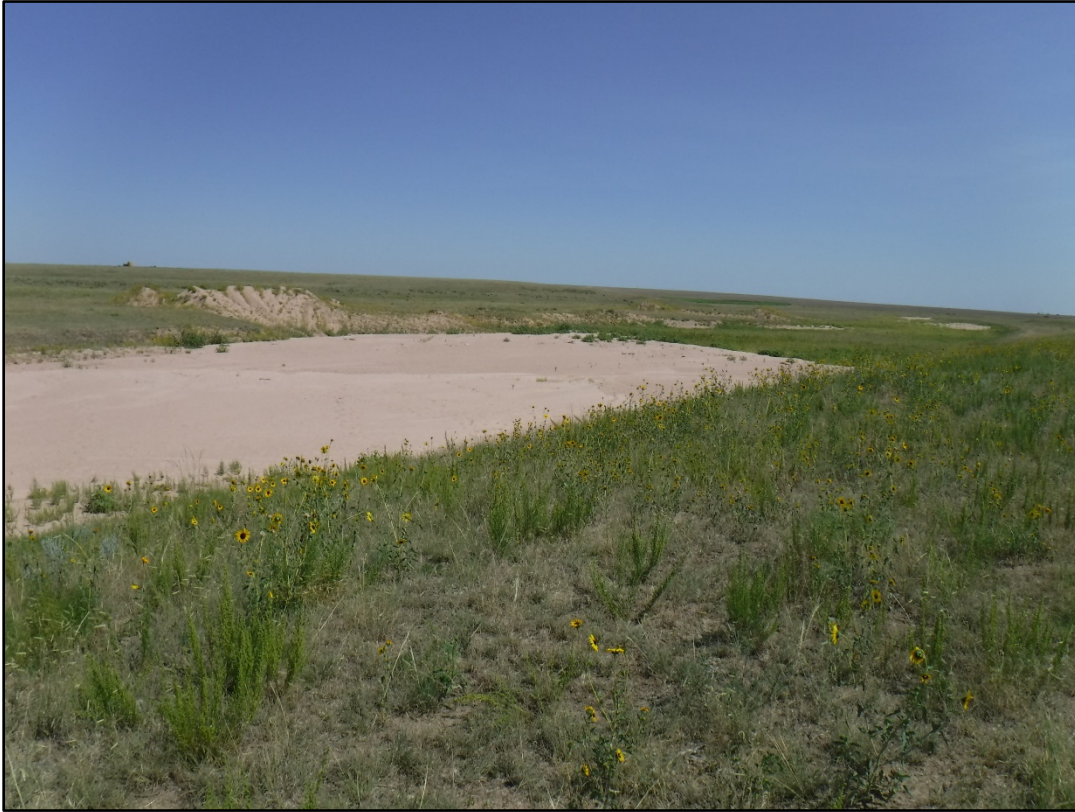
Photo 5: Riverbed area that has been mined in the past but not recently

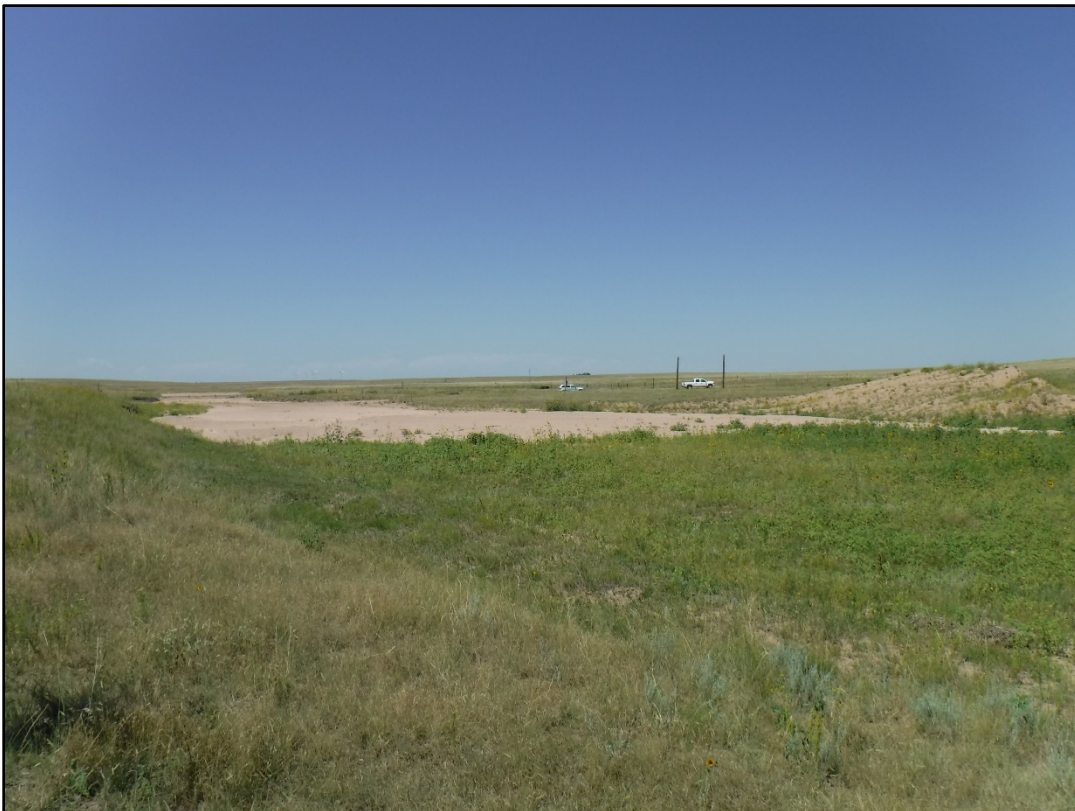
Photo 6: View looking east from the south bank showing the difference between the mined (no vegetation growing) and unmined (vegetation growing) portions of the riverbed
