MINERALS PROGRAM INSPECTION REPORT

MINE NAME: Van Valkenburg Gravel Pit	MINE/PROSPECTING ID#: M-2005-003	MINERAL: Sand and gravel	COUNTY: Jackson
INSPECTION TYPE: Monitoring	INSPECTOR(S): Peter S. Hays	INSP. DATE: August 14, 2019	INSP. TIME: 11:00
OPERATOR: Van Valkenburg Cattle Company, LLC	OPERATOR REPRESENTATIVE: Chris Van Valkenburg	TYPE OF OPERATION: 112c - Construction Regular Operation	
REASON FOR INSPECTION: Normal I&E Program	BOND CALCULATION TYPE: Complete Bond	BOND AMOUNT: \$10,800.00	
DATE OF COMPLAINT: NA	POST INSP. CONTACTS: None	JOINT INSP. AGENCY: None	
WEATHER: Clear	INSPECTOR'S SIGNATURE:

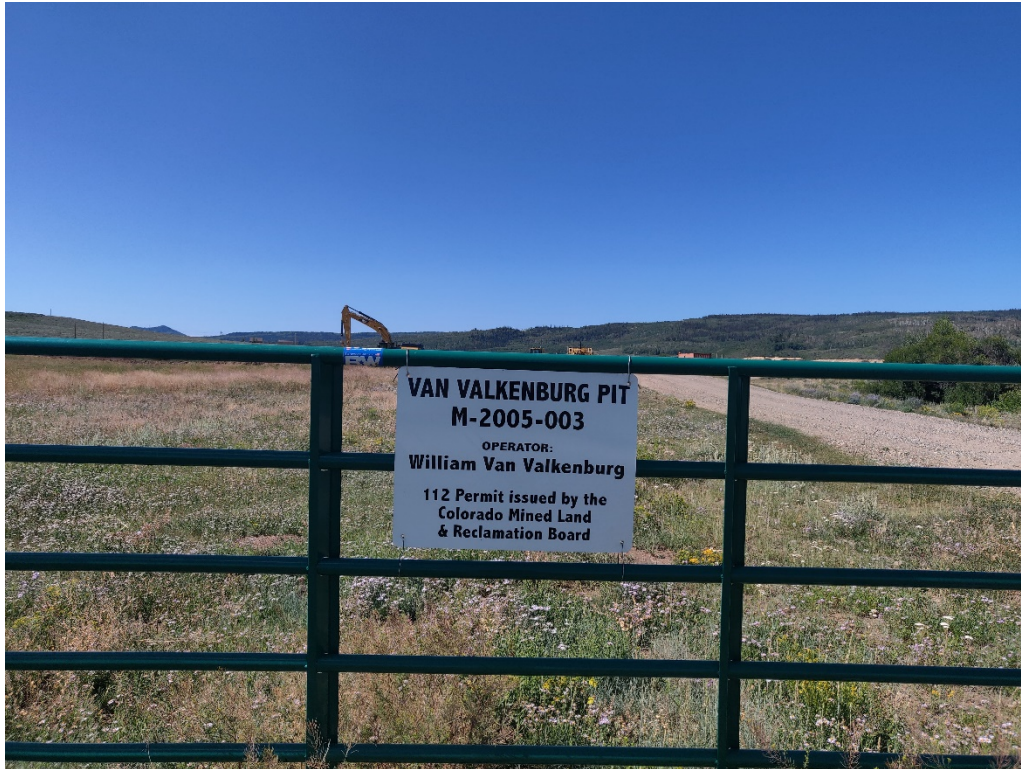
The Division currently holds a financial warranty in the amount of \$10,800, which is adequate to reclaim the current disturbance at the site. The mine sign and boundary markers were observed pursuant to Rule 3.1.12. Photographs taken during the inspection are attached.

Van Valkenburg Pit mine sign

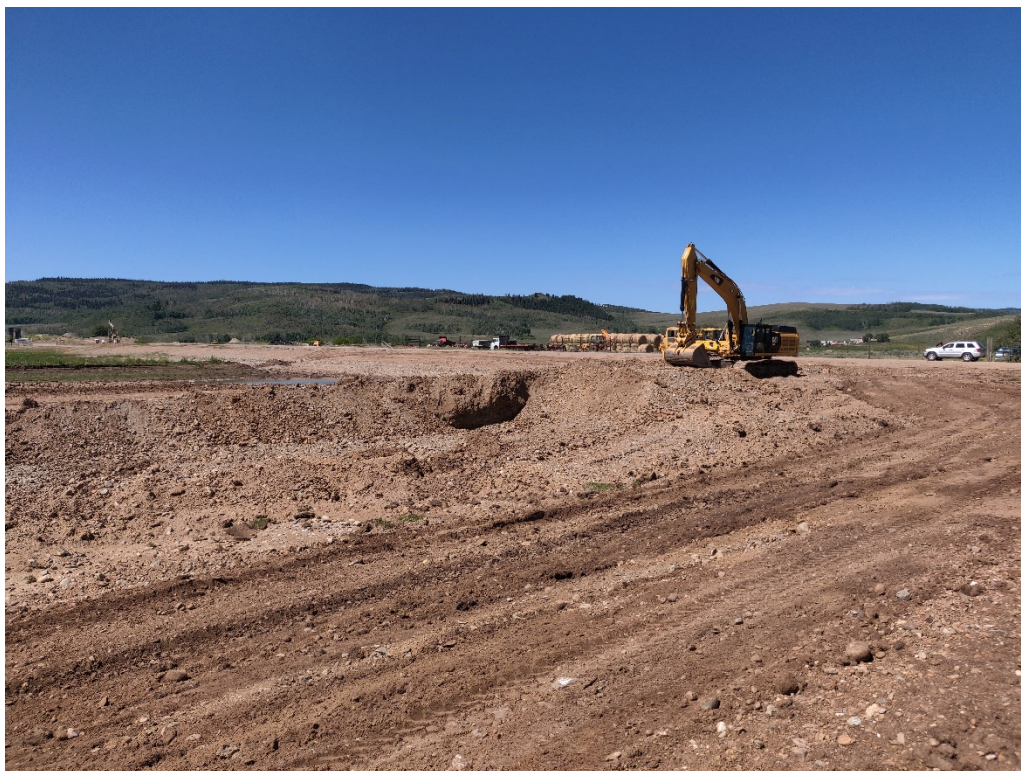
View of active mining operation in the north section of the site

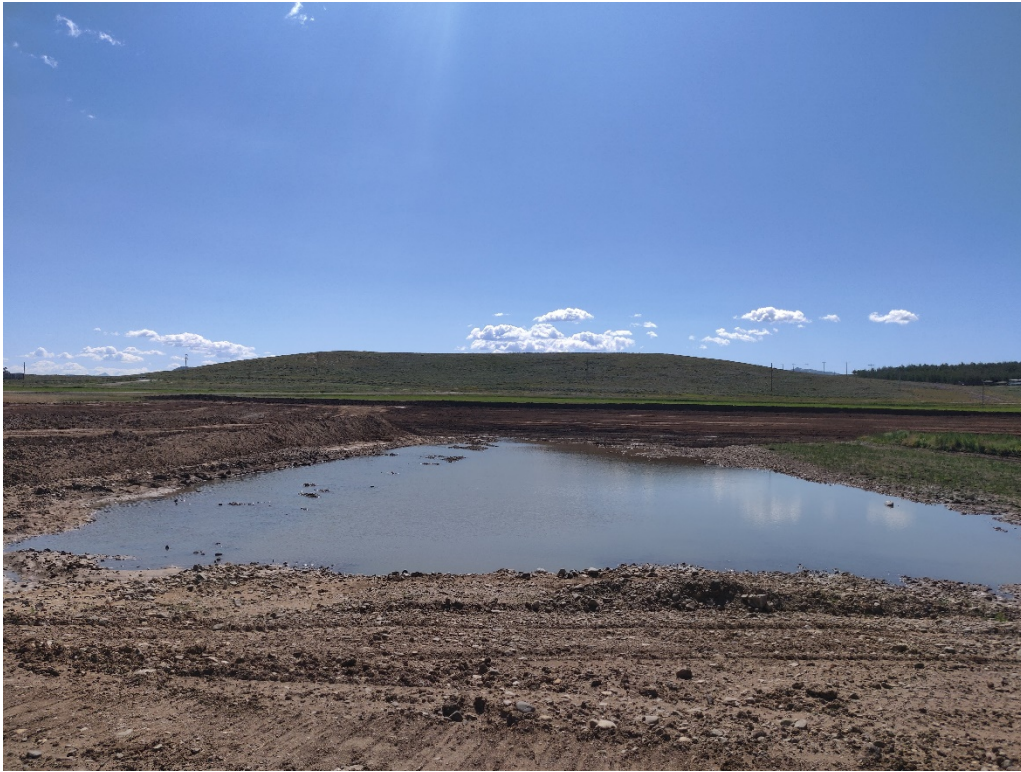
View of the recently mined area in the north section of the site

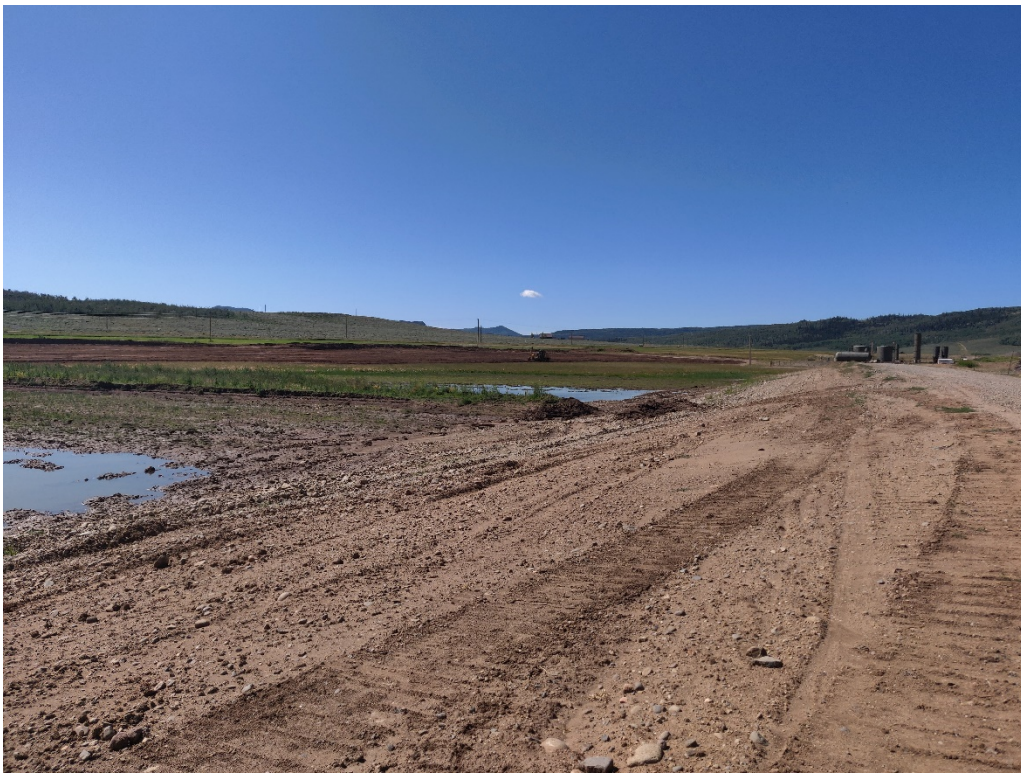
View of the previous year's mining area and reclamation

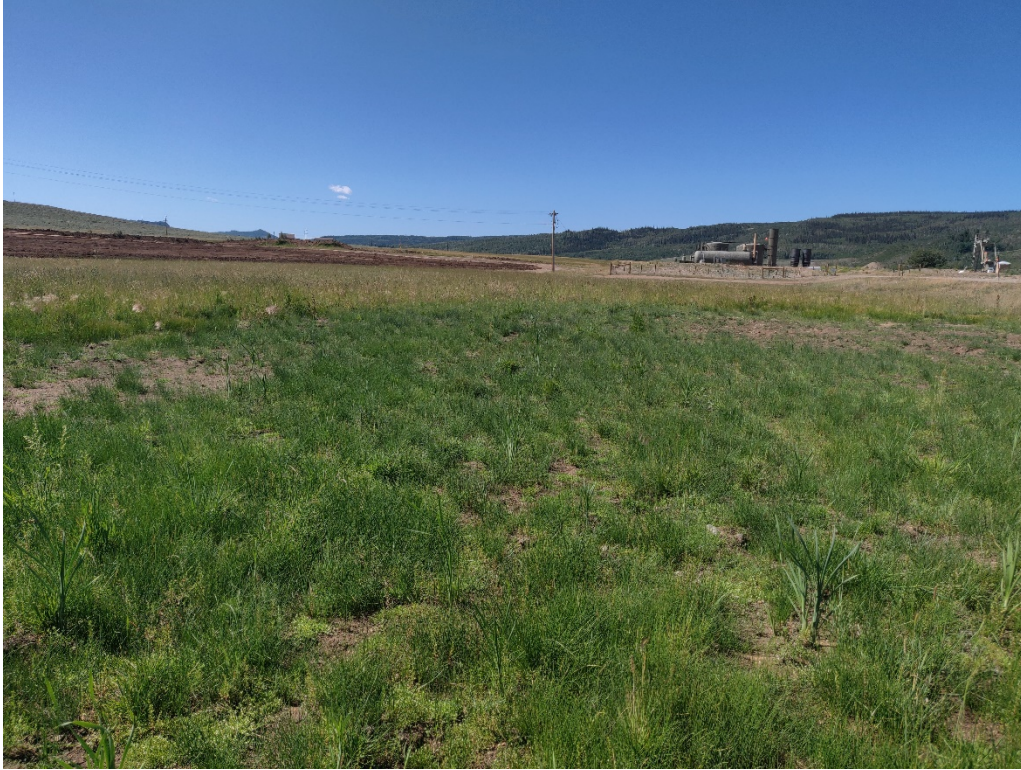
View of reclamation from last year in the south portion of the north mining area

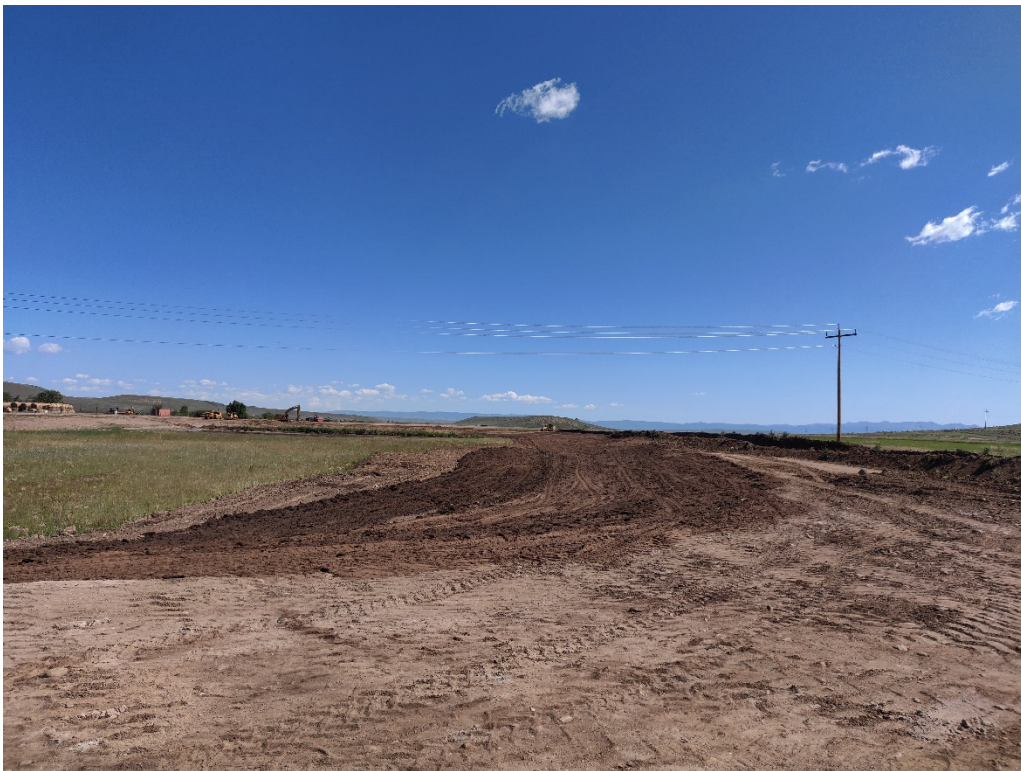
View of the north mining area from the southeast corner of the area looking northwest

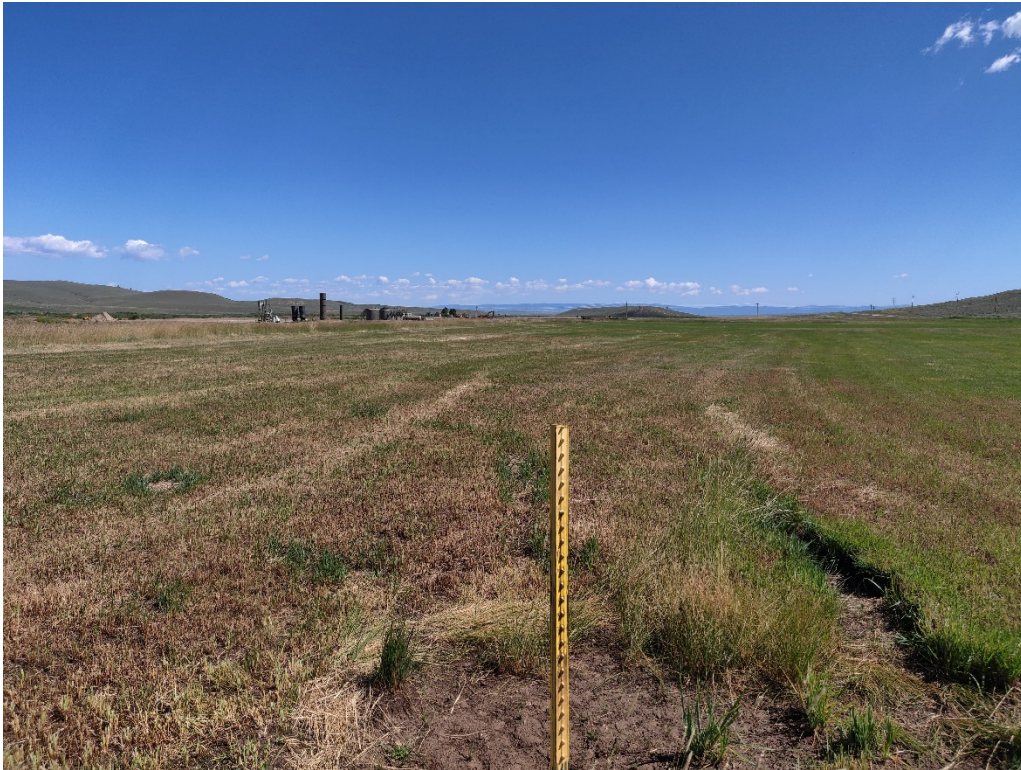
View of the site from the southeast corner of the mine site looking northwest

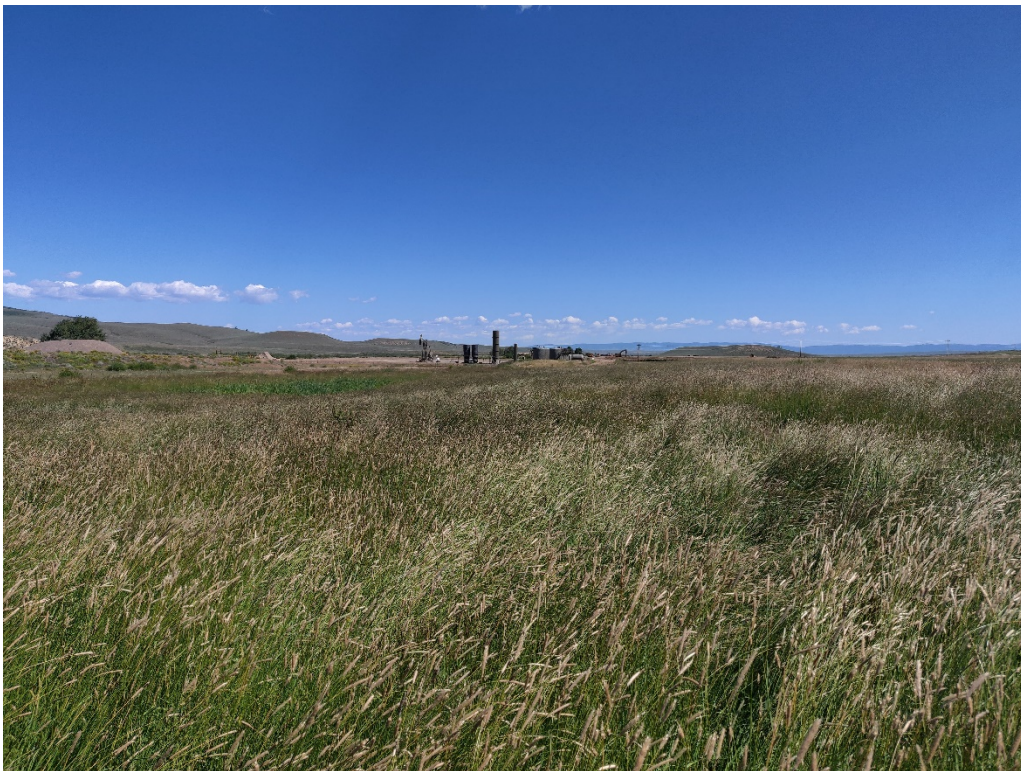
The approved post-mining land use for the site is pastureland. The site is roughly divided into two (2) areas of reclamation: north and south of the oil & gas facility. The older south area contained well-established pastureland grasses and vegetation. The north area has been reclaimed concurrently with the mining activity. The contact mining company is required to reclaim the area disturbed in the previous year every fall. Topsoil replacement and grading of the east slope of the north mining area was occurring during the inspection. Canada thistle was observed along the western boundary of the site and on the west slope of the central topsoil stockpile. The Permittee stated weed spraying was scheduled to be completed soon.

View of the vegetation in the south portion of the site

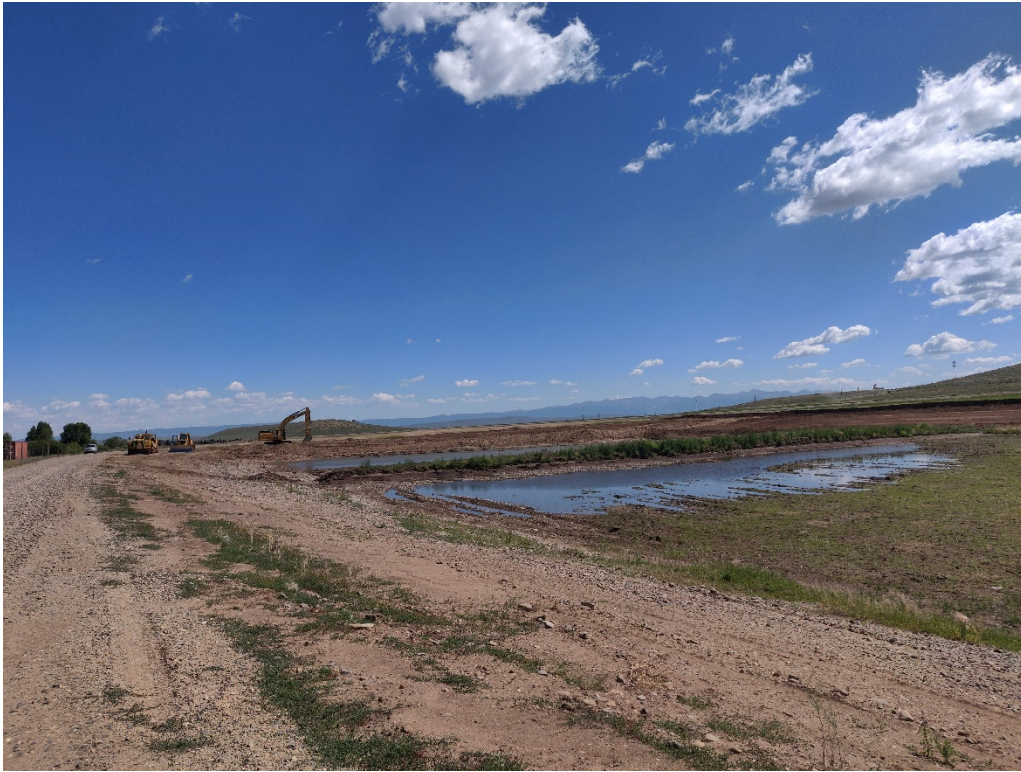
View of the north mining area from the access road looking north

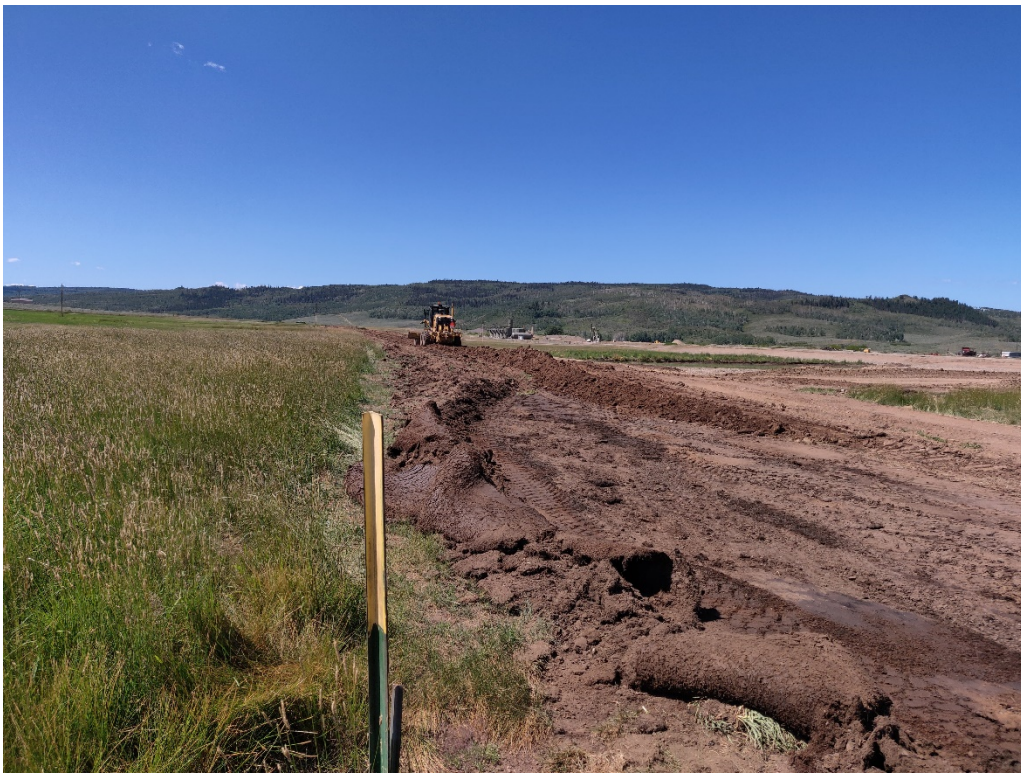
View of the topsoil replacement in the north mining area from the northeast corner of the site

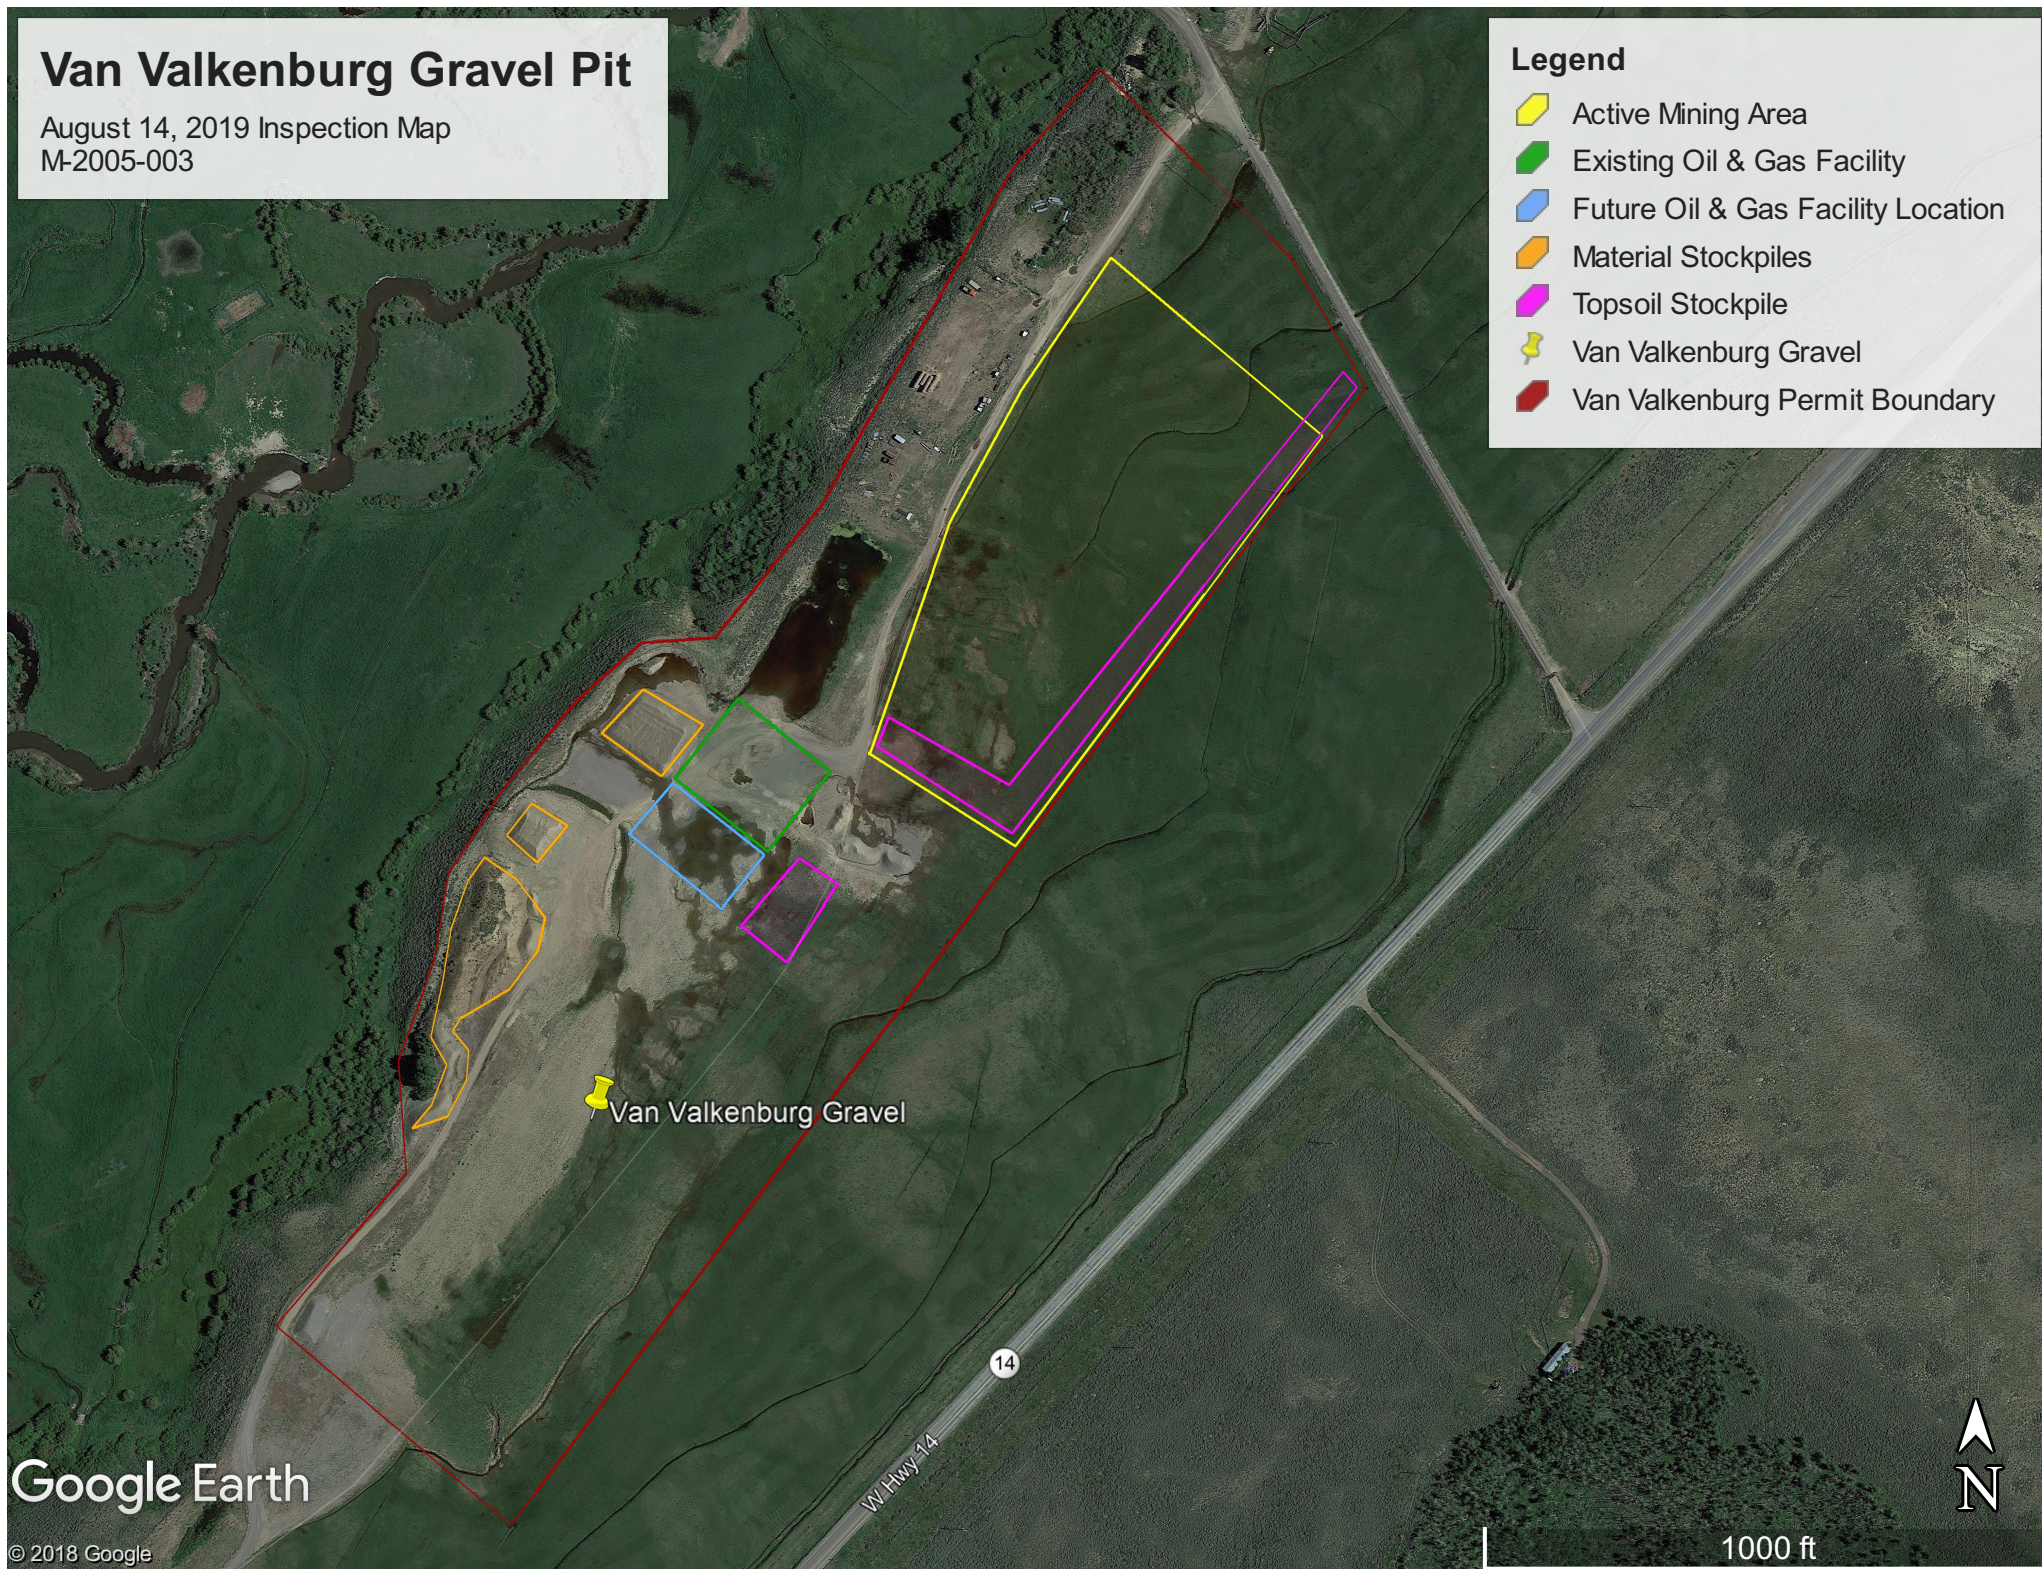
August 14, 2019 Inspection Map
M-2005-003

An oil & gas facility was constructed in the middle of the site near the western boundary since the last inspection. The Division will require the Permittee to submit a technical revision to update the Mining and Reclamation Plan Maps to include the oil & gas facility into the permit. The Permittee stated an additional gas pumping station may be constructed southwest of the current facility. The Division recommends the Permittee submit the updated Mining and Reclamation Plan Maps following the construction of the new facility.
