MINERALS PROGRAM INSPECTION REPORT
PHONE: (303) 866-3567

MINE NAME: Wamsley Pit	MINE/PROSPECTING ID#: M-2011-027	MINERAL: Gravel and sand	COUNTY: Jackson
INSPECTION TYPE: Monitoring	INSPECTOR(S): Peter S. Hays	INSP. DATE: August 14, 2019	INSP. TIME: 12:15
OPERATOR: Richard L Wamsley dba- RLW Enterprises	OPERATOR REPRESENTATIVE: Richard Wamsley	TYPE OF OPERATION: 110c - Construction Limited Impact	
REASON FOR INSPECTION: Normal I&E Program	BOND CALCULATION TYPE: Complete Bond	BOND AMOUNT: \$8,800.00	
DATE OF COMPLAINT: NA	POST INSP. CONTACTS: None	JOINT INSP. AGENCY: None	
WEATHER: Clear	INSPECTOR'S SIGNATURE:

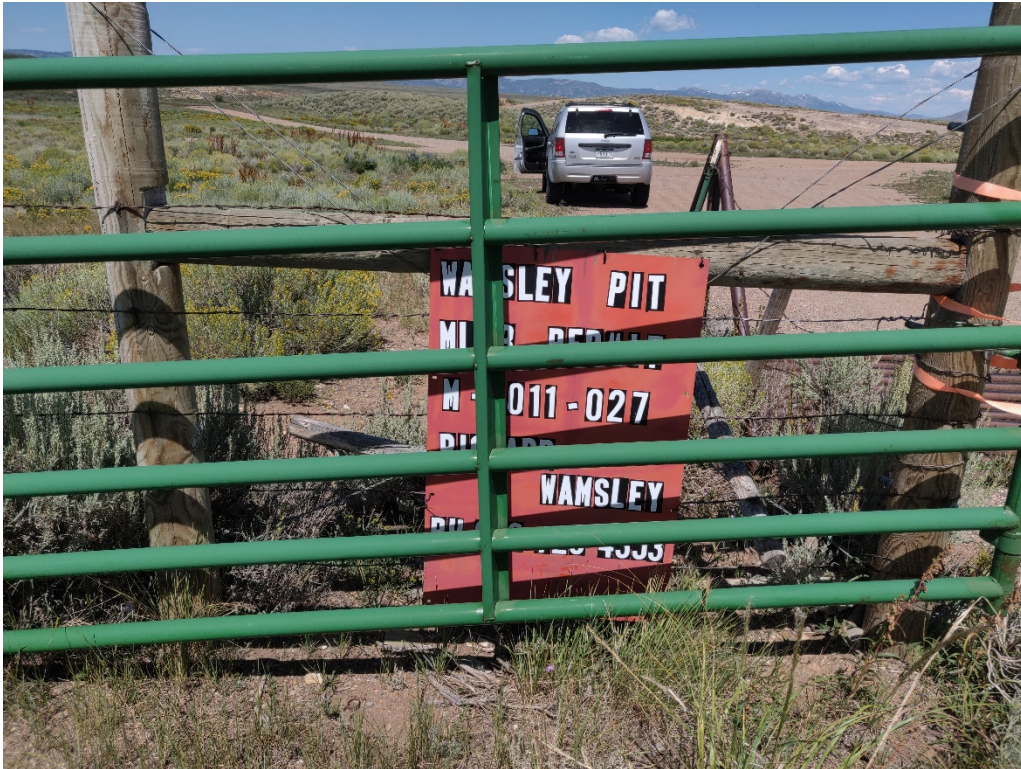
The site is located approximately 19 miles south of Walden, Colorado in Jackson County. The Division currently holds a financial warranty in the amount of \$8,800, which appears adequate to complete reclamation at the site based on this inspection. The required mine sign and boundary markers were observed as required by Rule 3.1.12. The mine sign was located on the entrance gate to the site off Highway 14 and the permit boundary was delineated with wood posts.

Wamsley Pit mine sign

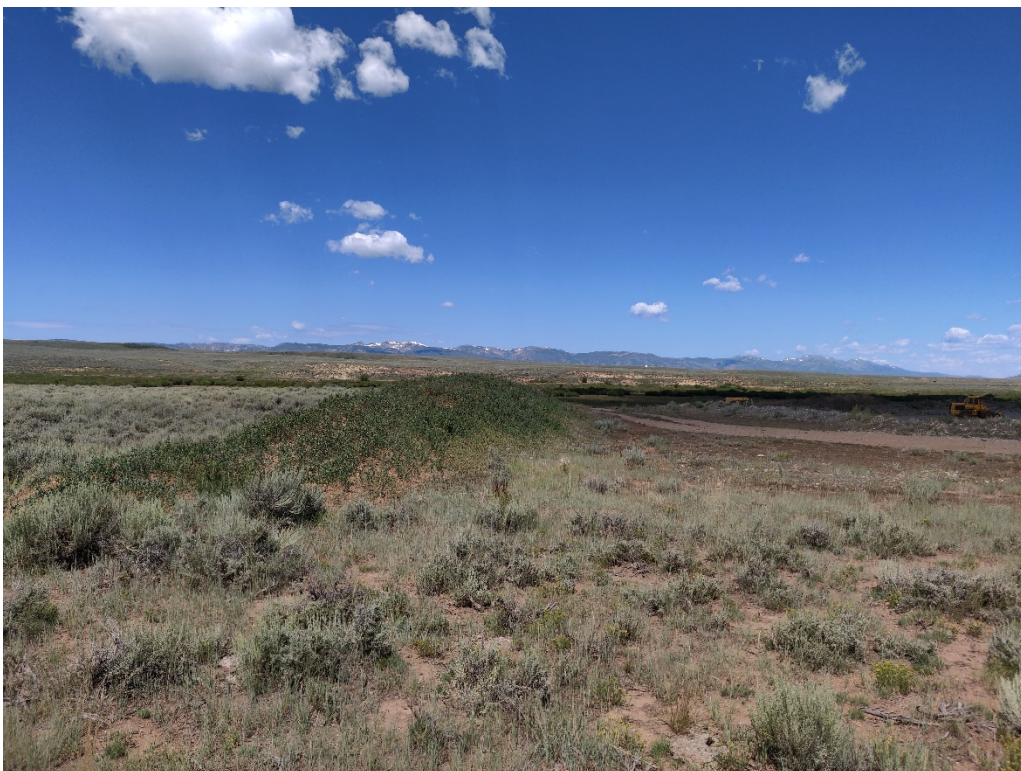
The proposed post-mining land use for the site is general agriculture. No noxious weeds were observed during the inspection. Topsoil stockpiles were observed adjacent to three sides of the pit. The stockpiles were stable and mostly vegetated with annual weeds. No reclamation activities were observed. Photographs taken during the inspection are attached.

View of topsoil stockpile adjacent to the south permit boundary

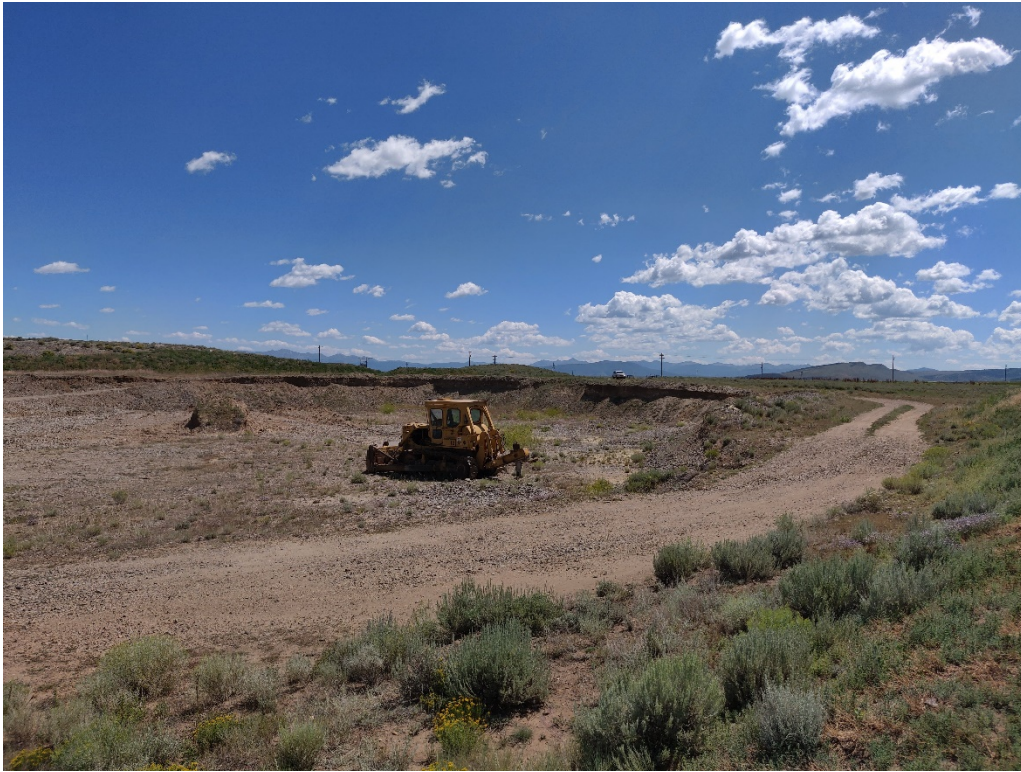
View of site from the southwest corner looking northeast

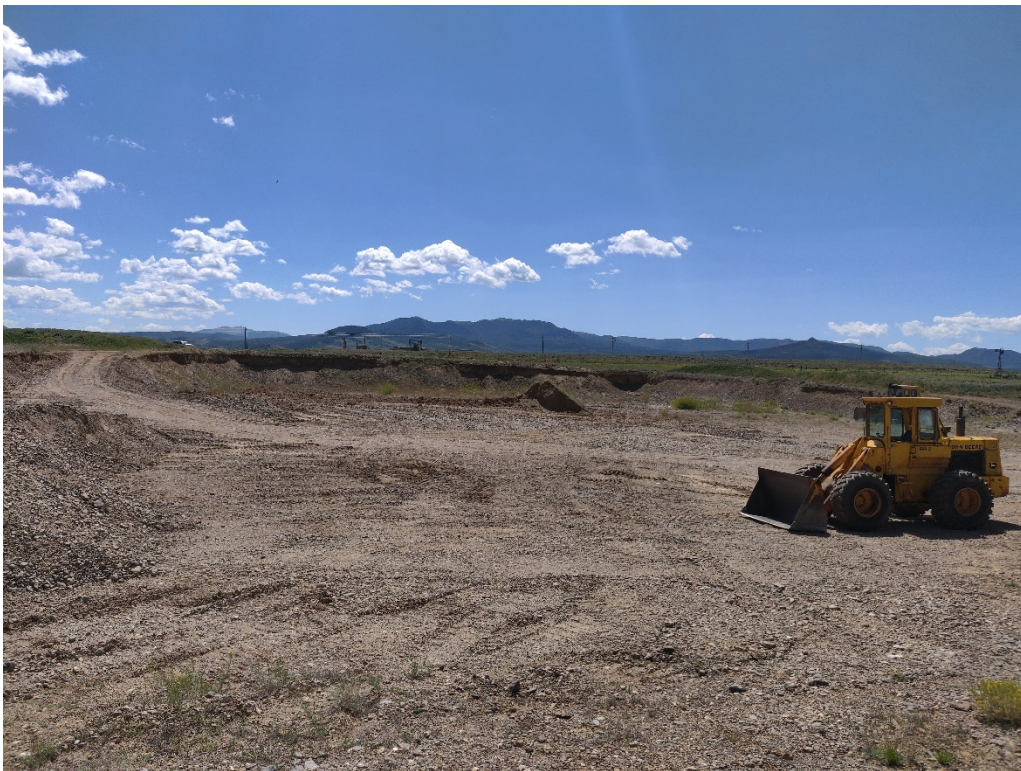
View of the site from the northwest corner looking east

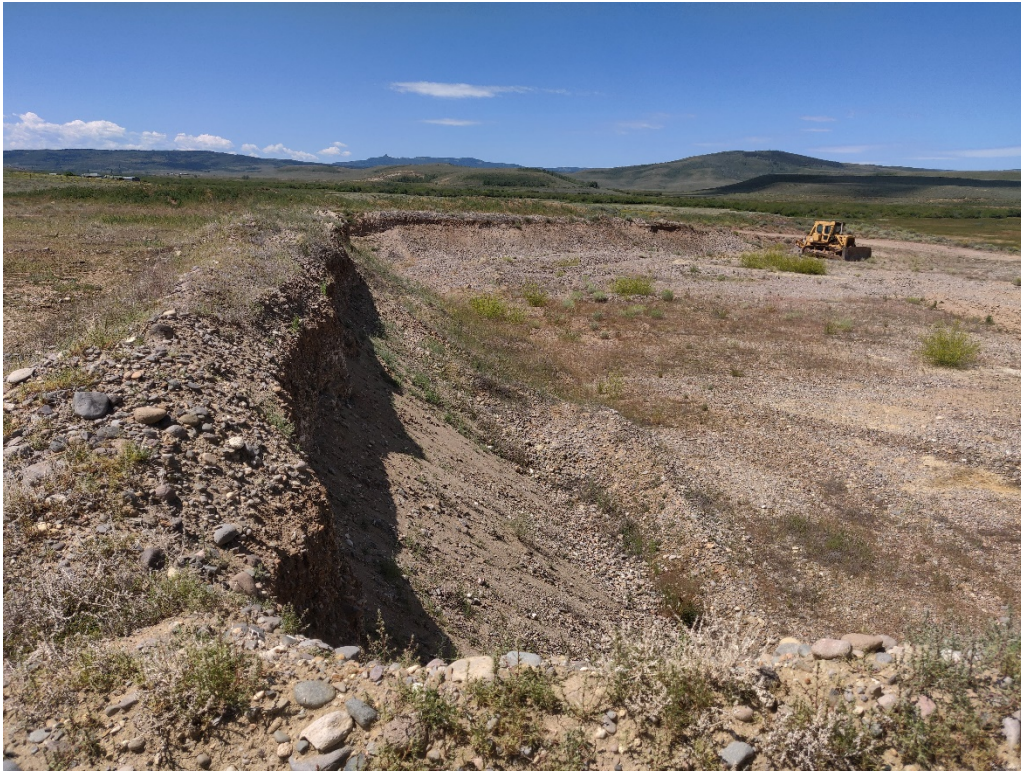
The site is an 110c operation permitted for 6.74 acres. The mining excavation will create a flat area with 3H:1V slopes along all sides of the site. No processing equipment was on-site. The site is used as a source of pit run material only. The east highwall was estimated at 8 feet in height at a 1H:1V to vertical slope. The south and north highwalls tapered from east to west from 8 feet in height to the elevation of the pit floor. The Operator most recently mined the northeast corner of the site to begin establishing a passive stormwater path. The pit floor was dry and no erosion features were observed during the inspection.

View of the east highwall looking southwest
