MINERALS PROGRAM INSPECTION REPORT
PHONE: (303) 866-3567

MINE NAME: Bond Pit	MINE/PROSPECTING ID#: M-2007-035	MINERAL: Sand	COUNTY: Jackson
INSPECTION TYPE: Monitoring	INSPECTOR(S): Peter S. Hays	INSP. DATE: August 14, 2019	INSP. TIME: 14:30
OPERATOR: Glenn E Sessions & Sons, Inc.	OPERATOR REPRESENTATIVE: Brian Jerkins	TYPE OF OPERATION: 112c - Construction Regular Operation	
REASON FOR INSPECTION: Normal I&E Program	BOND CALCULATION TYPE: Partial Bond	BOND AMOUNT: \$35,527.00	
DATE OF COMPLAINT: NA	POST INSP. CONTACTS: None	JOINT INSP. AGENCY: None	
WEATHER: Clear	INSPECTOR'S SIGNATURE:

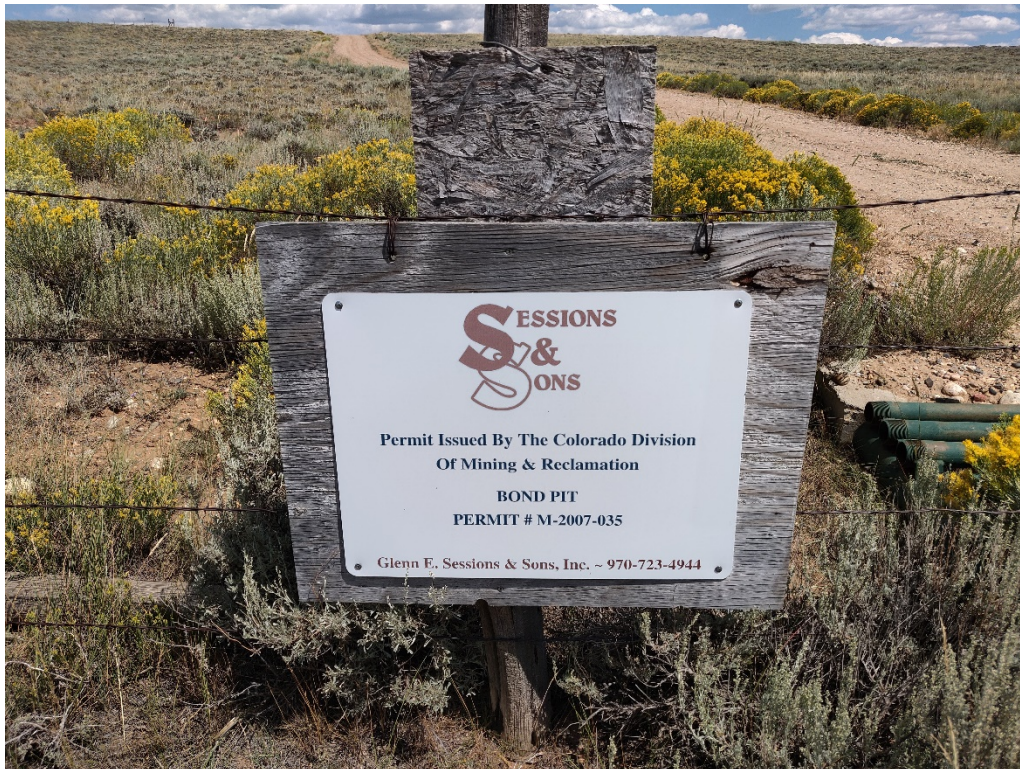
Bond Pit mine sign

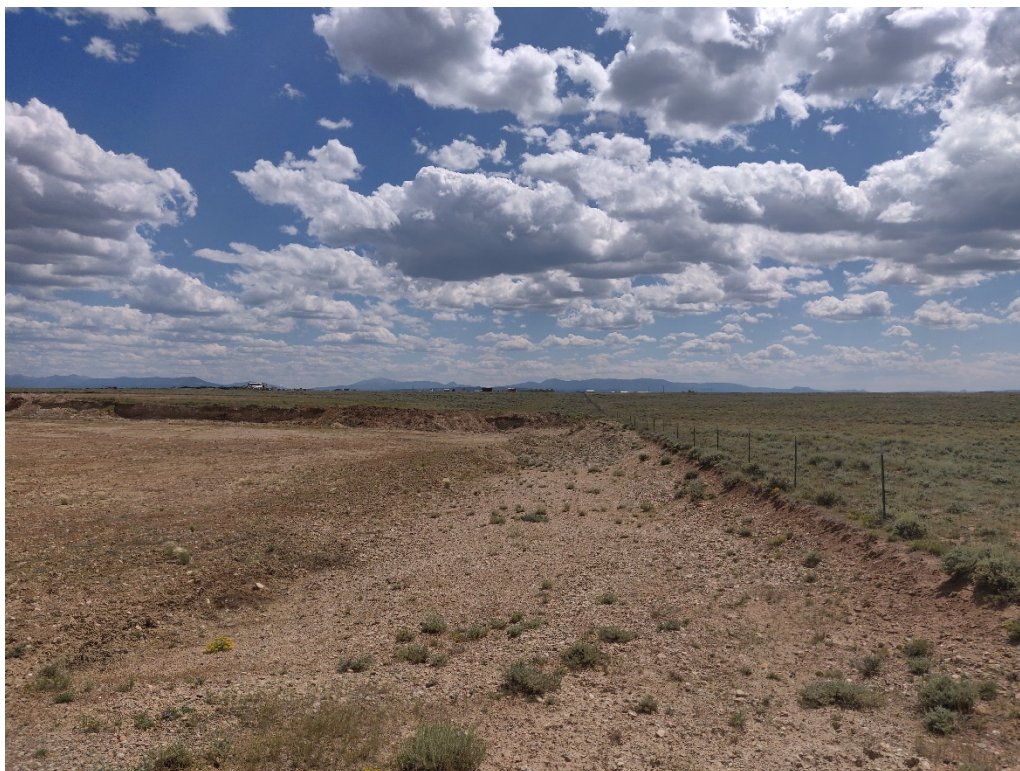
View of site from the northwest corner looking south

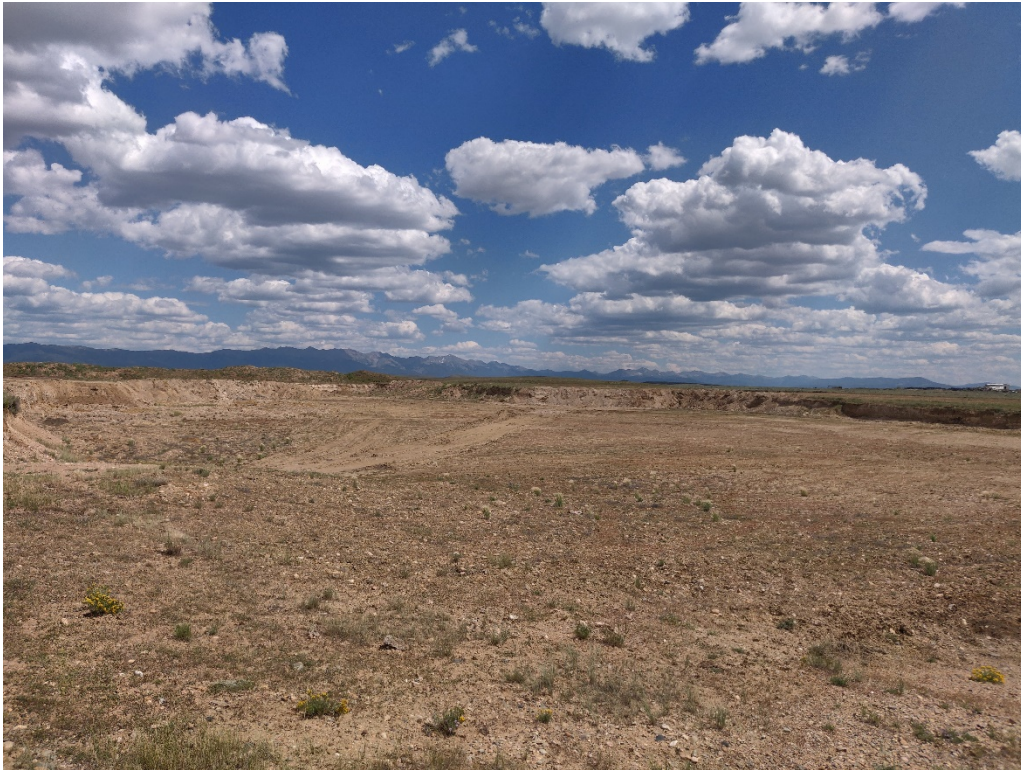
View of site from the northwest corner looking southeast

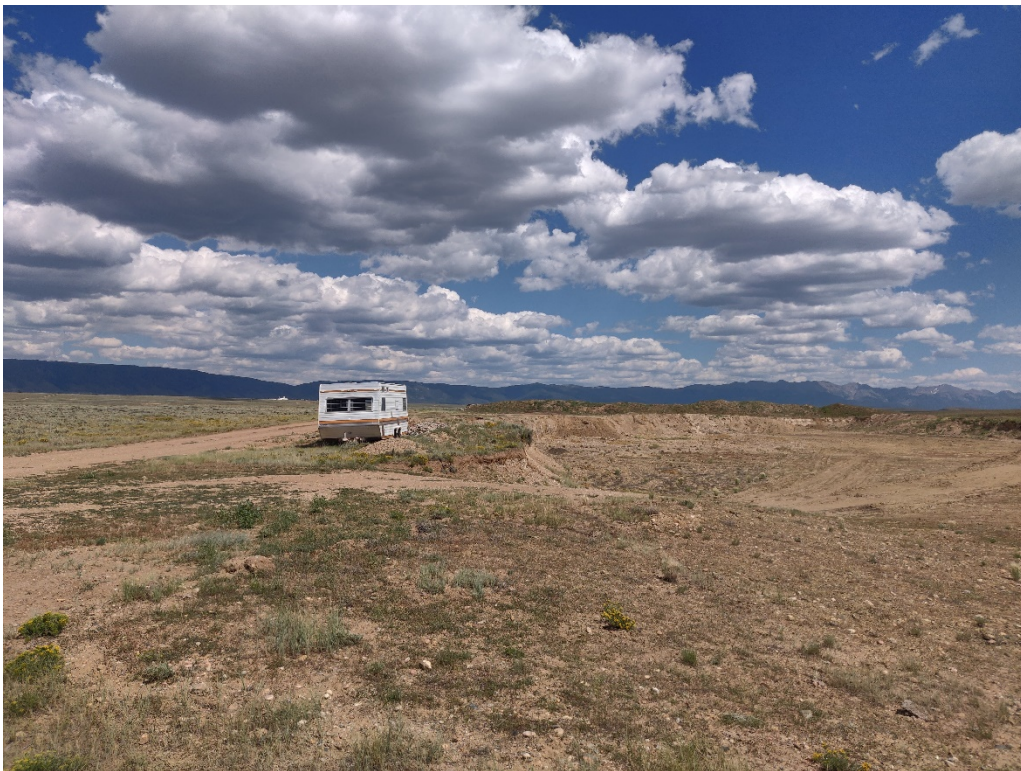
View of site from the northwest corner looking east

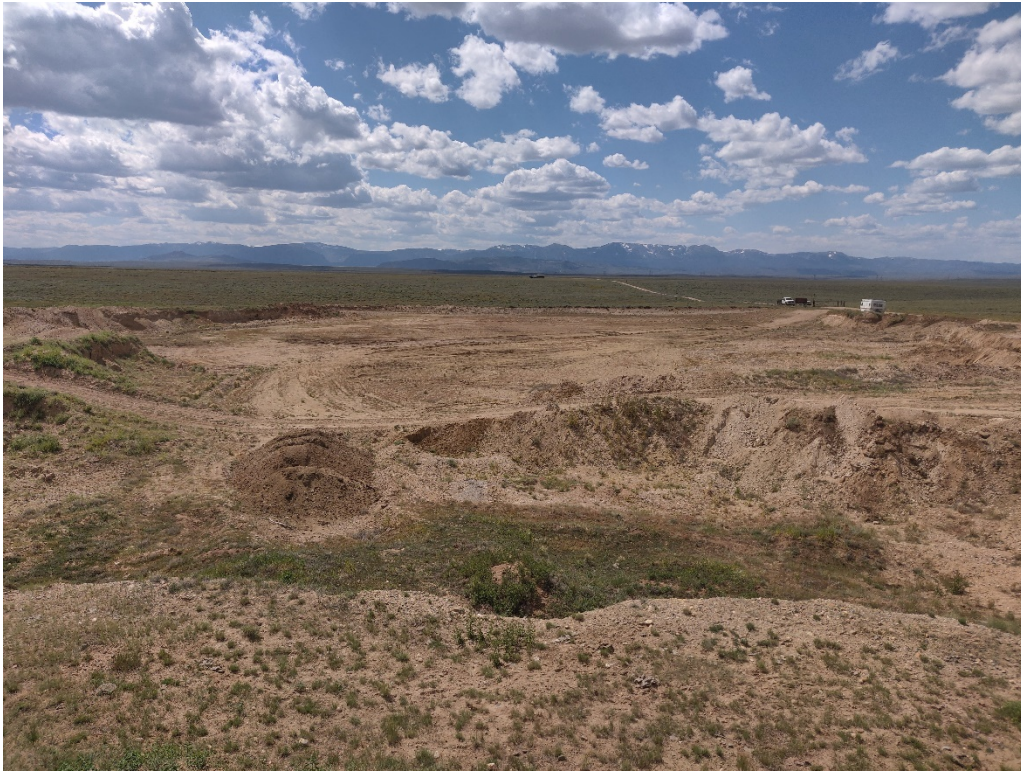
View of the site from the topsoil stockpile looking west

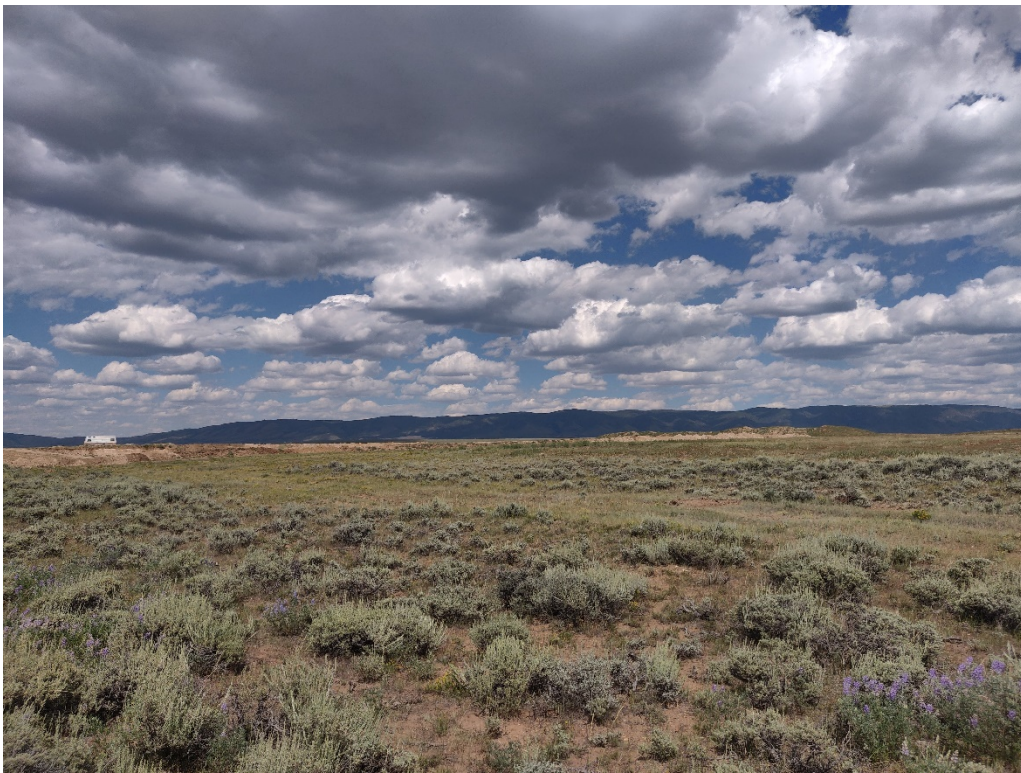
View of site from the southwest corner looking northeast
