MINERALS PROGRAM INSPECTION REPORT
PHONE: (303) 866-3567

MINE NAME: Sprague Scraper Service Pit	MINE/PROSPECTING ID#: M-2005-032	MINERAL: Gravel, sand and clay	COUNTY: Washington
INSPECTION TYPE: Monitoring	INSPECTOR(S): Brock F. Bowles	INSP. DATE: August 14, 2019	INSP. TIME: 12:00
OPERATOR: JC Farms Inc	OPERATOR REPRESENTATIVE: Jeff Sprague	TYPE OF OPERATION: 110c - Construction Limited Impact	
REASON FOR INSPECTION: Normal I&E Program	BOND CALCULATION TYPE: Complete Bond	BOND AMOUNT: \$33,000.00	
DATE OF COMPLAINT: NA	POST INSP. CONTACTS: None	JOINT INSP. AGENCY: None	
WEATHER: Clear	INSPECTOR'S SIGNATURE:

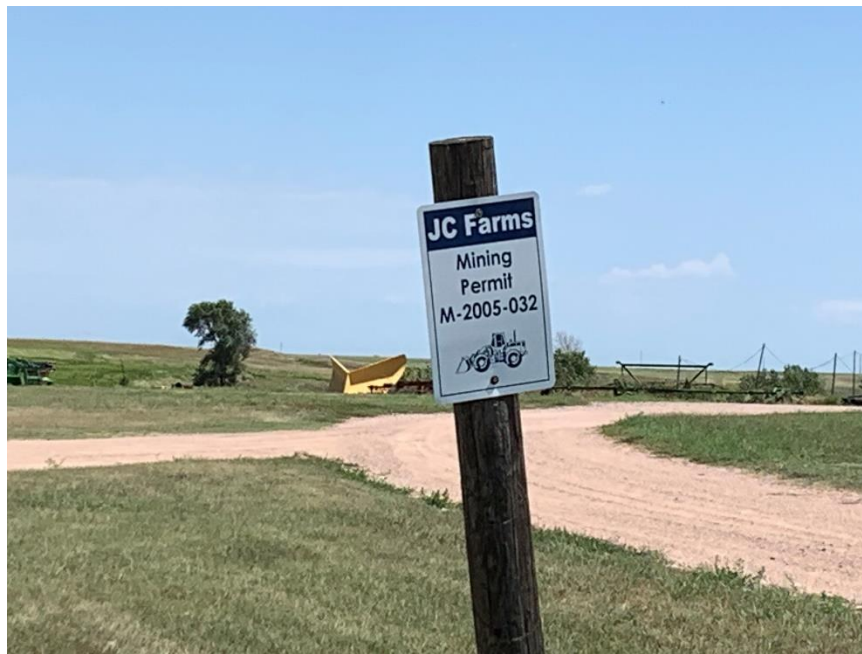
The permit identification sign was in place at the mine entrance and legible. The permit boundary markers were in place.

Mine entrance sign on County Road ZZ

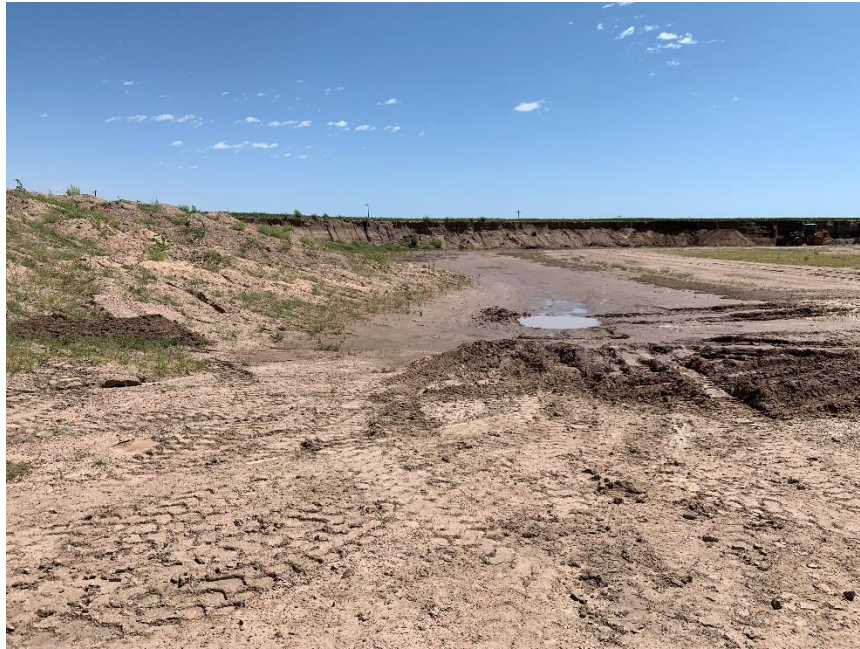
Mining activities were being conducted in the pit area in the center of the permitted area. About 8 acres have been disturbed which is consistent with the Annual Report. The highwall was about 15 feet high and the approved height is 15 feet. There were no mining activities occurring during the time of the inspection; however, there was a frontend loader in the pit and the pit had recent activity.

Pit floor facing east

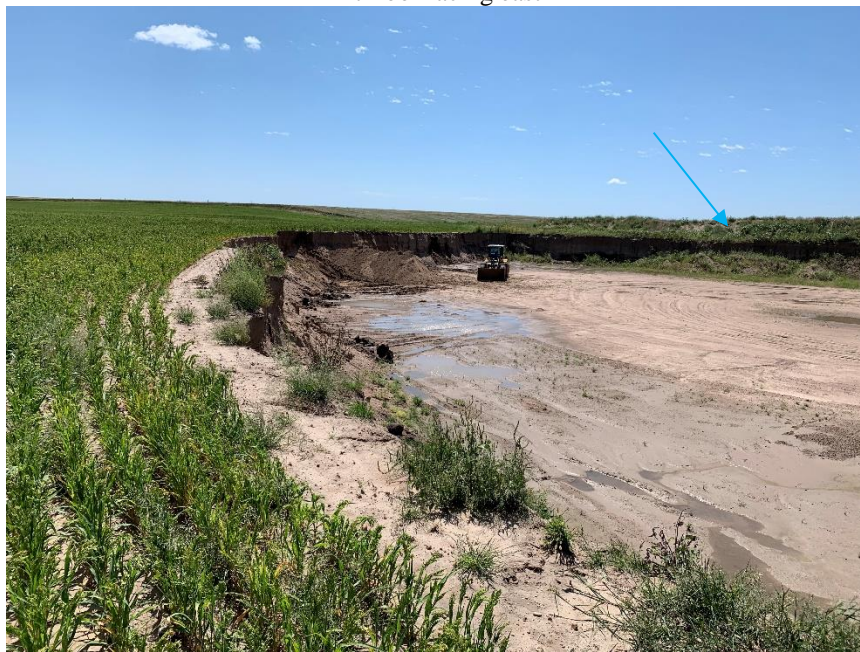
Topsoil was salvaged from in front of the pit and placed in stockpiles. The stockpiles are located on the south, west, and north sides of the pit. The stockpiles were well vegetated and appeared to be stable.

Highwall area and topsoil stockpile on right side

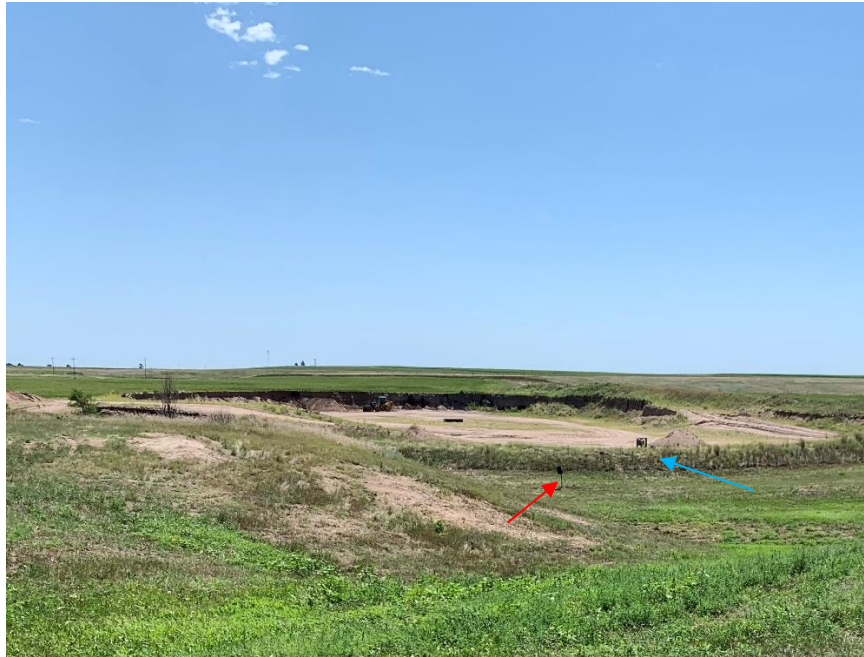
Permit boundary marker (red arrow) and topsoil pile (blue arrow)
