**MINERALS PROGRAM INSPECTION REPORT**  
**PHONE: (303) 866-3567**

<b>MINE NAME:</b> Colorado Land Board Pit	<b>MINE/PROSPECTING ID#:</b> M-2010-009	<b>MINERAL:</b> Sand and gravel and (general)	<b>COUNTY:</b> Washington
<b>INSPECTION TYPE:</b> Monitoring	<b>INSPECTOR(S):</b> Brock F. Bowles	<b>INSP. DATE:</b> August 14, 2019	<b>INSP. TIME:</b> 11:00
<b>OPERATOR:</b> Washington County	<b>OPERATOR REPRESENTATIVE:</b> Robert Frick	<b>TYPE OF OPERATION:</b> 112c - Construction Regular Operation	
<b>REASON FOR INSPECTION:</b> Normal I&E Program	<b>BOND CALCULATION TYPE:</b> None	<b>BOND AMOUNT:</b> \$0.00	
<b>DATE OF COMPLAINT:</b> NA	<b>POST INSP. CONTACTS:</b> None	<b>JOINT INSP. AGENCY:</b> None	
<b>WEATHER:</b> Clear	<b>INSPECTOR'S SIGNATURE:</b>

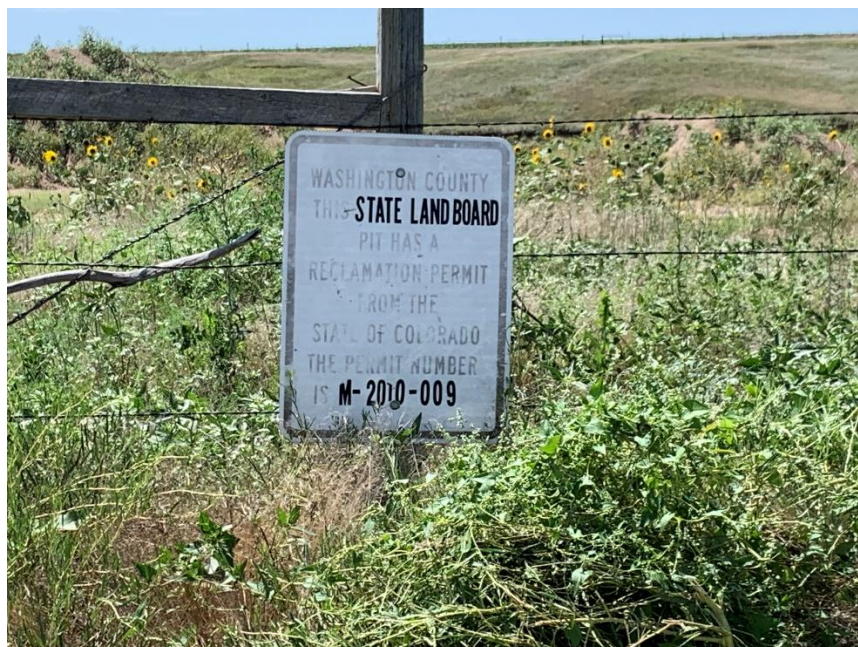
The permit identification sign was in place at the mine entrance and legible. The permit boundary markers were in place.

Mine entrance sign from County Road 55

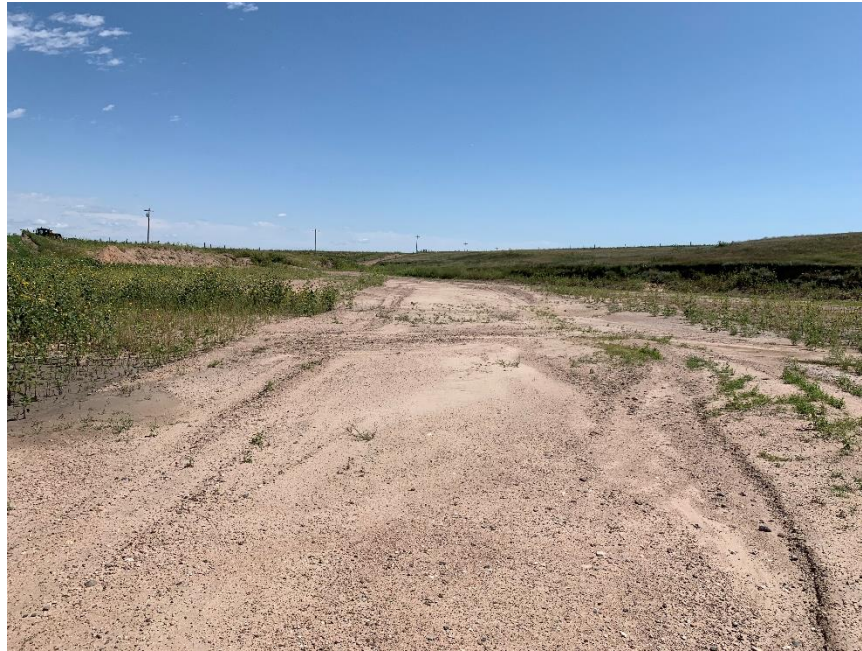
There was a small section of highwall remaining on the east side of disturbance area. The highwall was approximately 8 feet high and 75 feet long.

Pit area facing east. Remaining highwall on left side

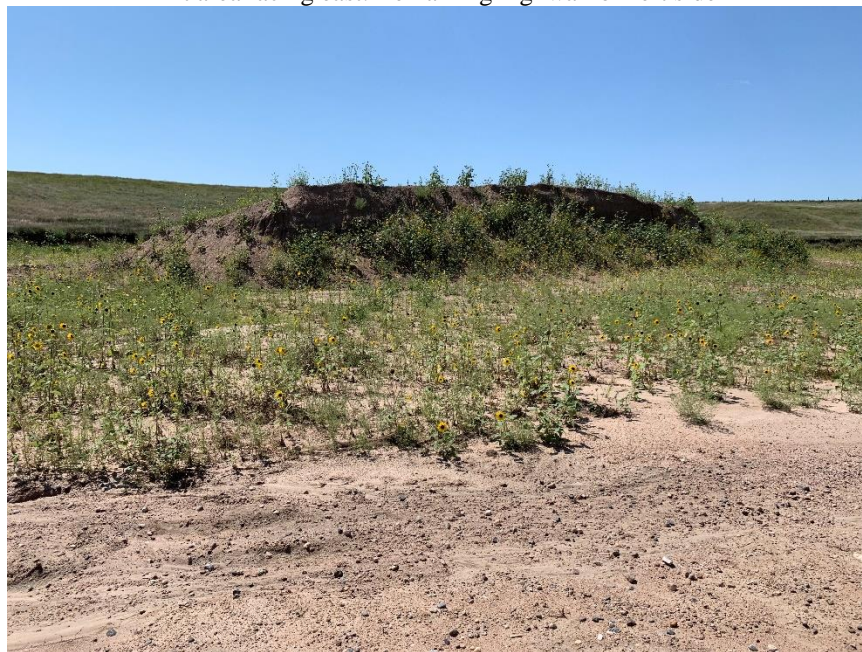
The topsoil piles were originally placed along the creek bottom during mining operations. Some of the topsoil piles have been moved north of the pit along the county road. Moving the piles allowed for final grading of the pit area along the creek bottom.

Topsoil pile along the creek bottom.
