MINERALS PROGRAM INSPECTION REPORT

MINE NAME: Fairbanks Pit	MINE/PROSPECTING ID#: M-2003-058	MINERAL: Sand and aggregate	COUNTY: Jackson
INSPECTION TYPE: Monitoring	INSPECTOR(S): Peter S. Hays	INSP. DATE: August 14, 2019	INSP. TIME: 14:50
OPERATOR: Glenn E Sessions & Sons, Inc.	OPERATOR REPRESENTATIVE: Brian Jerkins	TYPE OF OPERATION: 112c - Construction Regular Operation	
REASON FOR INSPECTION: Normal I&E Program	BOND CALCULATION TYPE: Complete Bond	BOND AMOUNT: \$25,420.00	
DATE OF COMPLAINT: NA	POST INSP. CONTACTS: None	JOINT INSP. AGENCY: None	
WEATHER: Clear	INSPECTOR'S SIGNATURE:

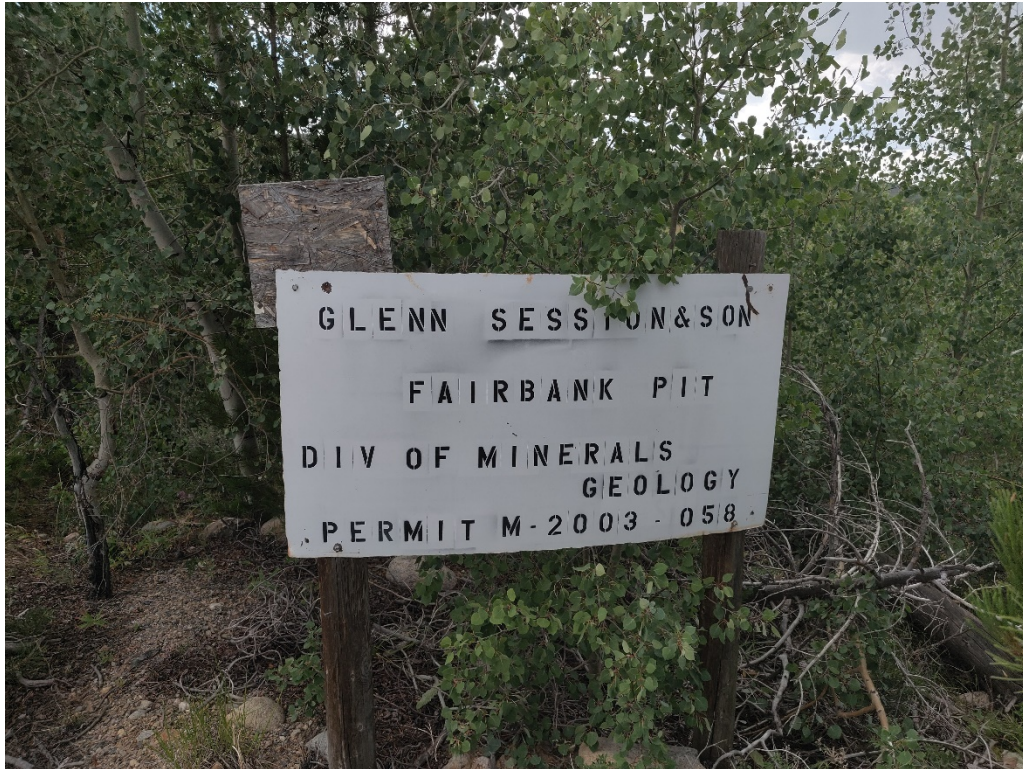
Fairbanks Pit mine sign

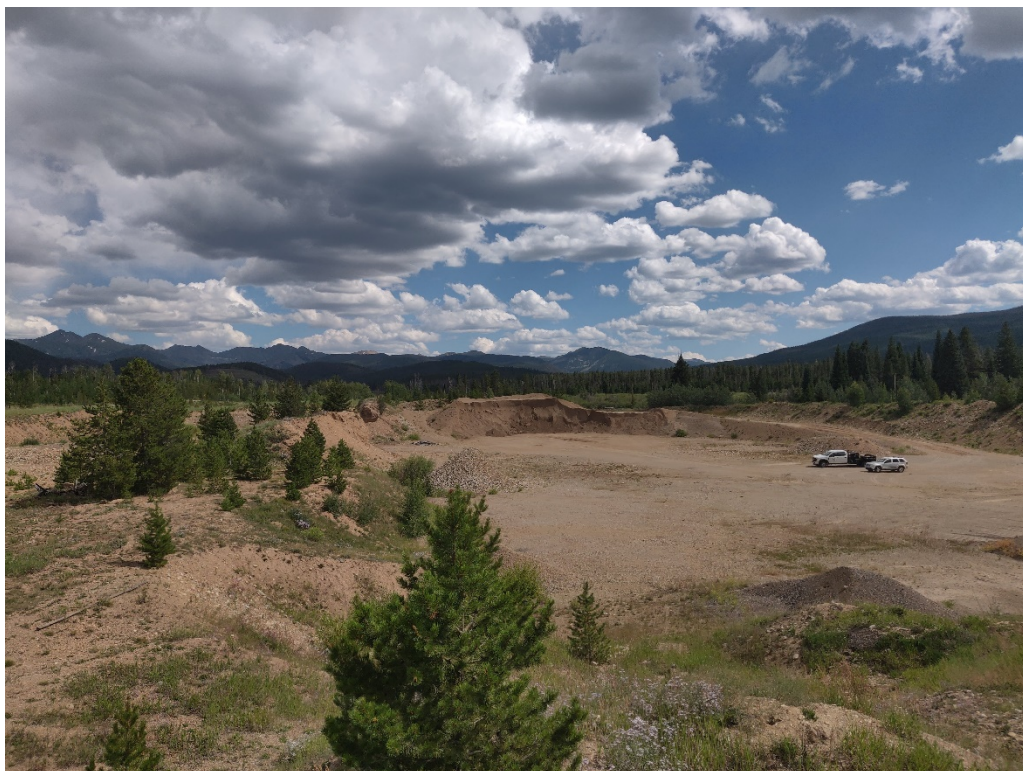
View of south pit from the dividing peninsula looking east

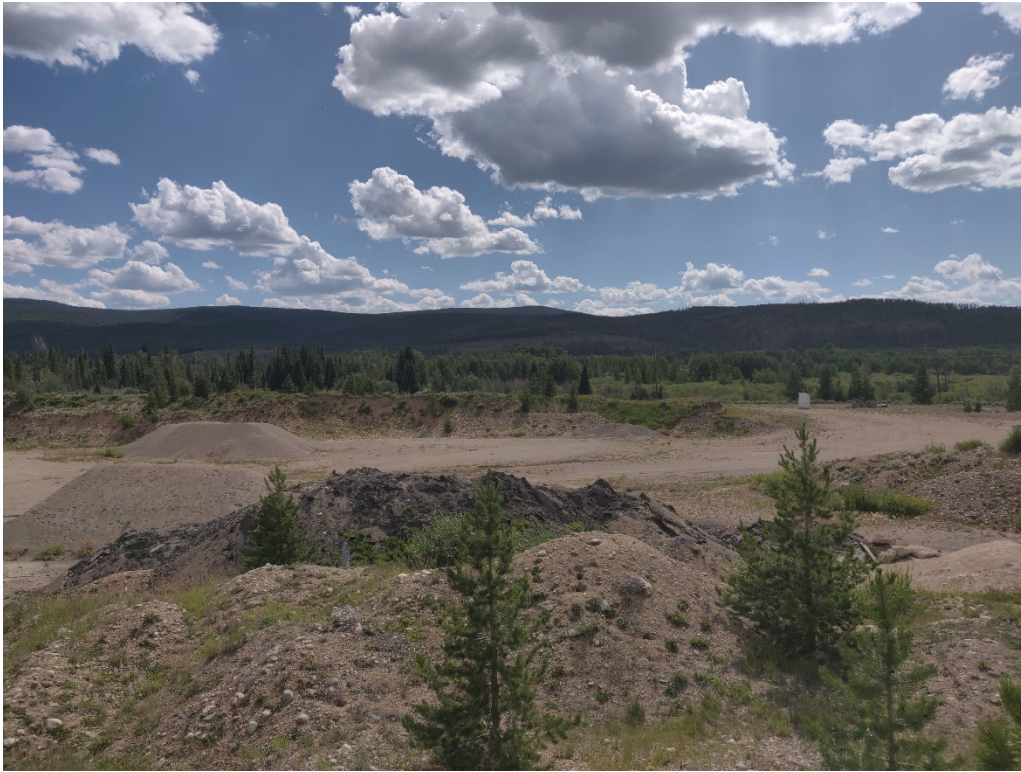
View of south pit from the dividing peninsula looking south

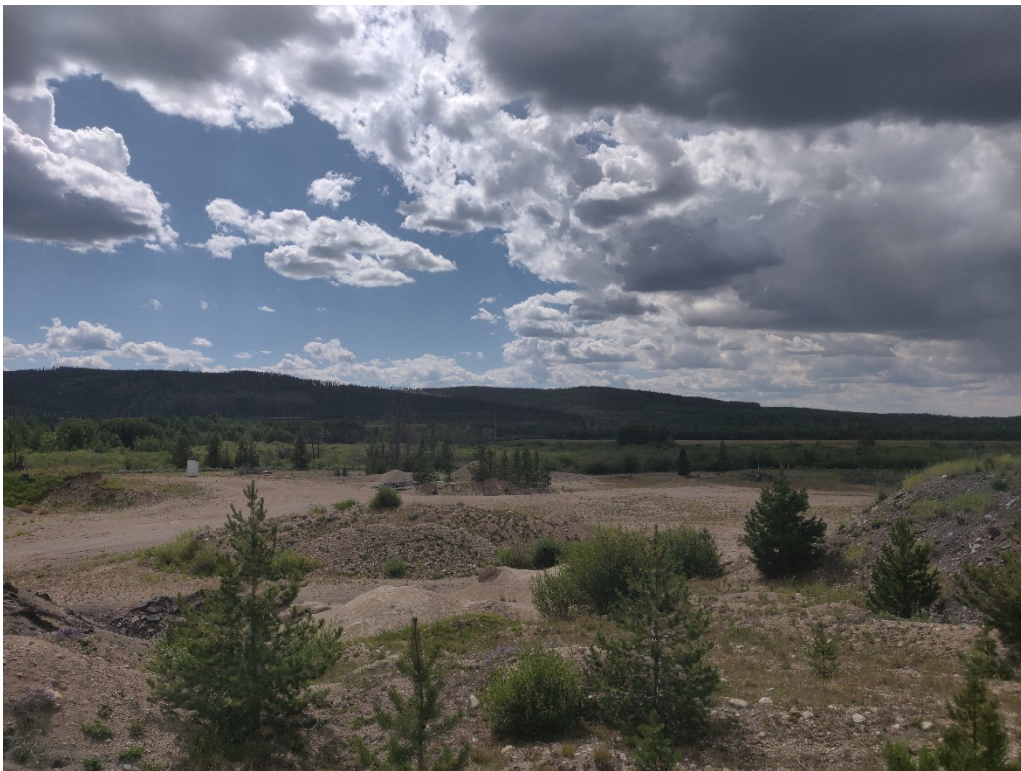
View of south pit from the dividing peninsula looking southwest

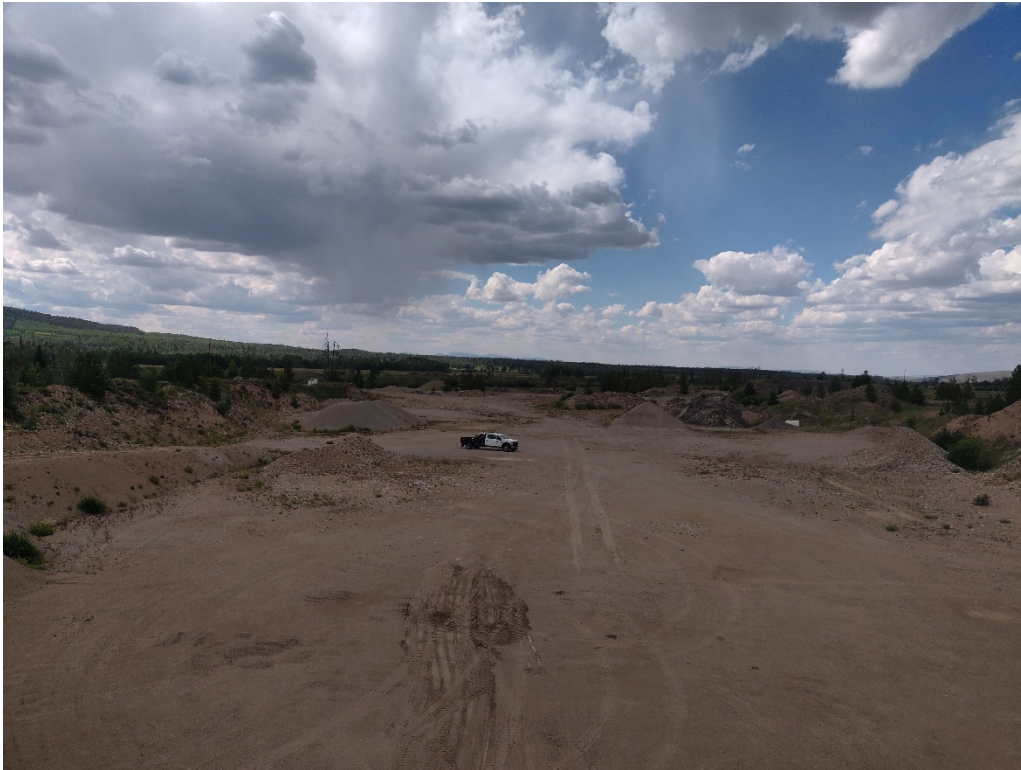
View of the south pit from the west highwall looking west

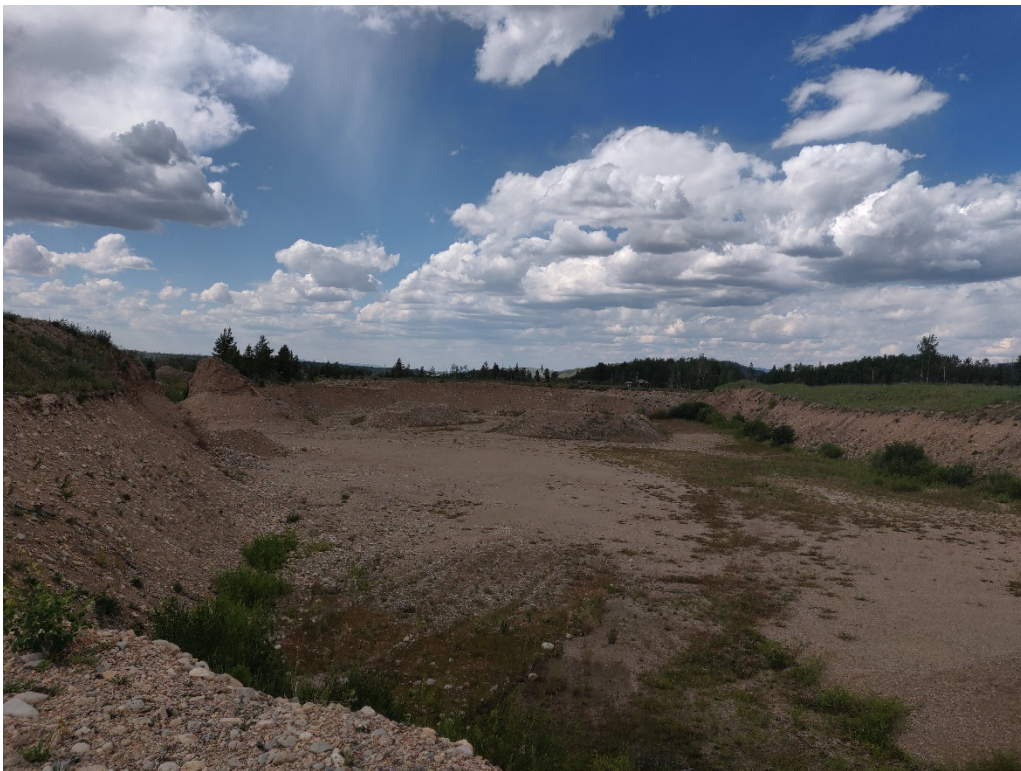
View of the north pit from the east highwall looking west
