MINERALS PROGRAM INSPECTION REPORT
PHONE: (303) 866-3567

MINE NAME: Ducray Pit #2	MINE/PROSPECTING ID#: M-2019-035	MINERAL: Borrow material	COUNTY: Mesa
INSPECTION TYPE: Preoperation Inspection	INSPECTOR(S): Amy C. Yeldell	INSP. DATE: August 14, 2019	INSP. TIME: 08:15
OPERATOR: Martinez Western Constructors Inc.	OPERATOR REPRESENTATIVE: None	TYPE OF OPERATION: 110c - Construction Limited Impact	
REASON FOR INSPECTION: Preoperation Inspection	BOND CALCULATION TYPE: None	BOND AMOUNT: \$6,447.00	
DATE OF COMPLAINT: NA	POST INSP. CONTACTS: None	JOINT INSP. AGENCY: None	
WEATHER: Clear	INSPECTOR'S SIGNATURE:

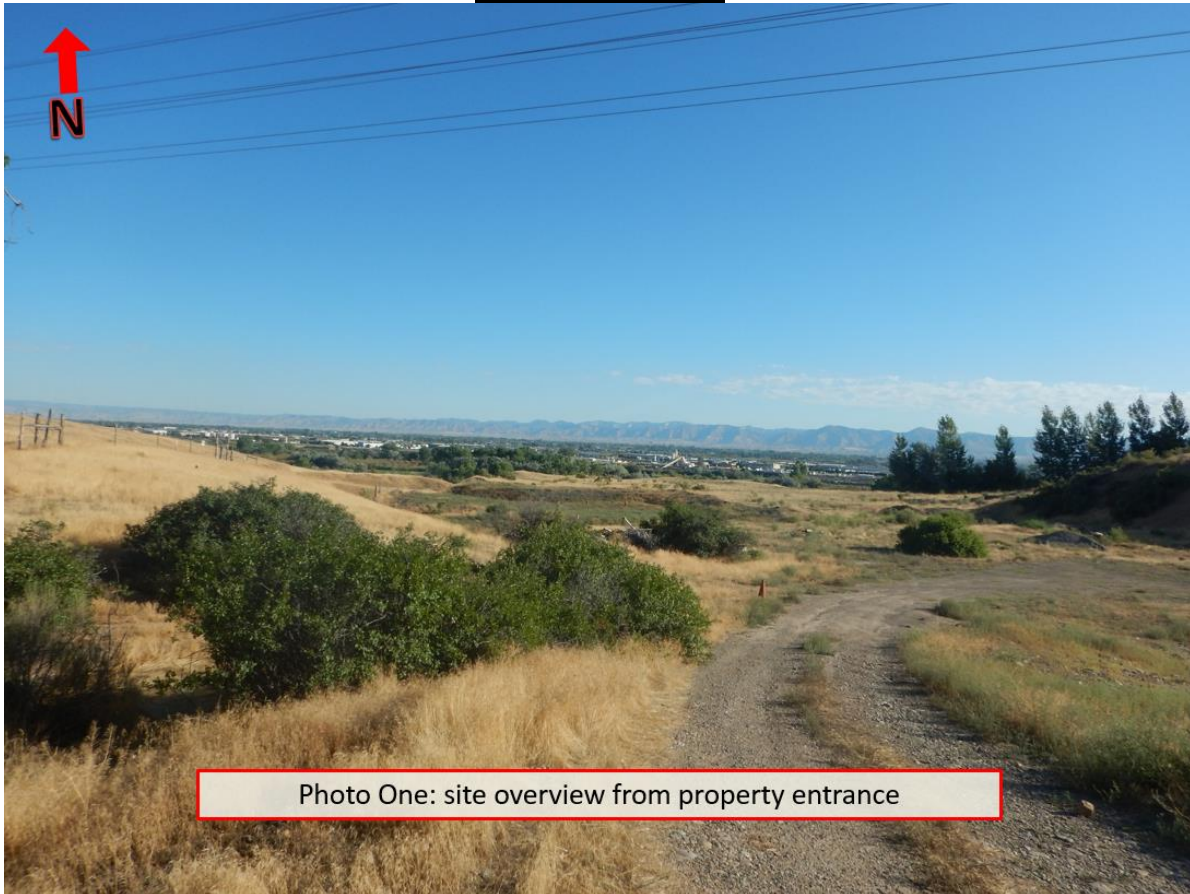
Photo One: site overview from property entrance

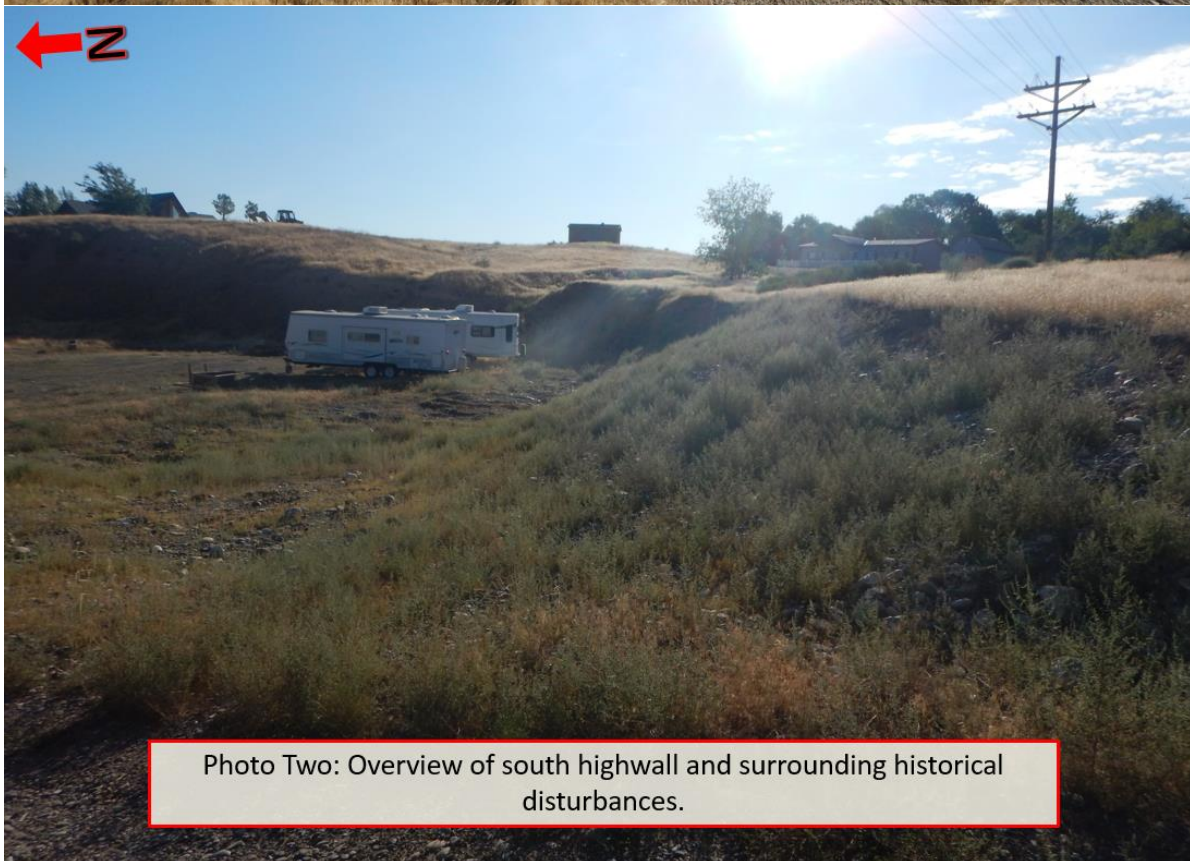
Photo Two: Overview of south highwall and surrounding historical disturbances.
