MINERALS PROGRAM INSPECTION REPORT

MINE NAME: Schwartzwalder Mine	MINE/PROSPECTING ID#: M-1977-300	MINERAL: Uranium	COUNTY: Jefferson
INSPECTION TYPE: Monitoring	INSPECTOR(S): Amy Eschberger, Michael Cunningham, Russ Means	INSP. DATE: June 11, 2019	INSP. TIME: 09:30
OPERATOR: Colorado Legacy Land, LLC	OPERATOR REPRESENTATIVE: Jim Harrington, Liz Busby, Paul Newman	TYPE OF OPERATION: 112d-2 - Designated Mining Operation	
REASON FOR INSPECTION: Normal I&E Program	BOND CALCULATION TYPE: None	BOND AMOUNT: \$8,900,000.00	
DATE OF COMPLAINT: NA	POST INSP. CONTACTS: None	JOINT INSP. AGENCY: Denver Water, Geosyntec Consultants	
WEATHER: Clear	INSPECTOR'S SIGNATURE:

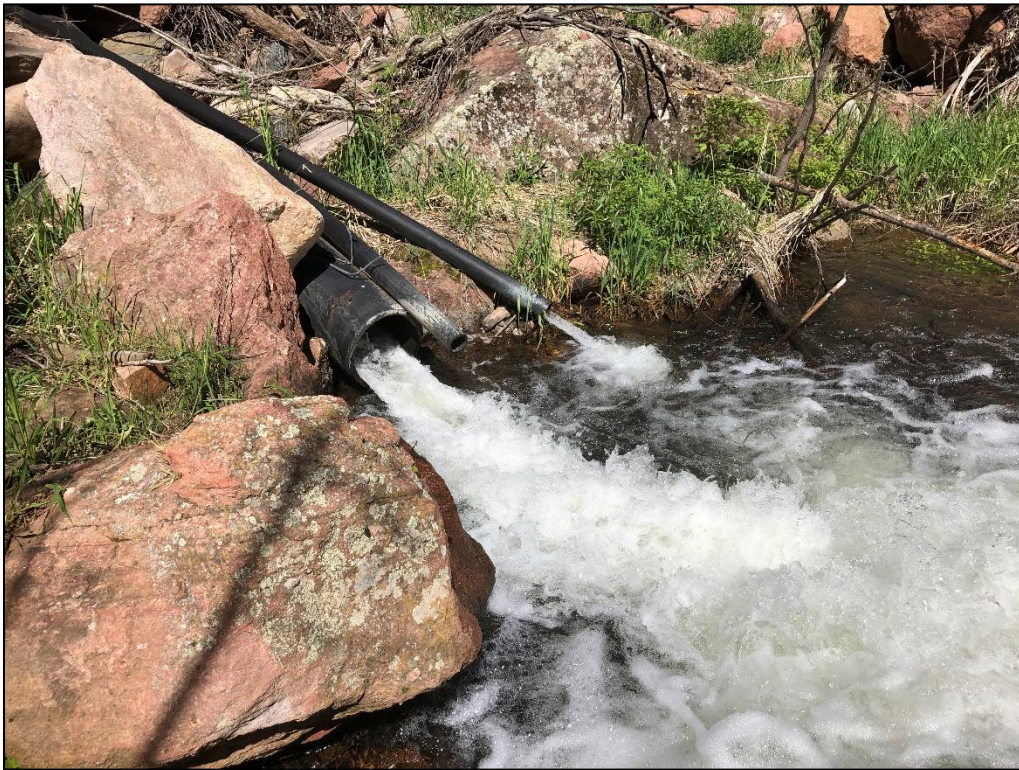
During the inspection, the Division observed the SW-BPL surface water monitoring location below property line, at which intercepted surface flows and alluvial groundwater from upgradient of the mine site, and treated groundwater collected from the mine, are discharged. The operator maintains a permit with the CDPHE, WQCD for this discharge point, under which the discharged water must meet specified water quality standards. The operator estimated the average discharge rate for intercepted water to be approximately 60 gallons per minute (gpm), and the average discharge rate for treated water to be approximately 150 gpm. Both the water diversion pipe and treated water pipe were discharging water into the creek during the inspection.

Photo 1. View of area where bypass pipeline (smaller pipe) and treated water pipeline (larger pipe) discharge into Ralston Creek at surface water monitoring station SW-BPL.

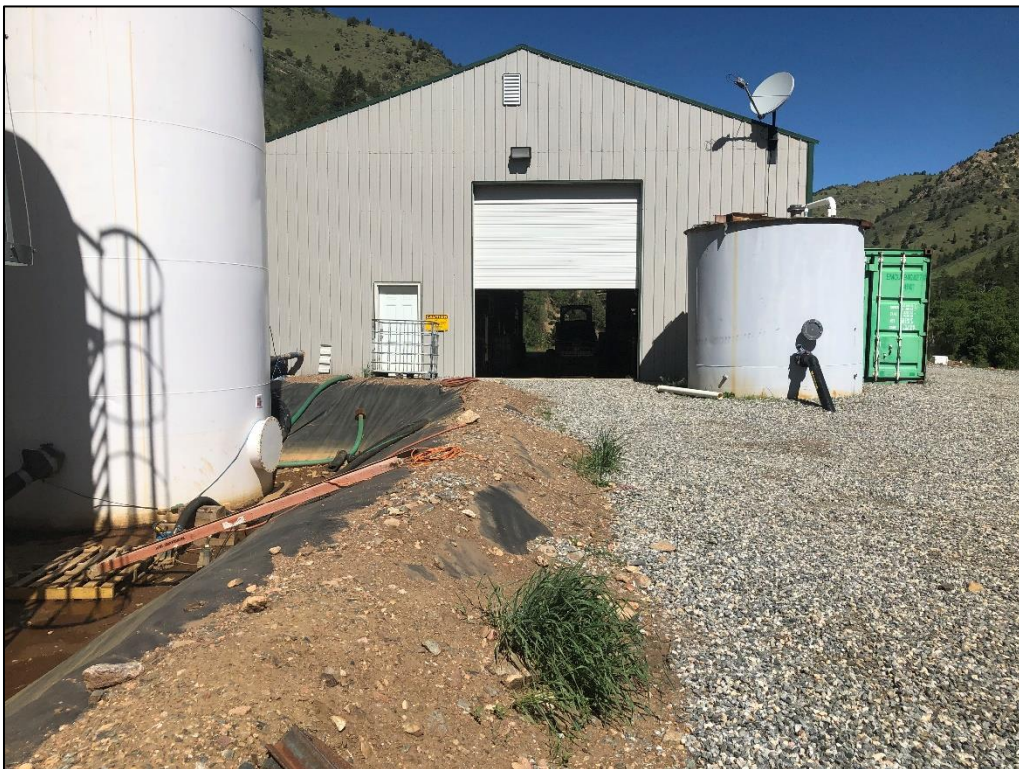
The water treatment plant was online during the inspection. The mine pool was at 160 feet below the Steve Level, which is 10 feet below the required 150-foot depth. The new mine pool dewatering 60 HP submersible pump (approved in Technical Revision No. 27) was installed on site this spring. This pump was lowered approximately 550 feet below the Sunshine Adit (approximately 410 feet below the Steve Adit) on a custom fabricated housing shed via a winch system. The dedicated winch system is adjacent to the Jeffrey Air Shaft on a concrete footer. The new pump was not online yet at the time of the inspection. Therefore, mine water was still being pumped from the Steve Adit. Once the new system is online, untreated water pumped from the Jeffrey Air Shaft will be conveyed downhill via a 5-inch High Density Polyethylene (HDPE) pipe installed inside a larger 8-inch HDPE pipe, to an existing holding tank located on the east side of the water treatment plant. This new pipeline has been installed.

Photo 2. View looking northwest at new water treatment plant located on top of mesa along southern edge of valley.

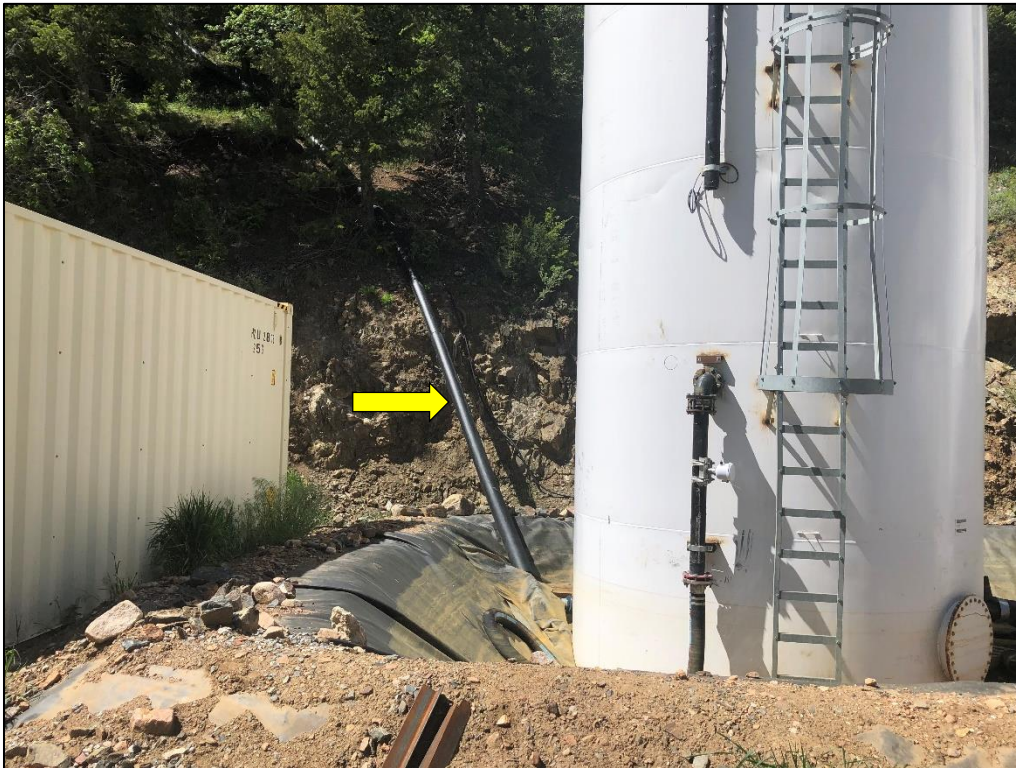
Photo 3. View of existing holding tank located on east side of water treatment plant, where untreated mine water will be pumped from Jeffrey Air Shaft via double-lined HDPE pipe, once the newly installed 60 HP submersible pump is online. The new pipeline has been installed (indicated with arrow).

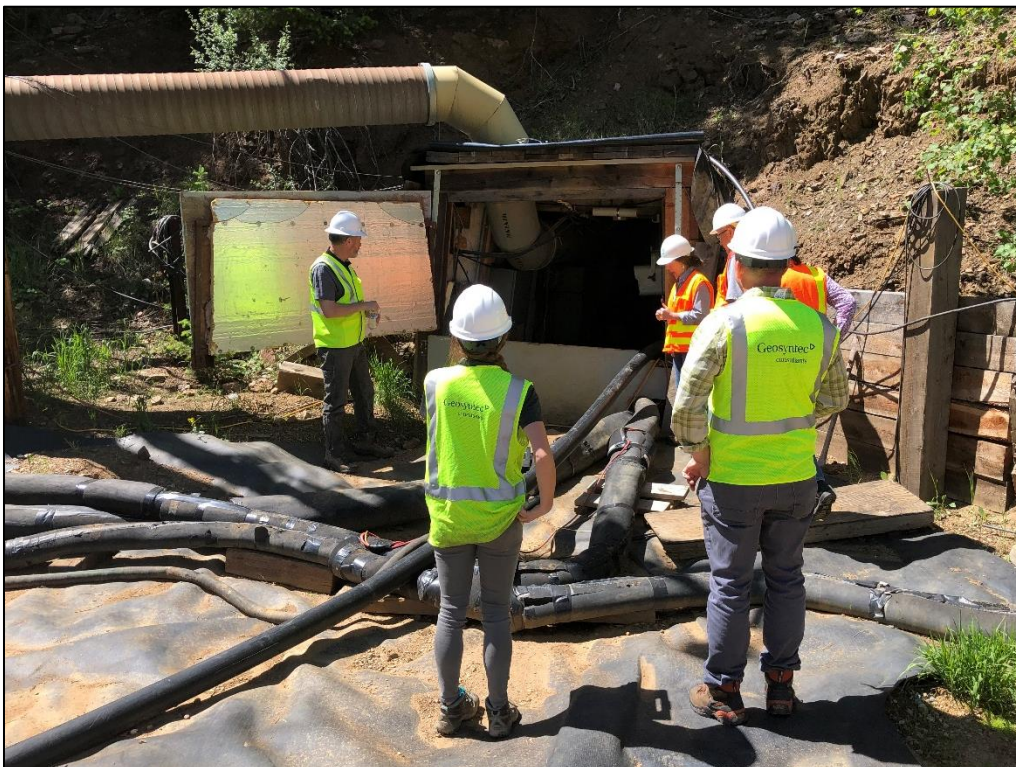
Photo 4. View of Steve Adit where water is currently pumped in from sump collection system and pumped out to water treatment plant (in lowering the mine pool).

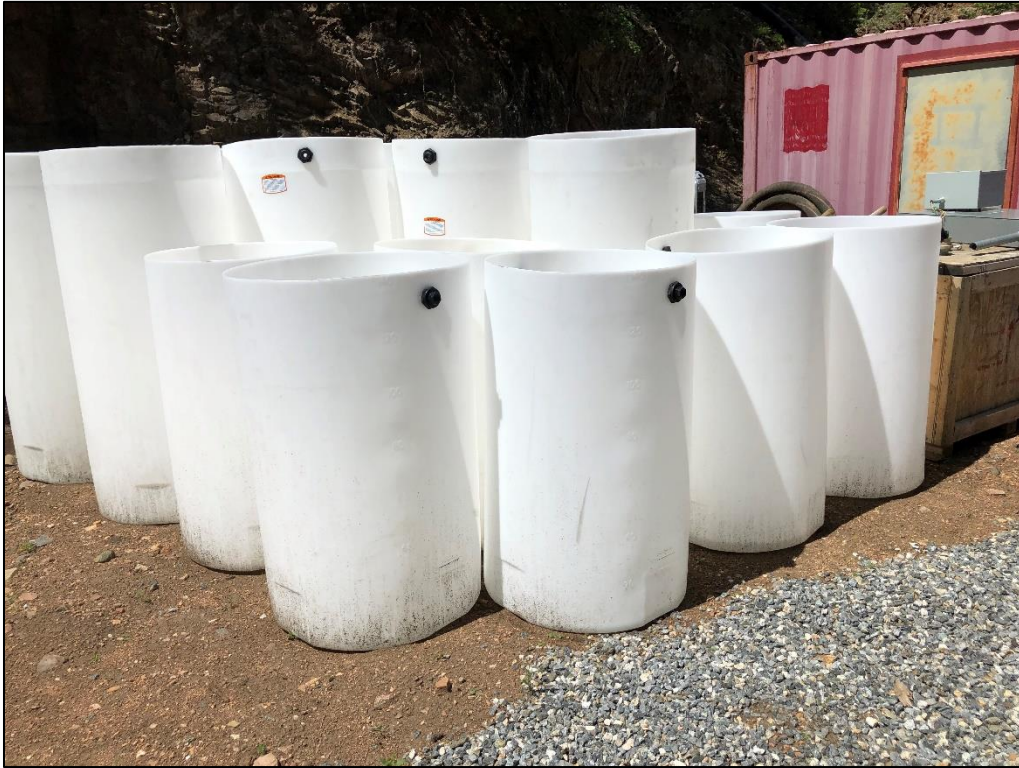
The operator was preparing to initiate a wetland study in which passive biochemical reactors will be explored for their potential use in final reclamation near the creek. This study will be conducted on top of the mesa, in the cleared off area east of the water treatment plant. Several open top plastic tanks to be used in the study were stored just east of the water treatment plant during the inspection.

Photo 5. View of area just east of the water treatment plant where several open top plastic tanks were being stored for use in an upcoming wetland study.

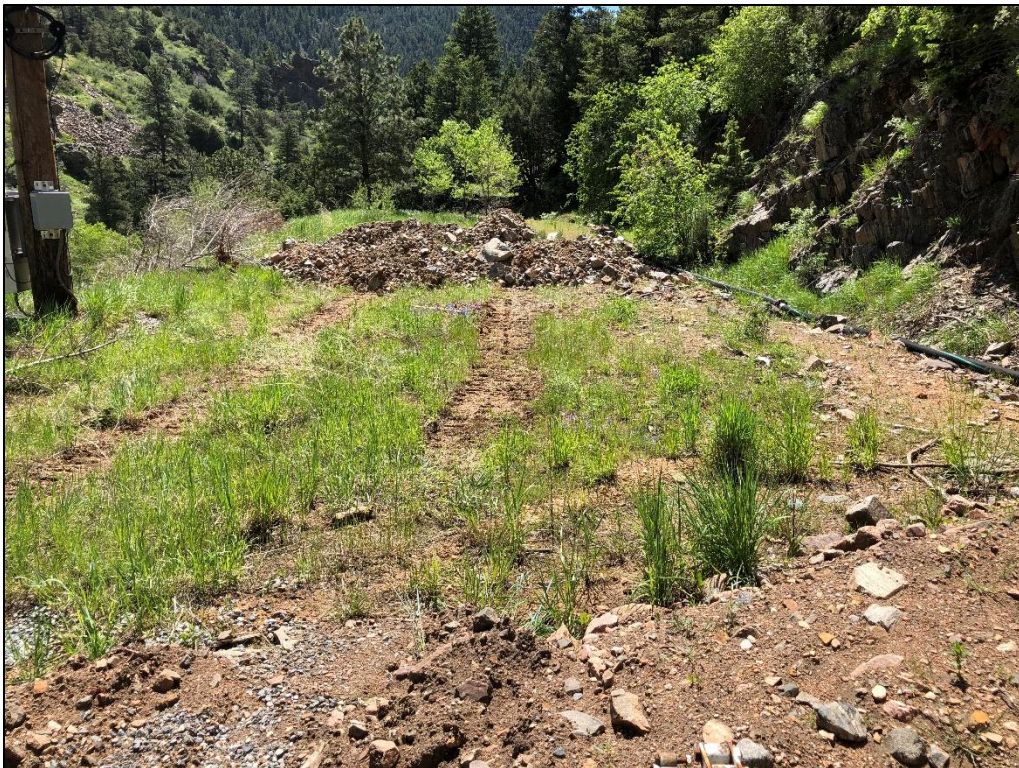
Photo 6. View of cleared off area on top of mesa, east of water treatment plant, where wetland study will be conducted.

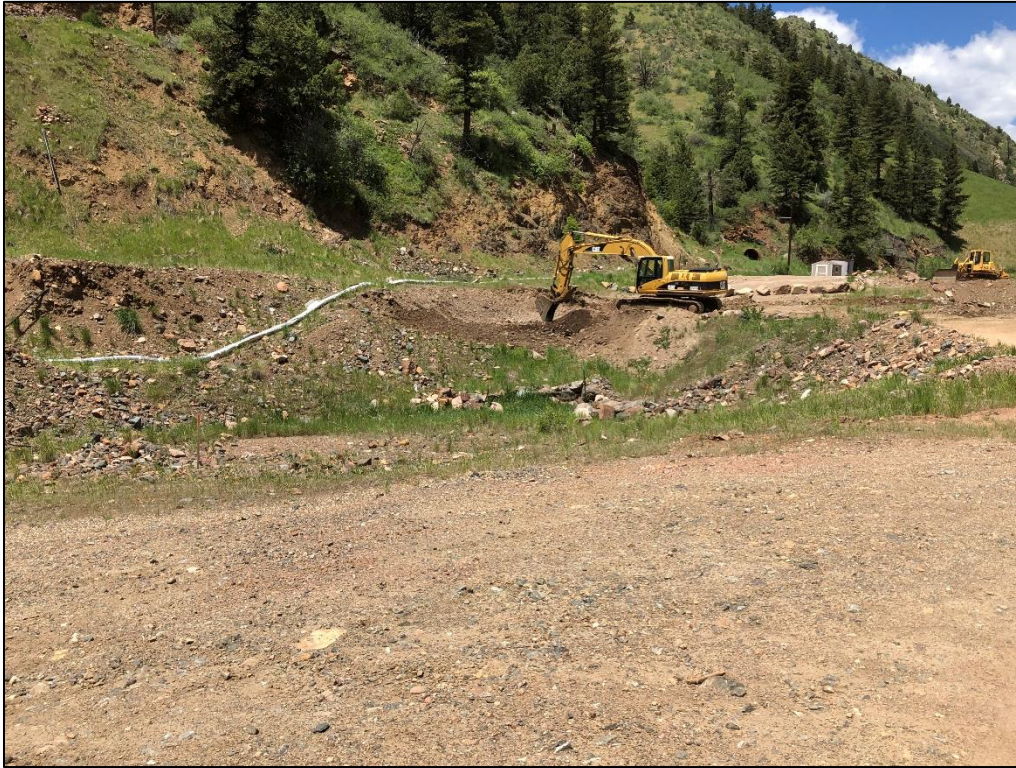
Excavation activities were taking place in the valley during the inspection. While the operator is authorized (by Technical Revision No. 23) to place additional excavated material onto the existing waste rock piles, the operation is currently only placing excavated material in the other approved on-site disposal location, the CV Glory Hole inside the Minnesota Adit. The operation was hauling excavated material uphill to the Minnesota Adit during the inspection. According to the operator, approximately 190 cubic yards of material is excavated per day during the active construction season.

Photo 7. View looking west showing excavation activities taking place in the valley during the inspection.

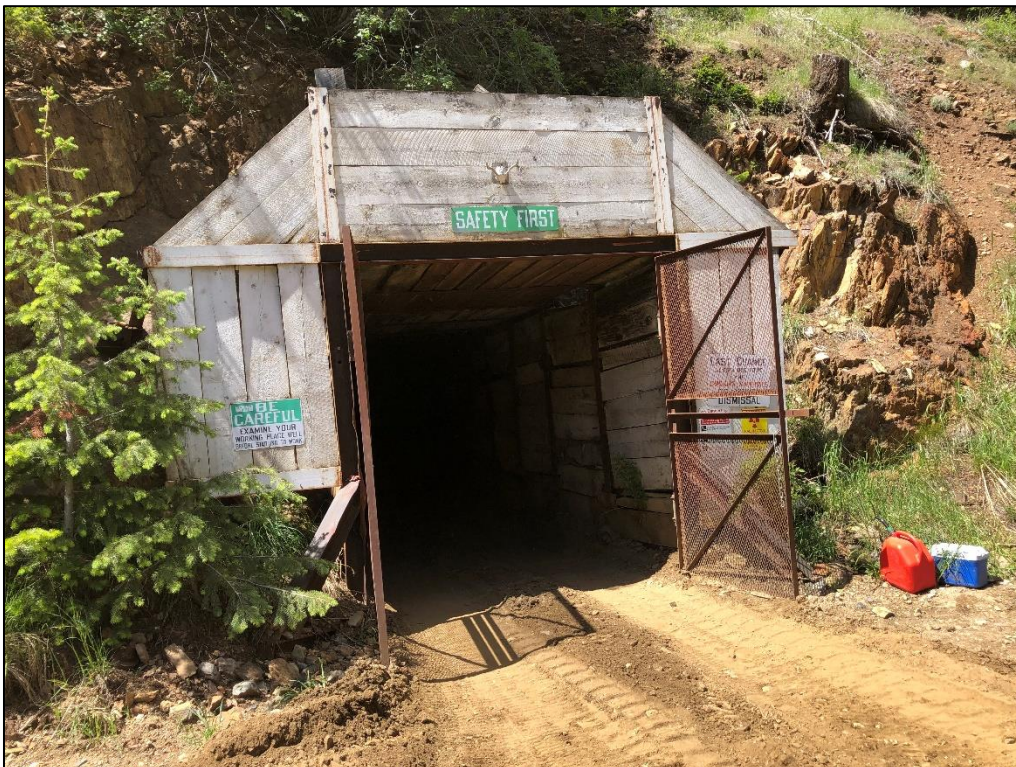
Photo 8. View of Minnesota Adit where excavated alluvial fill is transported for disposal into the CV Glory Hole.

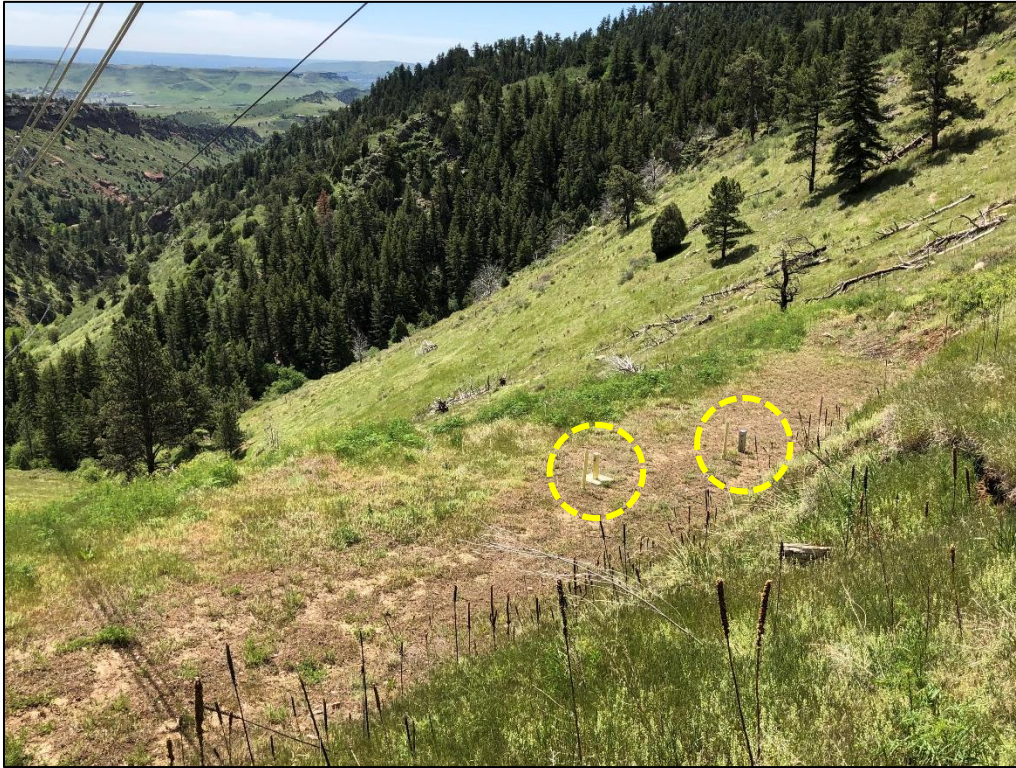
Photo 9. View looking east down the valley, showing groundwater monitoring wells MW-15 and MW-16 (circled) located on the hillside above the water treatment plant.

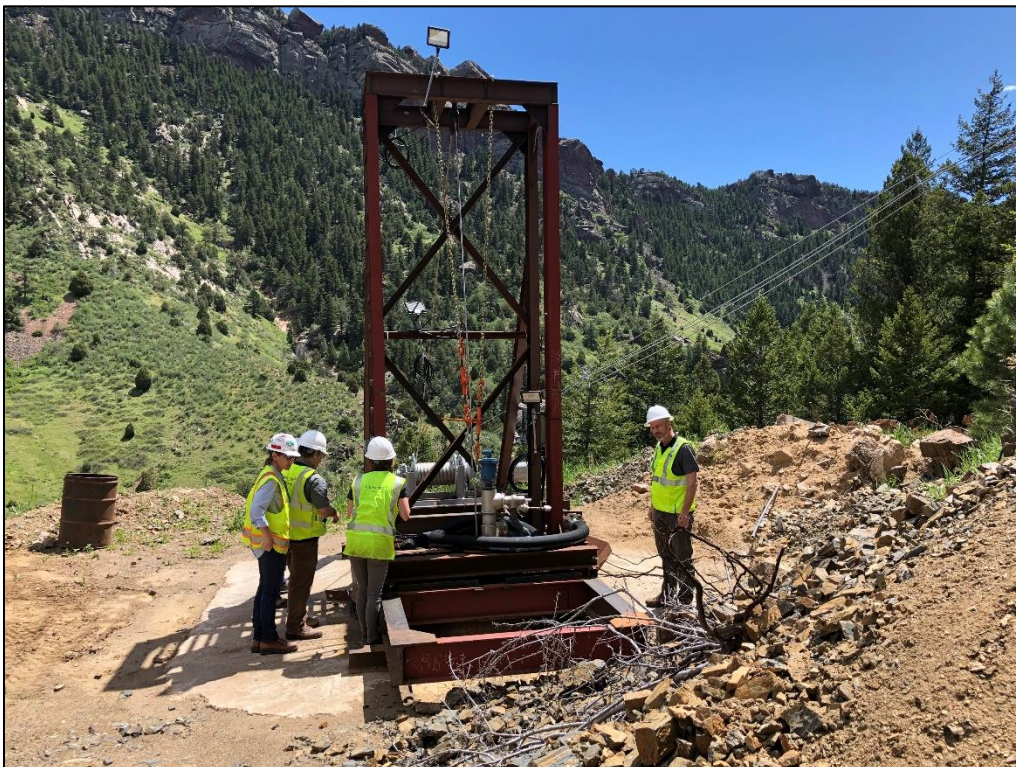
Photo 10. View looking east, showing dedicated winch system constructed on concrete footer adjacent to Jeffrey Air Shaft for new 60 HP submersible pump (installed inside the mine this spring).

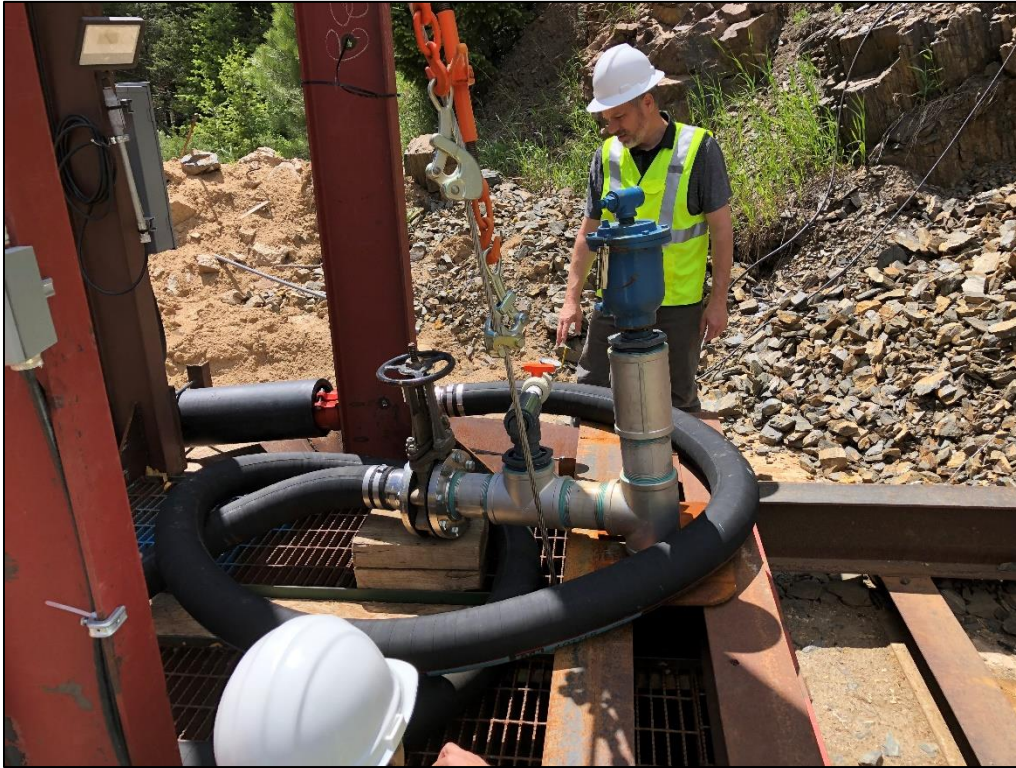
Photo 11. Closer view of Jeffrey Air Shaft in which new 60 HP submersible pump was installed this spring. Note double-walled HDPE pipe in which untreated mine water will be conveyed downhill to the water treatment plant once the new pump is online.

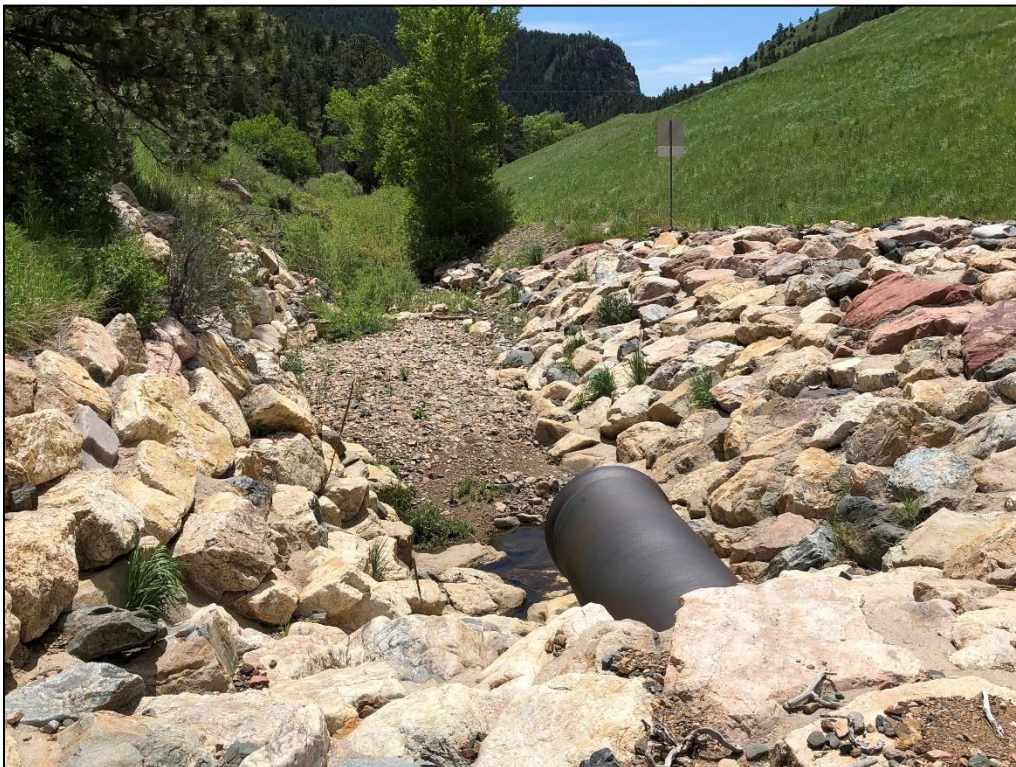
The Division inspected the upgradient cutoff wall and observed that all flows in Ralston Creek were being routed through the bypass pipeline. The Division also inspected the creek and adjacent areas upstream from the cutoff wall where the two areas of ponded (potentially impacted) water were observed during the inspection conducted on March 22, 2019. A problem was cited in the Division's inspection report sent on April 9, 2019, requiring the operator to sample the ponded water and submit the results to the Division along with any additional relevant monitoring data. Based on the sampling results (provided by the operator on May 9, 2019) and location of the ponded water, the operator believes the water is representative of sequential seeps from the nearby North Waste Rock Pile (NWRP), and the water is naturally attenuating prior to mixing with the creek. The hypothesized flow path begins with water in the ephemeral drainage above the NWRP, then expresses as surface water in the green-colored pool (located closest to the NWRP), and begins to mix with the creek in the red-colored pool (located closest to the creek), finally joining the creek prior to entering the bypass pipeline (at the cutoff wall). These two pools were still present during the current inspection, and appeared to have no significant changes in size or depth since the March 22, 2019 inspection.

Photo 12. View looking downstream from upgradient cutoff wall in Ralston Creek, showing creek dry during inspection.

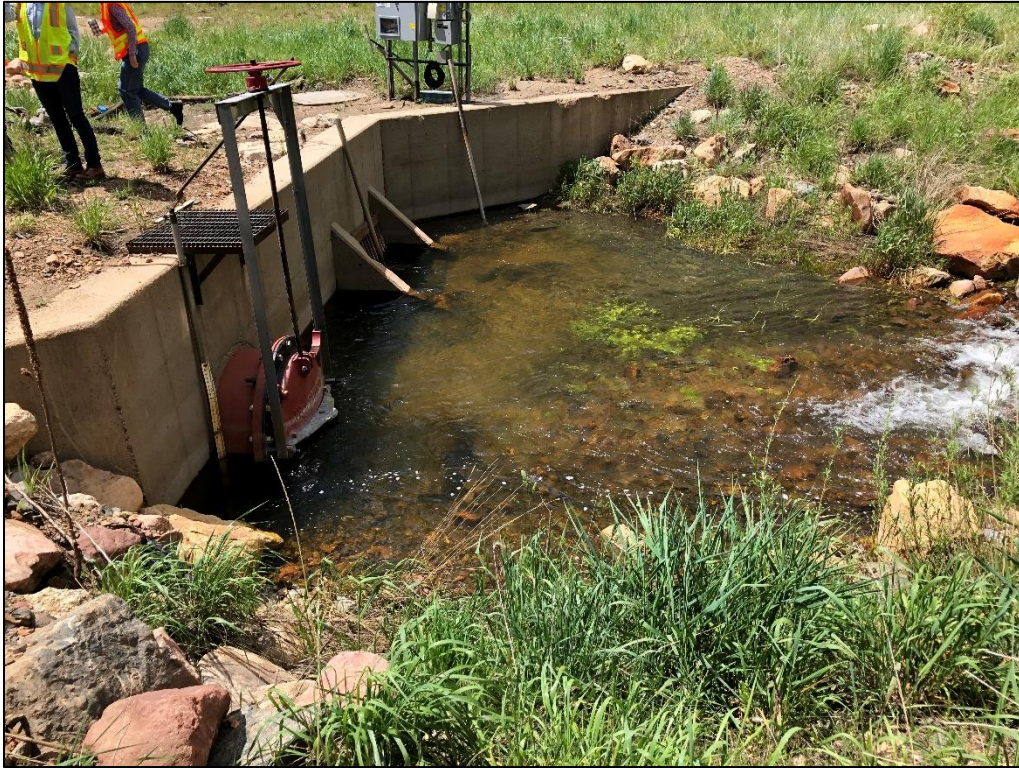
Photo 13. View looking at upgradient cutoff wall/head gate in Ralston Creek, showing creek flowing at time of inspection.

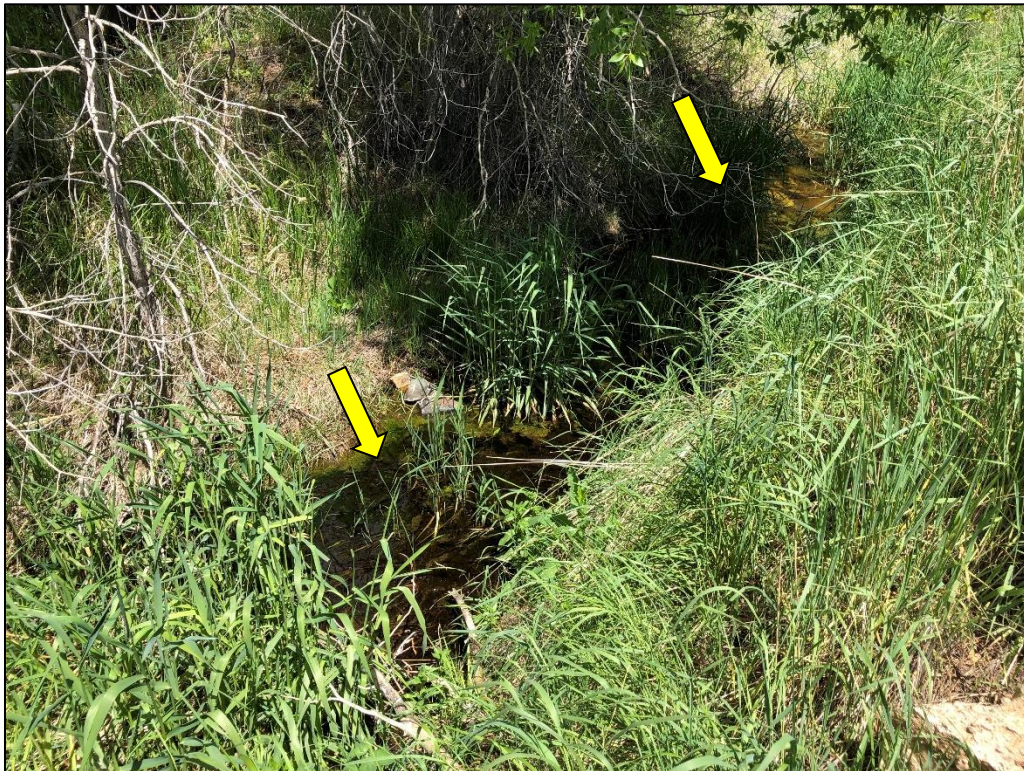
The operator stated in its May 9, 2019 corrective action response that sampling results from the downstream monitoring location (at SW-BPL) indicate contaminated surface waters are not leaving the affected lands. Additionally, any potentially contaminated alluvial groundwater would be collected in the sump collection system and pumped back on site for treatment. To address the NWRP seep issue, the operator submitted Technical Revision No. 28 (TR-28) on May 9, 2019 to revise the NWRP stormwater management plan to install structures that divert upgradient surface water around the pile to the creek below. TR-28 is still under review as of the signature date of this report, with a current decision date of August 16, 2019. The Division considers the two problems cited in the April 9, 2019 inspection report to be abated at this time. However, the effectiveness of the implemented stormwater management plan for the NWRP will be evaluated in future inspections.

Photo 14. View of green-colored pool (indicated with arrows) still present in ditch adjacent to Glencoe Valley Road, near toe of NWRP. The operator believes this is seep water from the nearby NWRP, and hopes to address this issue by installing the stormwater control structures proposed in TR-28.

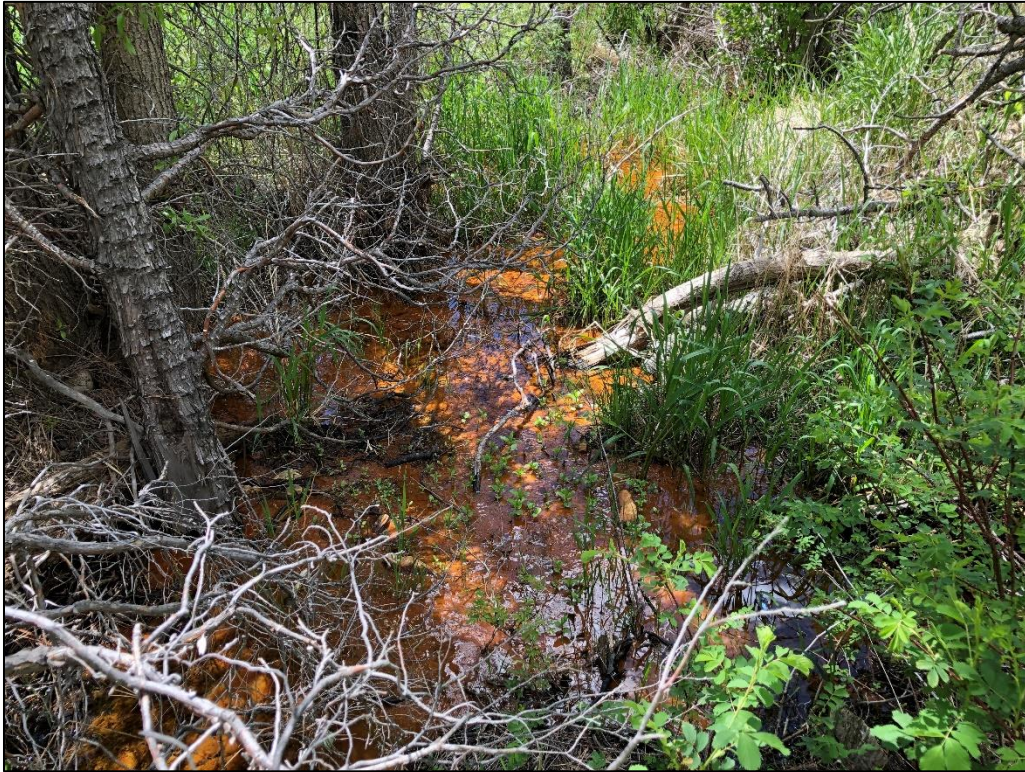
Photo 15. View of red-colored pool still present in area between creek and green-colored pool (shown in Photo 14). The operator believes this pool represents seep water starting to mix with creek water prior to joining the creek near the cutoff wall.

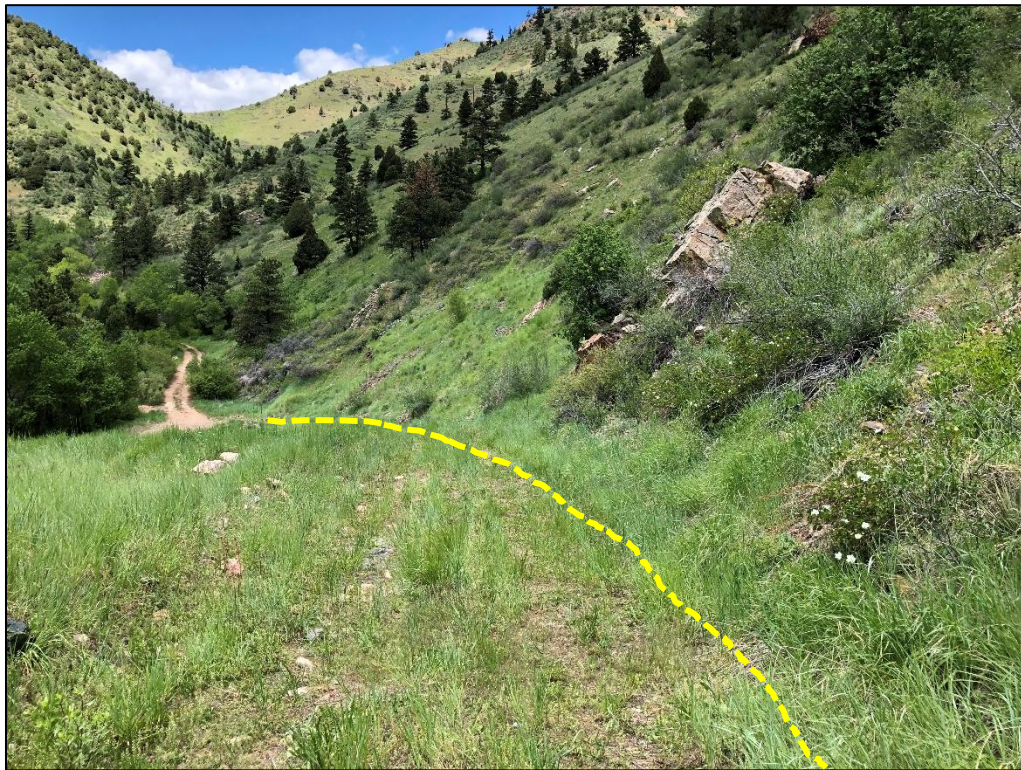
Photo 16. View looking west down north edge of NWRP (approx. edge of pile indicated with dashed yellow line) where operator proposes (in TR-28) installing a stormwater control structure to divert upgradient surface water around pile to creek below.

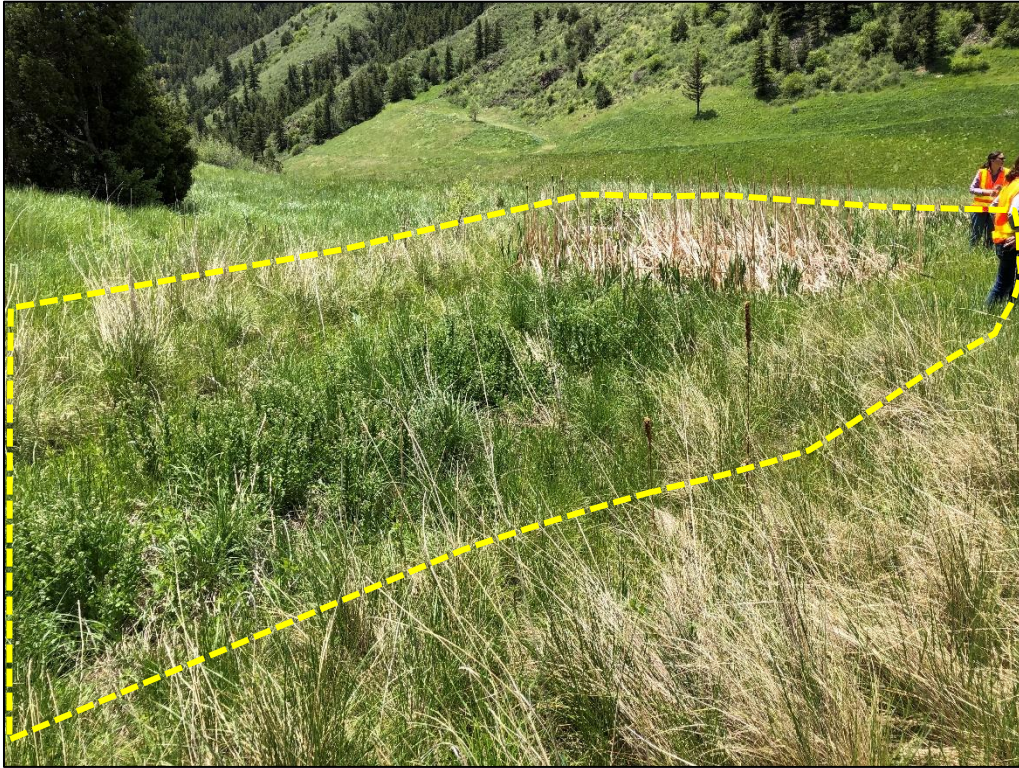
The Division inspected the top of the NWRP and found saturated conditions near the center top surface of the pile, where hydrophytic vegetation (mainly cattails) are growing. Saturated conditions were not observed in this area during the March 22, 2019 inspection. The Division inspected the narrow drainage above the NWRP which is composed of outcropped granitic bedrock. A trickle of water was flowing in the drainage during the inspection. This water appeared to be infiltrating the top of the NWRP. No surface flows across the top of the pile were observed. However, the Division did observe a pathway of flattened grass and woody debris where the drainage meets the top of the NWRP, indicating surface flows do occur, most likely during high runoff events. No erosion issues were observed on the sides of the NWRP. It appears the water mostly pools at the top of the pile, particularly in the area where saturated conditions were observed during this inspection.

Photo 17. View looking across top of NWRP, showing approximate area (indicated with yellow dashed line) where saturated conditions were observed during inspection.

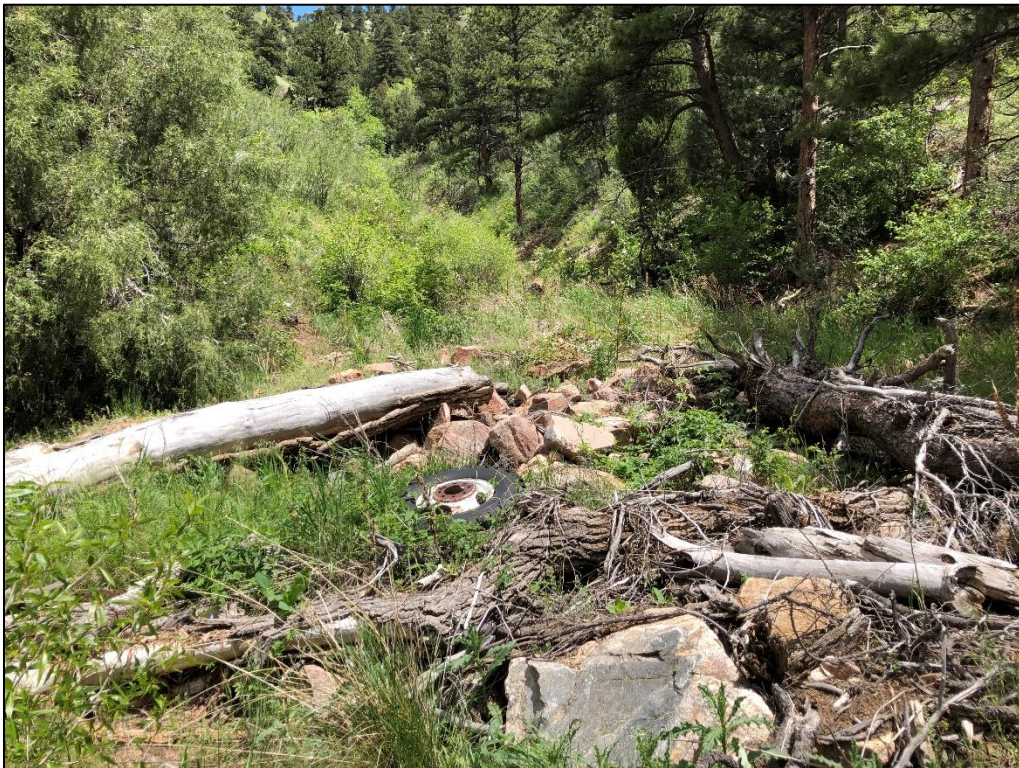
Photo 18. View looking up drainage above NWRP. Note pile of woody debris and large rocks present near area where drainage meets top of pile.

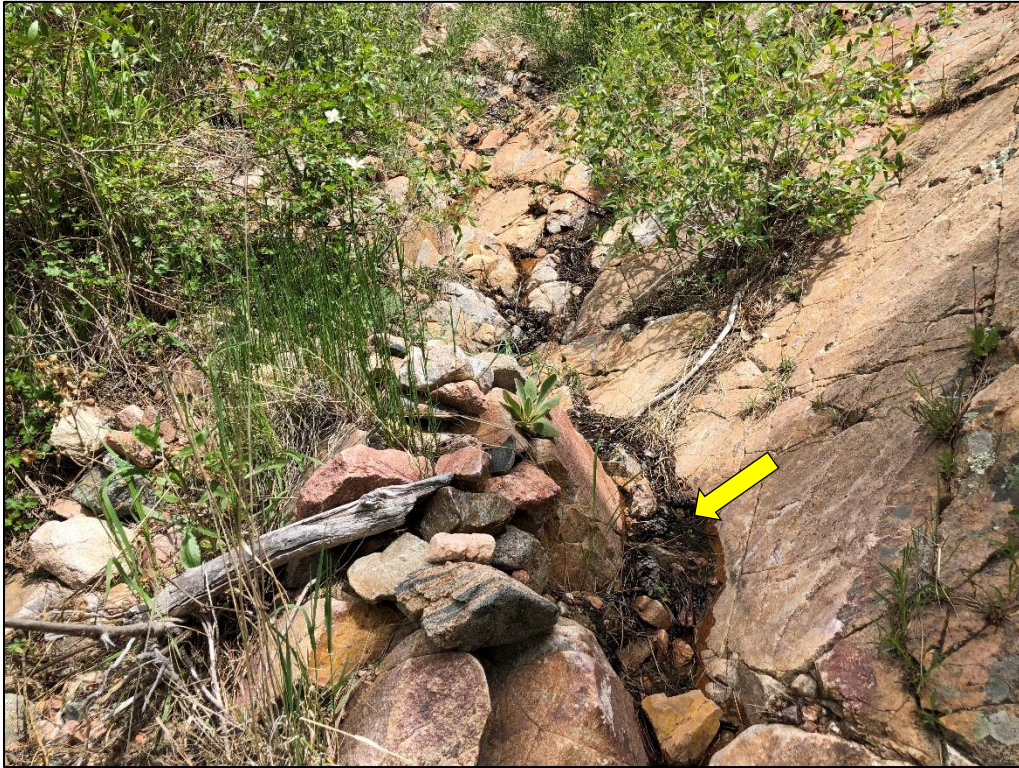
Photo 19. View looking up drainage above NWRP (further up drainage than shown in Photo 18). Note trickle of water flowing in drainage during inspection (indicated with arrow).

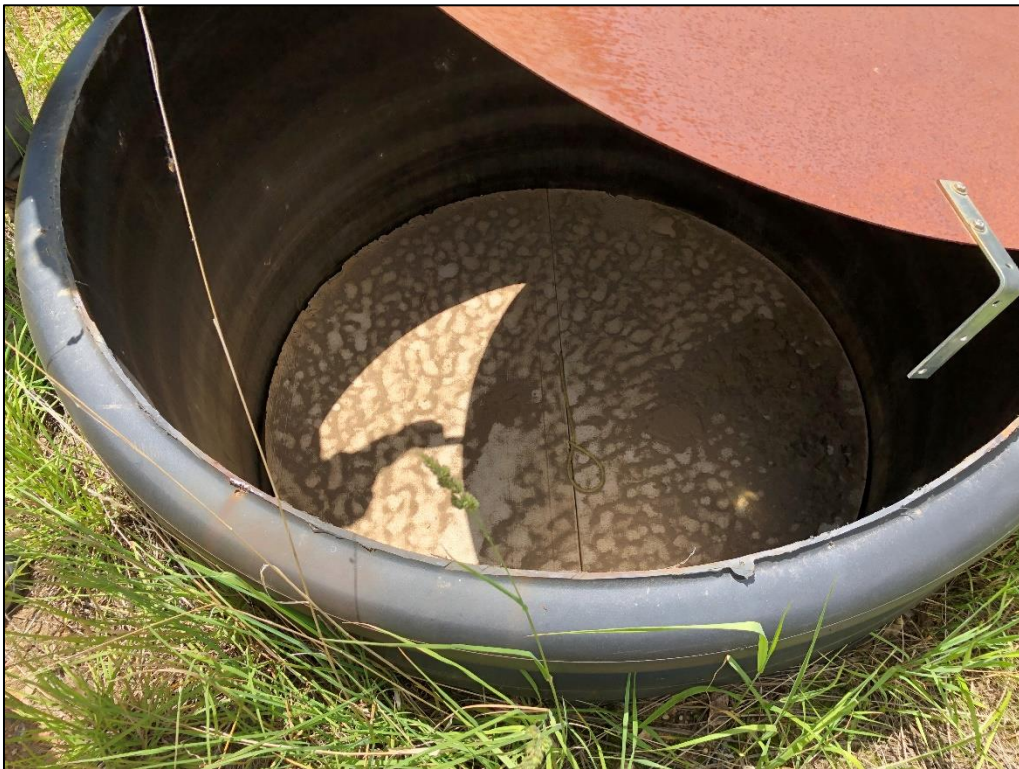
The Division inspected the pumpback sump #4, located northwest of the water treatment plant. This sump was dry during the inspection. The operator notified the Division after this inspection (via email on July 29, 2019) that sumps 9 and 10 (located northwest of the plant) will need to be taken offline as they are in an area targeted for excavation. The Division inspected these areas during its August 1, 2019 inspection of the site, and will document its observations in the associated inspection report.

Photo 20. View inside pumpback sump #4, showing sump dry during inspection.
