Re: Bowie Resources, LLC, Bowie No. 2 Mine
Coal Mine Waste Banks & Instrumentation Monitoring
Pond Quarterly Inspections
Permit C-1996-083

QUARTERLY POND INSPECTION REPORT

Coal Mine Waste Bank Nos. 1, 2, & 3 Inspections –1st Quarter 2019

Subject: Summary of Instrumentation Monitoring
1st Quarter 2019
Bowie Coal Waste Disposal Area No. 2
Paonia, Colorado

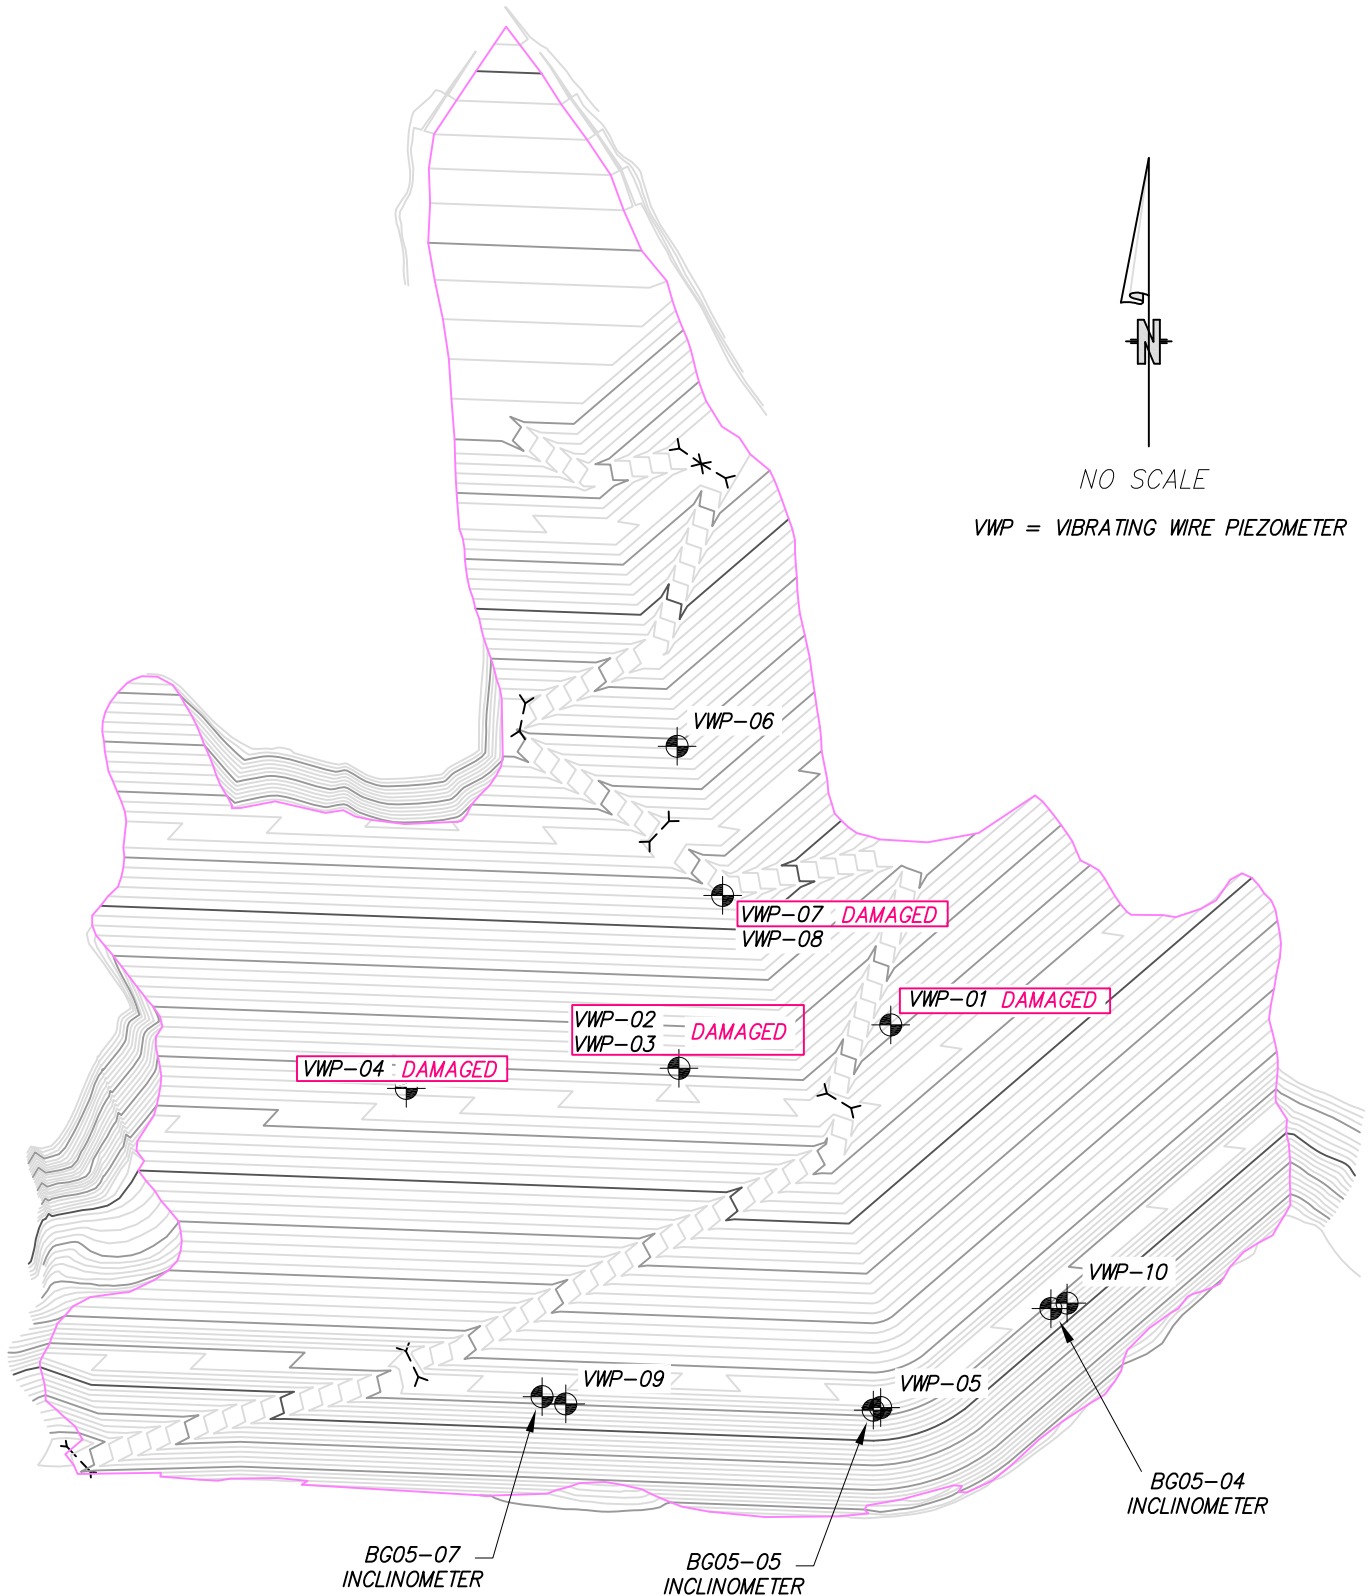
INSTRUMENTATION SITE PLAN

The physical locations of the piezometers are shown on the attached Instrumentation Site Plan (Map 1). As seen on this map, five of the original VWP's were damaged and some were replaced. Currently, there are five active VWP's and three of them are adjacent to the three inclinometers. The graph of historical data from 5/16/05 through 5/21/14 is presented for reference as Figure 1. A graph of measured pore pressures of active piezometers is presented on the attached Figure 2 and is presented numerically in Table 1 below.

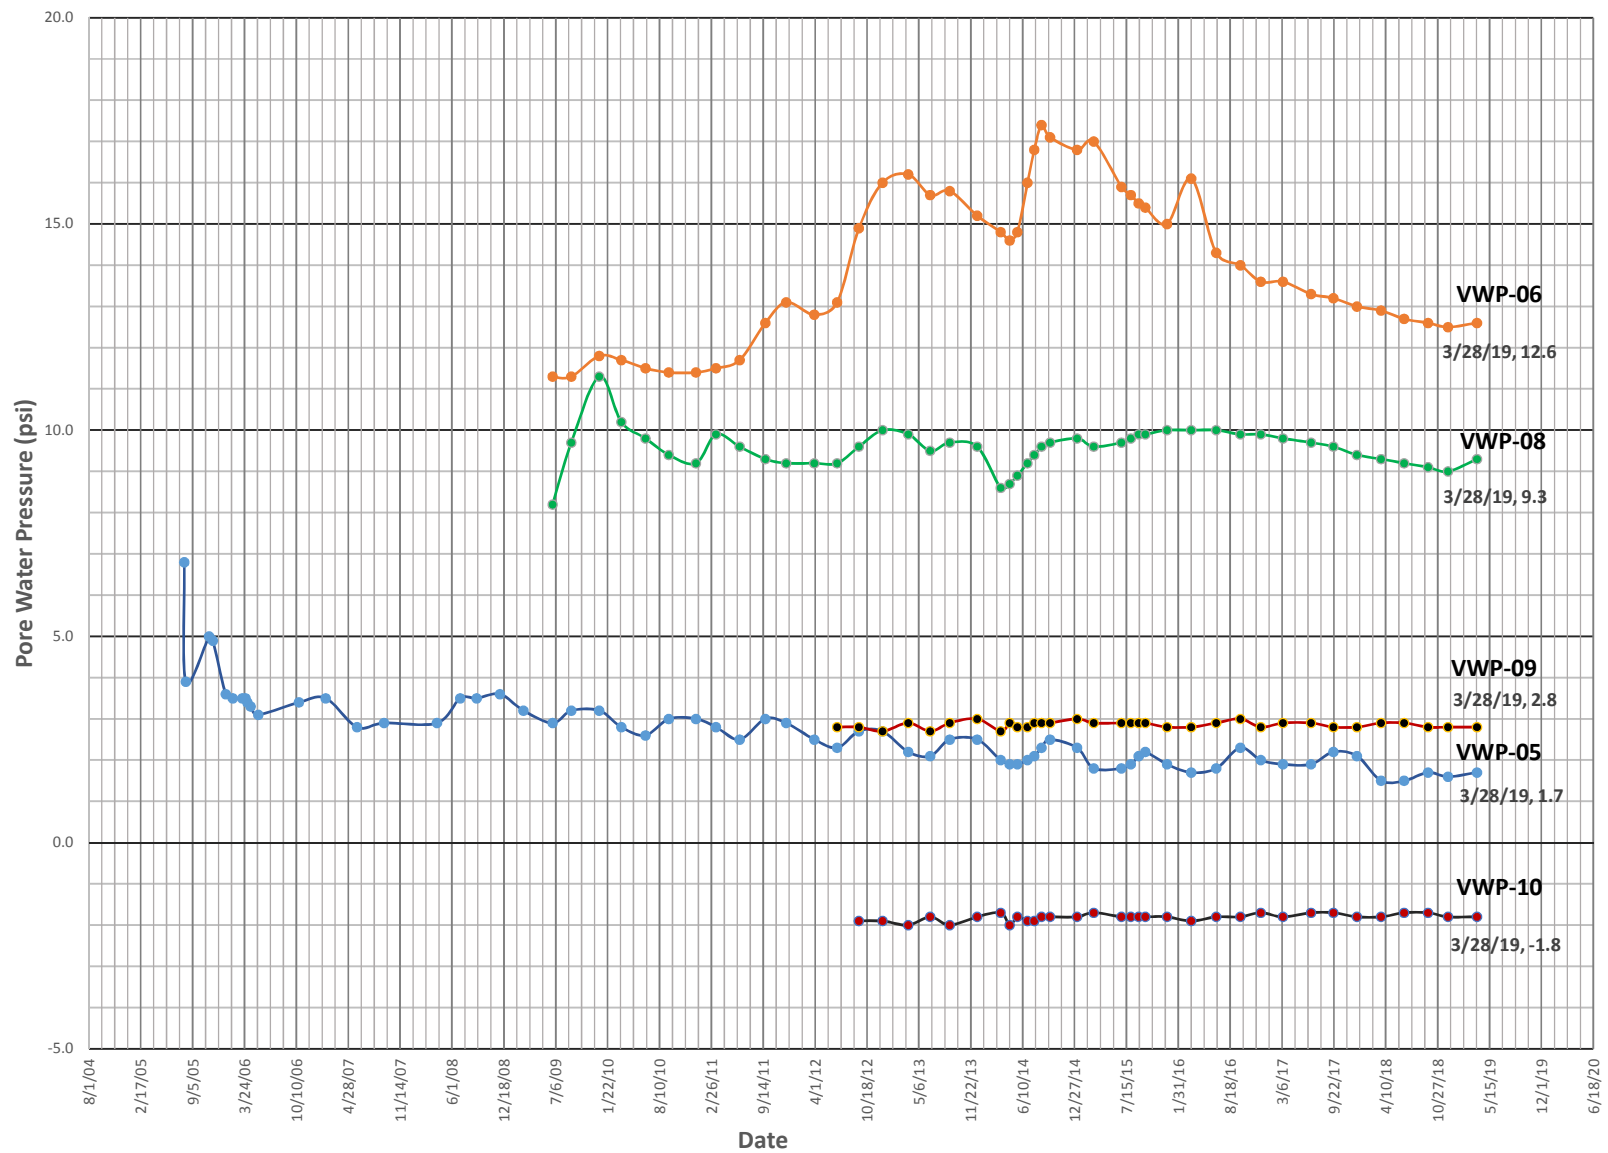
Figure 2 - Bowie Mine #2 - CWDA #2
Active Vibrating Wire Piezometer Data

The latest inclinometer readings indicate no major movements since the last quarterly reading. In general, the 1st Quarter 2019 monitoring data does not provide any indication of instability in CWDA No. 2.

In general, based upon the results of the recent VWP and inclinometer monitoring data, HBET does not believe that there is any reduction in the stability of CWDA No. 2. Due to the limited activity at the mine, HBET recommends that the monitoring frequency be reduced to semi-annually.

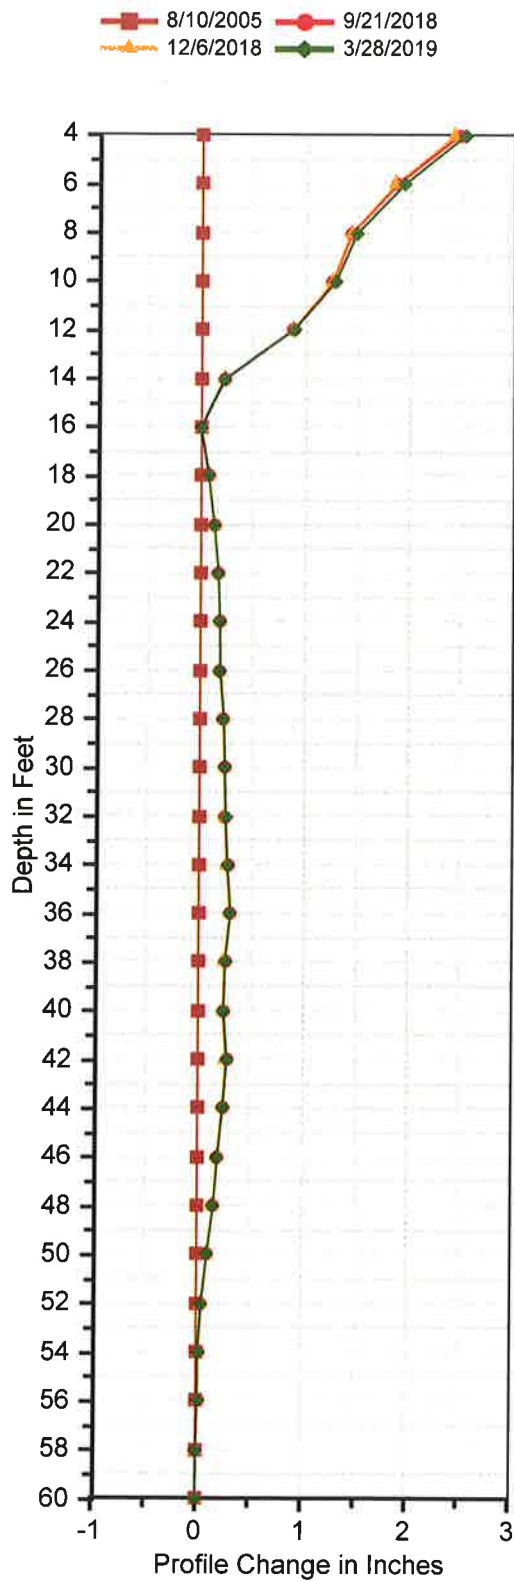
BOWIE BG05_5 A

As described in previous reports, we believe historic displacements indicated on the plots for the approximate upper ten feet of the inclinometers are likely due to placement of cover soil on the face of the waste bank during normal operations for maintenance and revegetation. Recent readings are generally consistent with previous readings.

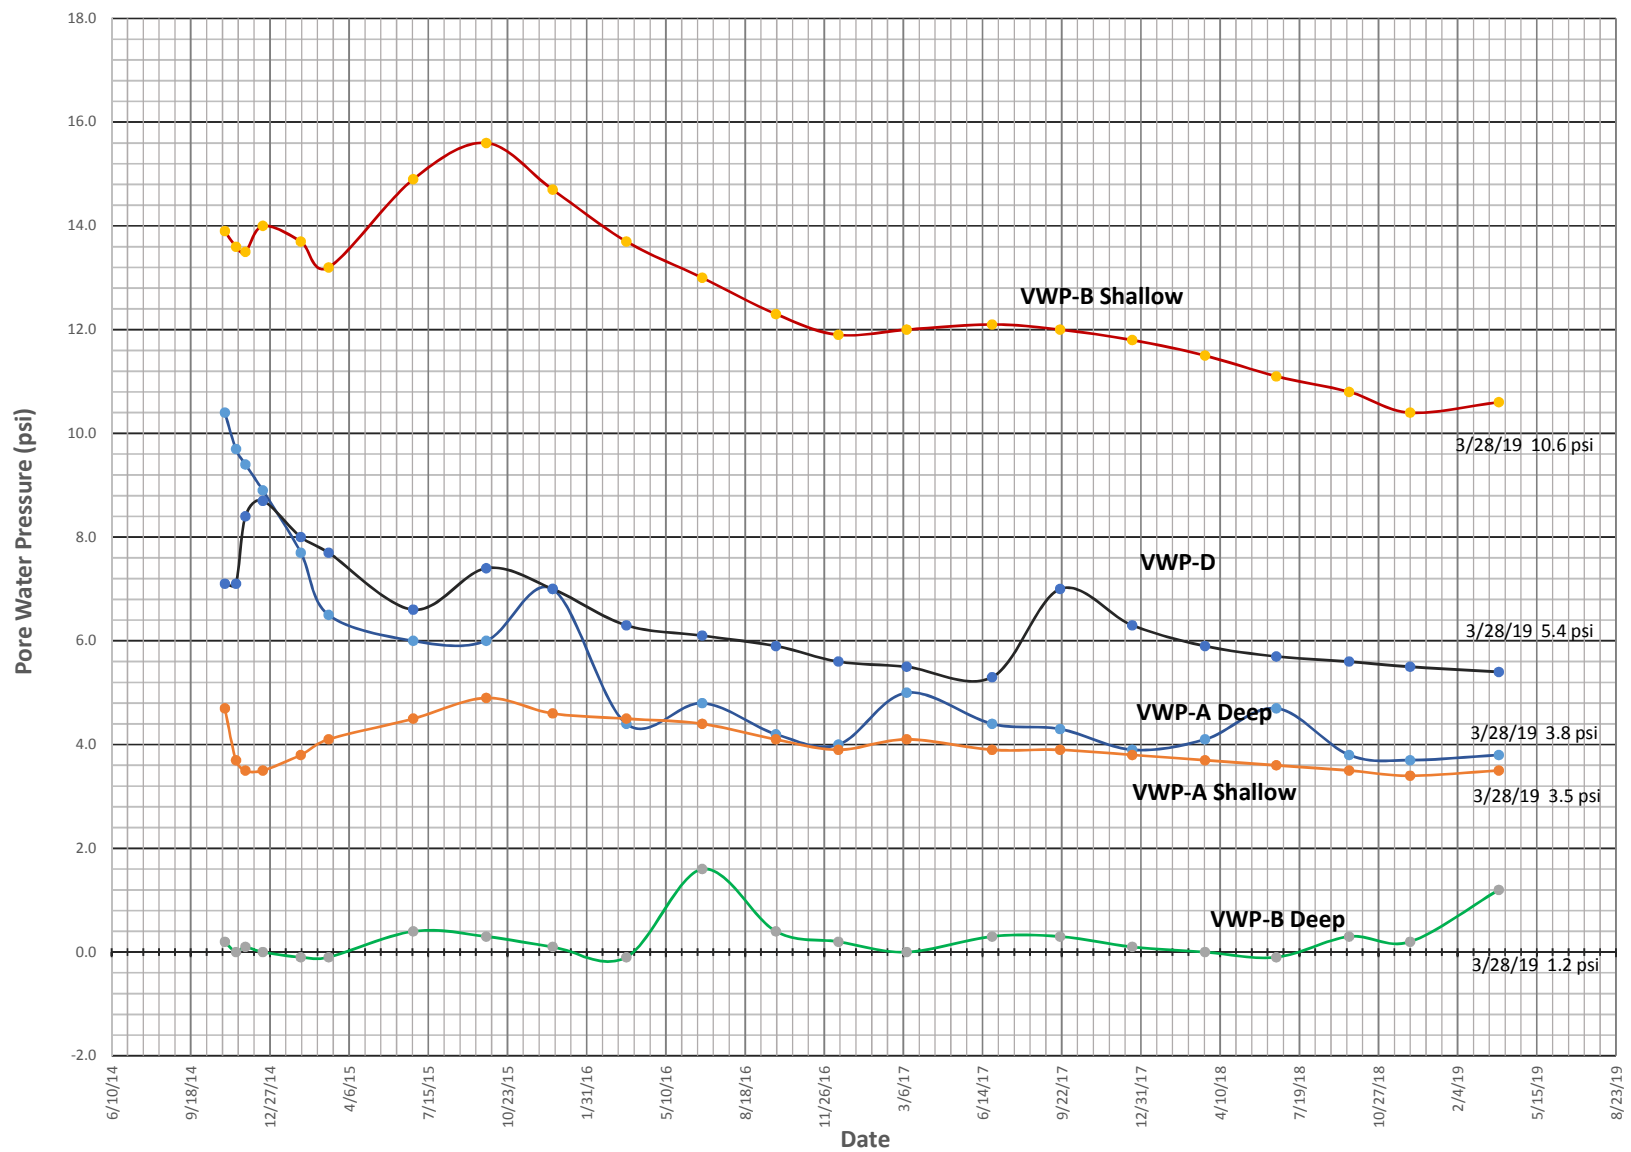
Figure 1 - Bowie Mine #2 - CWDA #3
Vibrating Wire Piezometer Data

VWP-B Deep was installed on October 6, 2014 in the west-central portion of CWDA No. 3. VWP-B Deep was installed in the foundation soil approximately ten feet below the bottom of the gob. Since installation, the pore pressures recorded at VWP-B Deep have fluctuated within a narrow range. The current data shows an increase of 1.0 psi since the previous reading and the cause of this increase is unknown as no significant changes were detected in the other instruments. In general, HBET does not believe that the pore pressure changes in VWP-B Deep are an indication of instability in CWDA No. 3. In addition, the 2nd Quarter 2019 readings will provide an indication of whether or not the recorded increase is an anomaly or not.

As seen on Figure 1, the readings are either consistent with previous historic readings. One VWP shows a slight decrease pore pressure over the most recent readings, three show a slight increase, and one shows a more substantial (1.0 psi) increase. The VWP with the most increase (VWP-B Deep) has had a similar rate and amount of increase as it experienced in the early summer of 2016 and could be related to greater influence of groundwater movement in a wetter year. If you have any questions regarding this letter or the instrumentation monitoring at CWDA #3, please contact me at (907) 562-2000 or jholland@dowl.com.

Based upon the results of the most recent VWP monitoring data, HBET does not believe that there is any reduction in the stability of CWDA No. 3. However, the 2nd Quarter 2019 readings will be used to further evaluate changes in pore pressure at VWP-B Deep.
