MINERALS PROGRAM INSPECTION REPORT
PHONE: (303) 866-3567

MINE NAME: Mineral County Pit	MINE/PROSPECTING ID#: M-1984-097	MINERAL: Sand and gravel	COUNTY: Mineral
INSPECTION TYPE: Monitoring	INSPECTOR(S): Stephanie J. Mitchell	INSP. DATE: August 14, 2019	INSP. TIME: 14:30
OPERATOR: Mineral County	OPERATOR REPRESENTATIVE:	TYPE OF OPERATION: 112c - Construction Regular Operation	
REASON FOR INSPECTION: Normal I&E Program	BOND CALCULATION TYPE: IT.Bondcalculationtype.CD.Desc	BOND AMOUNT: \$0.00	
DATE OF COMPLAINT: NA	POST INSP. CONTACTS: None	JOINT INSP. AGENCY: None	
WEATHER: Clear	INSPECTOR'S SIGNATURE:

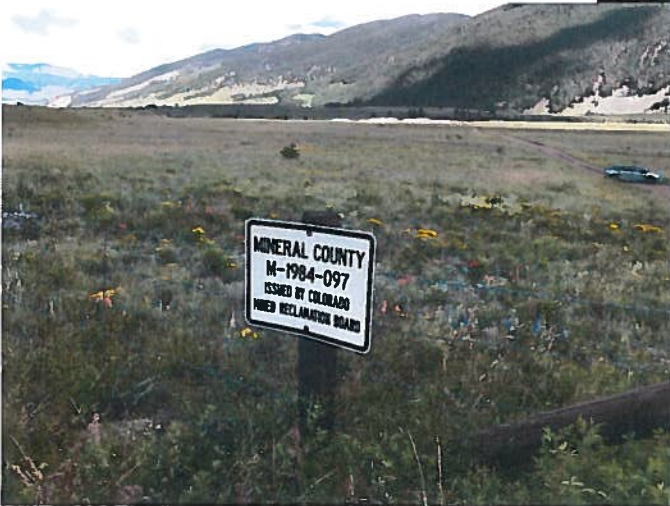
The required permit ID sign was observed posted at the entrance gate to the permitted area. Permit boundary markers (steel T-posts, earthen berms and boulders) were installed at the boundary corners and along the permit boundary. All mining-related disturbances are within the permit boundary.

Mine ID Sign

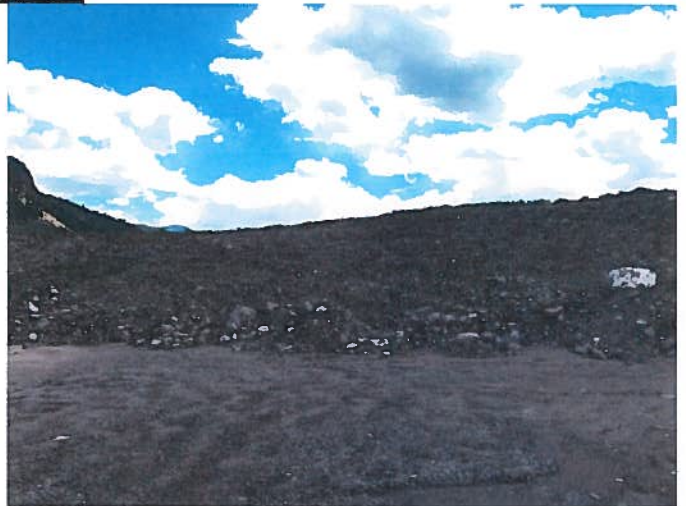
Recent Grading

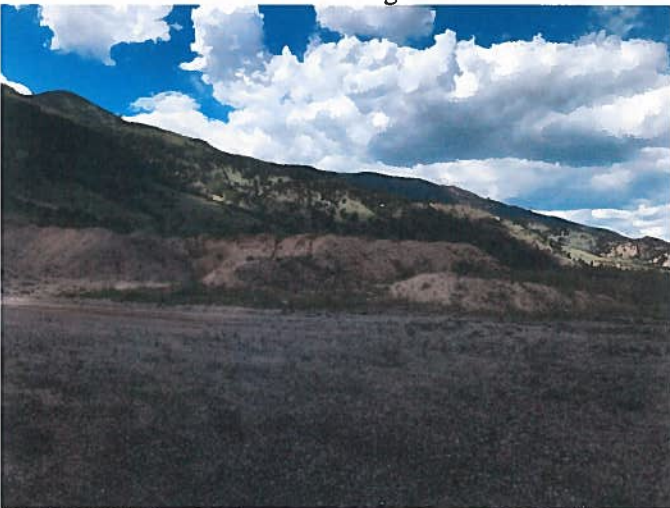
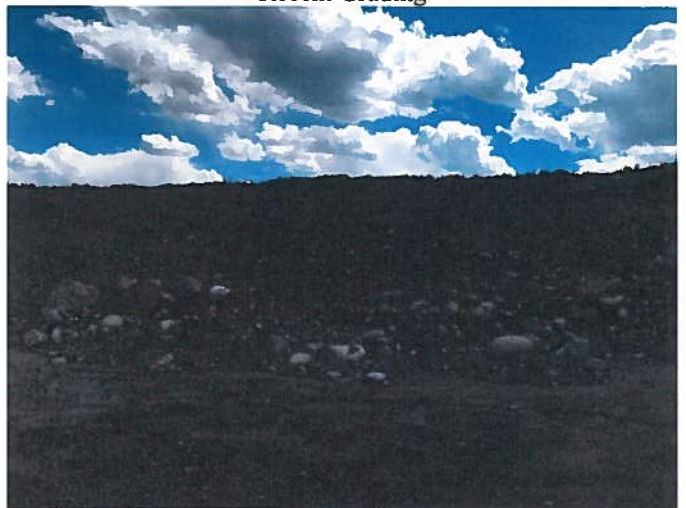
Recent Grading

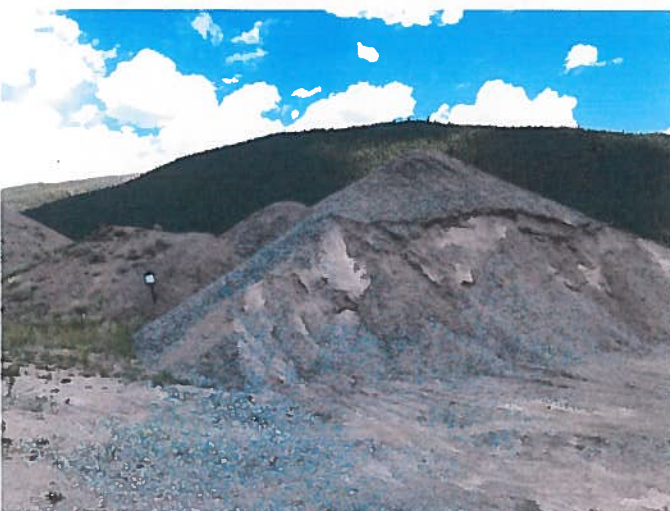
There are several stockpiles of different materials in the pit. One stockpile in the NW part of the pit floor (near the pile of waste asphalt) has been drawn from recently. A couple large stockpiles of 3/4 inch crushed gravel are in the center of the pit floor. There are several hundred large boulders (1 to 3 feet in diameter) piled in a couple places in the pit.

Material Stockpiles
