**MINERALS PROGRAM INSPECTION REPORT**  
**PHONE: (303) 866-3567**

<b>MINE NAME:</b> Ophir Lode	<b>MINE/PROSPECTING ID#:</b> M-2001-063	<b>MINERAL:</b> Silver, gold, lead, zinc	<b>COUNTY:</b> Hinsdale
<b>INSPECTION TYPE:</b> Monitoring	<b>INSPECTOR(S):</b> Stephanie J. Mitchell	<b>INSP. DATE:</b> August 14, 2019	<b>INSP. TIME:</b> 11:30
<b>OPERATOR:</b> Midas Mining Company, Inc.	<b>OPERATOR REPRESENTATIVE:</b>	<b>TYPE OF OPERATION:</b> 110(2) - Hard Rock Limited Impact	
<b>REASON FOR INSPECTION:</b> Normal I&E Program	<b>BOND CALCULATION TYPE:</b> IT.Bondcalculationtype.CD.Desc	<b>BOND AMOUNT:</b> \$7,077.00	
<b>DATE OF COMPLAINT:</b> NA	<b>POST INSP. CONTACTS:</b> U.S.BLM	<b>JOINT INSP. AGENCY:</b> None	
<b>WEATHER:</b> Clear	<b>INSPECTOR'S SIGNATURE:</b>

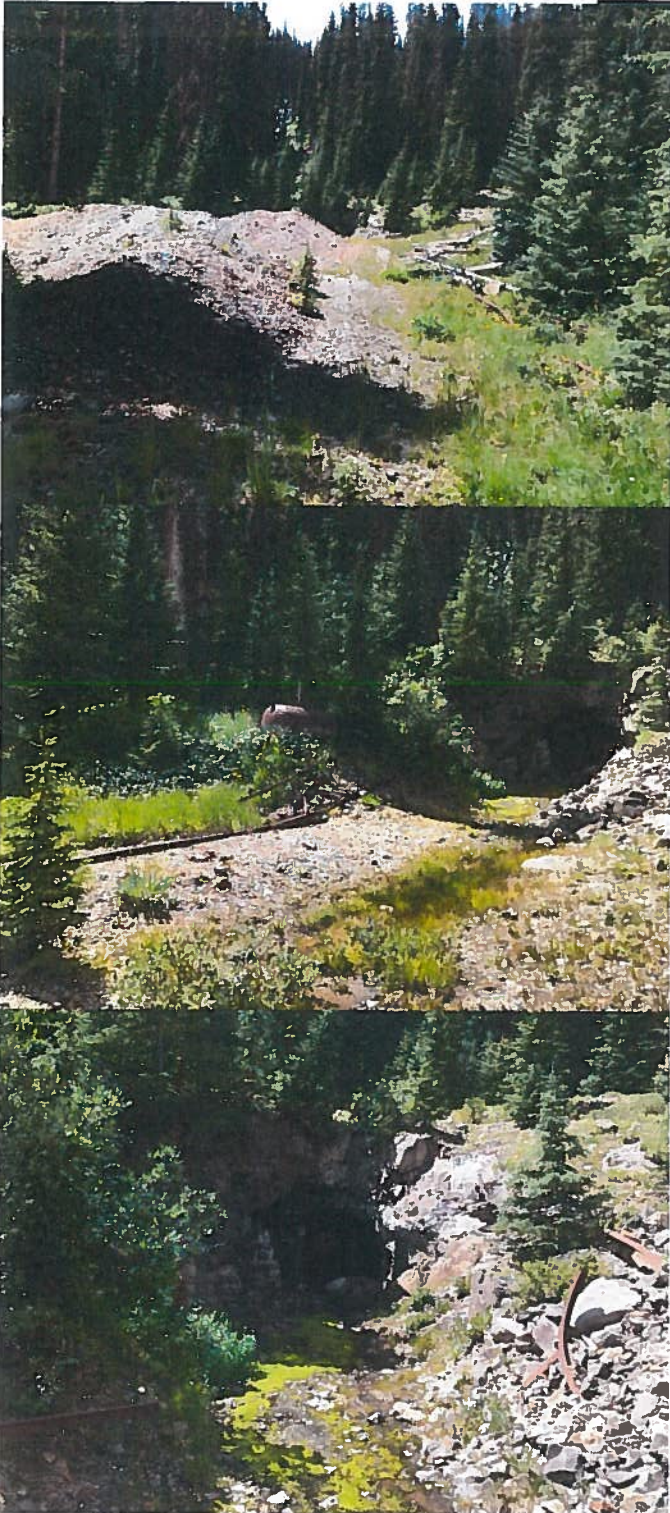
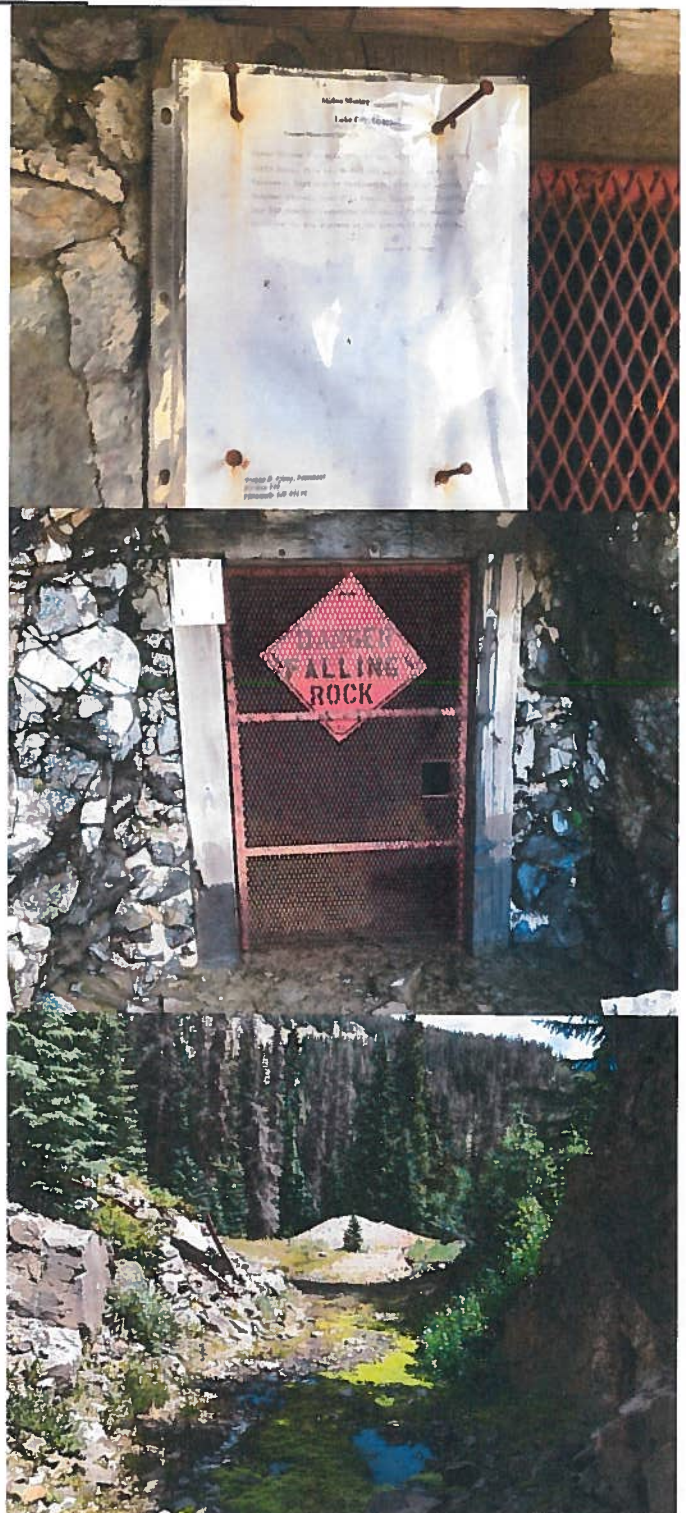
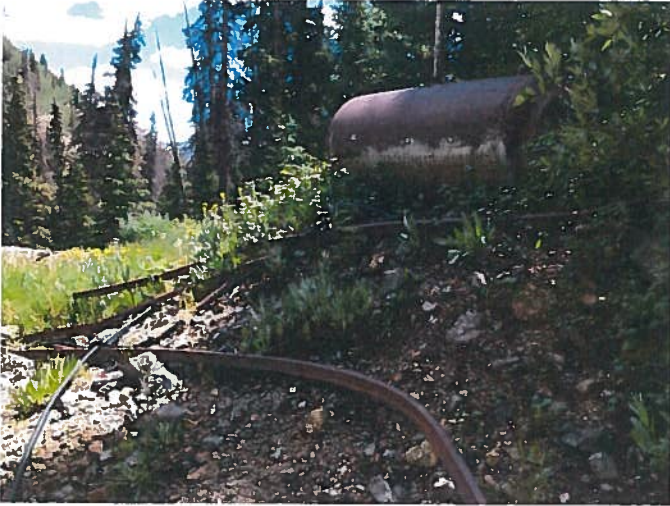
The portal was locked and secure. The mine ID sign was posted on the portal; permit boundary markers were observed to be installed on the eastern permit boundary corners.

There was a small trickle of water (< 3 gpm) discharging from the portal, which appeared to originate about 20 feet inby, from the fractures in the roof. (The portal and drift are located immediately below the channel of Red Cloud Creek, which contributes the water to the mine.) The discharge flows about northward along the portal access road, and completely percolates into the roadway within 50 feet. There was no iron or mineral staining in the water or on the road surface from the discharge.

The existing waste rock dump has not been recently disturbed. No surface staining from runoff was observed. The lower toe of the dump on the eastern side does not exhibit mineral staining, and there is no zone of dead vegetation due to leached minerals below the dump.

A few debris items were observed on the dump near the portal: loose rail sections, air tank, and steel pipe.
