**COLORADO**Division of Reclamation,
Mining and Safety

MINERALS PROGRAM INSPECTION REPORT**PHONE: (303) 866-3567**

MINE NAME: Soward Ranch Pit	MINE/PROSPECTING ID#: M-1988-021	MINERAL: Sand and gravel	COUNTY: Mineral
INSPECTION TYPE: Monitoring	INSPECTOR(S): Stephanie J. Mitchell	INSP. DATE: August 14, 2019	INSP. TIME: 16:00
OPERATOR: Big Bull Dog Trucking, Inc	OPERATOR REPRESENTATIVE: Randy Riggs	TYPE OF OPERATION: 110c - Construction Limited Impact	
REASON FOR INSPECTION: Normal I&E Program	BOND CALCULATION TYPE: IT.Bondcalculationtype.CD.Desc	BOND AMOUNT: \$15,034.00	
DATE OF COMPLAINT: NA	POST INSP. CONTACTS: None	JOINT INSP. AGENCY: None	
WEATHER: Clear	INSPECTOR'S SIGNATURE:

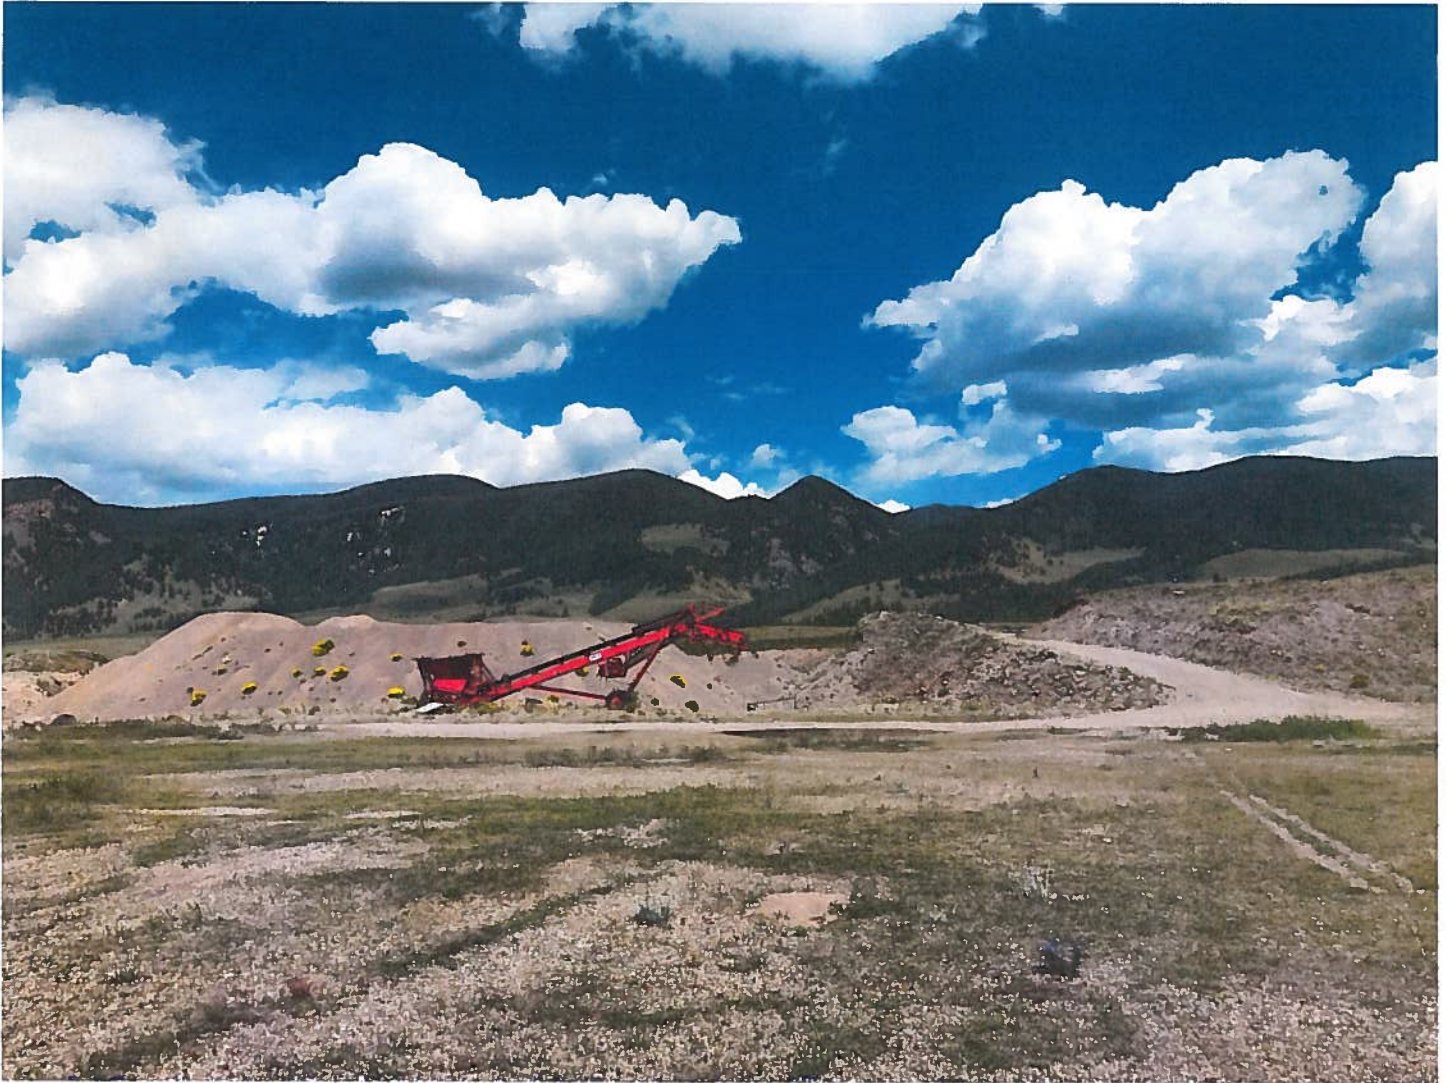
The newer portion of the permit on the north has been affected by more recent mining and processing activity. Mining is moving in a NE direction. This is the active portion of the permit, where the highwalls are steeper (2:1) or only partially sloped. The northern pit floor contains numerous stockpiles of material, containing about 5000 cu yds total. Topsoil has been stripped above the pit and is windrowed along the top of the highwalls. The pit is about 20 feet deep.
