MINERALS PROGRAM INSPECTION REPORT
PHONE: (303) 866-3567

MINE NAME: Schwartzwalder Mine	MINE/PROSPECTING ID#: M-1977-300	MINERAL: Uranium	COUNTY: Jefferson
INSPECTION TYPE: Monitoring	INSPECTOR(S): Michael A. Cunningham	INSP. DATE: August 1, 2019	INSP. TIME: 14:00
OPERATOR: Colorado Legacy Land, LLC	OPERATOR REPRESENTATIVE: Billy Ray	TYPE OF OPERATION: 112d-2 - Designated Mining Operation	
REASON FOR INSPECTION: Normal I&E Program	BOND CALCULATION TYPE: None	BOND AMOUNT: \$8,900,000.00	
DATE OF COMPLAINT: NA	POST INSP. CONTACTS: None	JOINT INSP. AGENCY: None	
WEATHER: Clear	INSPECTOR'S SIGNATURE:

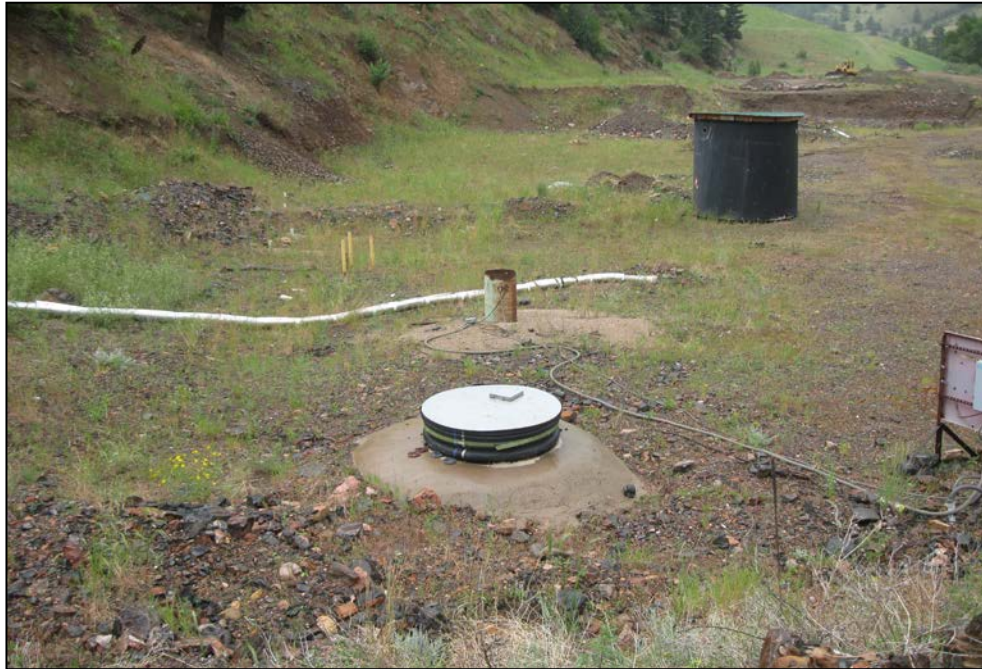
Current excavation has necessitated the removal of Sump #9 and #10. The Operator will continue to monitor for the collection of groundwater in the areas of Sump #9 and #10. In the event water collects in these areas, the water will be manually pumped to downgradient sumps. All shallow alluvial groundwater will continue to be captured and treated as it has been in the past. In addition to the removal of Sump #9 and #10, the Operator will relocate the electrical cables and drain lines for the remaining sumps. The pump house has been relocated to where the electrical substation was previously situated. The sump system was offline at the time of the inspection in order to relocate the pump house and associated infrastructure. On August 2, 2019, the Operator notified the Division the sump system was fully operational.

1. View of Sump #9 and #10, photo taken facing west.

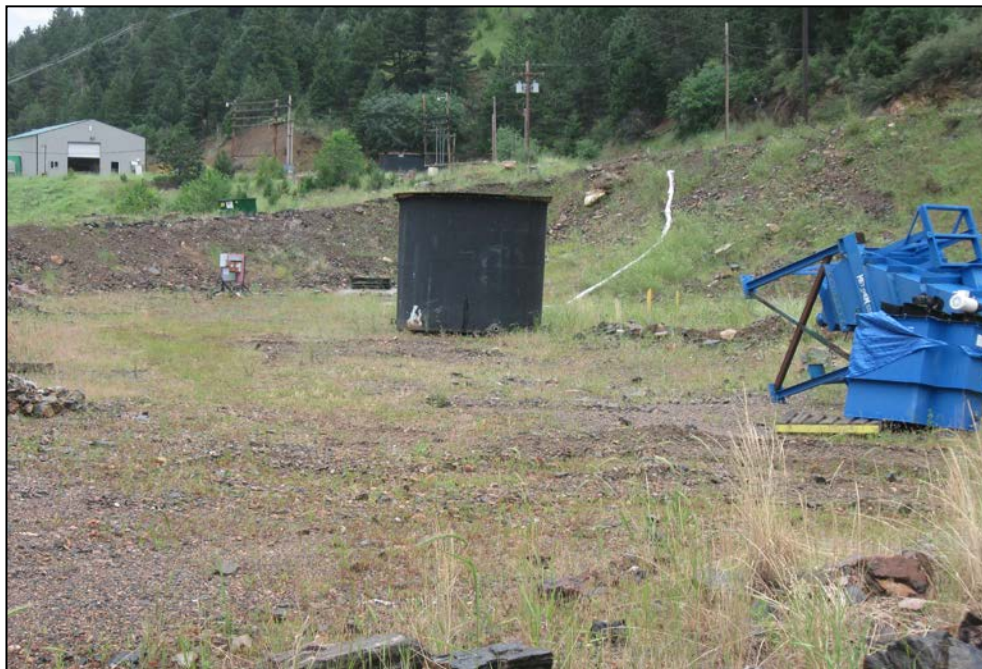
2. View of Sump #9 and #10, photo taken facing southeast.

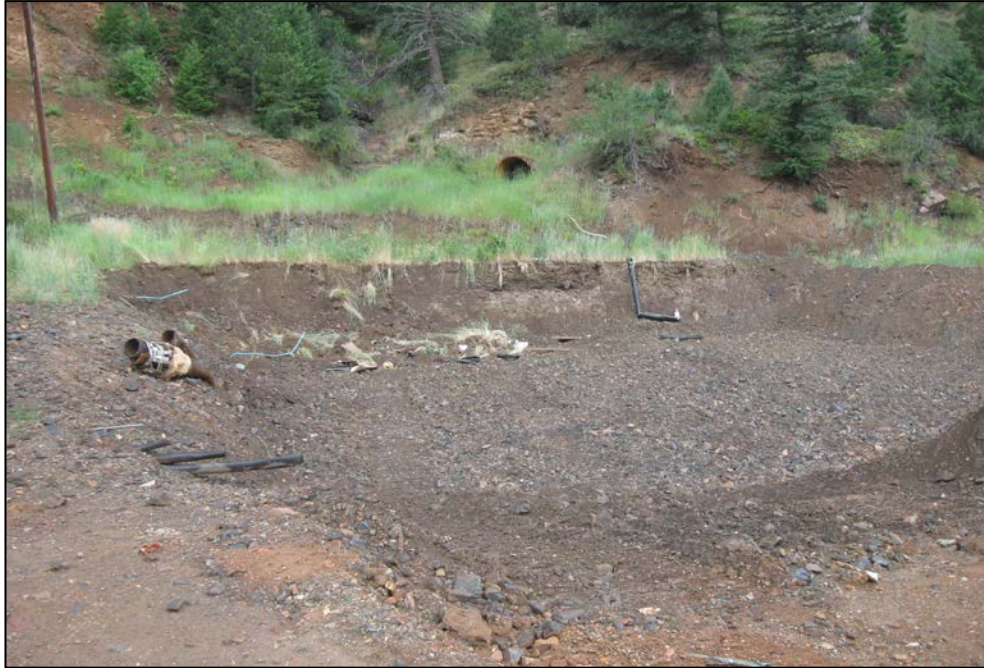
The Operator continues to excavate waste rock from the valley floor. The waste rock is currently being hauled to the Minnesota Portal and placed underground in the glory hole; excavation activities were not occurring at the time of the inspection. Excavation is being conducted in the vicinity of the old water treatment plant and is moving to the east. As excavation activities move down the valley, it has become necessary to remove sumps and the associated infrastructure in order to ensure that materials which exceed the gamma limit of 22 $\mu\text{R/hr}$ are removed. The excavation boundaries were identified under Technical Revision No. 23 (TR23); however, these boundaries were drawn using initial gamma scanning of the surface area. As excavation continues, the Operator scans the excavated area using hand-held gamma scan equipment to further define the limits of excavation. This method is repeated until gamma scans show the excavated areas are below the gamma limit, at which point excavation activities move to another area.

3. Current excavation area, photo taken facing south.

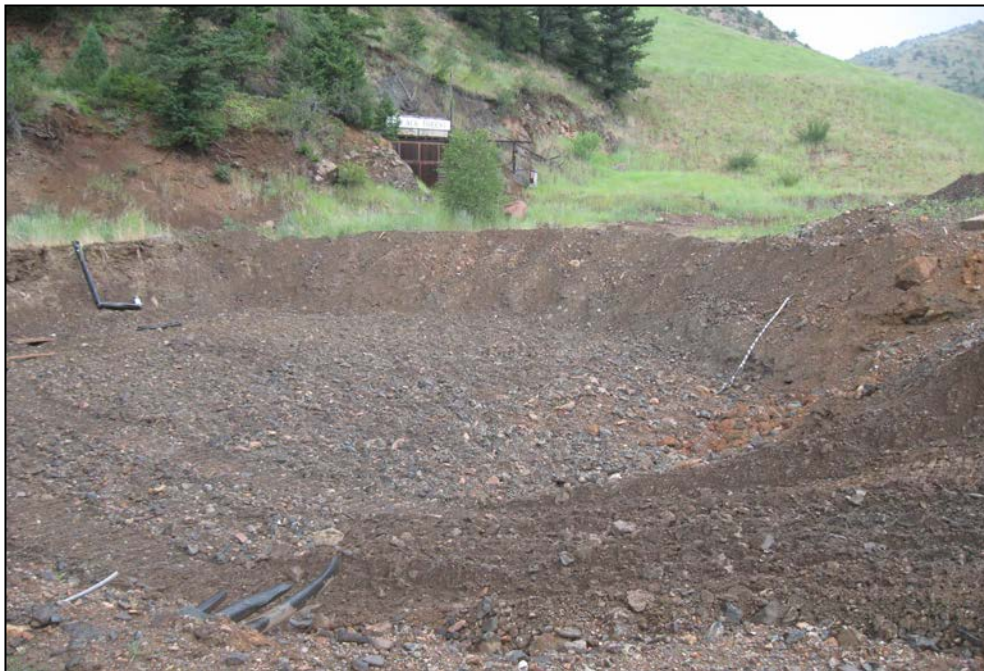
4. Current excavation area, photo taken facing southwest.

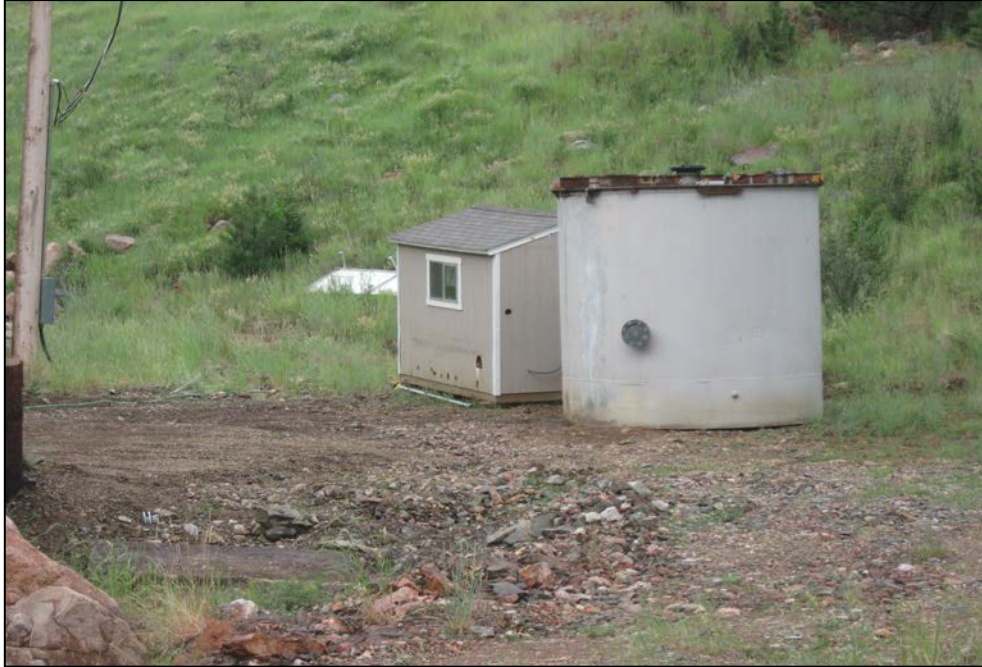
5. Relocated pump house. (located where the electrical substation was previously situated)
