MINERALS PROGRAM INSPECTION REPORT**PHONE: (303) 866-3567**

MINE NAME: Profitt	MINE/PROSPECTING ID#: M-1991-054	MINERAL: Gold and silver	COUNTY: Saguache
INSPECTION TYPE: Monitoring	INSPECTOR(S): Stephanie J. Mitchell	INSP. DATE: August 15, 2019	INSP. TIME: 13:30
OPERATOR: Indian Creek Mining Corp	OPERATOR REPRESENTATIVE:	TYPE OF OPERATION: 110(1) - Hard Rock Limited Impact

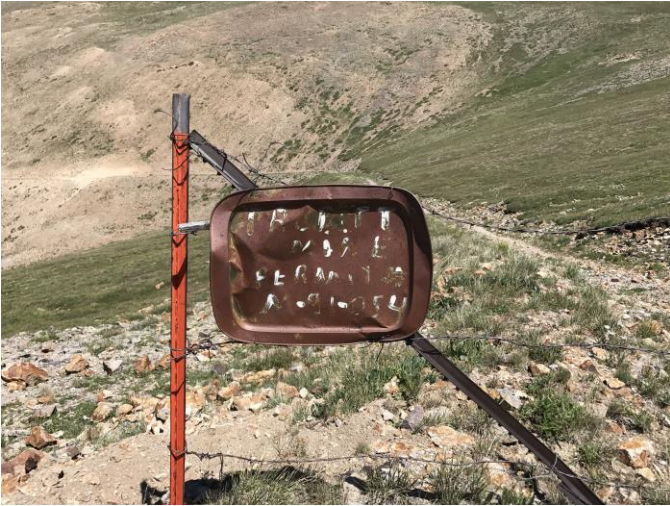
The required permit ID sign was observed posted at the entrance gate to the permitted area. Permit boundary markers were installed at the boundary corners of the upper area. The permitted area is divided into two separate rectangles, the upper one encompassing the former shaft location, staging pad, overburden storage area, and the highwall that is actively mined; and the lower one which includes the portal and waste rock dump/pad. The operator has not disturbed the lower portal area, but since it is also included in the permit, its boundaries must also be marked (the same type of T-posts will be fine to use).

Mine ID Sign

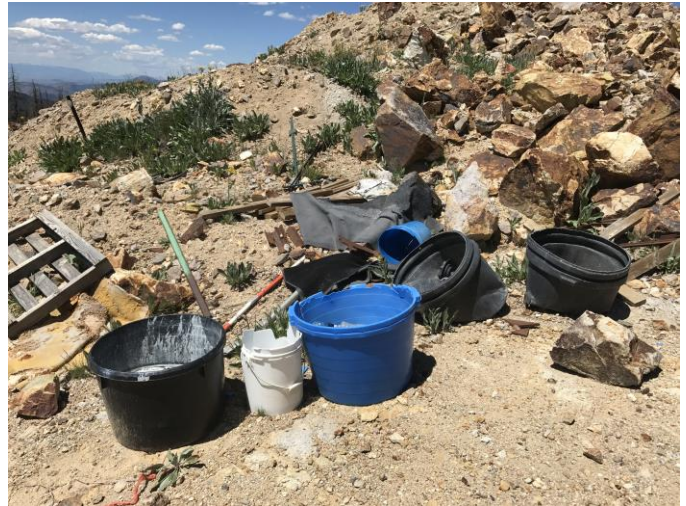
Buckets for Ore

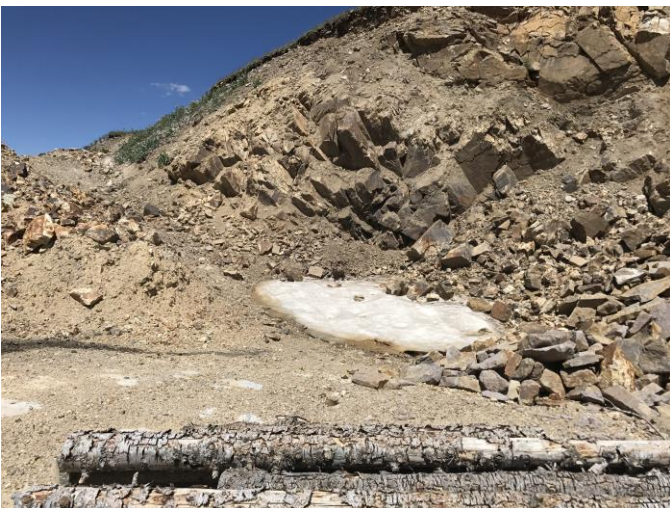
Portal covered in snow

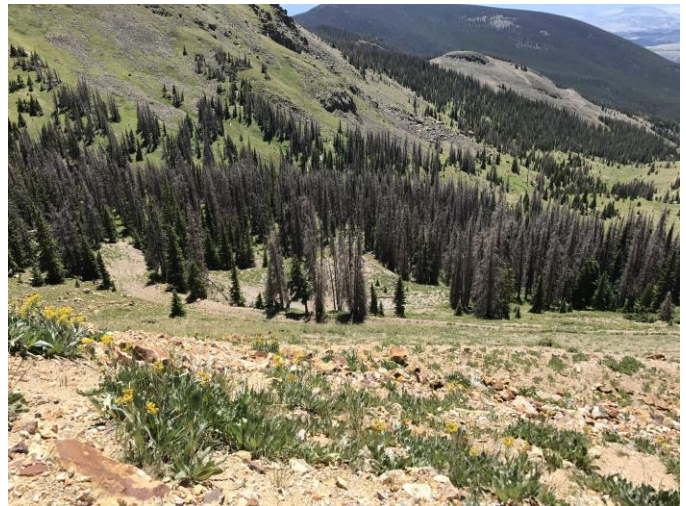
Area Below

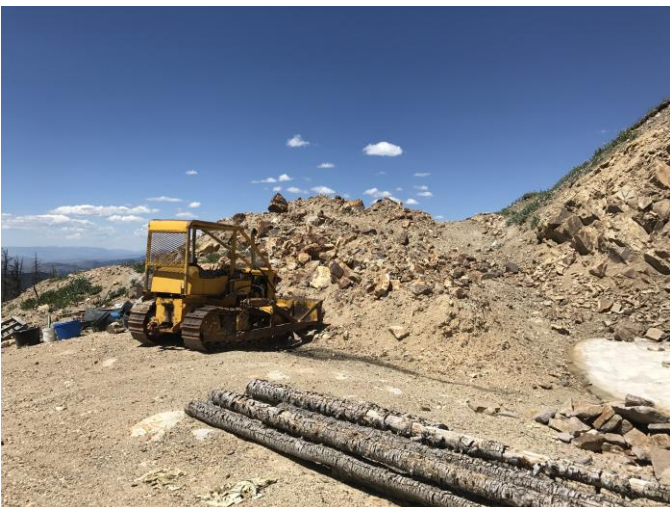
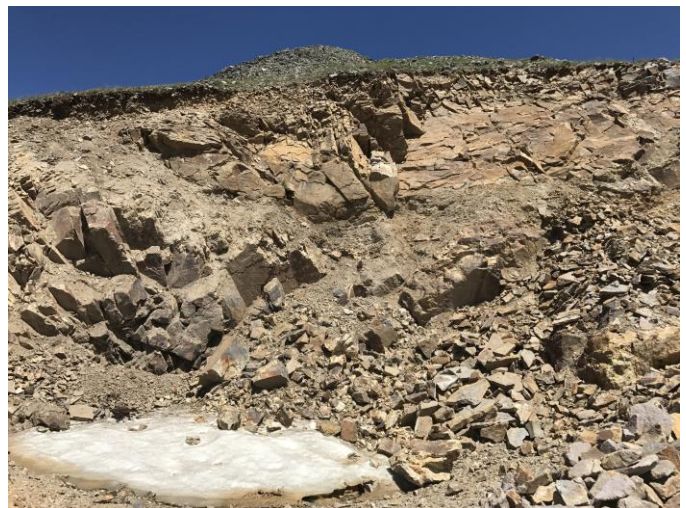
The lower portion of the site contains an old portal with crosscut leading back to the vein, but the adit is caved. It is not completely closed and it has not been used in many years. If the operator does not plan to use the portal, it should be sealed; if there are future plans to rehab it, it should be secured against unauthorized entry. The lower pad that was created from waste rock has not been recently disturbed either. (The operator should note that there is an empty 30-gallon steel drum on the lower pad that must be removed from the site. It is not a contaminant, but it is liable to roll off the pad.) The lower pad area is becoming revegetated by encroachment of native vegetation.

Portal

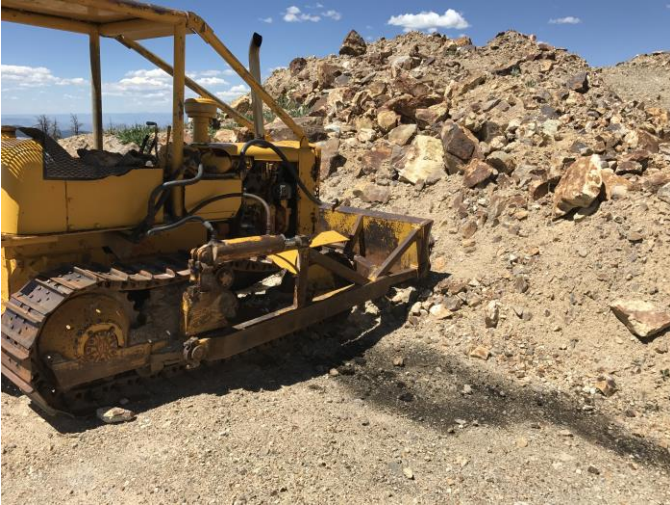
At the site, it was noted that there was a small dozer parked on the pad near the highwall. **The dozer was leaking hydraulic fluid and is listed as a problem at the beginning of this report.** There was no junk or stored fuel noted.

Hydraulic Fluid Leak

INSPECTION TOPIC: Hydrologic Balance**PROBLEM/POSSIBLE VIOLATION:** Problem: A fuel spill has occurred at the site which has impacted soils, surface water or groundwater.**CORRECTIVE ACTIONS:** The operator shall immediately remediate the spill and submit a final report to the Division containing at least the following information:

- 1.) A description of how the spill was cleaned up containing at a minimum - the appropriate maps, volumes removed, sample locations, analytical data, and photo documentation.
- 2.) Evidence in the form of a receipt that the contaminated soil was disposed of by an approved method (such as sent to an approved landfill, land farming, recycling center, etc.).

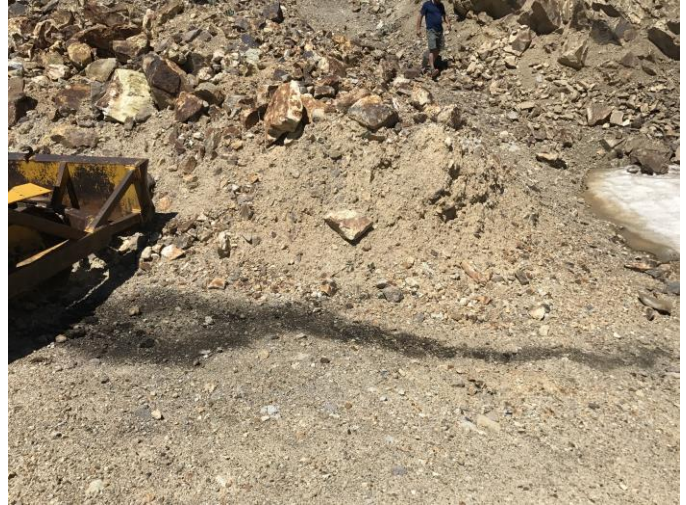
Hydraulic Fluid Leak- close up
