MINERALS PROGRAM INSPECTION REPORT
PHONE: (303) 866-3567

| MINE NAME: Cresson Project | MINE/PROSPECTING ID#: M-1980-244 | MINERAL: Gold | COUNTY: Teller |
| INSPECTION TYPE: Monitoring | INSPECTOR(S): Timothy A. Cazier | INSP. DATE: July 23, 2019 | INSP. TIME: 09:00 |

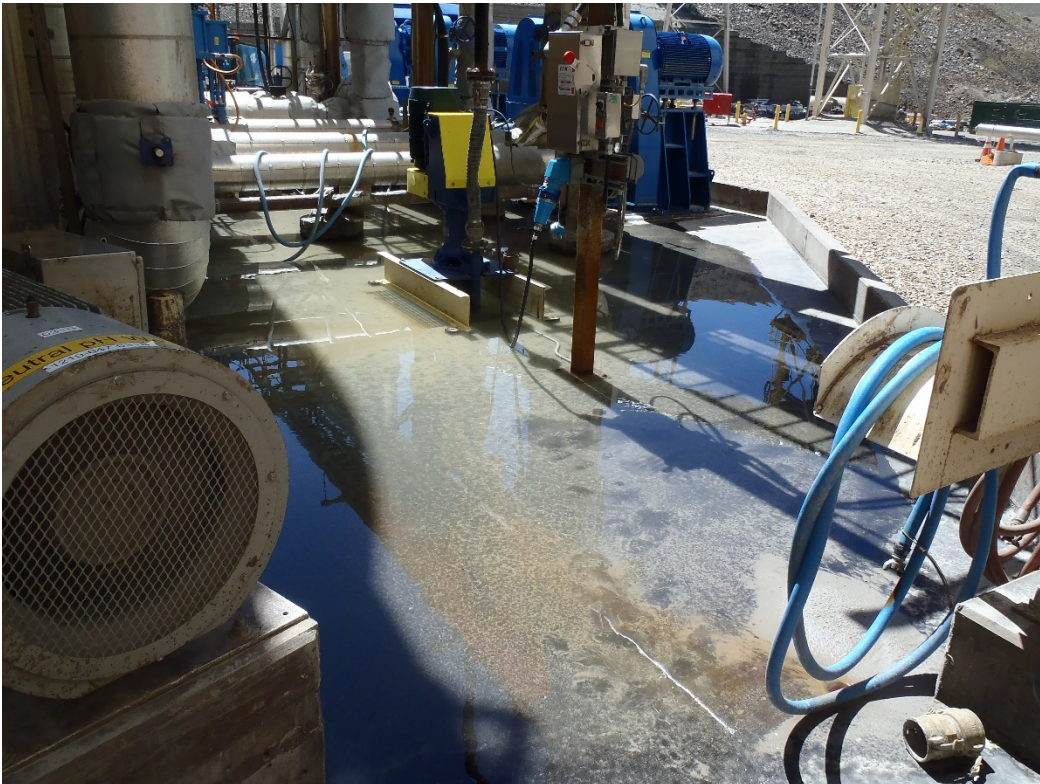
Photo 1. Rain water observed in Neutral pH Process Water Tank secondary containment area.

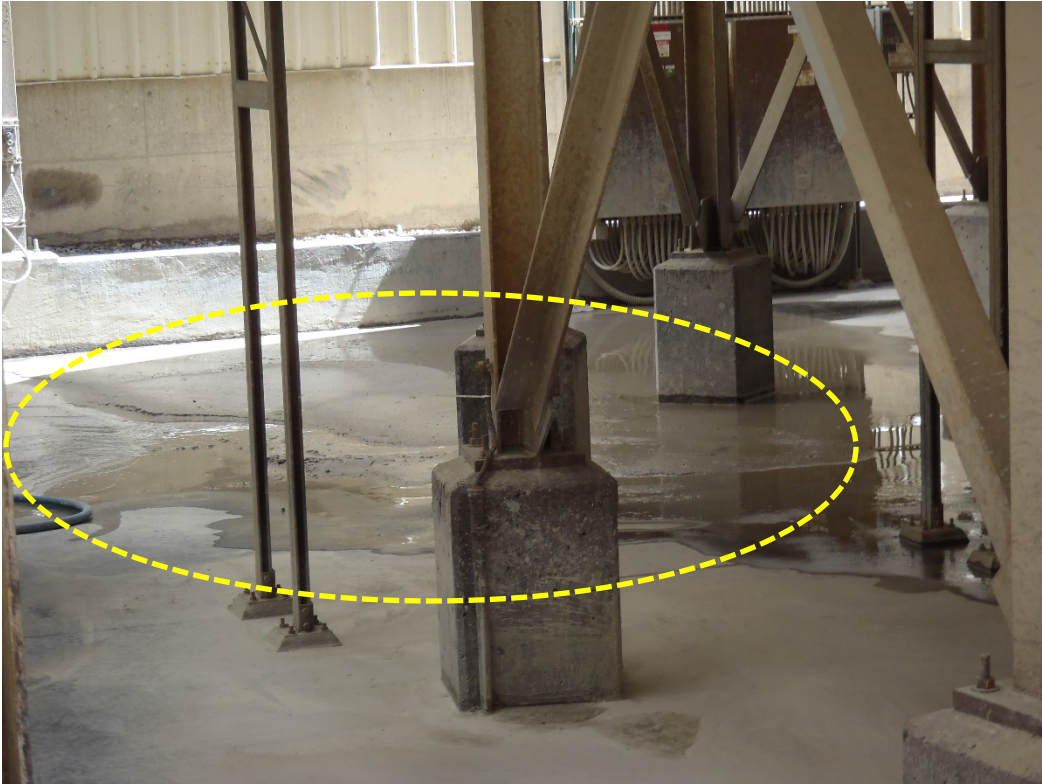
Photo 2. Small amount of sludge observed in Process Ore Thickener secondary containment area.

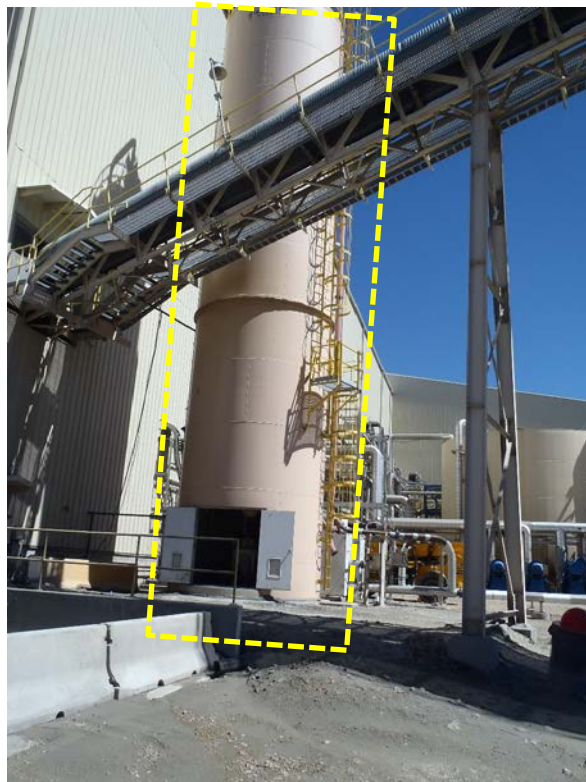
Photo 3. Silo being prepared to move to its new location.

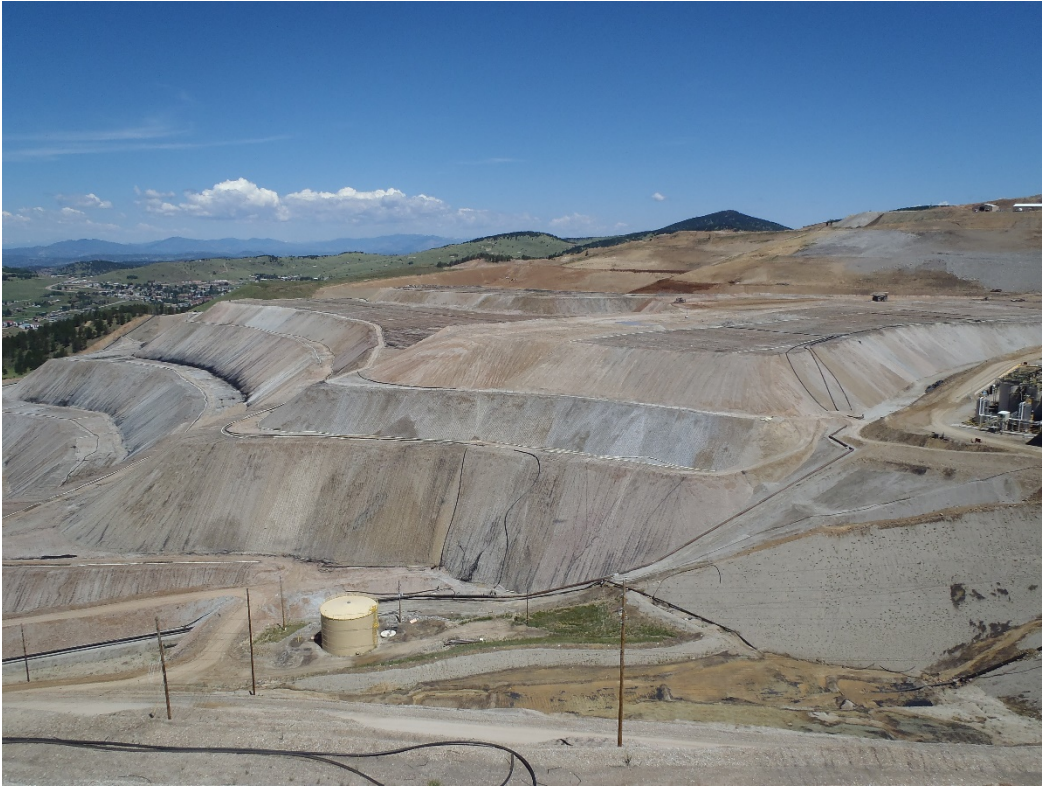
Squaw Gulch Valley Leach Facility (VLF 2): Messrs. Bissue and Bills accompanied the DRMS to the VLF 2 overlook (from VLF 1) and an observation point from the Projects Office for a closer view of the VLF 2 9,950 level. No ponded process solution was observed (See **Photos 4 and 5**).

Photo 4. VLF 2 from VLF 1 overlook – no ponded process solution observed.

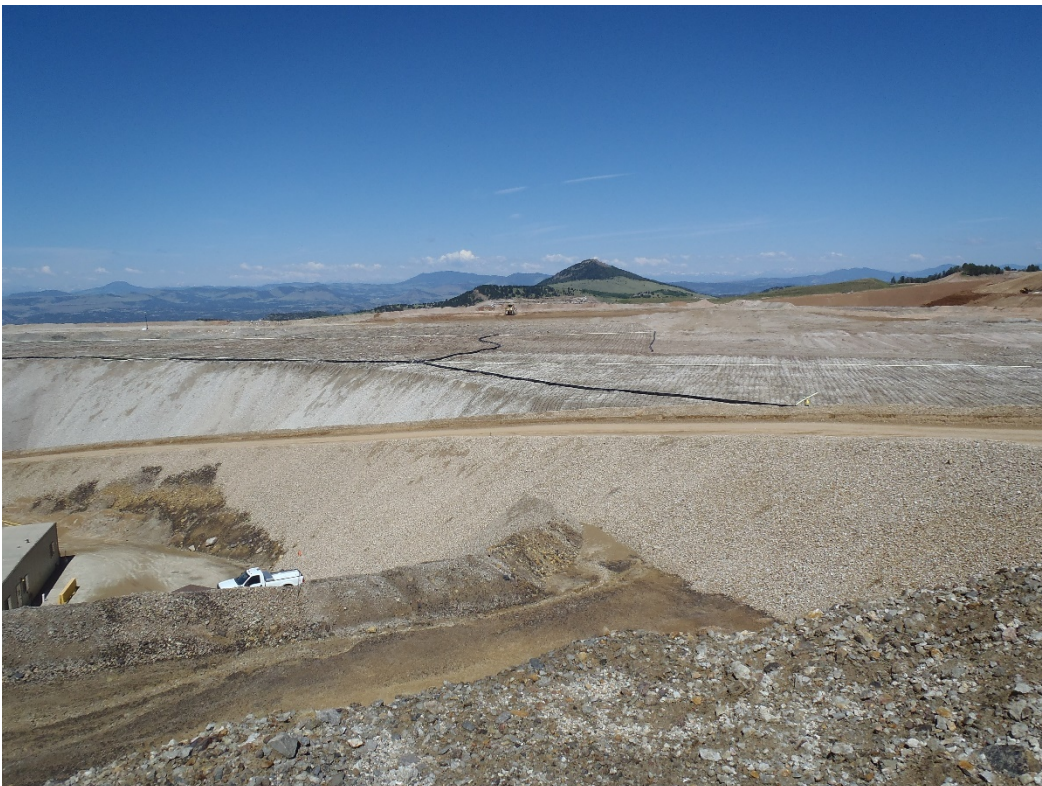
Photo 5. VLF 2 from Projects Office – no ponded process solution observed.

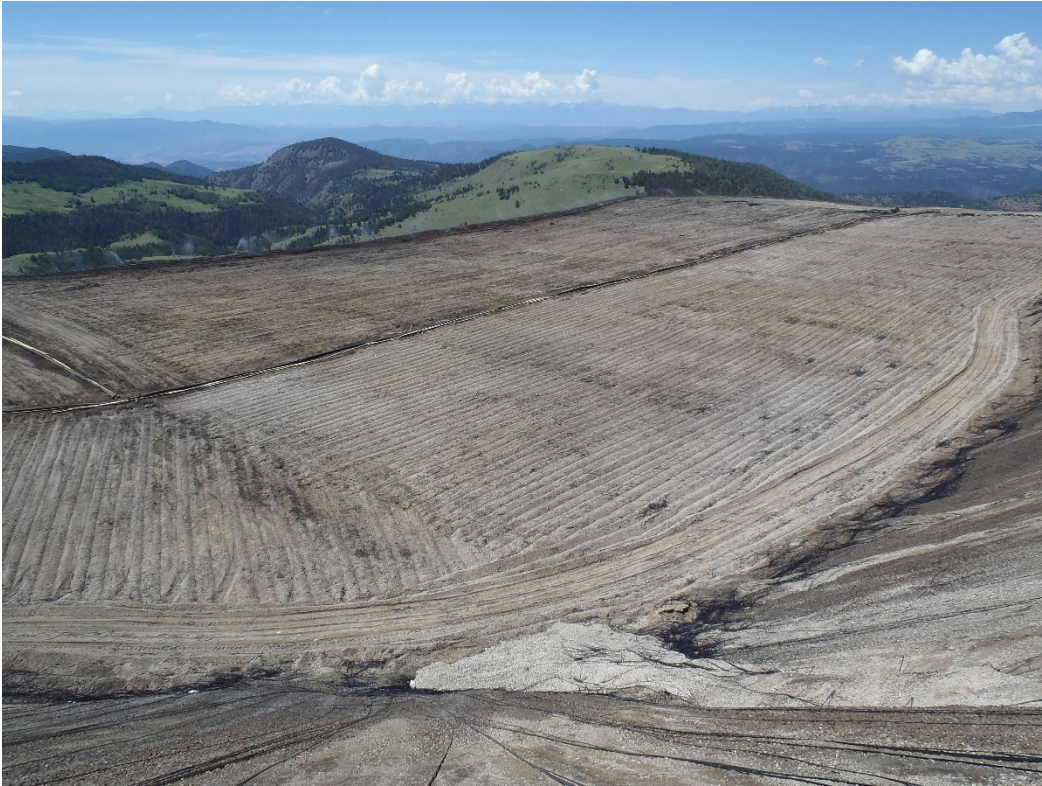
Arequa Gulch Valley Leach Facility (VLF1): Messrs. Bissue and Bills accompanied the DRMS to VLF 1. The 10,200 (See **Photo 6**), 10,300 (See **Photo 7**) and 10,400 (See **Photo 8**) levels had been recently ripped and were not being actively leached. Mr. Bissue explained the mine was focusing on leaching the VLF 1 outcrops (See **Photo 9**) using sprinklers.

Photo 6. VLF 1 – 10,200 level – no ponded process solution observed.

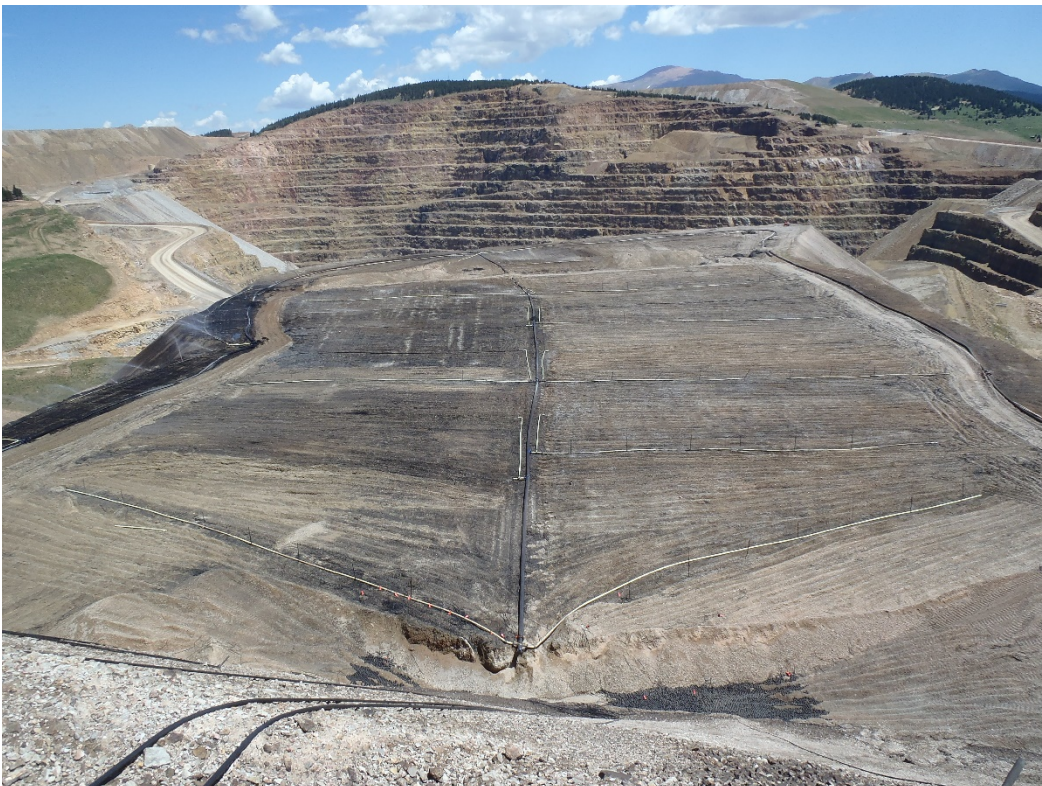
Photo 7. VLF 1 – 10,300 level – no ponded process solution observed.

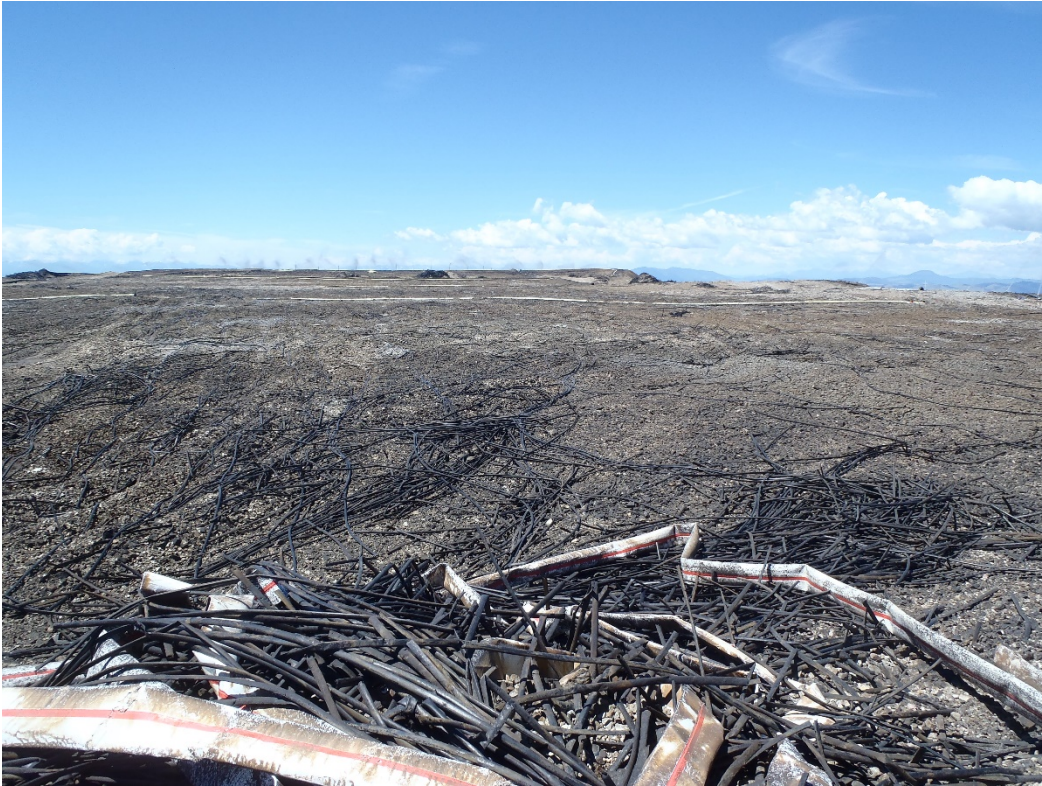
Photo 8. VLF 1 – 10,400 level – no ponded process solution observed.

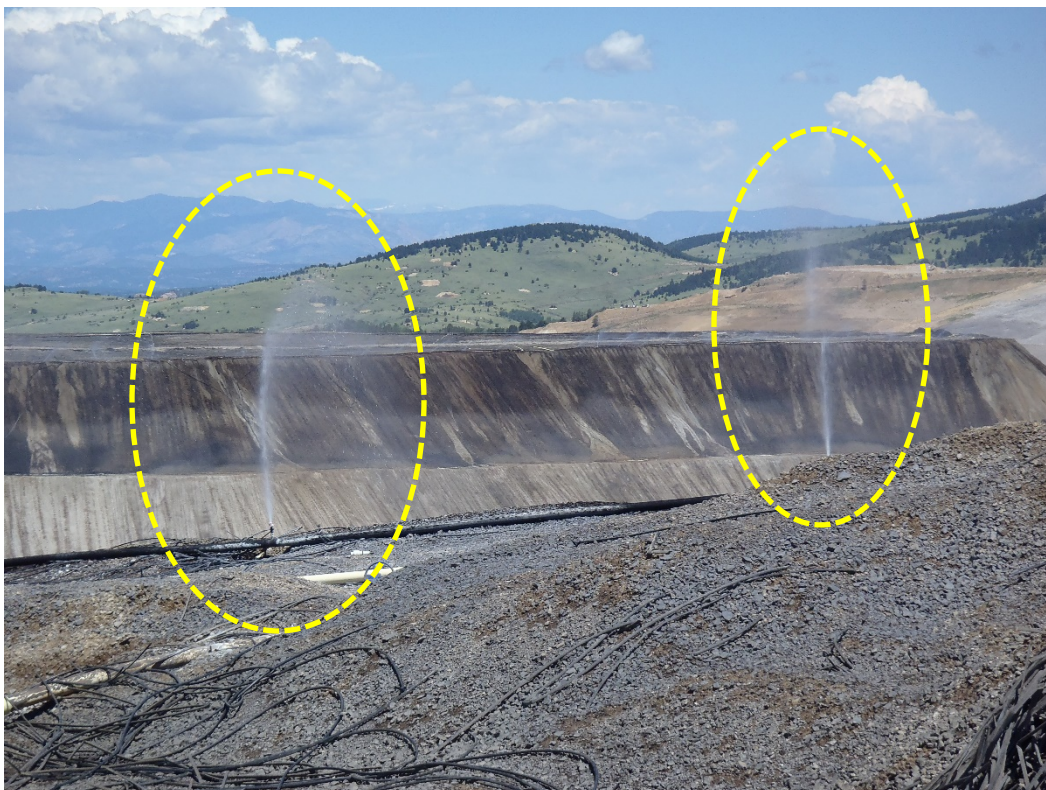
Photo 9. Leaching VLF 1 outslopes using sprinklers.

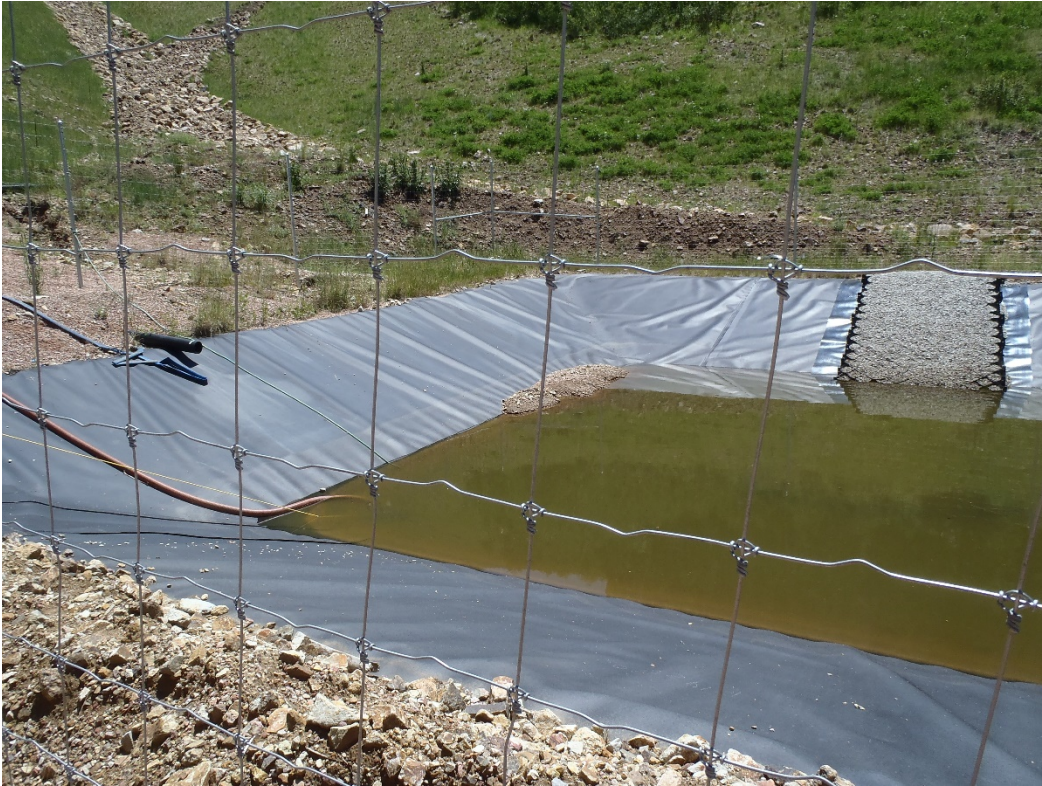
VLF 2 Underdrain Ponds: Messrs. Bissue and Bills accompanied the DRMS to the VLF 2 underdrain ponds. Mine representatives indicated the water observed in the ponds (See **Photos 10 and 11**) was meteoric. The water levels associated with the two pumps housed in the underdrain sump vault were checked via the two pump level indicators in the vault were 36.1 ft (pump 1) and 34.6 ft (pump 2). Pump 1 is set to turn on at 50 and turn off at 35. Pump 2 is set to turn on at 55 and turn off at 35 (**Photo 12**).

Photo 10. VLF 2 east underdrain pond.

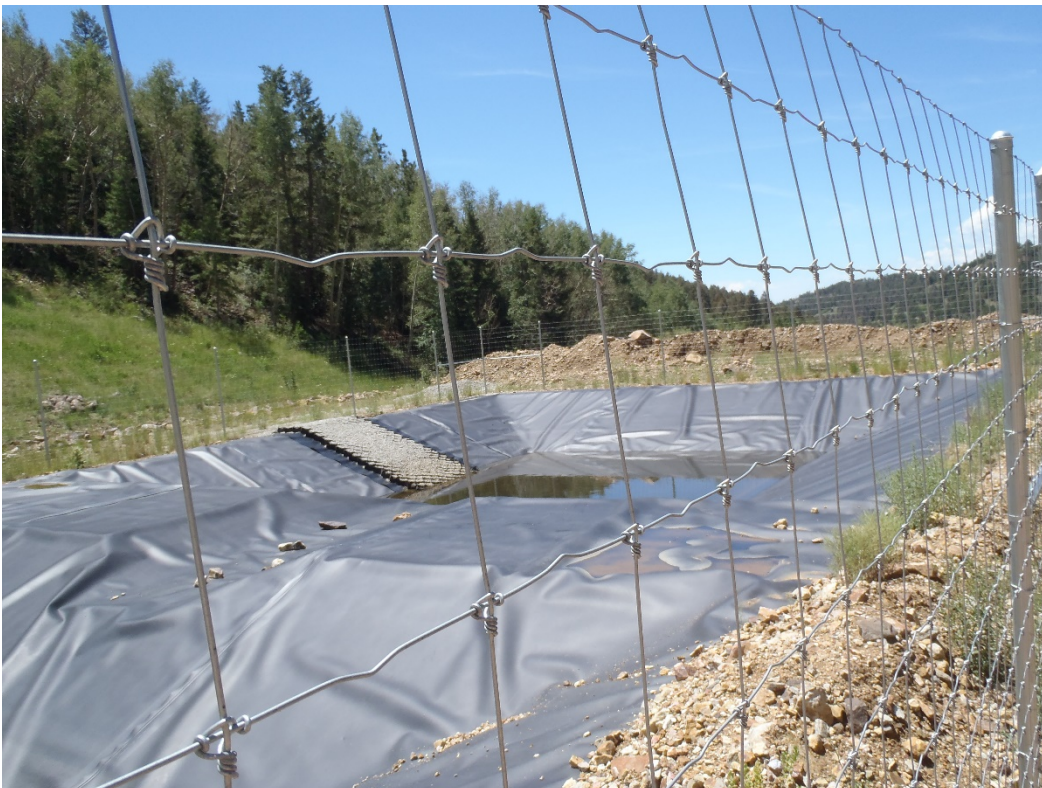
Photo 11. VLF 2 west underdrain pond.

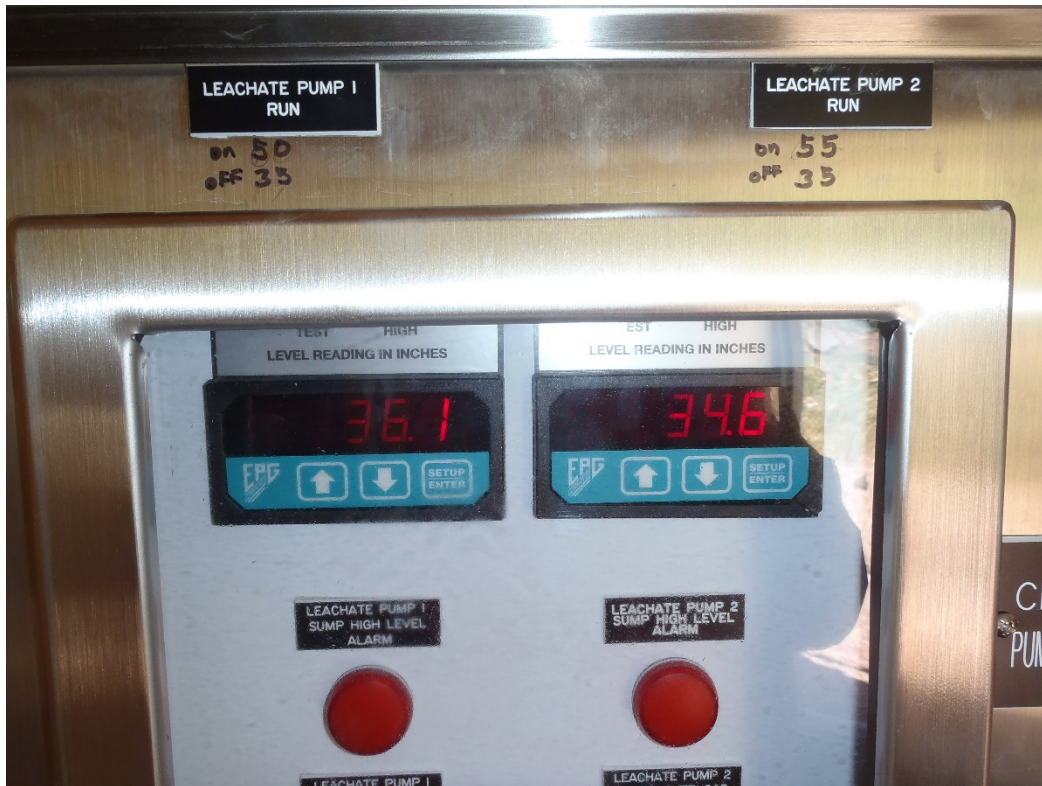
Photo 12. Pump level indicators in the VLF 2 underdrain sump vault.

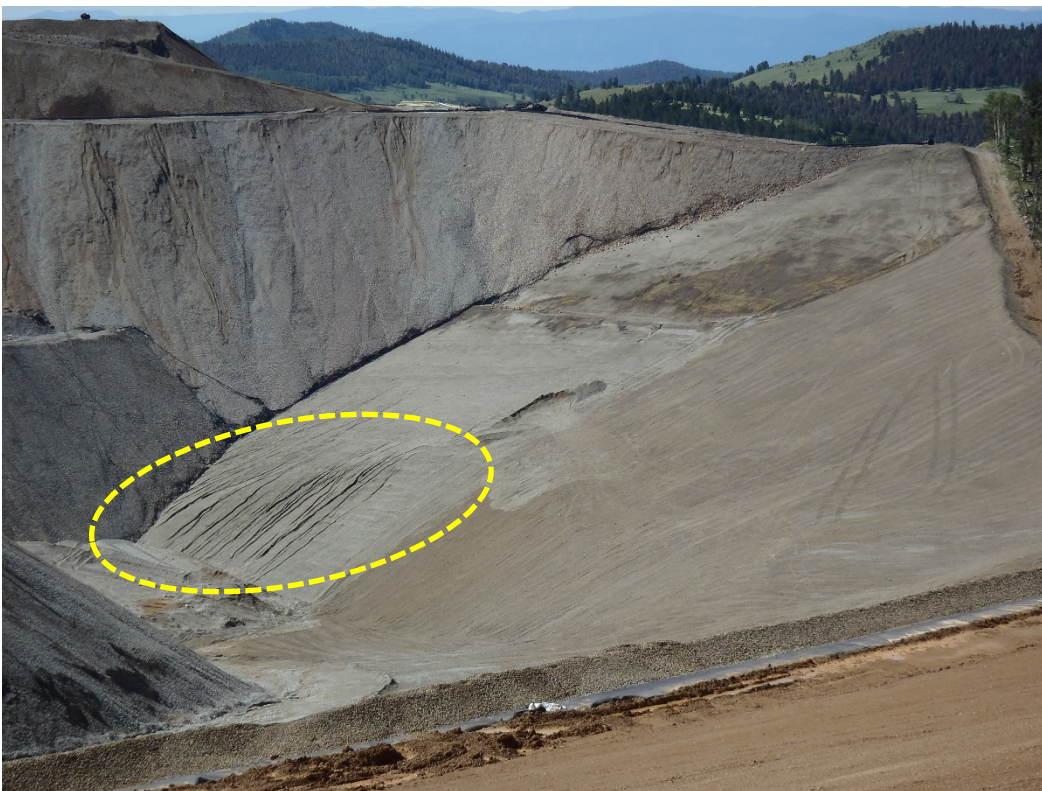
VLF 2 Phase 2 Construction: Messrs. Bissue and Bills accompanied the DRMS to VLF 2 Phase 2 construction area. Due to recent rains, construction activities were limited. Crews were waiting for the soil liner fill to dry out in order to recompact it and then lay down the geomembrane. While in the area, significant erosion of the drain cover fill (DCF) was observed (**Photo 13**) on the north end of the VLF 2 liner constructed in Phase 1 (completed

Photo 13. Significant erosion of DCF observed on north end of VLF 2 liner constructed in Phase 1.

in 2016). **The eroded DCF was cited as a problem, but resolved prior to this inspection report being completed. The corrective action consisted of a recertification report received and approved by the DRMS on August 12, 2019.**

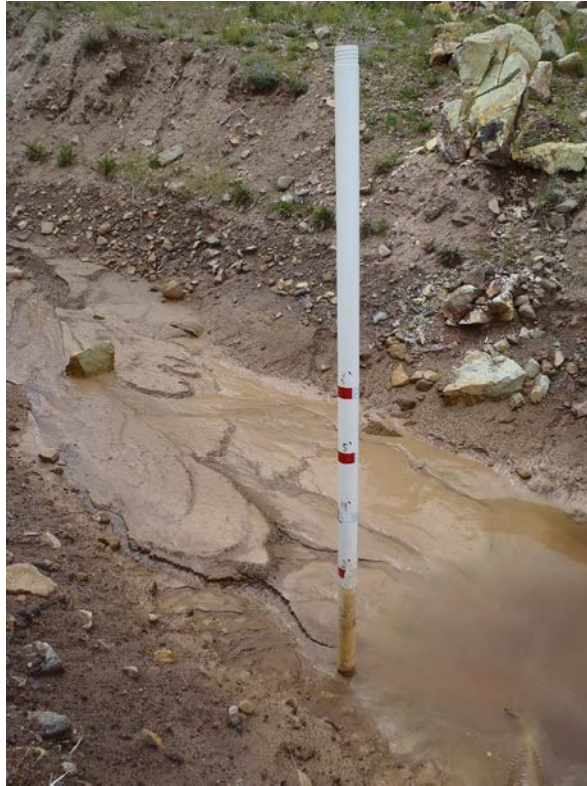
East Cresson Overburden Storage Area (ECOSA) Seep: The DRMS was accompanied by CC&V personnel (Mr. Bills & Ms. Jeana Ratcliff) to ECOSA seep area. The seepage area had some ponded water, but near zero inflow (see **Photo 14**) was observed.

Photo 14. ECOSA seep area with some water, but near zero inflow.
