**COLORADO DIVISION OF RECLAMATION, MINING AND SAFETY**  
**MINERALS PROGRAM INSPECTION REPORT**  
**PHONE: (303) 866-3567**

<b>MINE NAME:</b> Pit No 2	<b>MINE/PROSPECTING ID#:</b> M-1983-106	<b>MINERAL:</b> Sand and Gravel	<b>COUNTY:</b> Cheyenne
<b>INSPECTION TYPE:</b> Monitoring	<b>INSPECTOR(S):</b> Elliott R. Russell	<b>INSP. DATE:</b> June 29, 2016	<b>INSP. TIME:</b> 12:15
<b>OPERATOR:</b> Cheyenne County	<b>OPERATOR REPRESENTATIVE:</b> Victor Gibbs	<b>TYPE OF OPERATION:</b> 112c - Construction Regular Operation

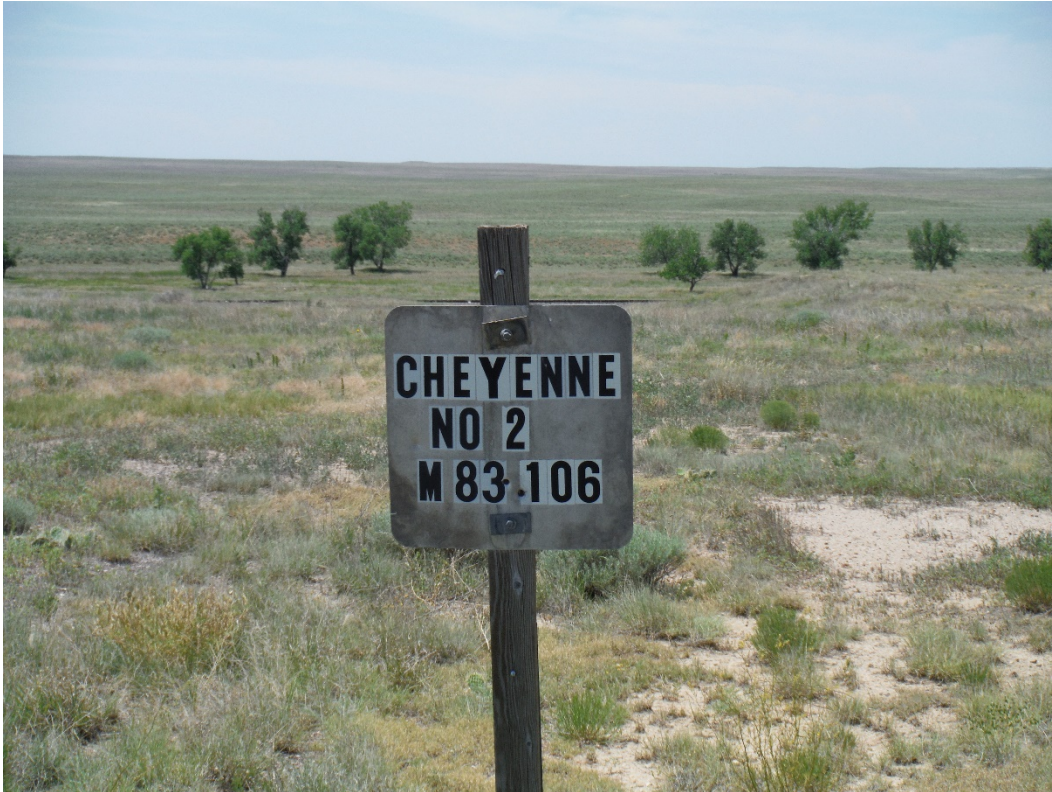
Mine identification sign; looking southwest.

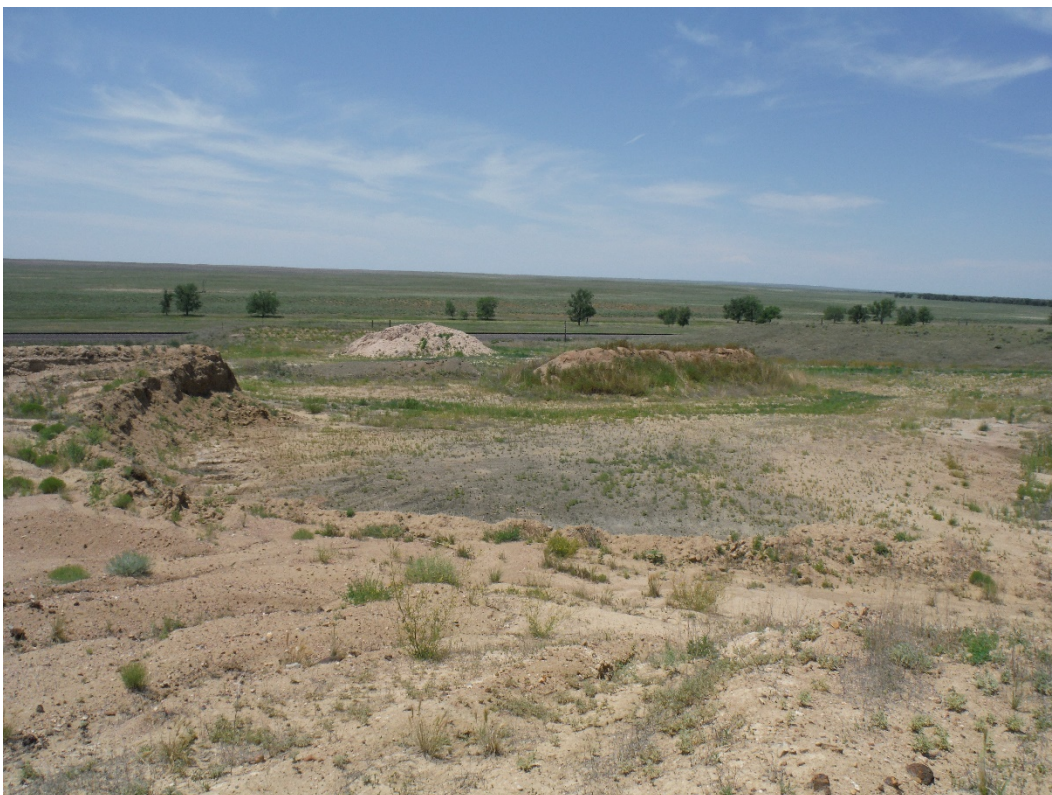
Most recently active pit in southeast portion of the site; looking west.

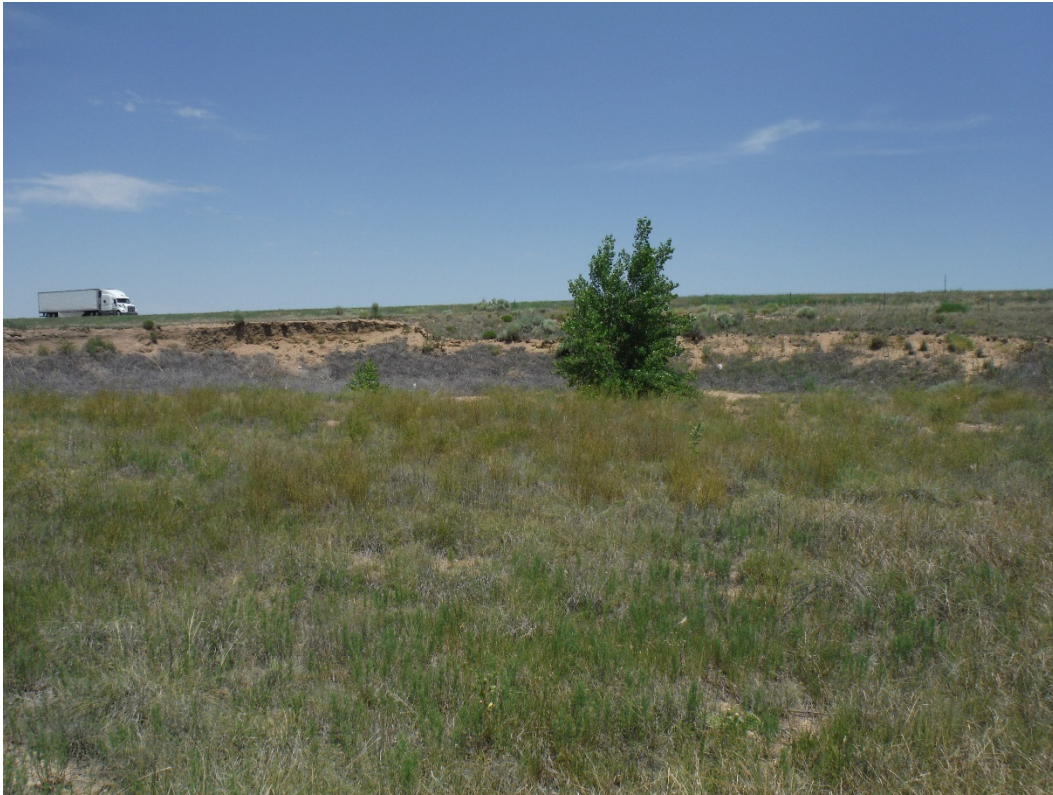
The elongated site consists of multiple disturbed areas which have been partly reclaimed with two main areas still being used. The most recently active excavated area is in the southeast portion of the site main pit area. There is also a laydown/storage area the county is utilizing for culverts in the northwest corner of the site. The Division observed a small excavated area along the northern permit boundary, approximately 700 feet northwest of the entrance, which will need to be sloped and seeded.

Small pit along north of the entrance; looking north.

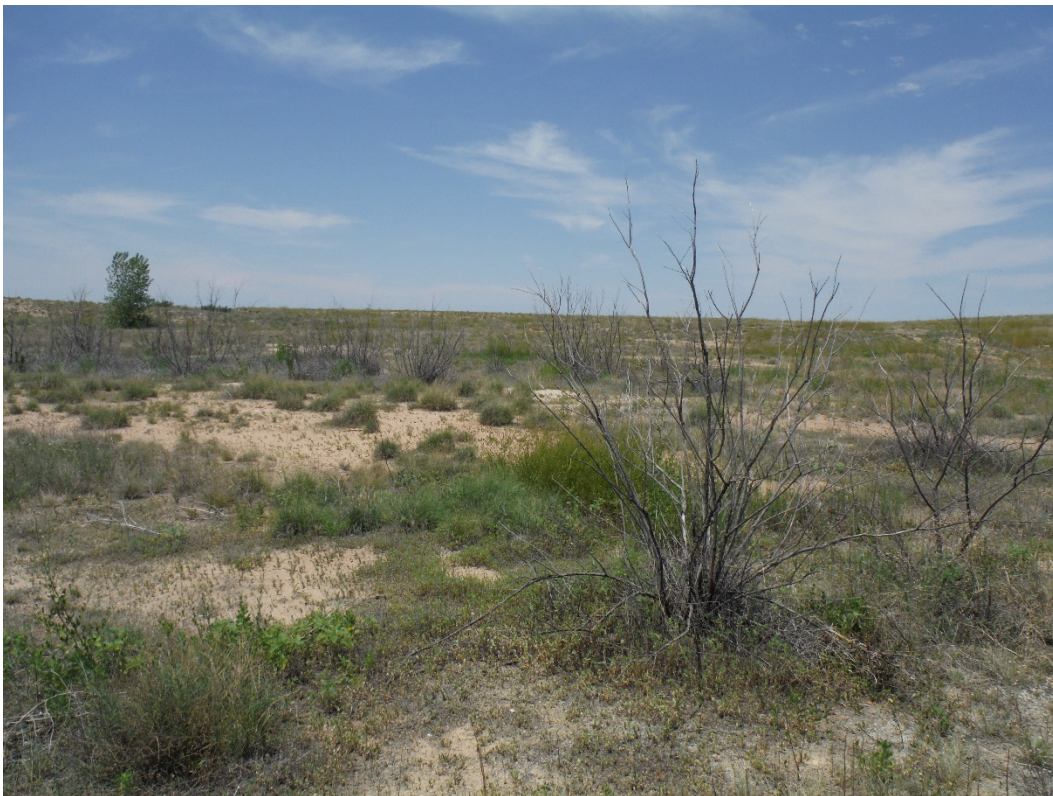
Treated tamarisks in central portion of the site; looking southeast.

The Operator has treated tamarisk (Salt Cedar) at the site but will need to continue to monitor and treat as necessary to control this state-listed noxious weed. The Operator should also treat the Russian olive trees which have started to establish at the site as well. As this time, the Division will not cite this as a problem as the Operator continues to control and treat the noxious weeds. Once eradicated, there are various areas of the permit which could be released through an Acreage Reduction.

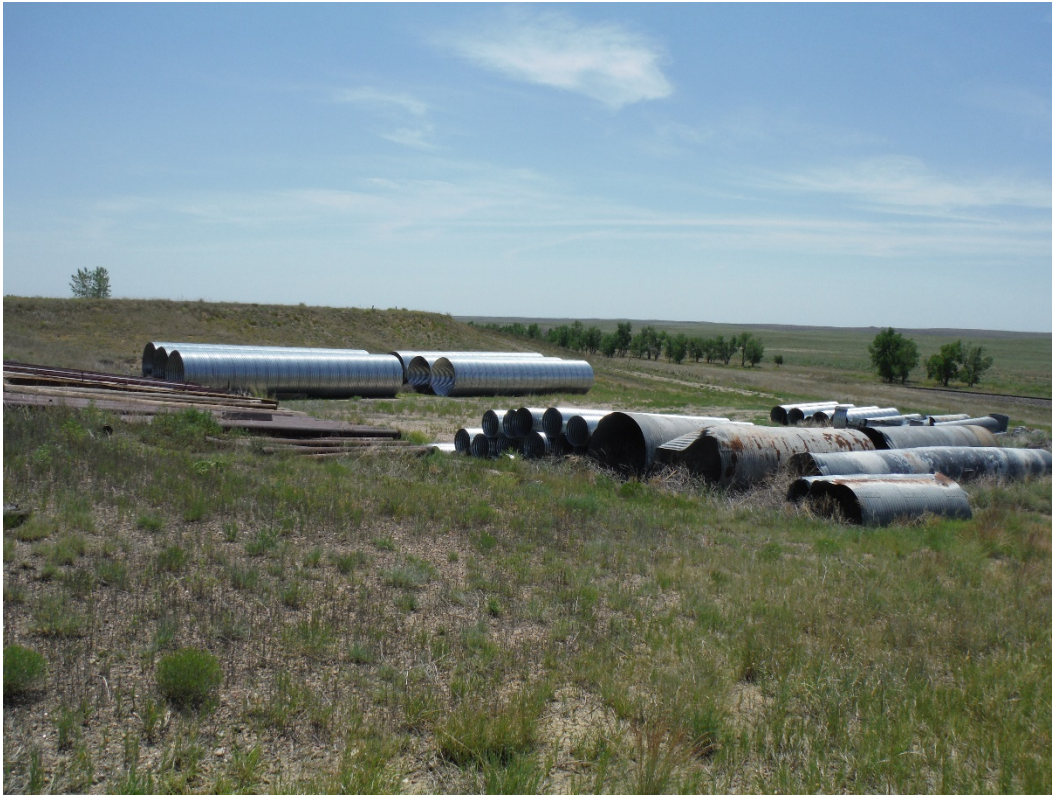
Culvert laydown/storage area located in northwest corner of the site; looking south.
