**COLORADO DIVISION OF RECLAMATION, MINING AND SAFETY**  
**MINERALS PROGRAM INSPECTION REPORT**  
**PHONE: (303) 866-3567**

<b>MINE NAME:</b> Rother Pit No. 1	<b>MINE/PROSPECTING ID#:</b> M-1999-083	<b>MINERAL:</b> Gravel	<b>COUNTY:</b> Cheyenne
<b>INSPECTION TYPE:</b> Monitoring	<b>INSPECTOR(S):</b> Elliott R. Russell	<b>INSP. DATE:</b> June 29, 2016	<b>INSP. TIME:</b> 10:00
<b>OPERATOR:</b> Cheyenne County	<b>OPERATOR REPRESENTATIVE:</b> Mike Engelbrecht	<b>TYPE OF OPERATION:</b> 110c - Construction Limited Operation

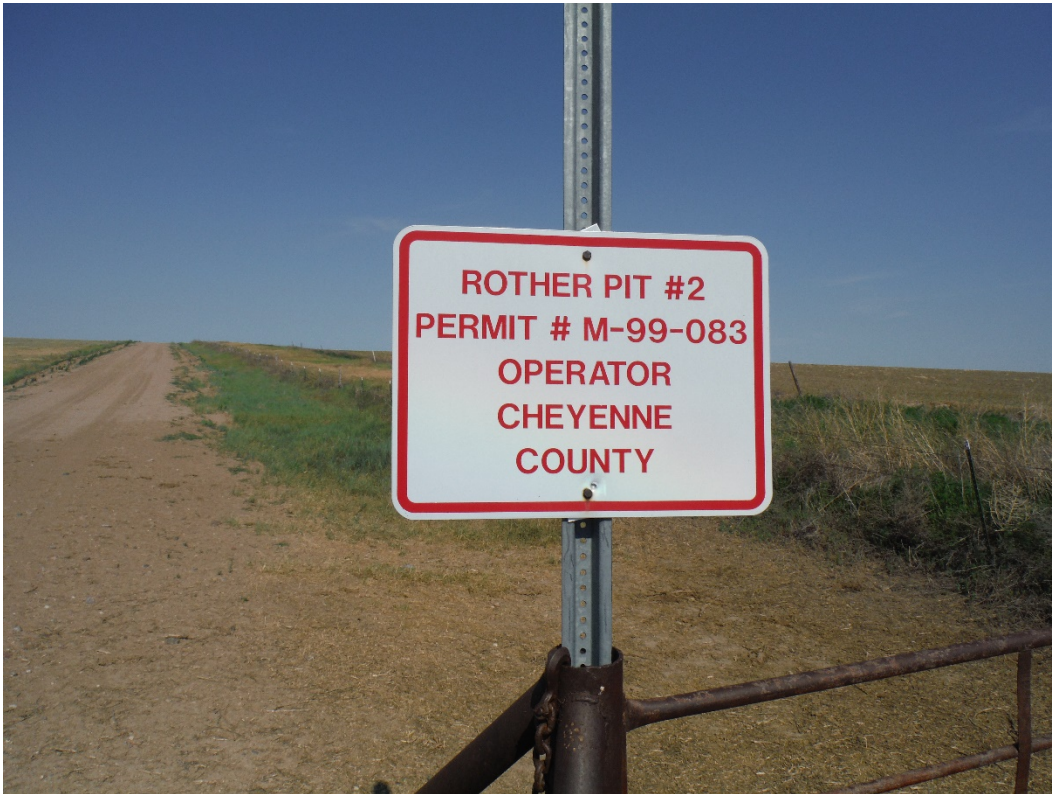
Mine identification sign; looking west.

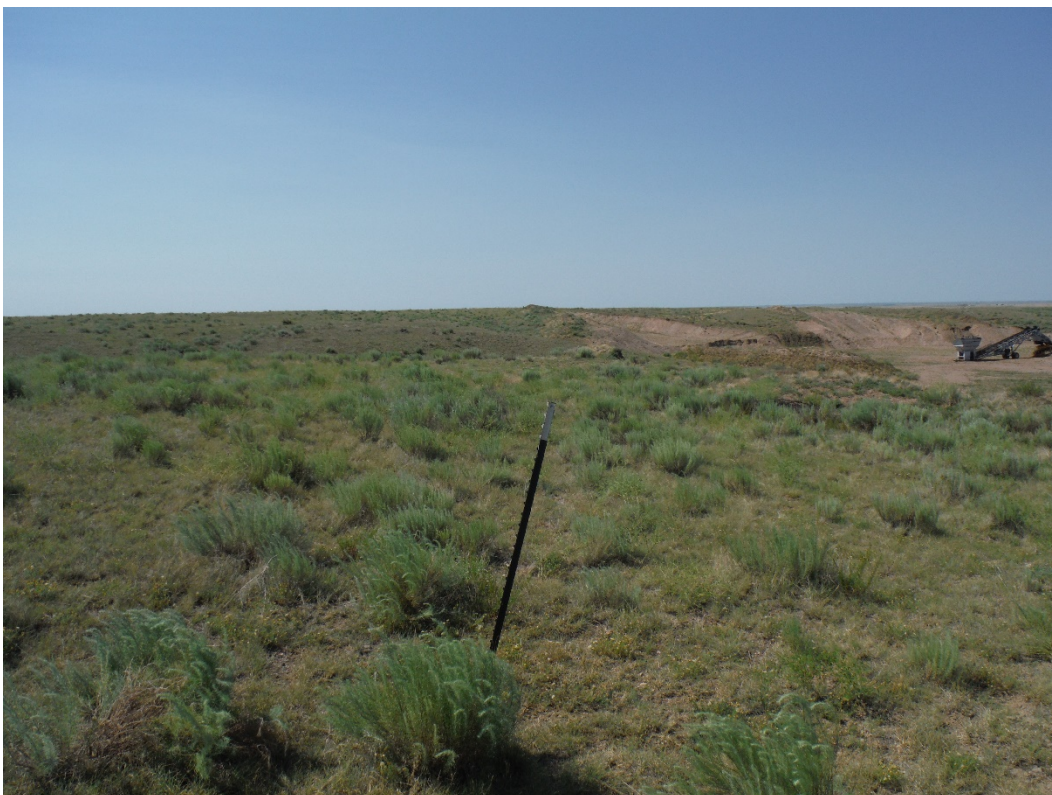
Northeast boundary marker; looking south.

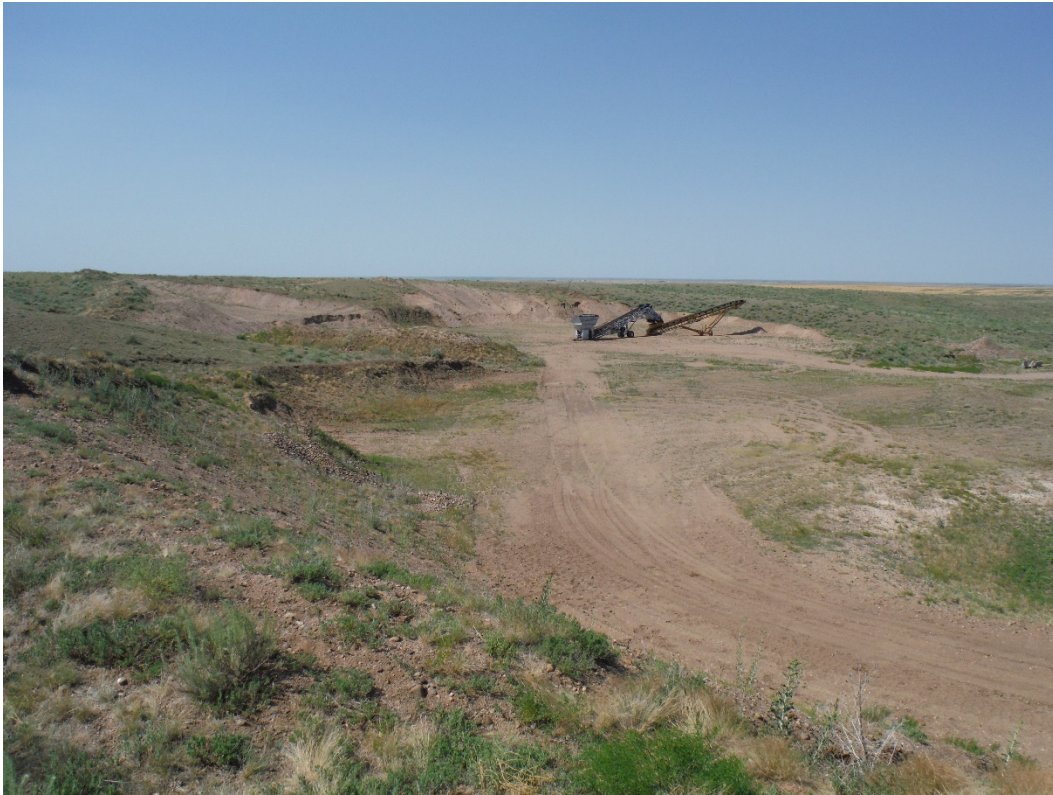
Site overview; looking southwest from the northeast corner of the pit.

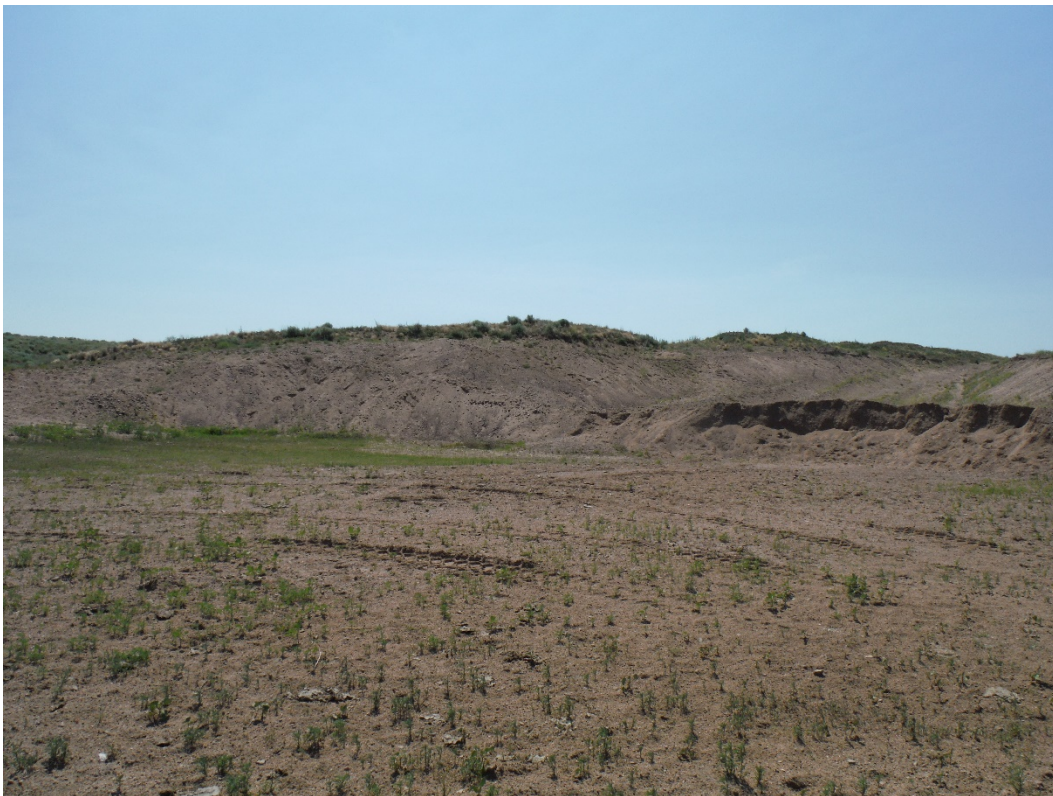
Active mining face along the eastern portion of the site; looking southeast.

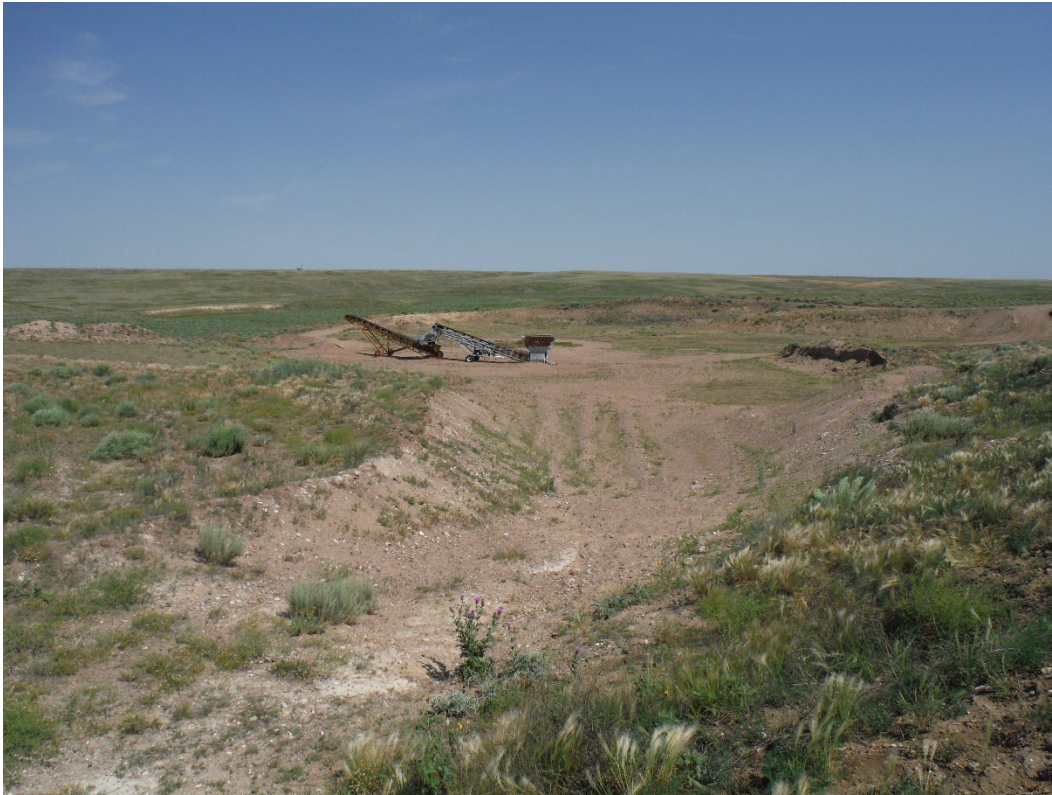
Site overview; looking northwest from the southeast corner of the pit.
