COLORADO DIVISION OF RECLAMATION, MINING AND SAFETY
MINERALS PROGRAM INSPECTION REPORT
PHONE: (303) 866-3567

MINE NAME: Meeks Pit	MINE/PROSPECTING ID#: M-2015-049	MINERAL: Sand, Gravel, Clay	COUNTY: Yuma
INSPECTION TYPE: Preoperation Inspection	INSPECTOR(S): Elliott R. Russell	INSP. DATE: March 10, 2016	INSP. TIME: 12:45
OPERATOR: Yuma County	OPERATOR REPRESENTATIVE: Don Marr	TYPE OF OPERATION: 112c - Construction Regular Operation

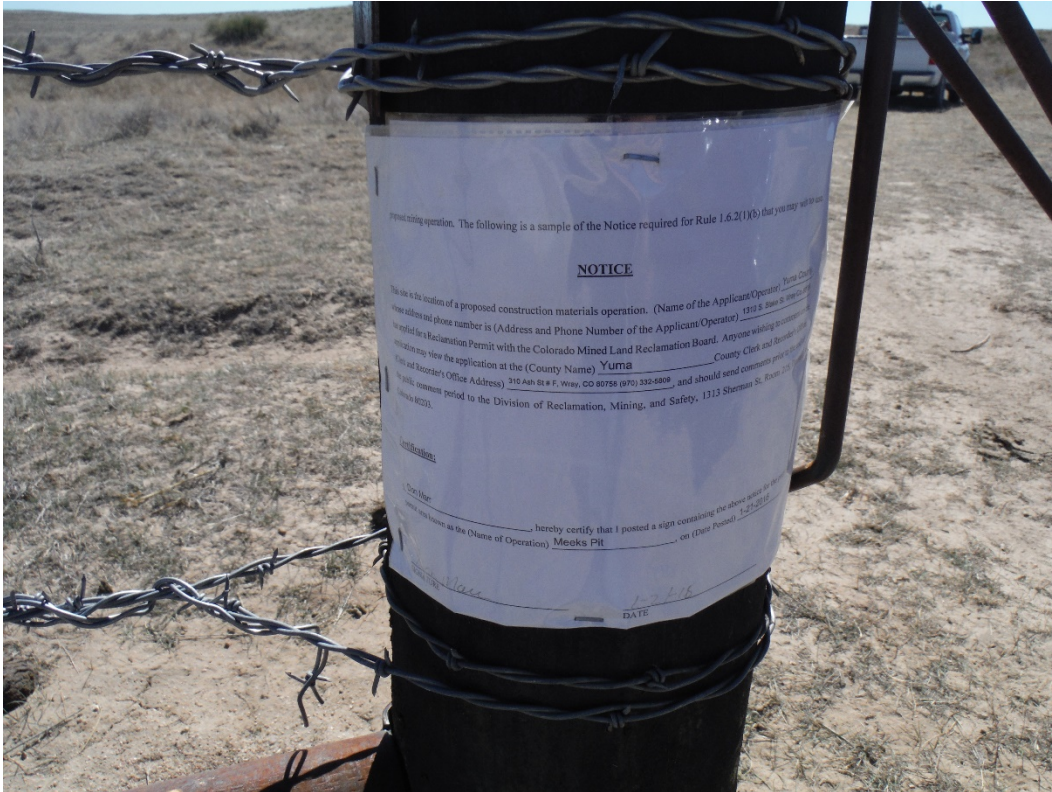
At 1245 hours, the Division met Mr. Marr at the proposed mine site. At the time of the inspection the temperature was warm, the sky was partly cloudy, and the ground was dry. The required on-site notice of the application was posted at the proposed entrance to the mine site.

On-site notice; looking south.

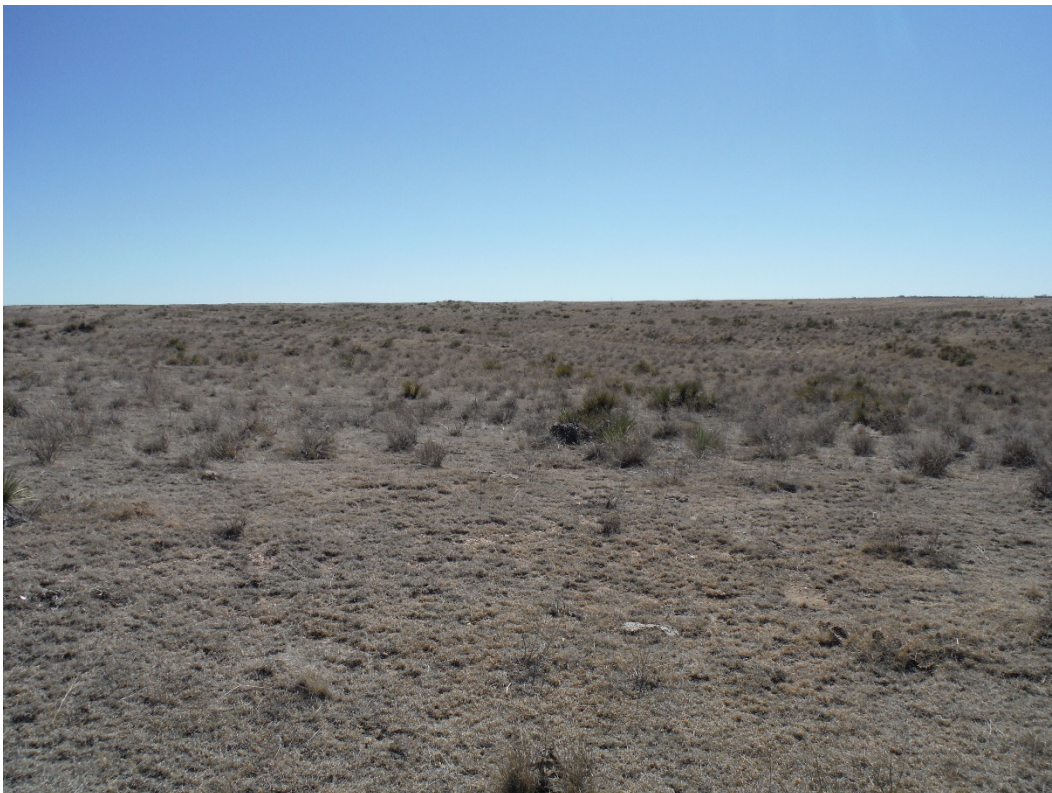
Sample photo of pre-permit conditions; looking south.

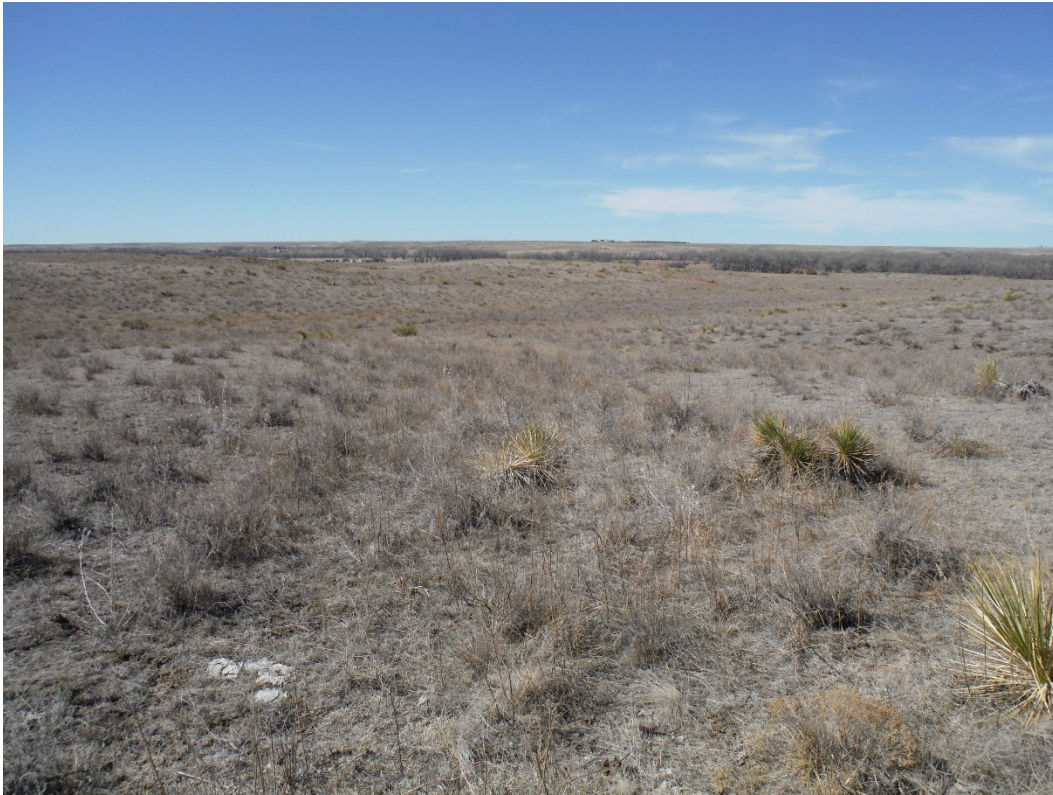
Sample photo of pre-permit conditions; looking northwest.

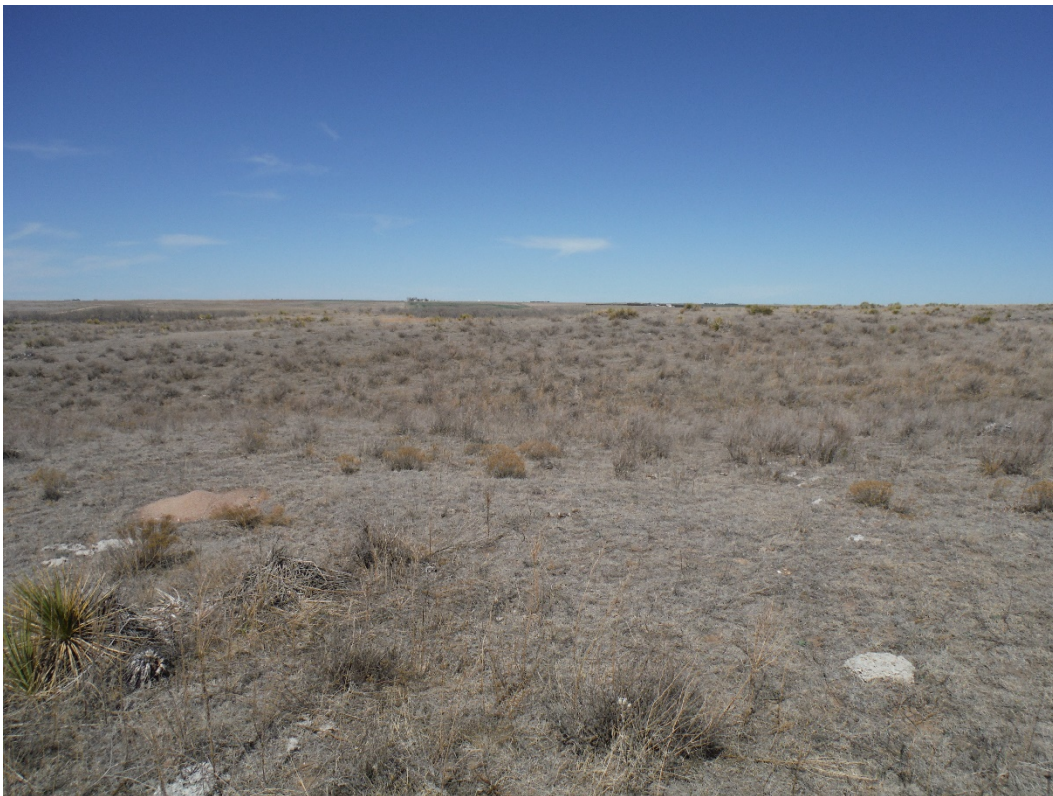
Sample photo of pre-permit conditions; looking north.

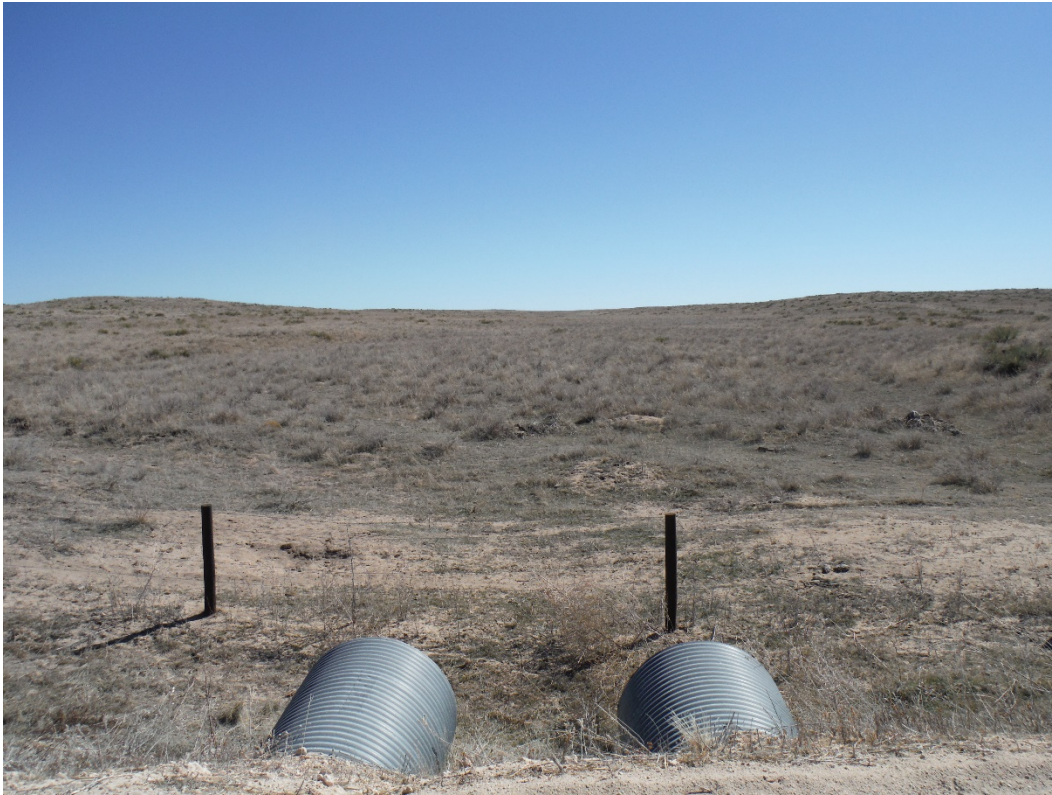
Sample photo of pre-permit conditions; looking south from County Road 2.

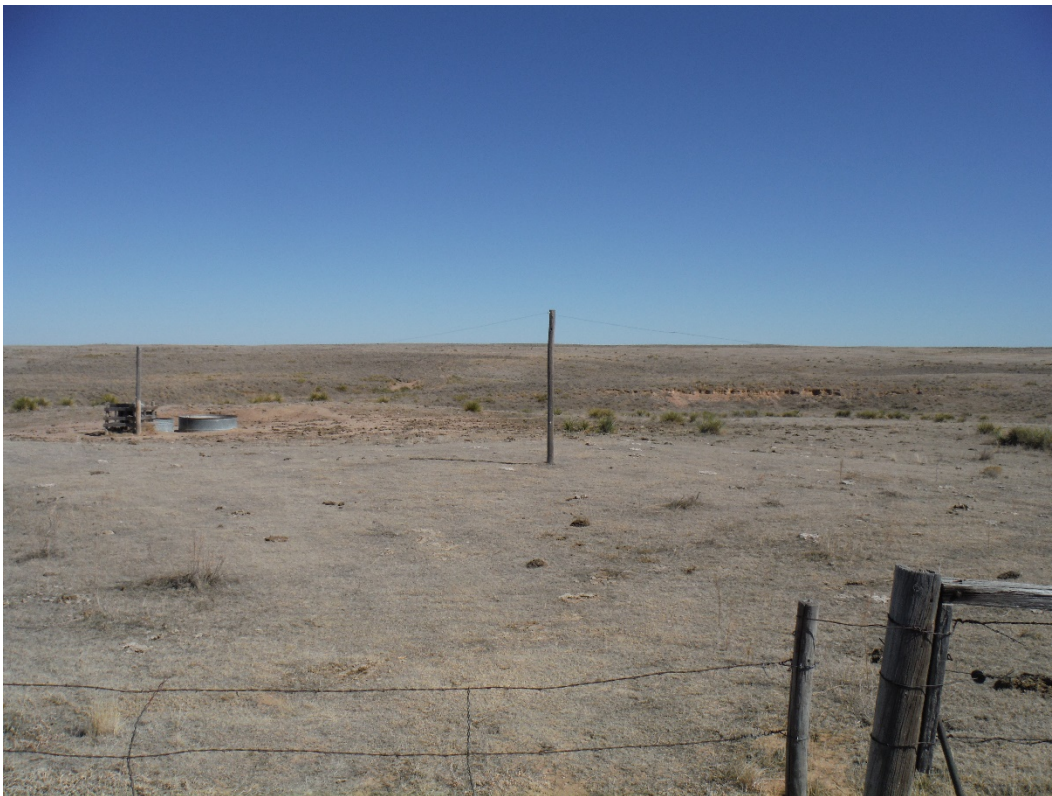
Sample photo of pre-permit conditions; looking east from County Road CC.

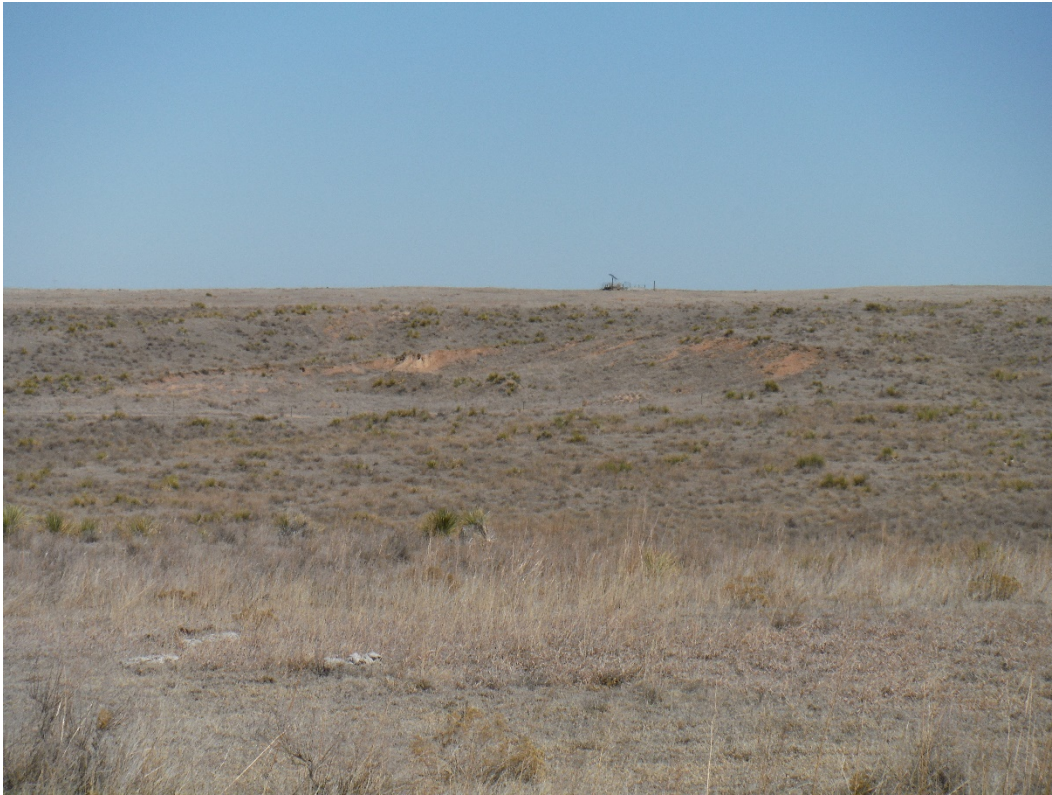
The site consists of multiple rolling hills/ridges bisected with drainages which flow toward the north. The site is bounded by County Road 2 on the north and County Road CC on the west. A historic gravel pit disturbance which appeared to be naturally reclaimed is located adjacent to the eastern permit boundary.

Pre-law disturbance east of the eastern permit boundary; looking east.
