COLORADO DIVISION OF RECLAMATION, MINING AND SAFETY
MINERALS PROGRAM INSPECTION REPORT
PHONE: (303) 866-3567

MINE NAME: Knodel Pit	MINE/PROSPECTING ID#: M-2011-042	MINERAL: Gravel and sand	COUNTY: Yuma
INSPECTION TYPE: Monitoring	INSPECTOR(S): Elliott R. Russell	INSP. DATE: March 10, 2016	INSP. TIME: 11:15
OPERATOR: Yuma County	OPERATOR REPRESENTATIVE: Don Marr	TYPE OF OPERATION: 112c - Construction Regular Operation

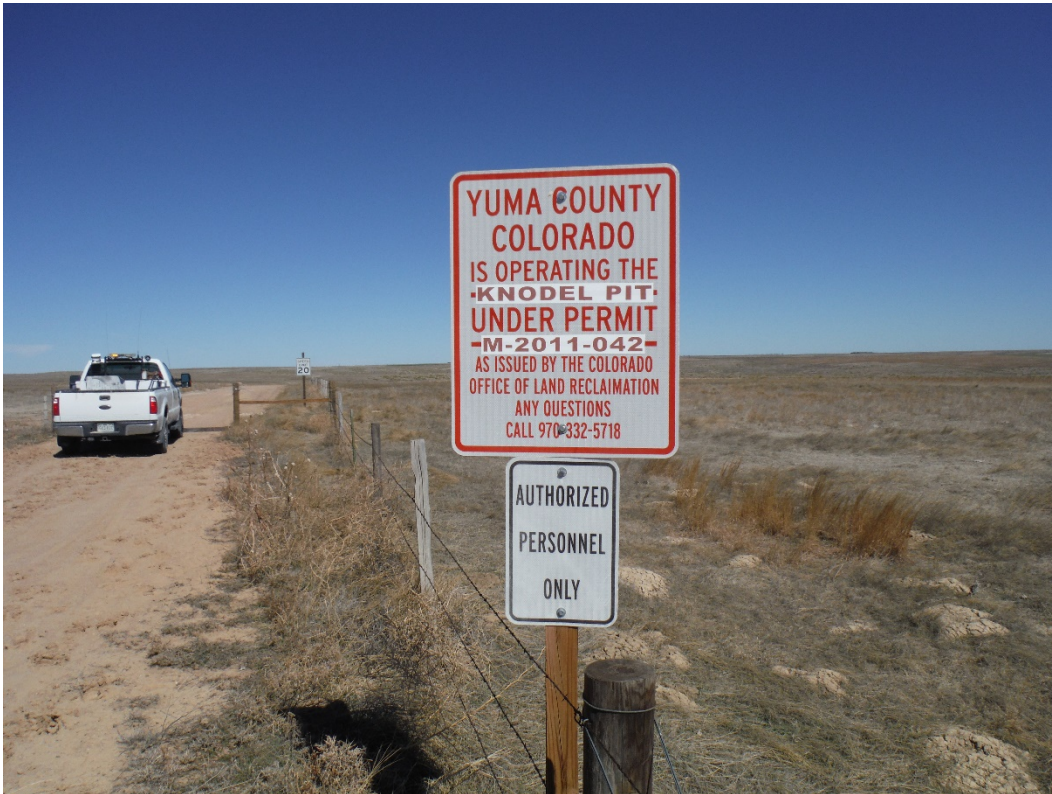
Mine identification sign; looking north.

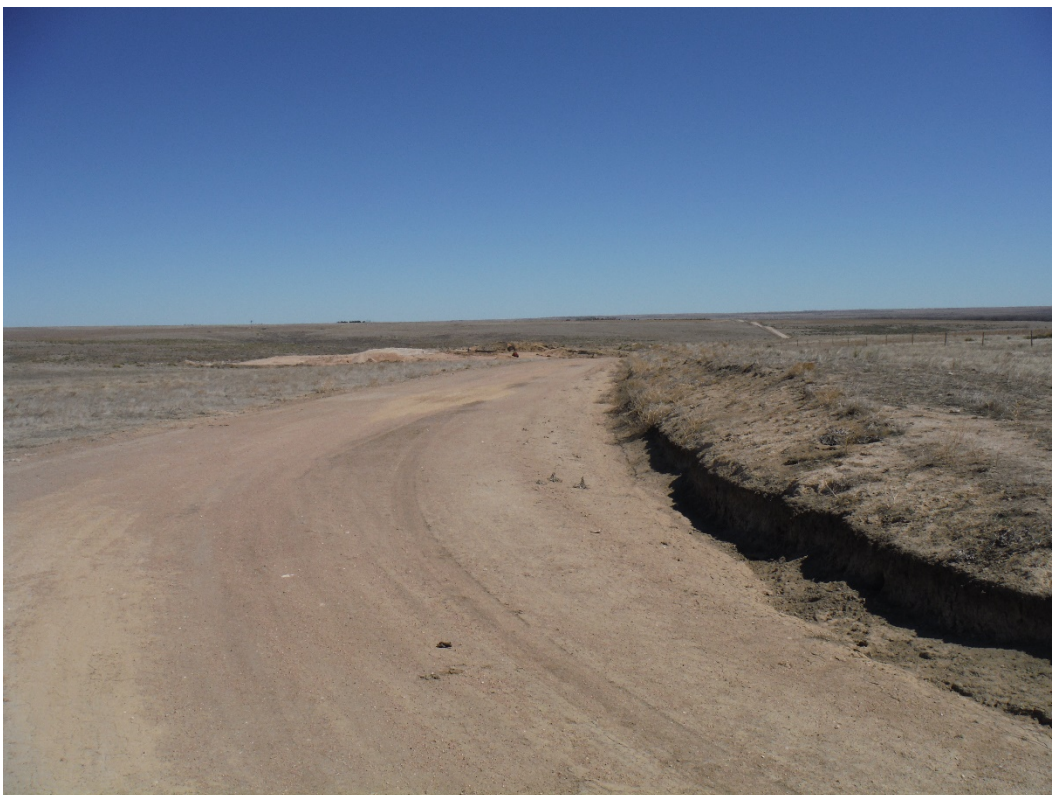
Access road into main pit area; looking east.

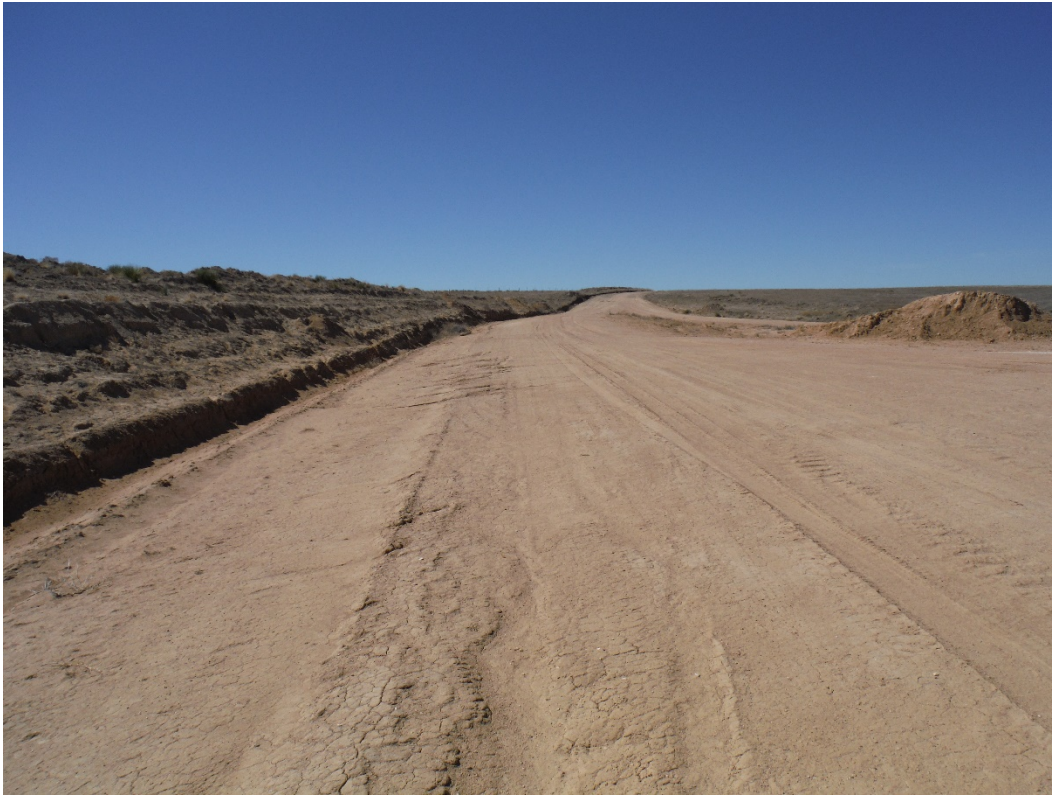
Western portion of the main pit; looking west.

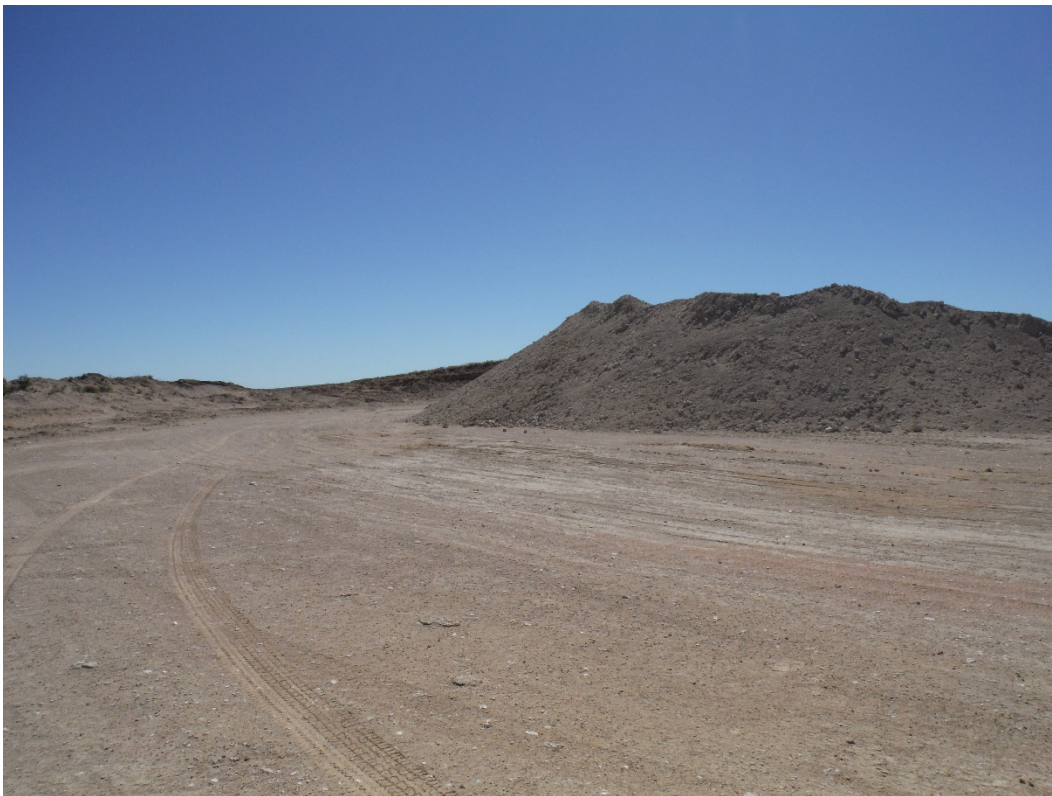
Product stockpile located in eastern portion of the main pit; looking southeast.

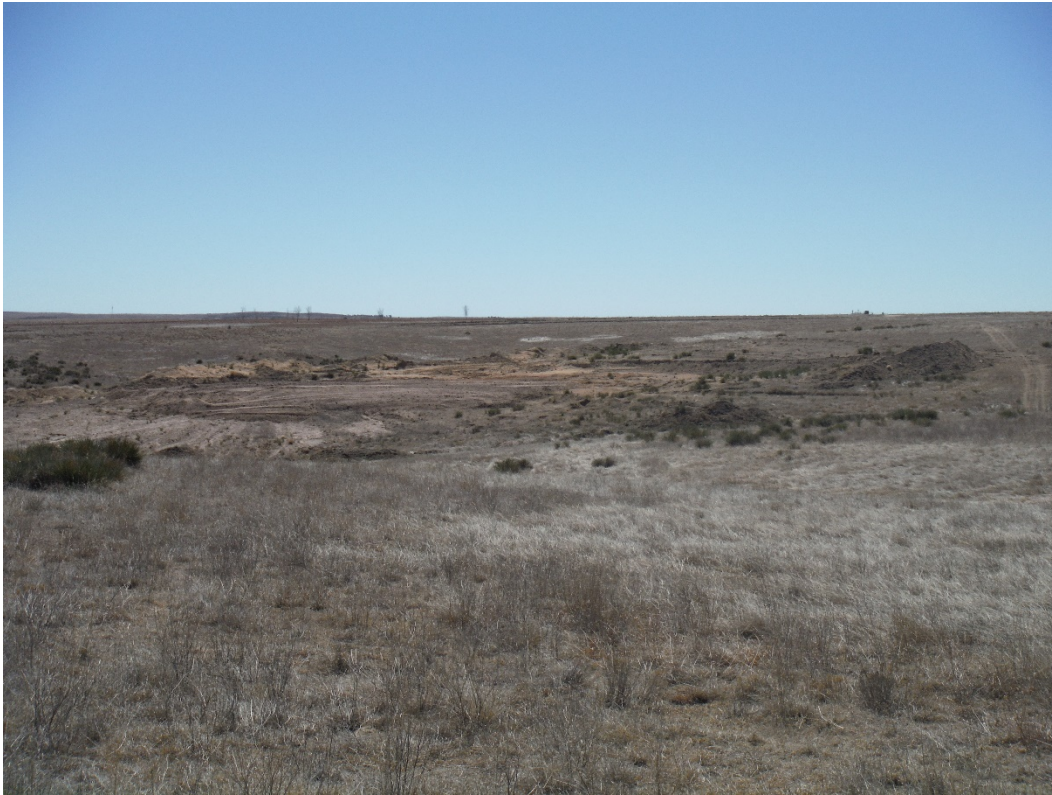
Northwest exploration area; looking south.
