**COLORADO**  
Division of Reclamation,  
Mining and Safety  
Department of Natural Resources

**PERMIT INFORMATION**

<b>Permit Number:</b> C-1981-025 <b>Mine Name:</b> North Thompson Creek Mine <b>Operator:</b> MINREC, Inc. <b>Operator Address:</b> Mr. James E Stover 2352 N 7th St, Ste B Grand Junction, CO 81501	<b>County:</b> Garfield <b>Operation Type:</b> Underground <b>Permit Status:</b> Inactive <b>Ownership:</b> Federal
	<b>Operator Representative Present:</b>  None
<b>Operator Representative Signature: (Field Issuance Only)</b>

<b>Inspection Start Date:</b> August 22, 2019 <b>Inspection Start Time:</b> 16:45 <b>Inspection End Date:</b> August 22, 2019 <b>Inspection End Time:</b> 17:30		<b>Inspection Type:</b> Coal Partial Inspection <b>Inspection Reason:</b> Normal I&E Program <b>Weather:</b> Clear	
<b>Joint Inspection Agency:</b>  None		<b>Joint Inspection Contacts:</b>  	
<b>Post Inspection Agency:</b>  None		<b>Post Inspection Contacts:</b>  	
<b>Inspector(s):</b>  Robert D. Zuber, P.E.  Janet H. Binns		<b>Inspector's Signature:</b>

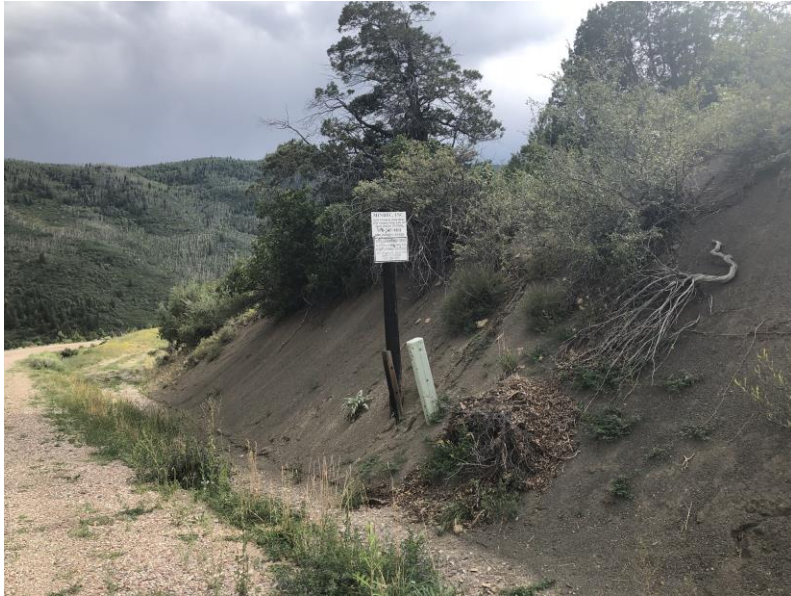
A sign was seen at the permit boundary. No issues were identified with it. Also, a Stream Buffer sign was in place.

**Entrance sign**

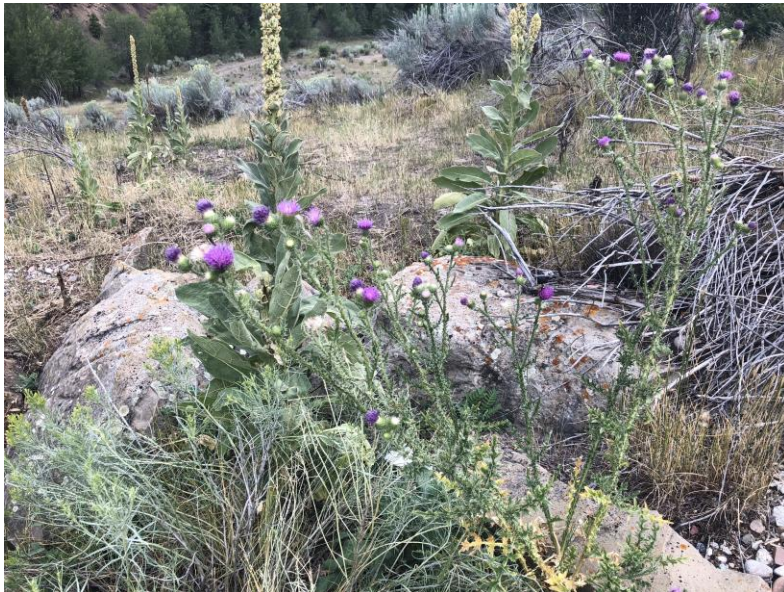
Thistle plants were seen on the hillside above the ponds.

**Thistle on hillside above ponds**

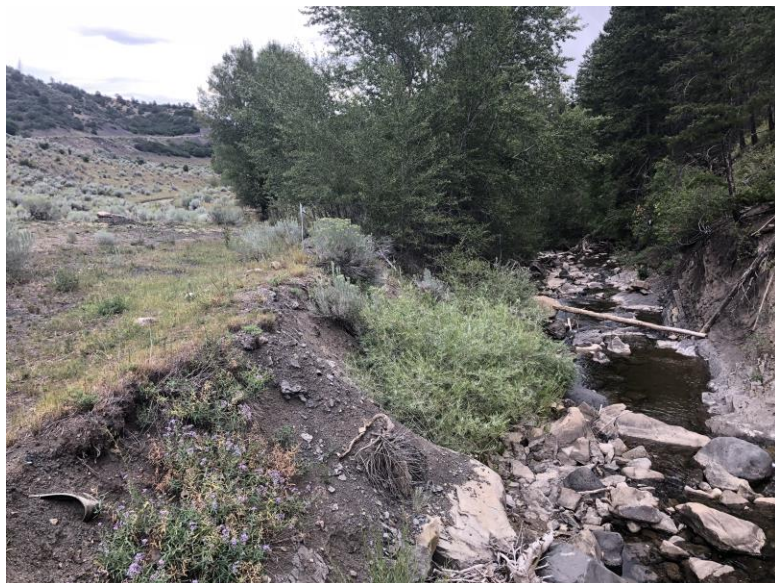
No signs of recent impacts from the mine were seen in the creek or on its banks.

**North Thompson Creek next to the mine site**

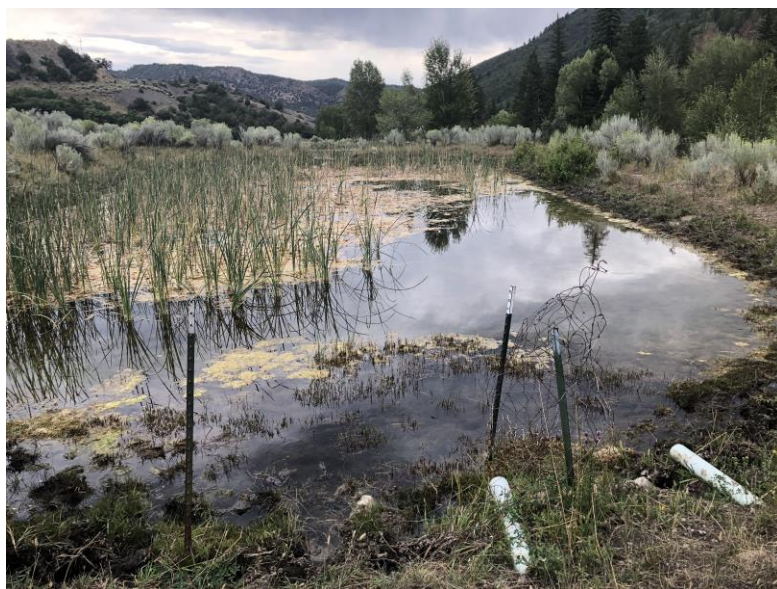
**Treatment Pond T-1**

The following ponds were inspected: the Long Pond, Treatment Pond T-1, Treatment Pond T-2, and the Polishing Pond (Pond 9). No problems were identified with the ponds. They were all discharging. The Refuse Pile Pond was not inspected.
