**COLORADO**Division of Reclamation,
Mining and Safety

MINERALS PROGRAM INSPECTION REPORT**PHONE: (303) 866-3567**

MINE NAME: Kate	MINE/PROSPECTING ID#: P-2016-019	MINERAL: Silver	COUNTY: Custer
INSPECTION TYPE: Surety Release Inspection	INSPECTOR(S): Brock F. Bowles	INSP. DATE: August 27, 2019	INSP. TIME: 11:00
OPERATOR: Viscount Colorado Holdings, LTD	OPERATOR REPRESENTATIVE: Rick Squire	TYPE OF OPERATION: MP - Mineral Prospecting	
REASON FOR INSPECTION: Surety Release Requested	BOND CALCULATION TYPE: Partial Bond	BOND AMOUNT: \$16,134.00	
DATE OF COMPLAINT: NA	POST INSP. CONTACTS: None	JOINT INSP. AGENCY: None	
WEATHER: Clear	INSPECTOR'S SIGNATURE:

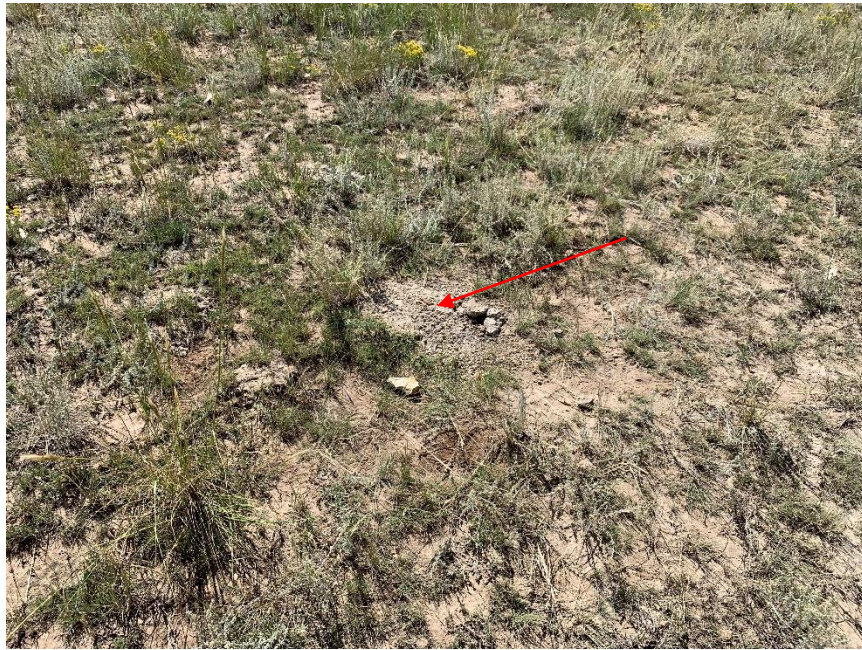
Each of the 10 drill holes were located and inspected. The casings were cut below the soil surface and the concrete plugs were level with the soil surface. The soil was graded around each drill site to blend in with the surrounding landscape. Grasses and forbs were growing on the backfilled areas and were consistent with the surrounding plant community.

Bore hole P17006, typical reclamation
