September 14, 2017

Subject: Mayflower (5 Dam) Seepwater Return Pipeline Leak, Mayflower Tailings Storage Facilities, Climax Mine, Permit No. M-1977-493

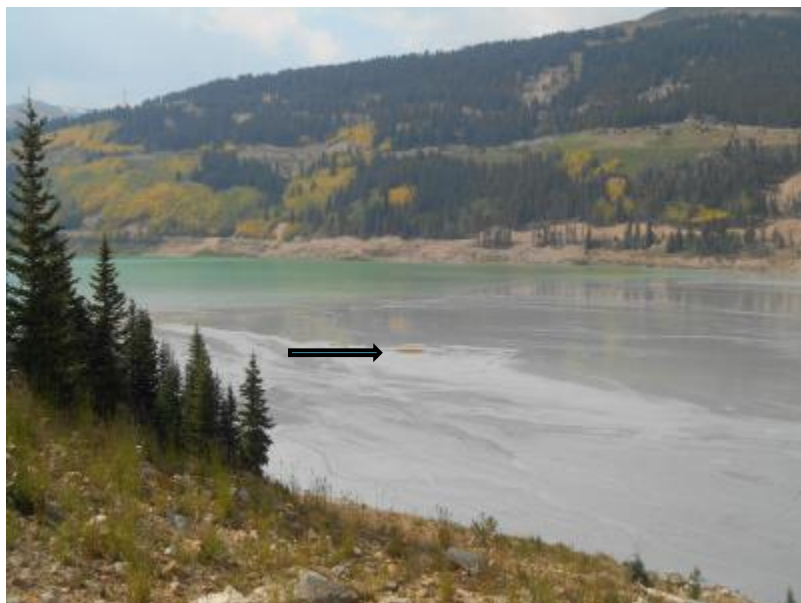
The Mayflower Seepwater pipeline pumps seepwater from the toe of 5 Dam up to the seepwater pond and pumpstation near the toe of 3 Dam (Tenmile). This 14-inch HDPE pipeline is located outside of the structural shell of the dam. The leak was first observed on September 5, 2017 and is shown in the photo below taken during AECOM's site visit on September 7, 2017. The leak is located near the edge of the existing Mayflower pond, over 2,000 feet upstream from the current dam crest and approximately 200 feet from the shoreline with a visible surface feature of approximately 10 feet in diameter. The leak is believed to be a result of a faulty valve buried approximately 12 to 15 feet below the tailings surface in this area.

Photo 1- Seepwater Pipeline Leak Location (shown with arrow) near Mayflower Decant Pond

After inspecting the area, reviewing pipeline and dam construction drawings, and considering the location of the leak, it is our opinion that the Mayflower seepwater pipeline leak identified has no impacts on 5 Dam stability, either currently or for the foreseeable future. The leak is located a significant distance from the current crest, not located within the structural dam shell and is close to the decant pond with the seep water flowing towards the decant pond water. AECOM will continue to work with the Climax team to monitor this leak as part of the regular review of the TSF's performance and will advise Climax if and when it should abandon the portion of line where the leak is occurring.
