**MINERALS PROGRAM INSPECTION REPORT**  
**PHONE: (303) 866-3567**

<b>MINE NAME:</b> Pickering Family Pit	<b>MINE/PROSPECTING ID#:</b> M-2009-086	<b>MINERAL:</b> Gravel and sand	<b>COUNTY:</b> Grand
<b>INSPECTION TYPE:</b> Monitoring	<b>INSPECTOR(S):</b> Peter S. Hays	<b>INSP. DATE:</b> August 15, 2019	<b>INSP. TIME:</b> 11:30
<b>OPERATOR:</b> Flintstone Gravel & Trucking, Inc.	<b>OPERATOR REPRESENTATIVE:</b> Ted Pratt	<b>TYPE OF OPERATION:</b> 112c - Construction Regular Operation	
<b>REASON FOR INSPECTION:</b> Normal I&E Program	<b>BOND CALCULATION TYPE:</b> Complete Bond	<b>BOND AMOUNT:</b> \$64,000.00	
<b>DATE OF COMPLAINT:</b> NA	<b>POST INSP. CONTACTS:</b> None	<b>JOINT INSP. AGENCY:</b> None	
<b>WEATHER:</b> Clear	<b>INSPECTOR'S SIGNATURE:</b>

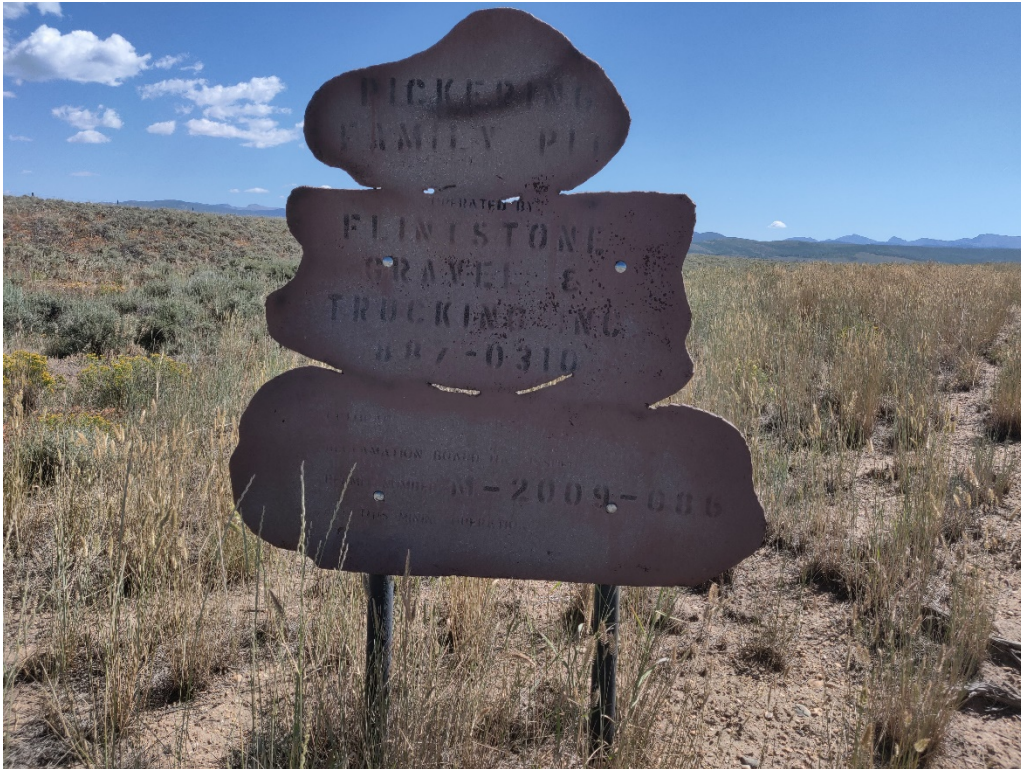
The mine sign and boundary markers were observed as required by Rule 3.1.12. The mine sign was located on the left side of the access road as the road enters the mining area and was faded making it difficult to read. Rule 3.1.12 states the mine sign should be placed at the entrance of the mine site and be clearly visible from the access road. The Division will require the Operator relocated the mine sign near the entrance gate off of County Road 61. The Operator showed a template to repaint the existing sign for better visibility.

Pickering Family Pit mine sign

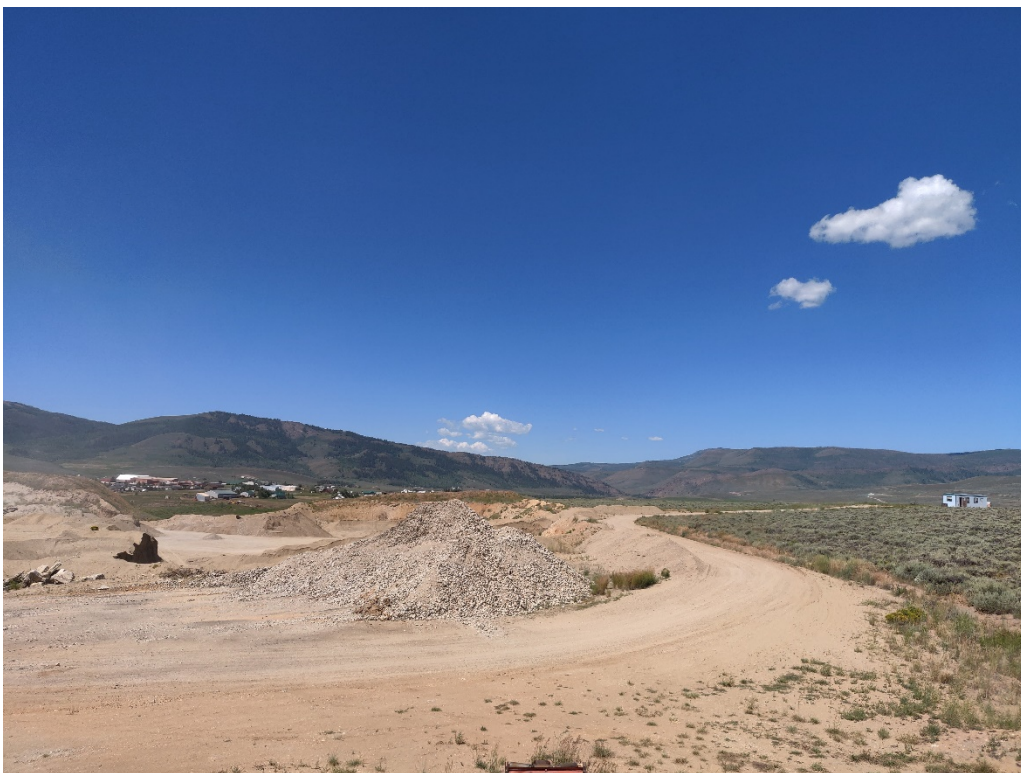
View of the site from the northeast corner looking west

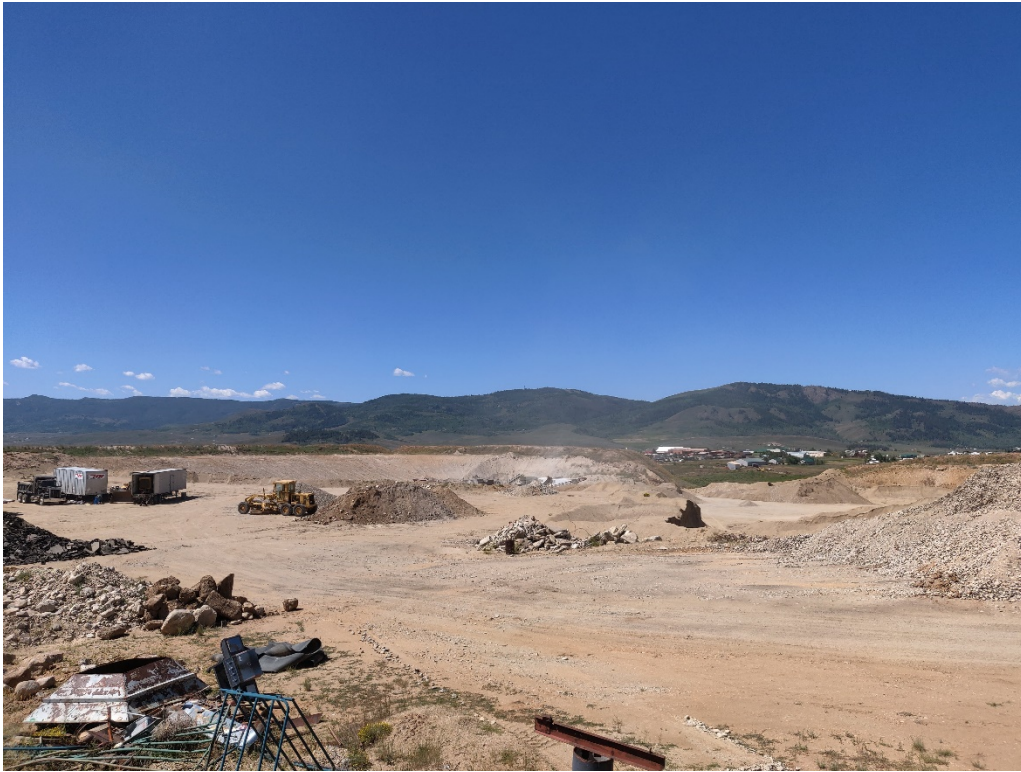
View of the site from the northeast corner looking southwest

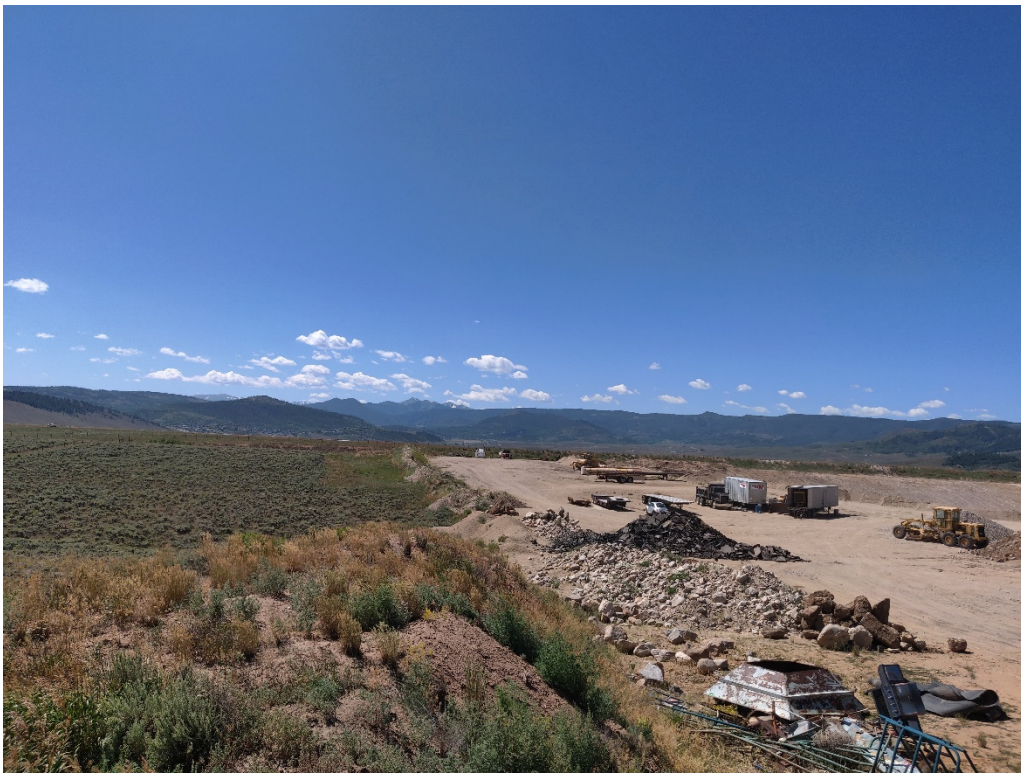
View of the site from the northeast corner looking south

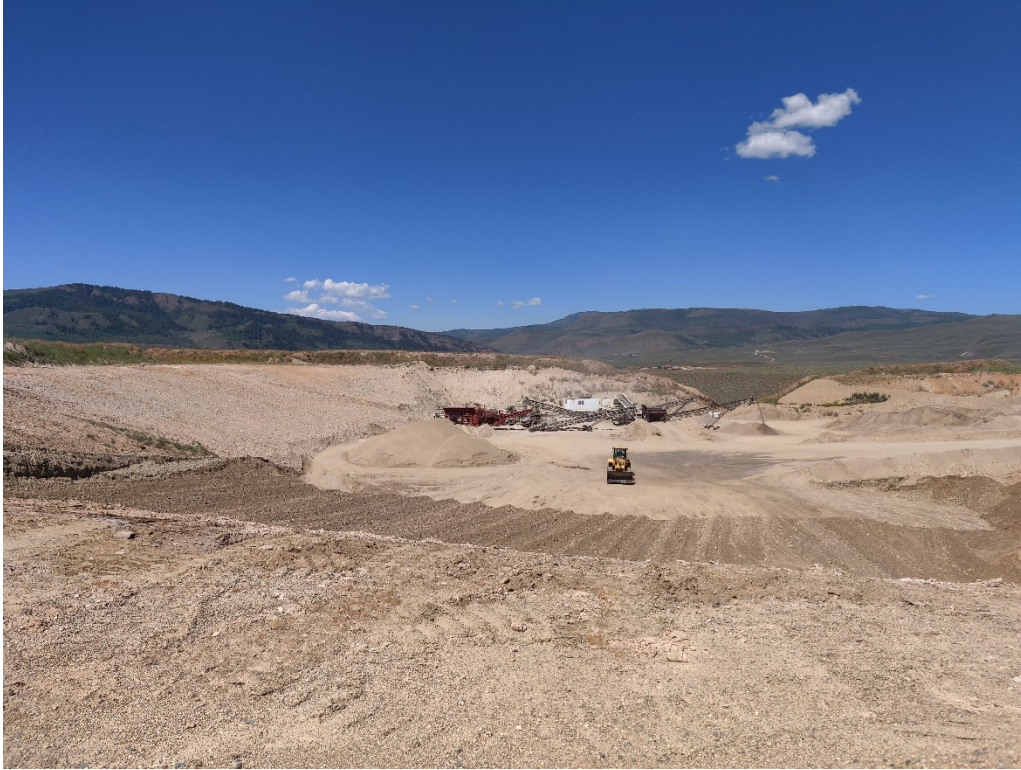
View of mining and processing from the highwall in the southeast corner of Phase 1B

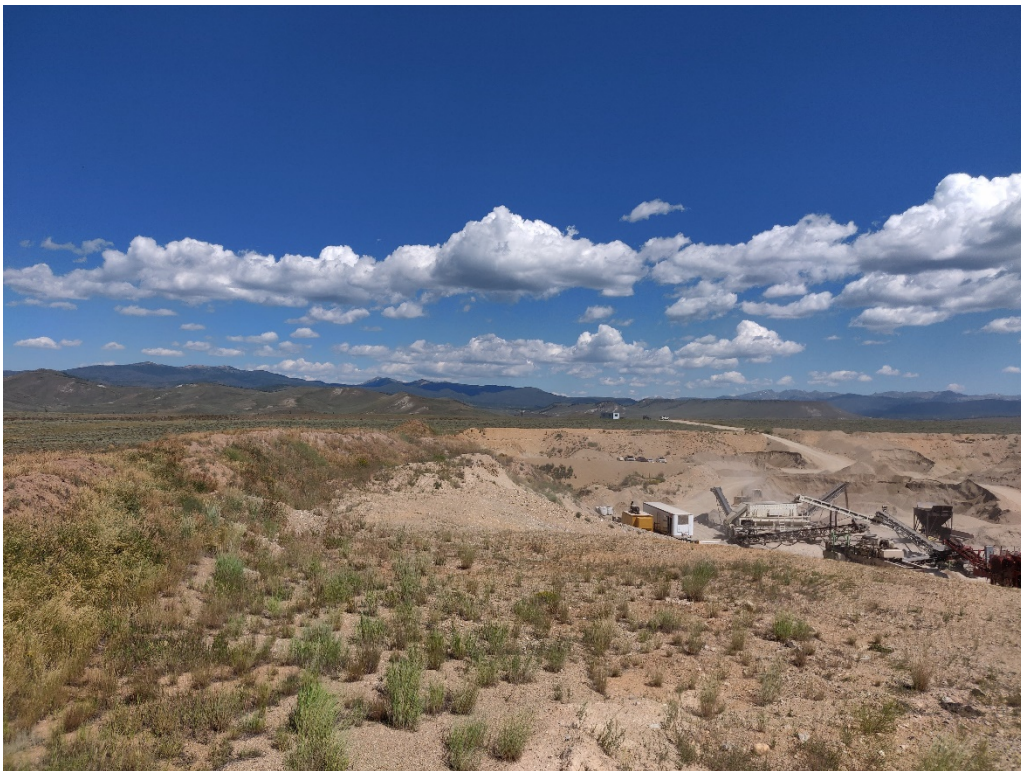
View of the site from the southwest corner looking north

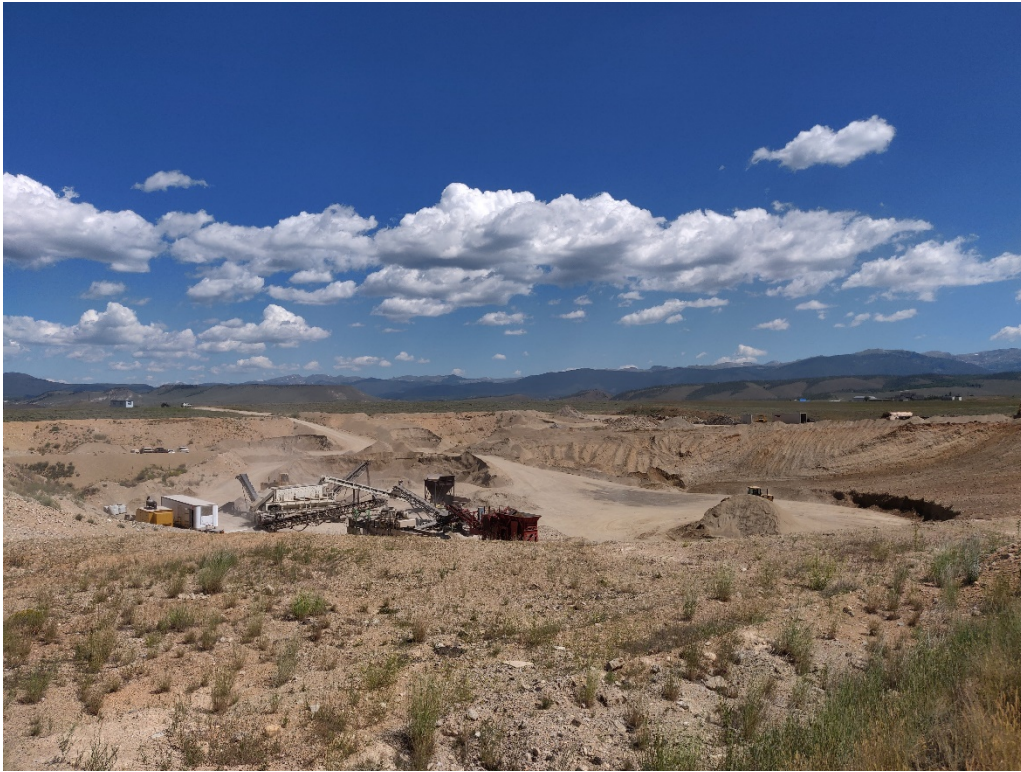
View of the site from the southwest corner looking northeast

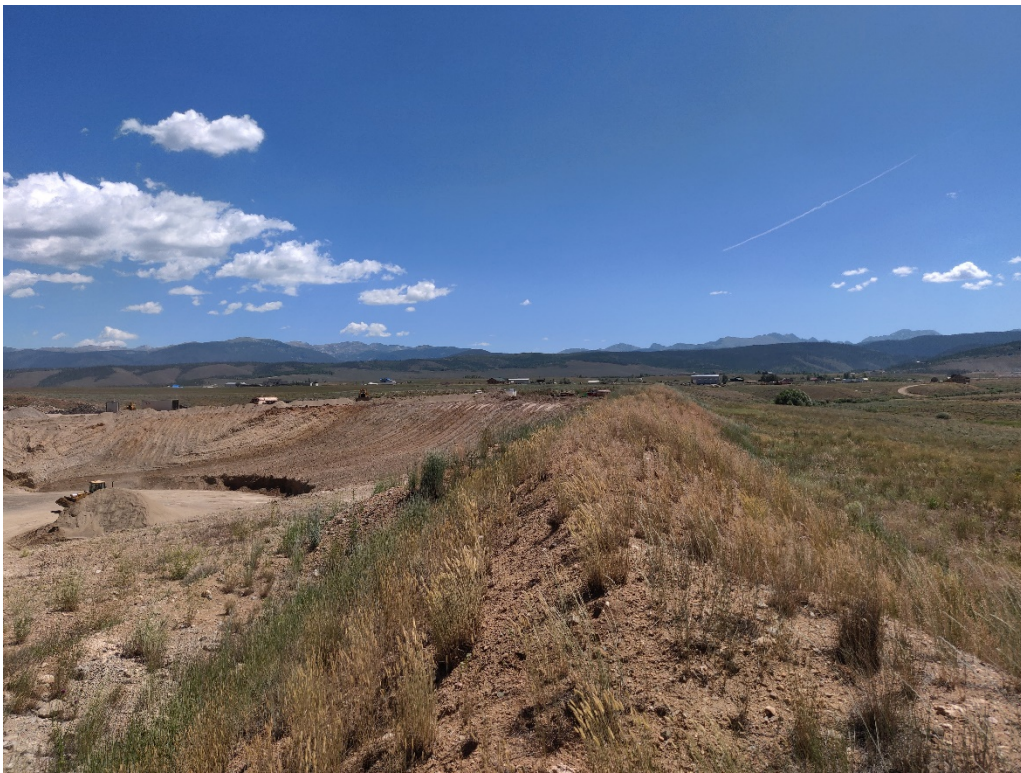
View of the site from the southwest corner looking east

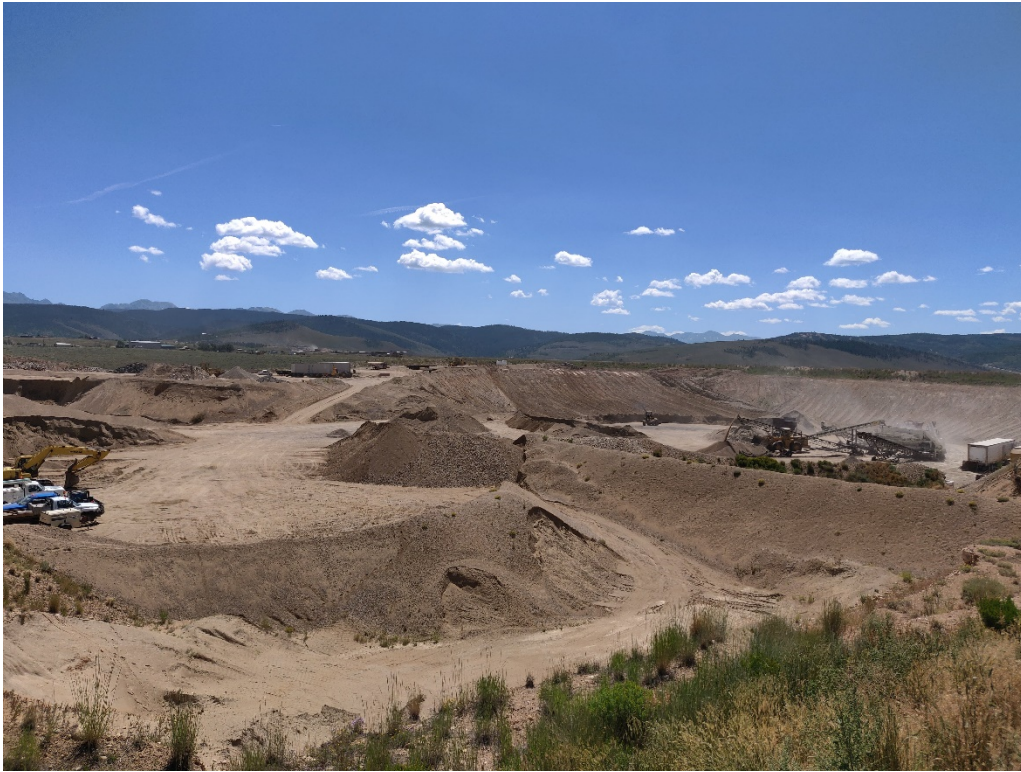
View of the site from the northwest corner looking southeast
