MINERALS PROGRAM INSPECTION REPORT
PHONE: (303) 866-3567

MINE NAME: Pueblo East Pit	MINE/PROSPECTING ID#: M-2000-041	MINERAL: Sand and gravel and borrow material for construction	COUNTY: Pueblo
INSPECTION TYPE: Surety-Related Inspection	INSPECTOR(S): Patrick Lennberg	INSP. DATE: September 6, 2019	INSP. TIME: 09:00
OPERATOR: Fremont Paving & Redi-Mix, Inc.	OPERATOR REPRESENTATIVE: Jodi Schreiber	TYPE OF OPERATION: 112c - Construction Regular Operation	
REASON FOR INSPECTION: Surety Related	BOND CALCULATION TYPE: Partial Bond	BOND AMOUNT: \$3,274,361.00	
DATE OF COMPLAINT: NA	POST INSP. CONTACTS: None	JOINT INSP. AGENCY: None	
WEATHER: Clear	INSPECTOR'S SIGNATURE:

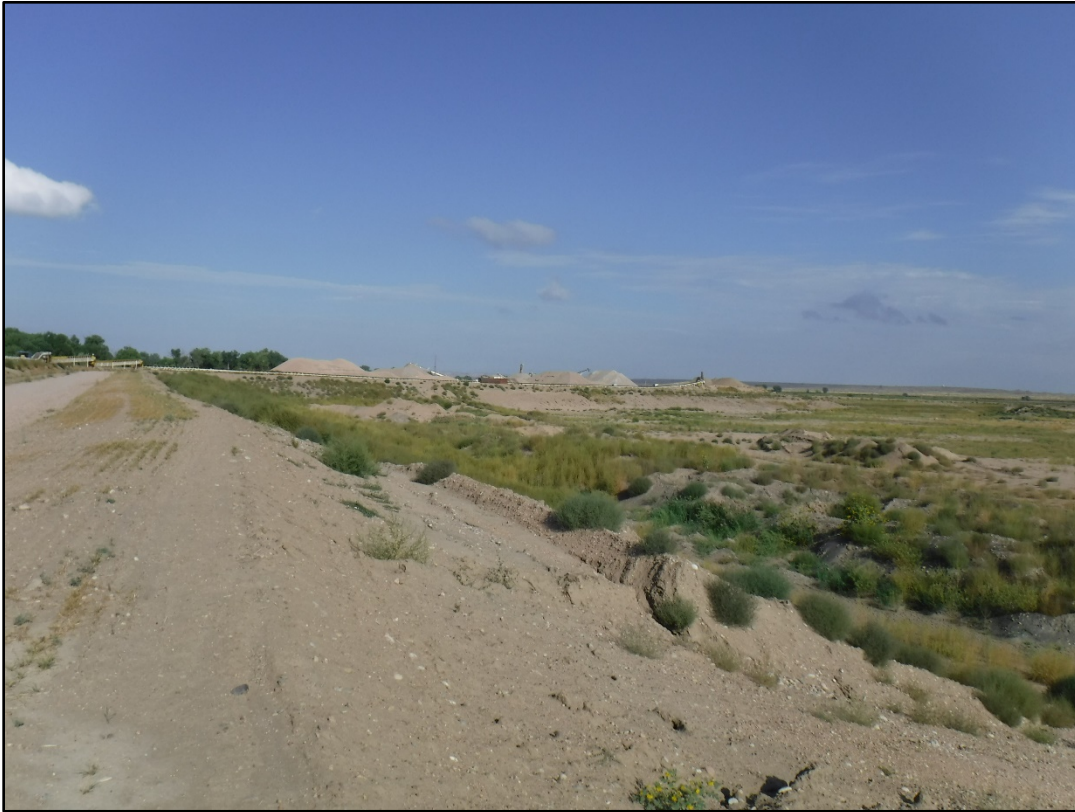
Photo 1: Looking west along the southern boundary of pond

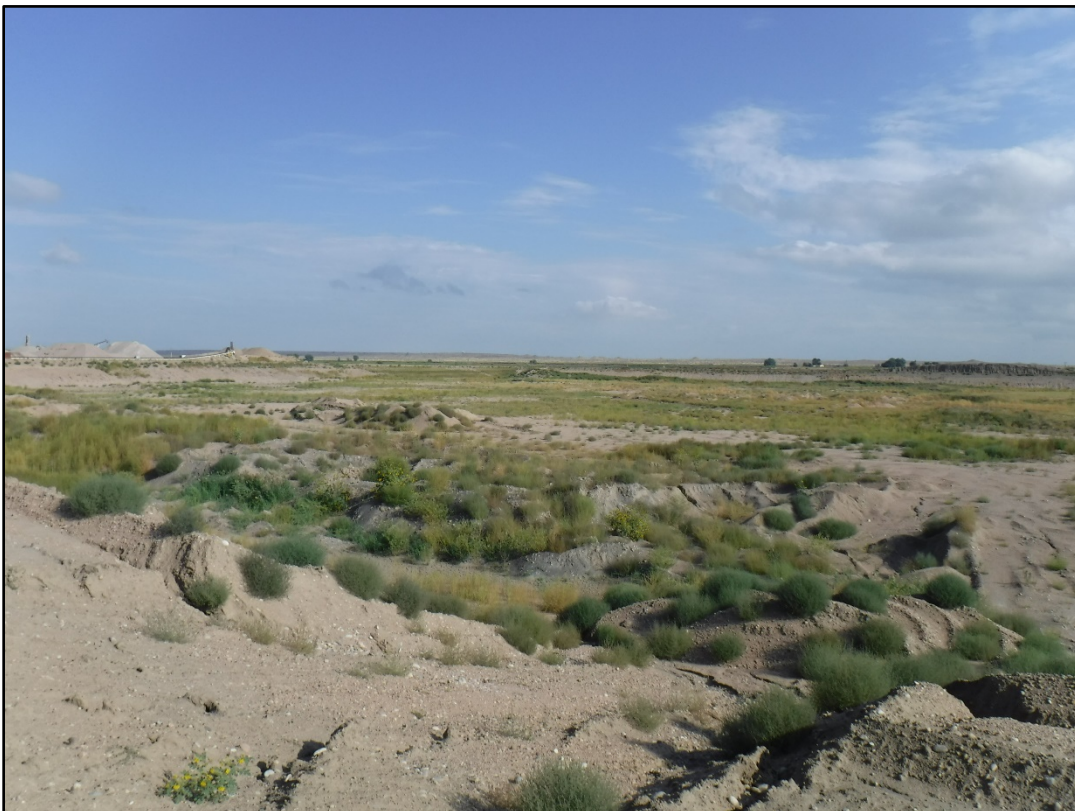
Photo 2: Looking northwest across the pond from near the southeastern corner

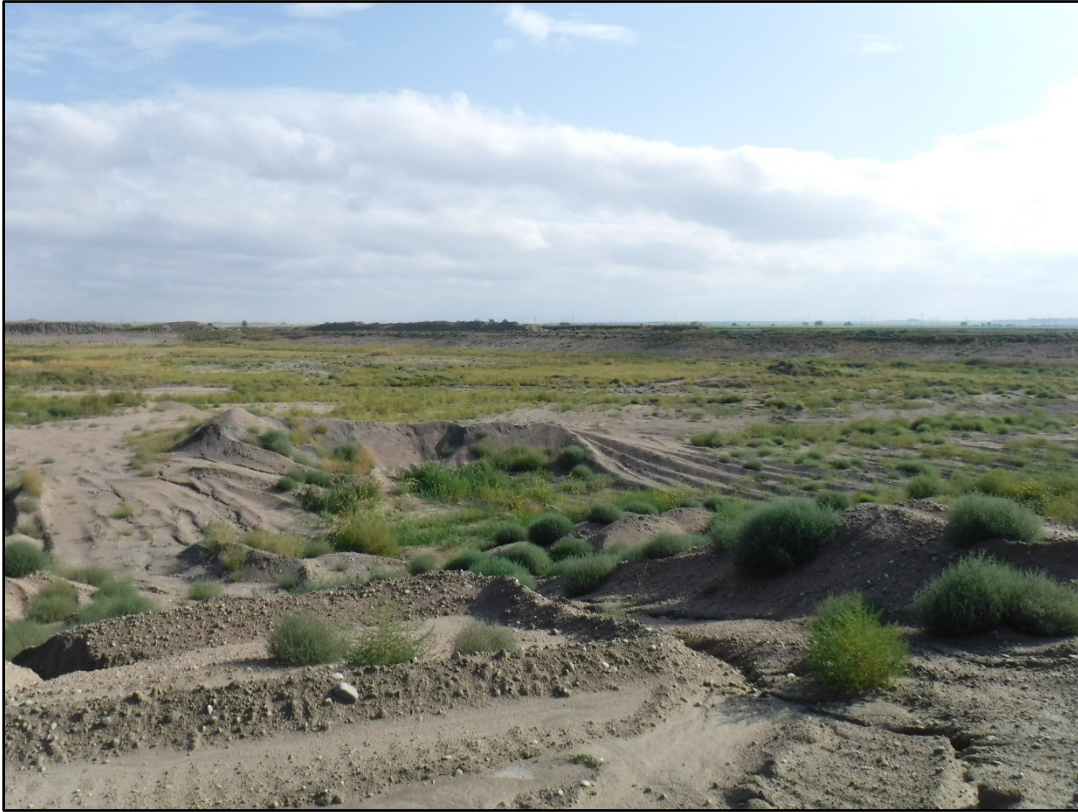
Photo 3: Looking to the northeast corner of pond from the southern boundary of pond

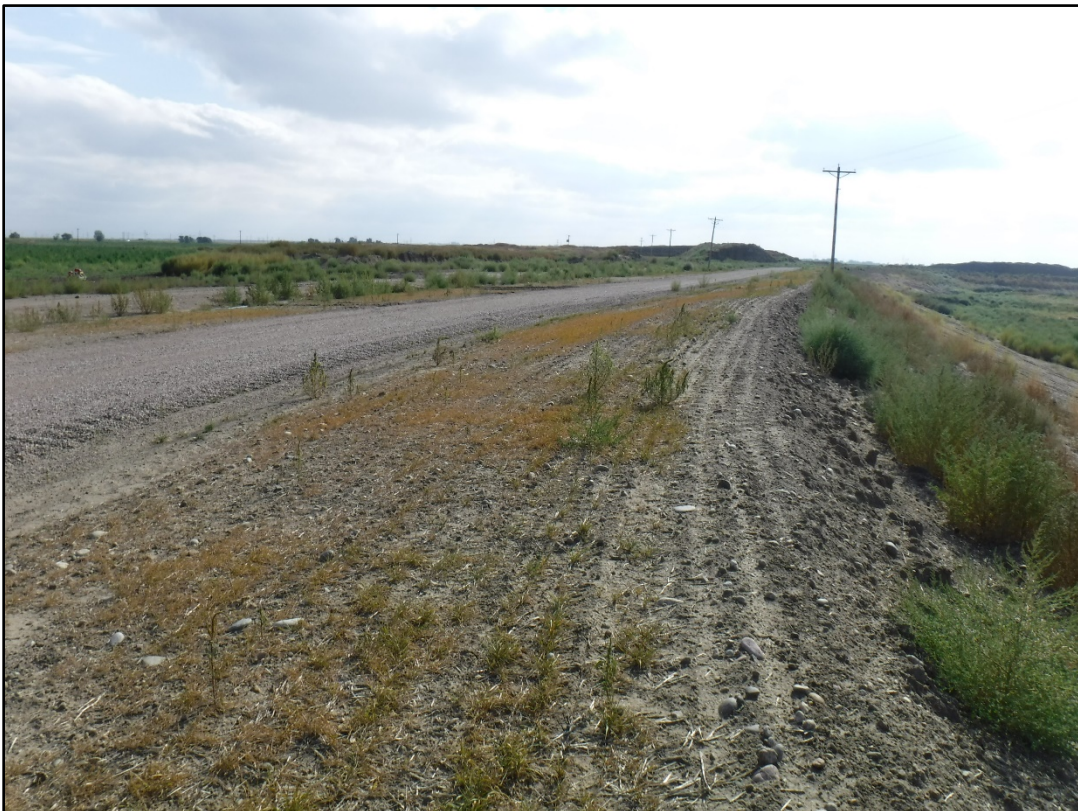
The pond side slopes have been graded to a 3H:1V or shallower all around the perimeter. The pond has not been filled with water yet. The banks, outside the pond, have been seeded and there is some growth that has begun to establish but has not had sufficient time to get established. The spillway has not been constructed yet per TR-04. In discussion with the Operator during the inspection it was determined that the original contractor that was to build the spillway is no longer in business and the spillway will need to be redesigned. The Operator was notified that a Technical Revision will need to be submitted prior to the new spillway construction.

Photo 4: Looking east along the northern boundary of pond, note revegetation planted earlier this year

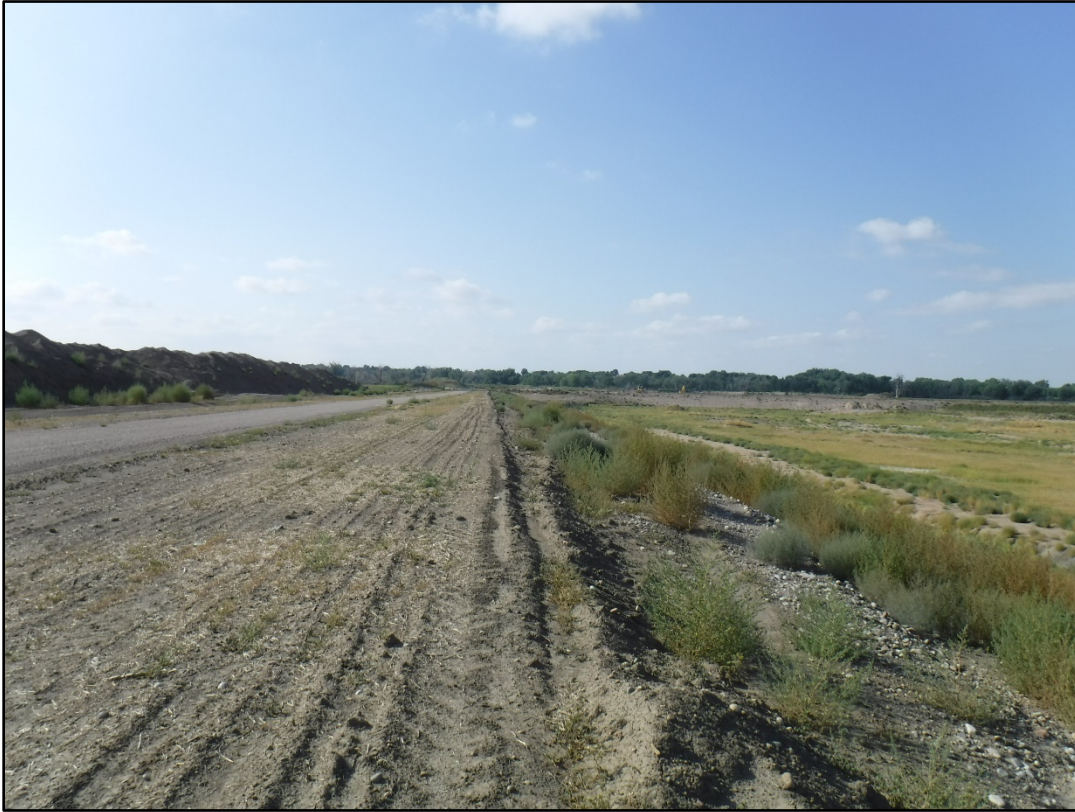
Photo 5: Looking south from near the northeastern corner of pond

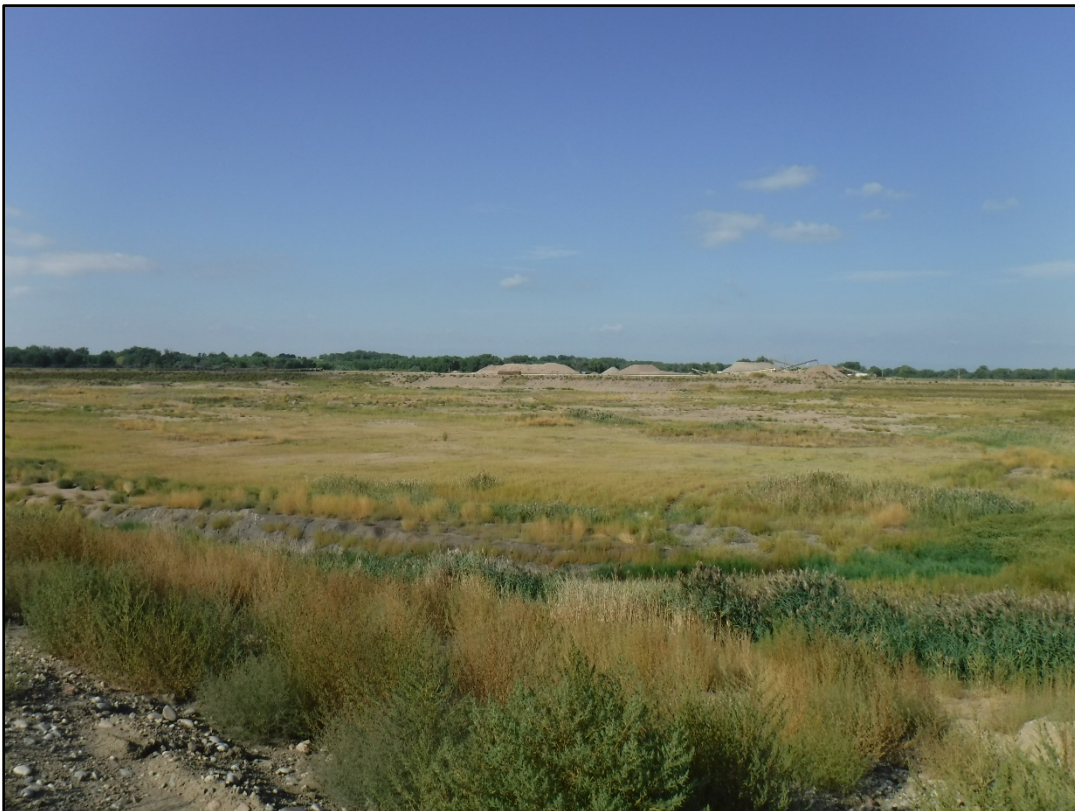
Photo 6: Looking southwest towards the southwestern corner of pond

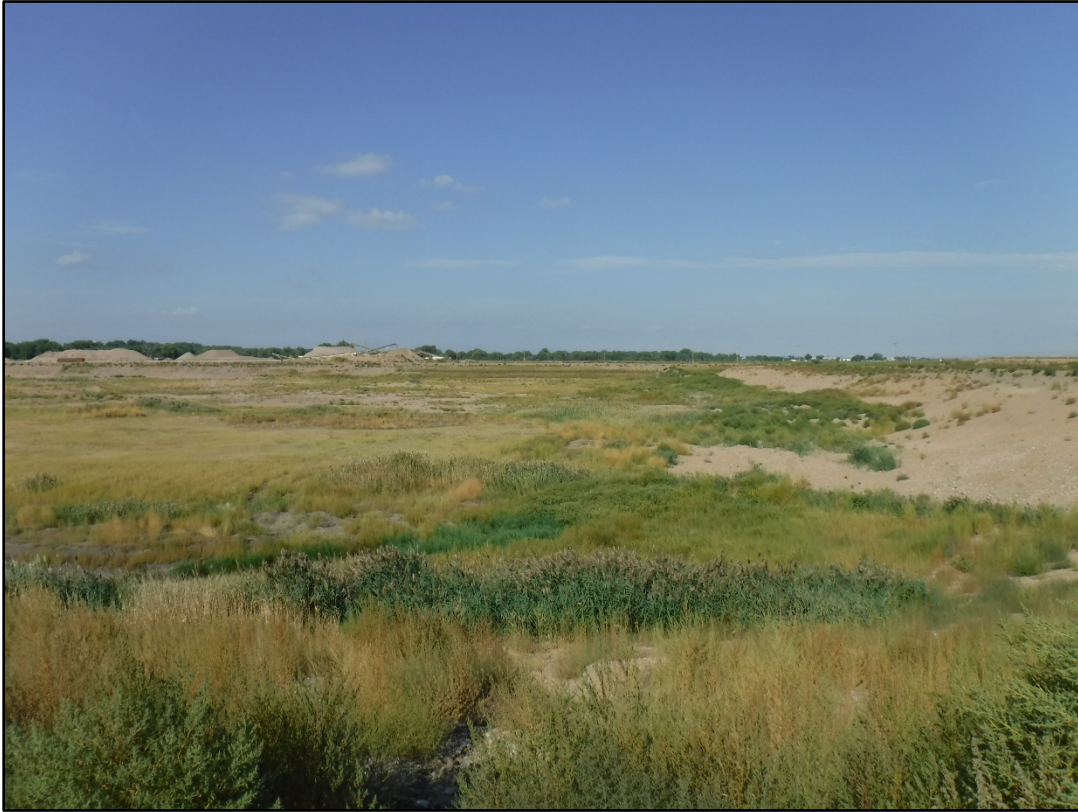
Photo 7: Looking west along the northern boundary of the pond

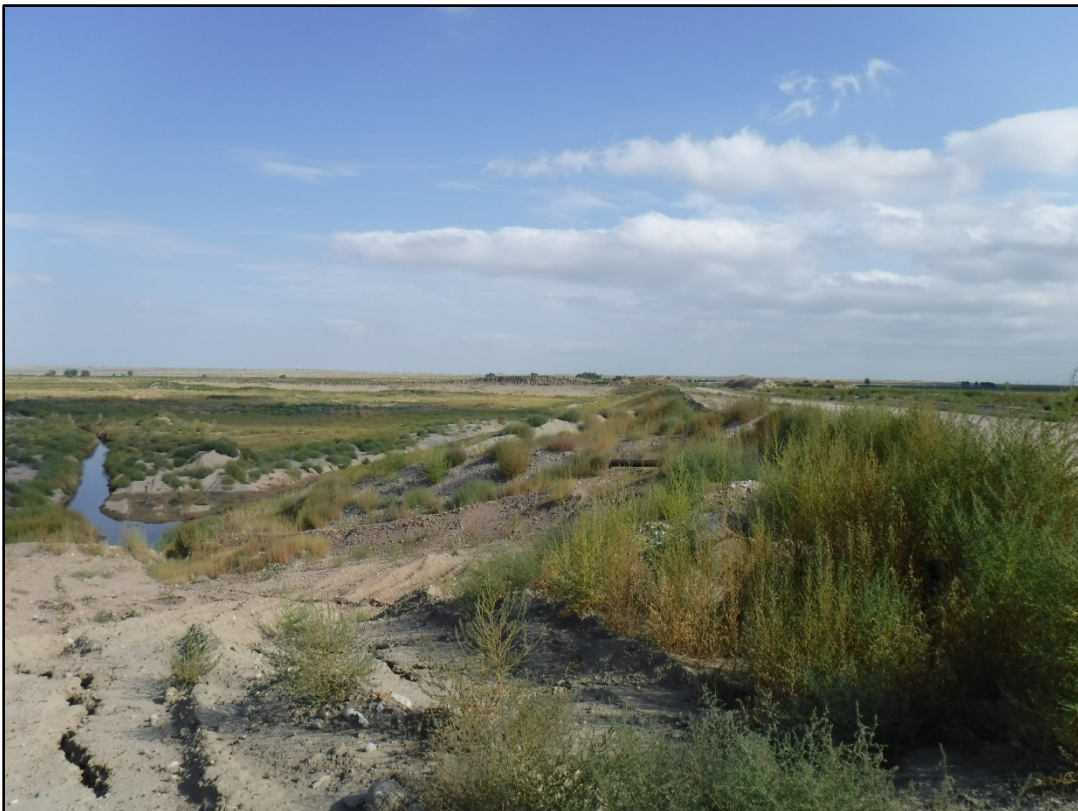
The spillway approved under TR-04 is a critical component of the slurry wall infrastructure, which was designed to safely pass flood waters from a 100-year flood event. Until such time as the spillway is constructed, the slurry wall remains at risk from damage during a flood event. Therefore, the Division is willing to reduce the financial warranty to \$1,318,581, which is 50% of the cost to install the slurry wall. The Operator will need to submit a new TR for approval of the redesigned spillway. When spillway construction is complete the Operator may seek release of an addition 30% or \$791,149 of the bond.

Photo 8: Area of where the spillway is to be constructed, looking north

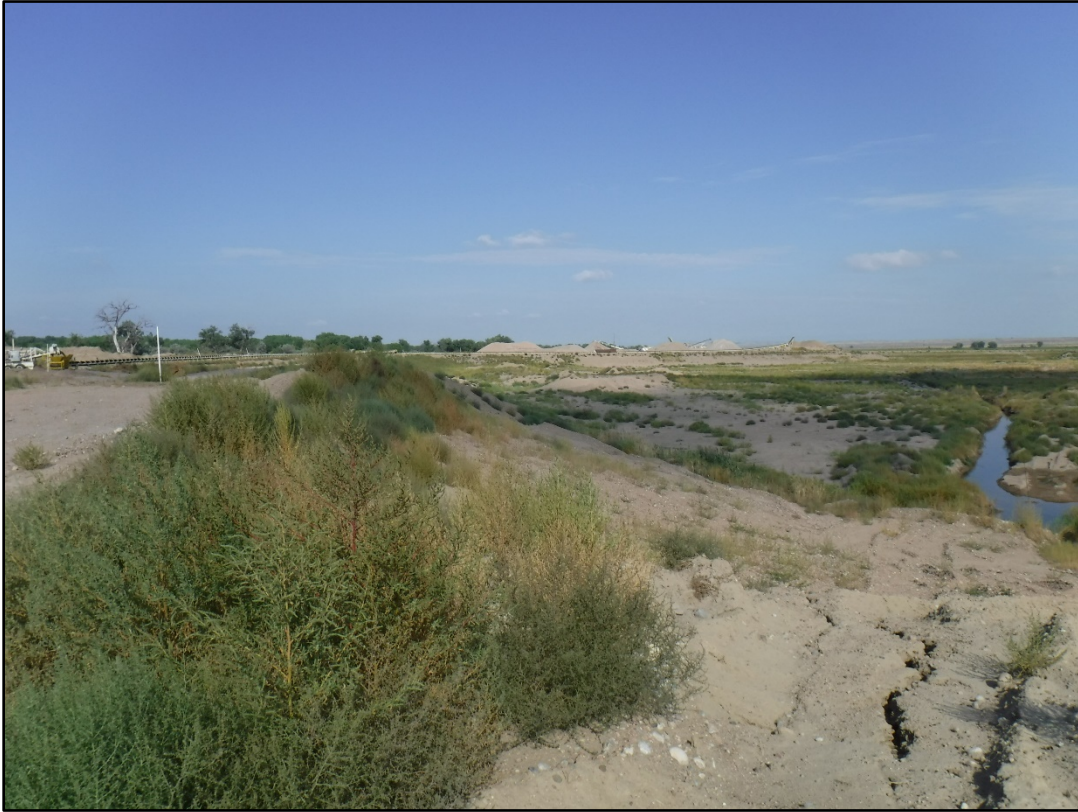
Photo 9: Area near where the spillway is to be constructed, looking west

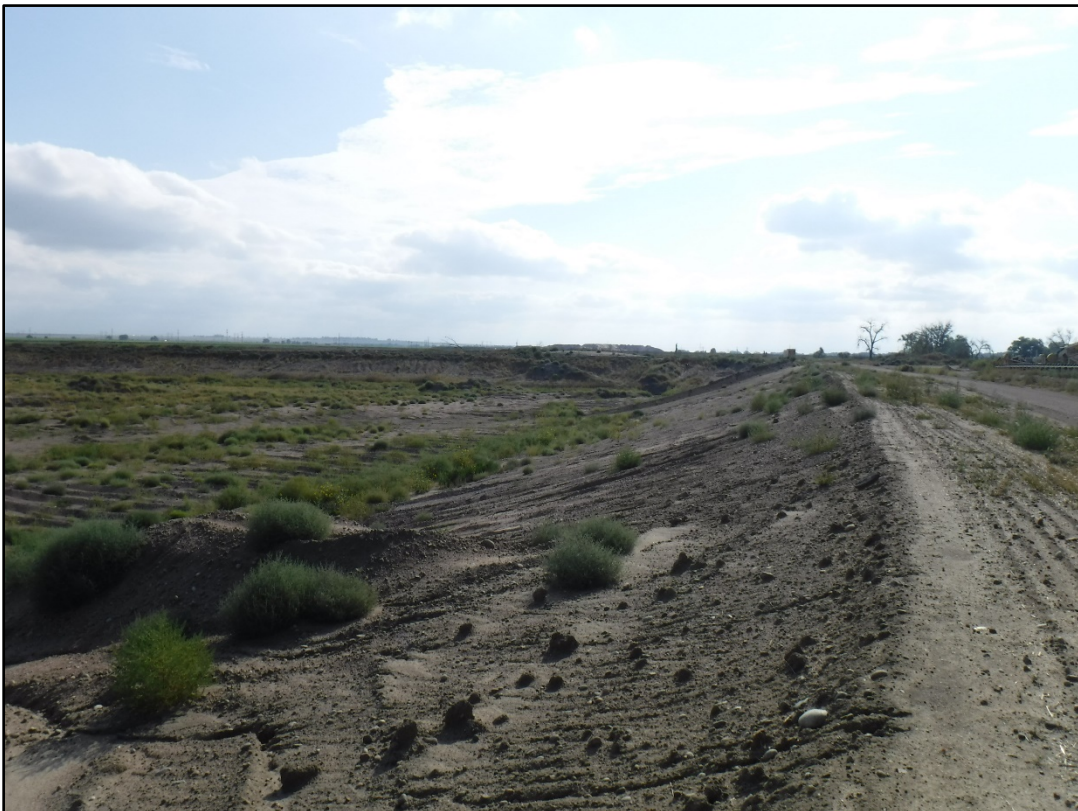
Photo 10: Looking east towards the area for spillway construction
