COLORADO
**Division of Reclamation,
Mining and Safety**
Department of Natural Resources
1313 Sherman Street, Room 215
Denver, CO 80203

RE: Western Slope Flagstone Quarry No. 2, Permit No. M-1996-076, Unresolved Problem Noted in a Past Inspection Report

MINERALS PROGRAM INSPECTION REPORT
PHONE: (303) 866-3567

MINE NAME: Western Slope Flagstone Quarry No. 2	MINE/PROSPECTING ID#: M-1996-076	MINERAL: Gravel	COUNTY: Mesa
INSPECTION TYPE: Monitoring	INSPECTOR(S): Amy C. Yeldell	INSP. DATE: July 9, 2019	INSP. TIME: 18:00
OPERATOR: Rudolph Fontanari	OPERATOR REPRESENTATIVE: None	TYPE OF OPERATION: 112c - Construction Regular Operation	
REASON FOR INSPECTION: High Priority	BOND CALCULATION TYPE: None	BOND AMOUNT: \$88,251.00	
DATE OF COMPLAINT: NA	POST INSP. CONTACTS: None	JOINT INSP. AGENCY: State Engr. (Water Resources)	
WEATHER: Clear	INSPECTOR'S SIGNATURE:

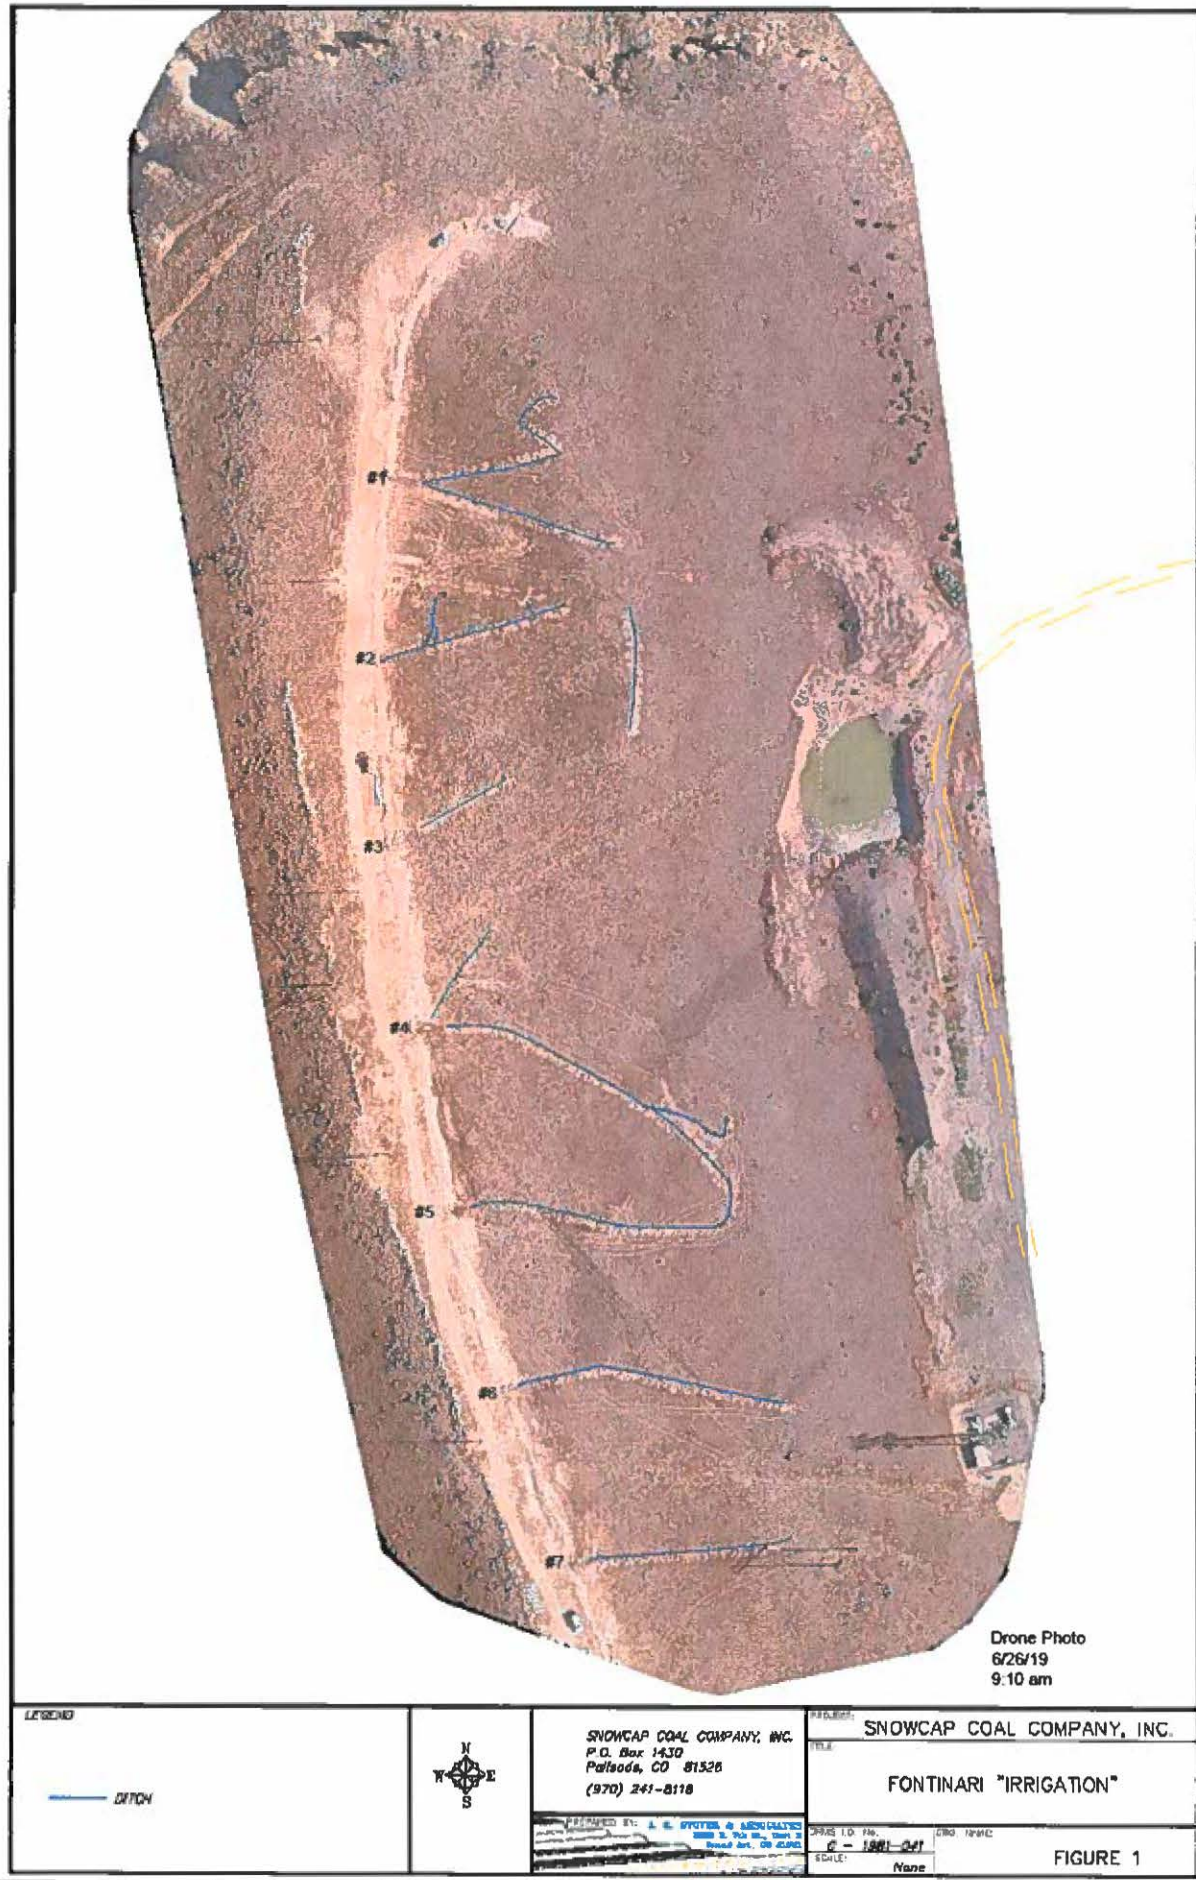
FIGURE 1

As the result of an inspection problem in 2018 the Operator was required to delineate the permit boundary. In areas where topography was unsafe and unsuitable for mining the Operator indicated that the permit boundary would be inset. At the time the Division approved this as a reasonable practice. Upon site inspection the permit boundary marker was placed well within the permit boundary on flat land. This mis-identification of the permit boundary delineates the irrigated areas as being outside of the mine permit boundary which is not the case. The incorrectly delineated permit boundary is cited as an inspection problem. The Operator shall place boundaries on the mine permit boundary, regardless of the mining feasibility. Alternatively the Operator may request an acreage reduction of un-affected lands thus reducing the permit boundary to that which is delineated on the ground and/or suitable for mining. The Operator shall provide photo documentation that boundary markers have been properly placed on the mine permit boundary by the corrective action deadline listed on page two of this report. If the Operator wishes to request an acreage reduction the request must be made prior to the corrective action date, however the problem will not be abated until the revision is approved.

CORRECTIVE ACTIONS: The Operator shall place boundaries on the mine permit boundary, regardless of the mining feasibility. Alternatively the Operator may request an acreage reduction of un-affected lands thus reducing the permit boundary to that which is delineated on the ground and/or suitable for mining. The Operator shall provide photo documentation that boundary markers have been properly placed on the mine permit boundary by the corrective action deadline listed on page two of this report. If the Operator wishes to request an acreage reduction the request must be made prior to the corrective action date, however the problem will not be abated until the revision is approved.
