MINERALS PROGRAM INSPECTION REPORT
PHONE: (303) 866-3567

MINE NAME: Spring Creek Pit	MINE/PROSPECTING ID#: M-1994-097	MINERAL: Sand & Gravel	COUNTY: Montrose
INSPECTION TYPE: Monitoring	INSPECTOR(S): Stephanie J. Mitchell	INSP. DATE: August 27, 2019	INSP. TIME: 10:00
OPERATOR: Old Castle SW Group	OPERATOR REPRESENTATIVE: Jerry Austin	TYPE OF OPERATION: 112c - Construction Regular Operation	
REASON FOR INSPECTION: Normal I&E Program	BOND CALCULATION TYPE: Complete Bond	BOND AMOUNT: \$192,460.00	
DATE OF COMPLAINT: NA	POST INSP. CONTACTS: None	JOINT INSP. AGENCY: None	
WEATHER: Clear	INSPECTOR'S SIGNATURE:

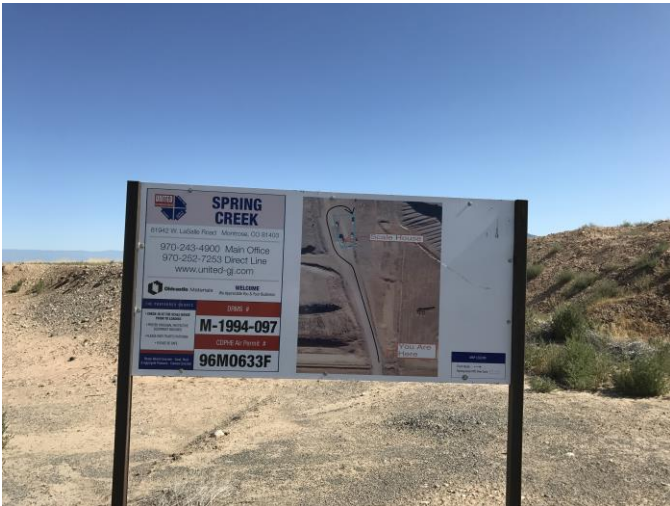
The Spring Creek Pit is located approximately four miles northwest of Montrose and accessed from LaSalle Road. The site is a 112c operation that includes a total of 200.29 permitted acres. The Division currently holds a financial warranty amount of \$192,460.00 for this site. The Division has reviewed the reclamation costs, in order to ensure the financial warranty reflects the actual current cost of fulfilling the requirements of the Reclamation Plan, and determined that the current financial warranty amount is adequate at this time. Adequate mine identification signage was noted at the entrance to the site.

Mine ID Sign

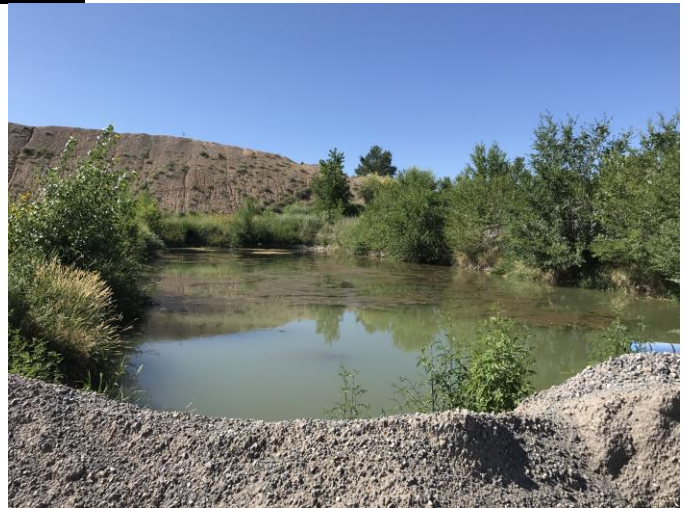
Irrigation Run off Pond

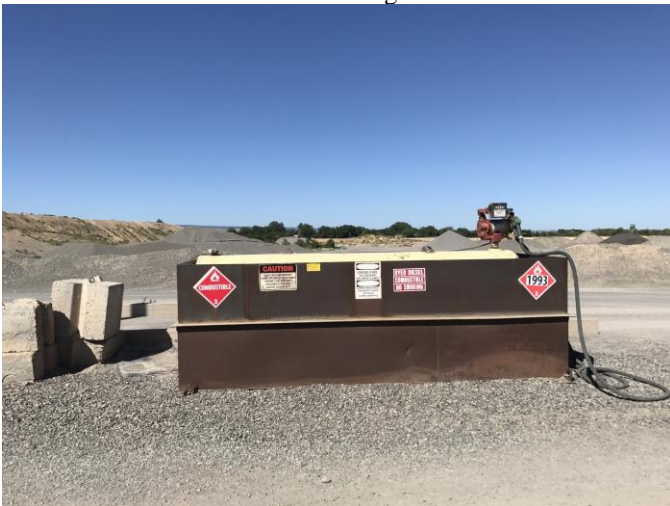
Fuel w Secondary Containment

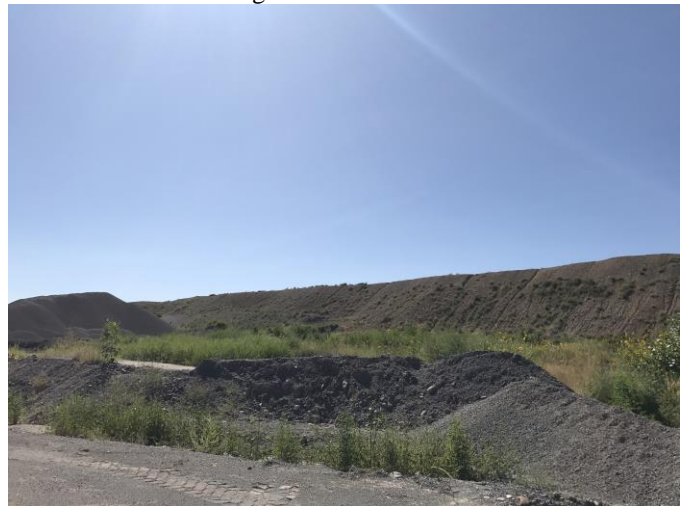
Topsoil

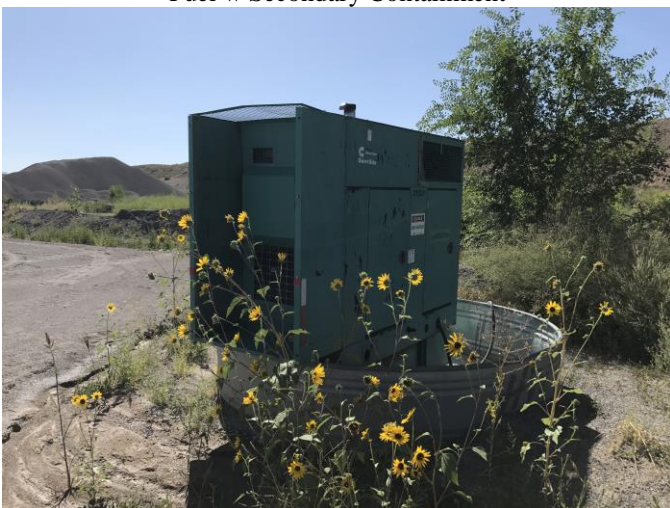
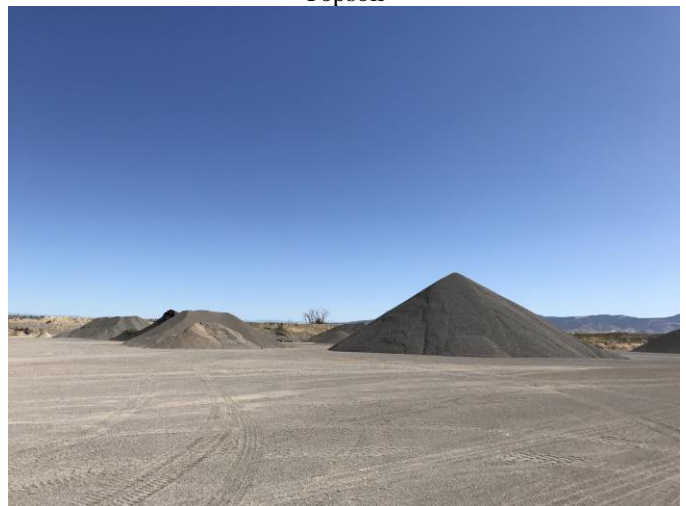
Material Stockpiles

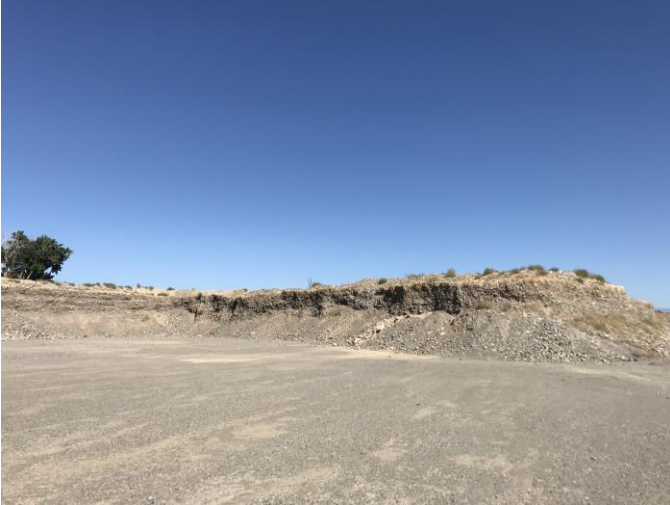
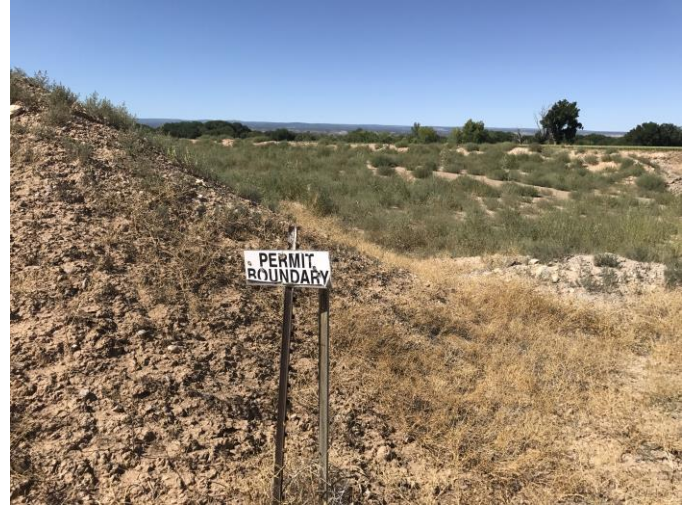
The affected area was marked by fencing and posts that were clearly visible and adequate to delineate the affected area boundary.

Permit NE Marker

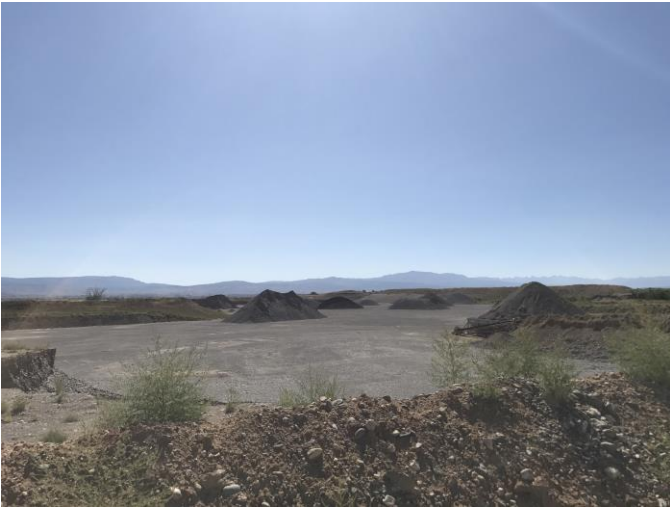
There are approximately sixty-three acres currently disturbed at the site. Mining is moving to the north, Reclamation work is occurring in the west end of the pit with the slopes reduced to 3H:1V or flatter. The pit has been excavated to a depth of approximately twenty feet. The highwall on the south side of the pit has been left at approximately 2H:1V. The remaining highwalls are near vertical with sloughed material piled at the base. Materials stockpiles are located throughout the pit floor. Topsoil is stockpiled around the perimeter of the pit.

Overall Site

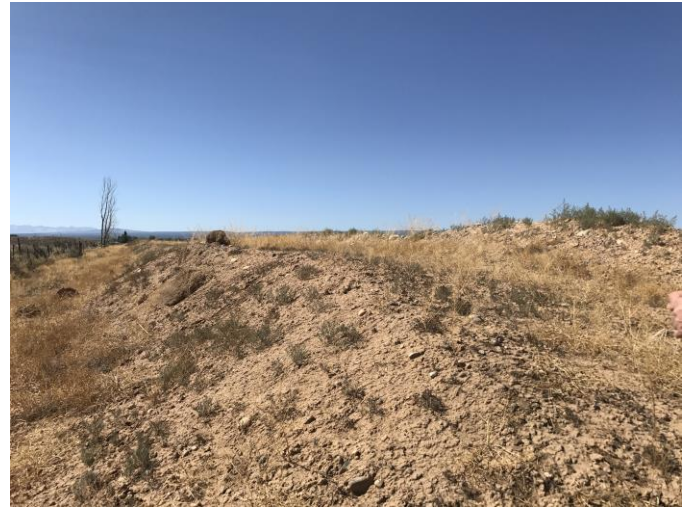
Topsoil
