MINERALS PROGRAM INSPECTION REPORT
PHONE: (303) 866-3567

MINE NAME: Haldorson Sand and Gravel Mine	MINE/PROSPECTING ID#: M-2003-037	MINERAL: Sand and gravel	COUNTY: Montrose
INSPECTION TYPE: Monitoring	INSPECTOR(S): Stephanie J. Mitchell	INSP. DATE: August 27, 2019	INSP. TIME: 12:00
OPERATOR: Oldcastle SW Group, Inc. dba United Compai County	OPERATOR REPRESENTATIVE: Jerry Austin	TYPE OF OPERATION: 112c - Construction Regular Operation	
REASON FOR INSPECTION: Normal I&E Program	BOND CALCULATION TYPE: Complete Bond	BOND AMOUNT: \$306,730.00	
DATE OF COMPLAINT: NA	POST INSP. CONTACTS: None	JOINT INSP. AGENCY: None	
WEATHER: Clear	INSPECTOR'S SIGNATURE:

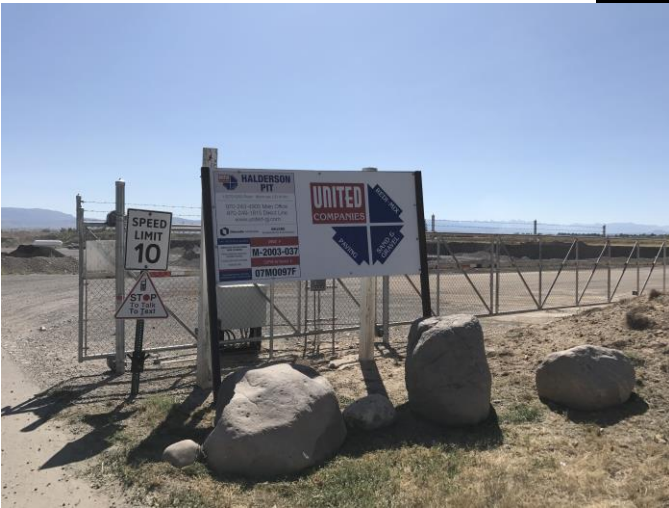
Mine ID Sign

Adequate mine identification signage was noted at the entrance to the site.

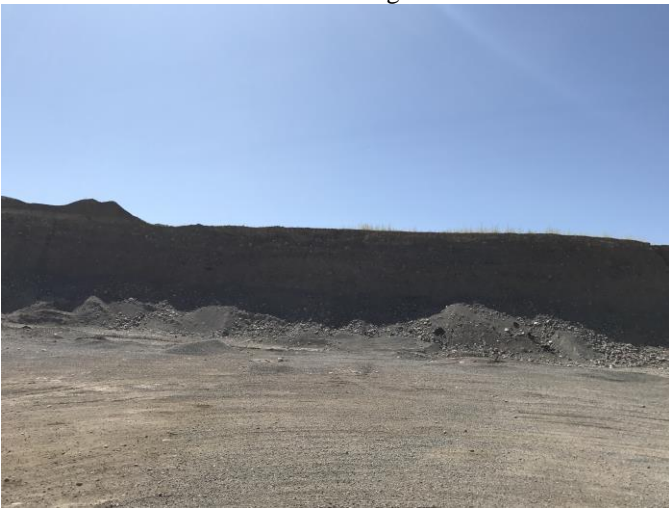
Highwall

The northern part of the pit appears to be lowered to a depth of approximately 50 feet, while the rest of the pit is approximately 20 feet deep. Slopes around the pit range from 1H:1V to 2H:1V. The slopes appear to be stable. Materials stockpiles are located throughout the pit floor.

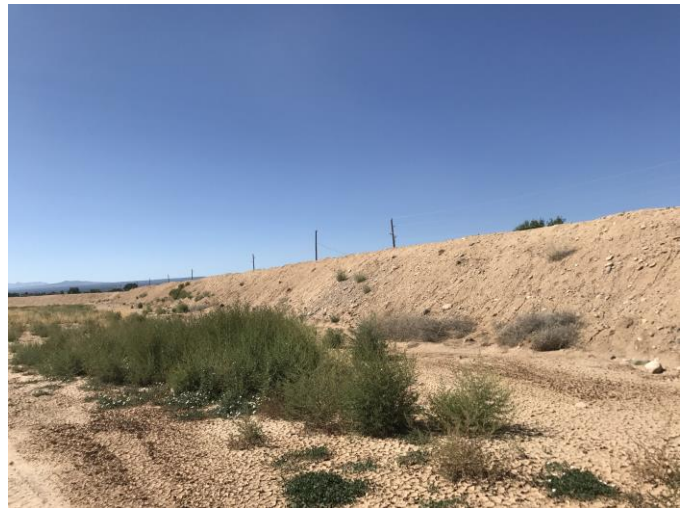
Topsoil is stockpiled in a visual berm around the perimeter of the site on the north and west sides. The topsoil piles are vegetated and appear adequately stabilized.

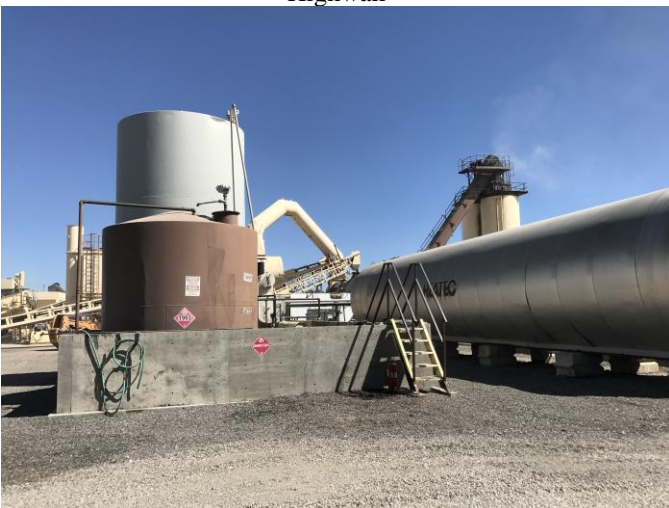
Fuel Storage

The asphalt and concrete plants are still located in the east side of the pit. Fuel stored in these areas is adequately contained. No problems were noted related to these areas.
