## Bureau of Land Management Colorado River Valley Field Office Minerals Inspection Report

General Information	
<b>Date</b>	9/9/2019
<b>Project Name</b>	Rifle Quarry
<b>Operator</b>	Colorado Lien Company
<b>Serial Number</b>	COC-077876
<b>Project Classification</b>	Plan of Operations
<b>Project Location</b>	T4S R92W Sec15, Garfield County
<b>Inspection Purpose</b>	Reclamation site inspection
<b>Time Period Onsite</b>	1 hour
<b>Attendees</b>	Jessica Lopez Pearce, BLM Geologist (report author)
	Stephanie Buckreis, BLM Park Ranger
	Scott Norman, Pete Lien & Sons, Inc. Quarry Superintendent

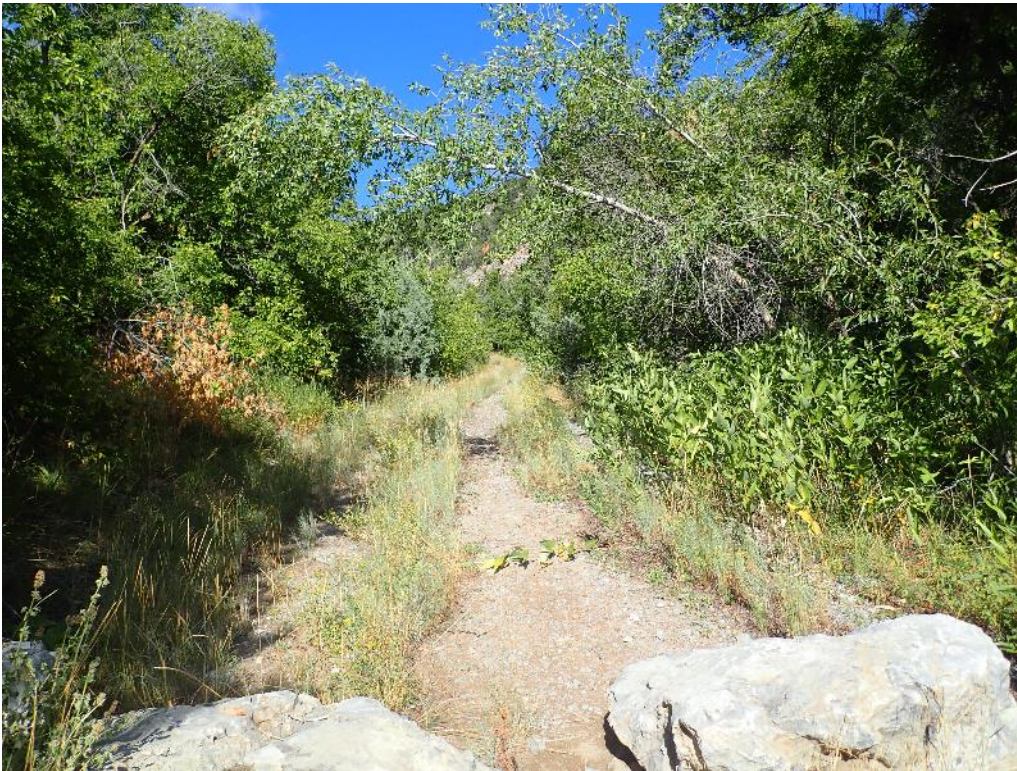
I observed the access road blocked per the Final Reclamation Plan. There was evidence of approved alternative growth media and mulching material (a combination of fish emulsion solids, spent grain solids, spent potato mash solids, mulch, and topsoil) on the surface of the road; however, it had washed away in some areas, exposing crushed rock. There was significantly more vegetation along the sides and down the middle of the old road than in the wheel ruts.

Photo 1: Grasses and forbs were observed growing in the middle and along the sides of the access road, but there was very little vegetation success within the wheel ruts.

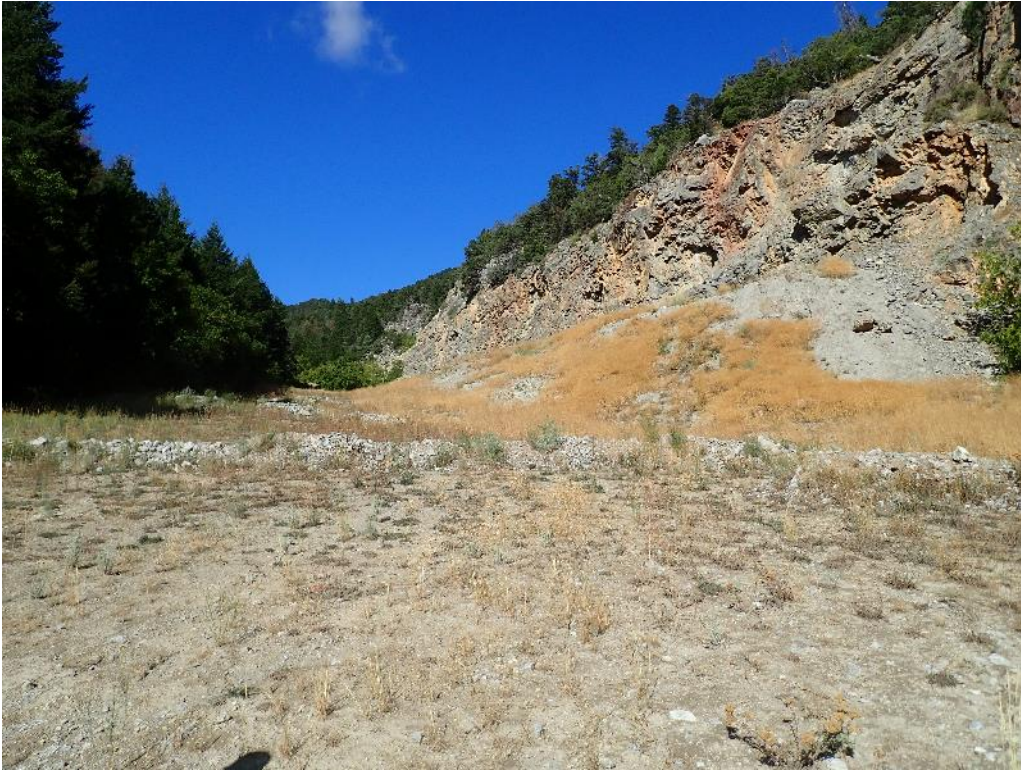
Photo 2: Looking west to the quarry floor. Dried and brown London rocket, an annual mustard, is abundant on the south-facing slope.

- BLM requires Pete Lien and Sons to perform noxious weed removal within the Rifle Quarry. In order to conduct weed spraying activities on public lands, Pete Lien and Sons will need to submit a Pesticide Use Proposal to the CRVFO. Please contact Kristy Wallner, CRVFO Weeds Coordinator, at 970-876-9023 or [kwallner@blm.gov](mailto:kwallner@blm.gov) to learn the process of submitting and receiving approval for your PUP. Processing time for a PUP may take approximately 60 days. Alternatively, Pete Lien and Sons may consider manual removal of the noxious weeds as this would not require a PUP and at this point there were no large infestations. Within 30 days of receipt of this report, Pete Lien and Sons must either initiate the PUP process or conduct manual weed removal.

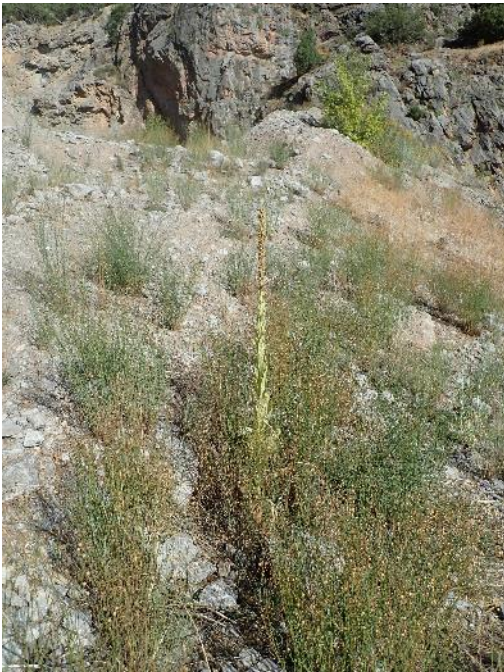
Photo 3: Mullein was observed growing on the far eastern side and within the quarry.

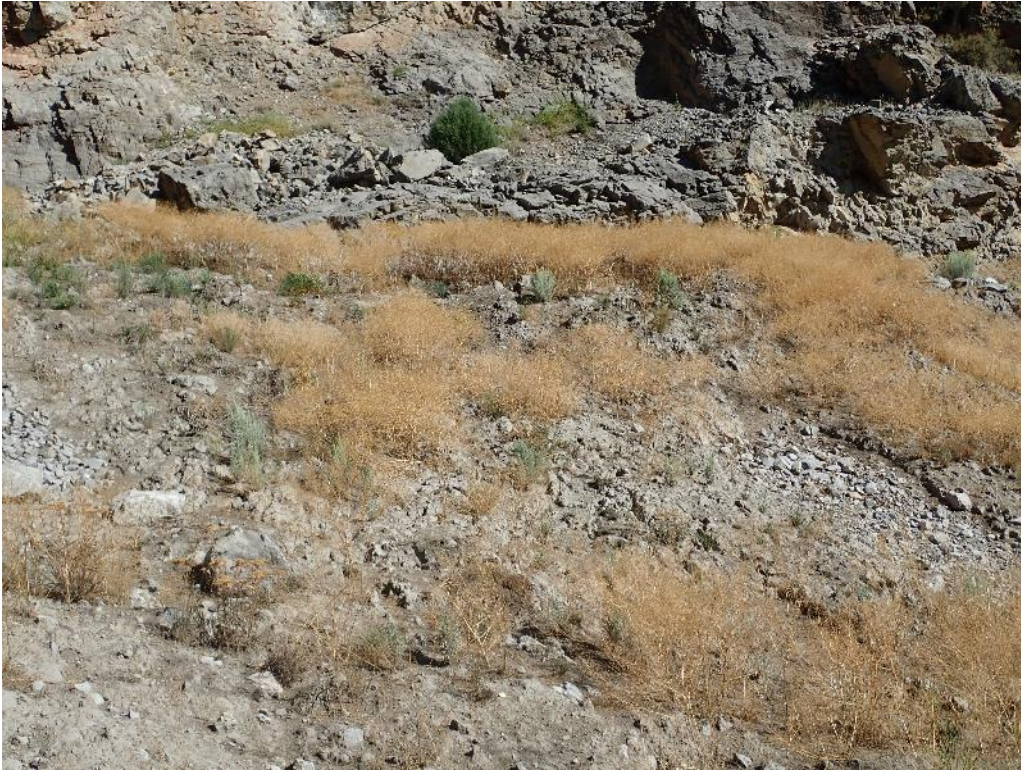
Photo 4: Looking north to the revegetation on the upper bench slope. Some sage was growing in this area.

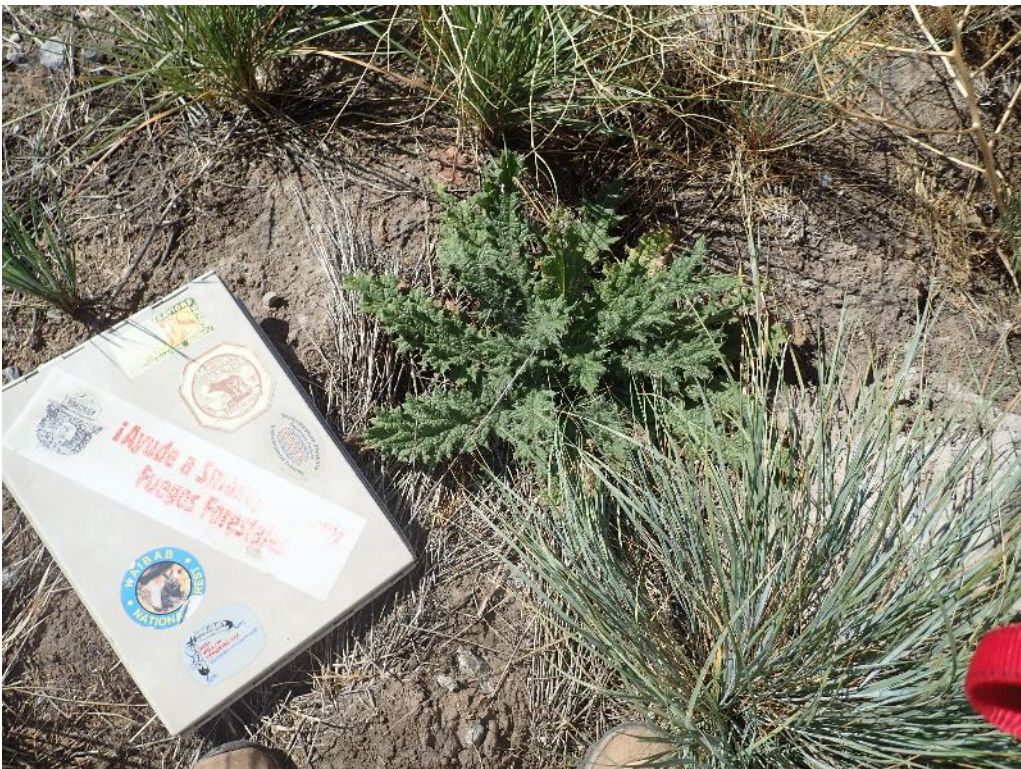
Photo 5. Bull thistle was observed on the upper bench of the reclaimed quarry. Clipboard for scale.

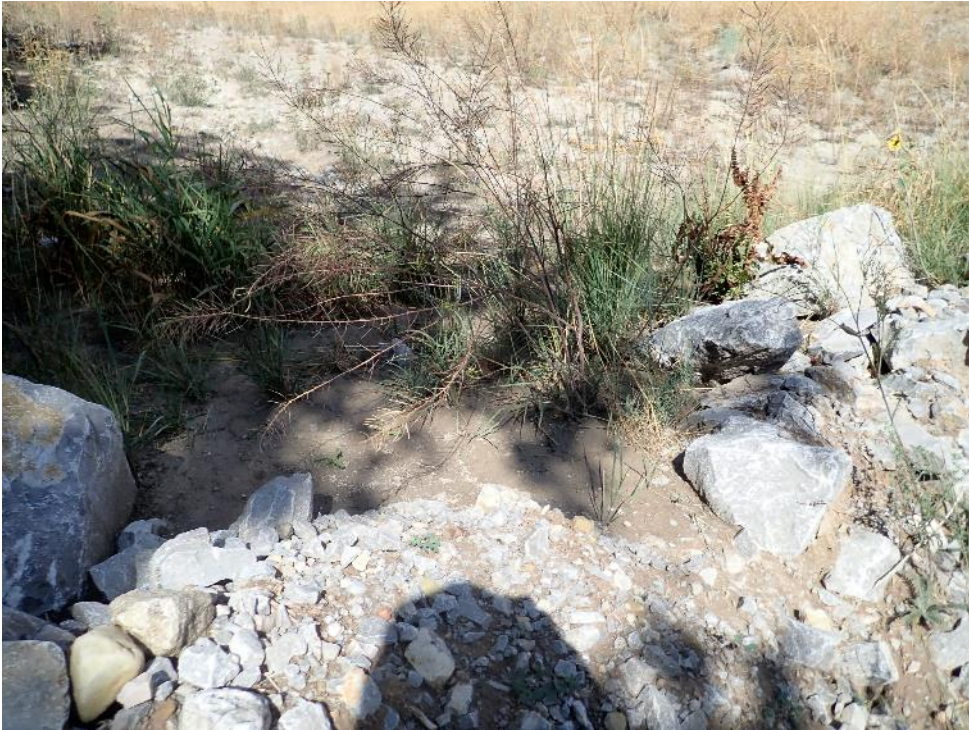
erosion will occur if measures are not taken. The westernmost sediment berm had become overtopped, as sediment had built up to the top of the berm on the up-gradient side. The operator must ensure adequate sediment control within the site. Future inspections will continue to monitor effectiveness of sediment control.

Photo 6. Looking northwest to the westernmost stormwater berm. Sediment is accumulating upstream from the berm, causing it to overtop with sediment and stormwater. This berm is in need of maintenance.

- Within 30 days of receipt, Pete Lien and Sons must take steps to prevent erosion and ensure adequate sediment control and soil stability within Rifle Quarry.

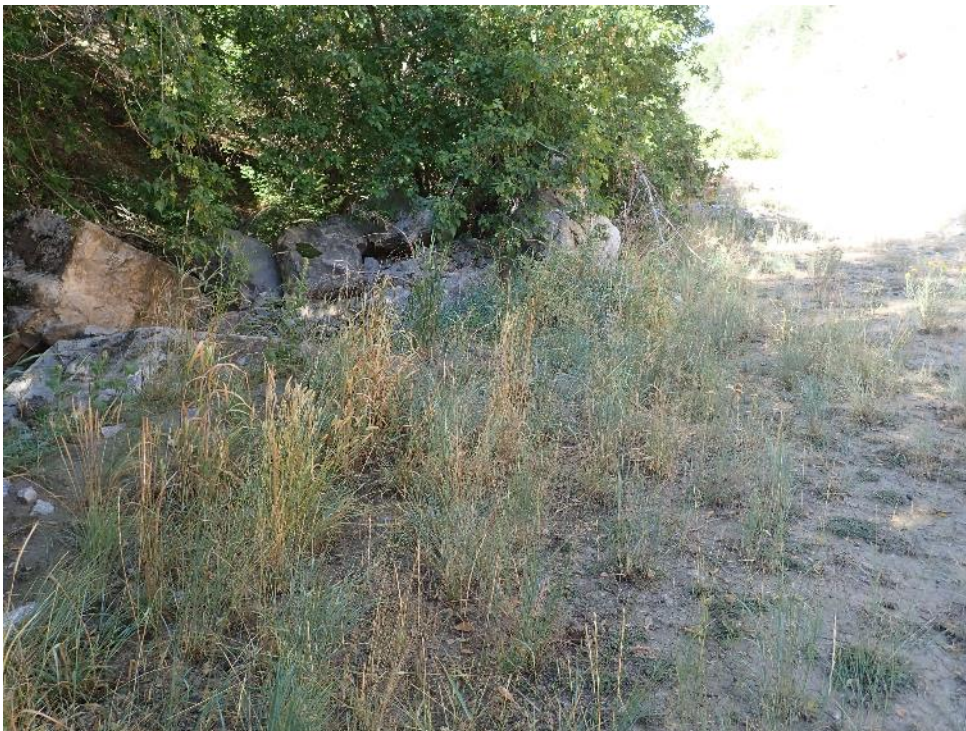
Photo 7: Grasses were growing well in the shade on the southern side of the quarry floor.

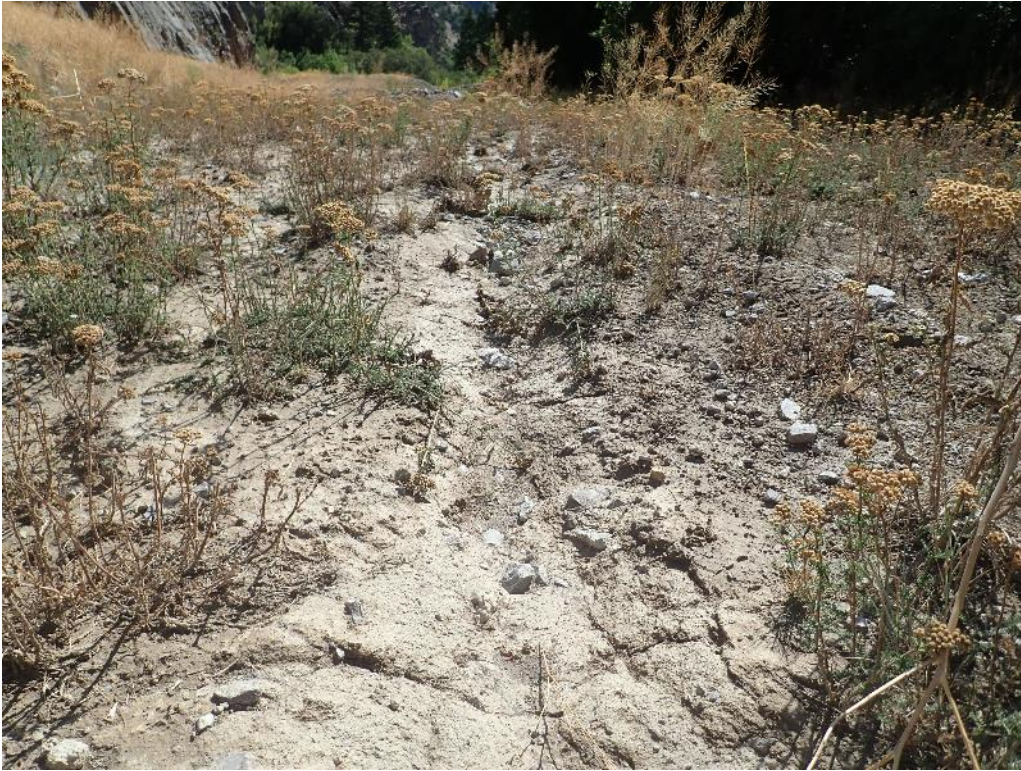
There were several 24" tall sediment control windrows running perpendicular to the west-to-east gradient on the quarry floor. These windrows were effective at trapping sediment and eroded growth media. The vegetation on the quarry floor also appeared to prevent erosion. There was evidence of gullying and erosion of material in channels on the quarry floor. The channelization and erosion wasn't extensive, but additional

Photo 6: Looking east from the western end of the quarry floor. Gullying and erosion are worsening on this end of the site.
