MINERALS PROGRAM INSPECTION REPORT

MINE NAME: Bates-Hunter Mine	MINE/PROSPECTING ID#: M-1990-041	MINERAL: Gold	COUNTY: Gilpin
INSPECTION TYPE: Monitoring	INSPECTOR(S): Jared L. Ebert	INSP. DATE: September 12, 2019	INSP. TIME: 08:53
OPERATOR: Central City Consolidated Mng	OPERATOR REPRESENTATIVE: Matt Collins, Matt Mason, Mike Meter	TYPE OF OPERATION: 110(2) - Hard Rock Limited Impact

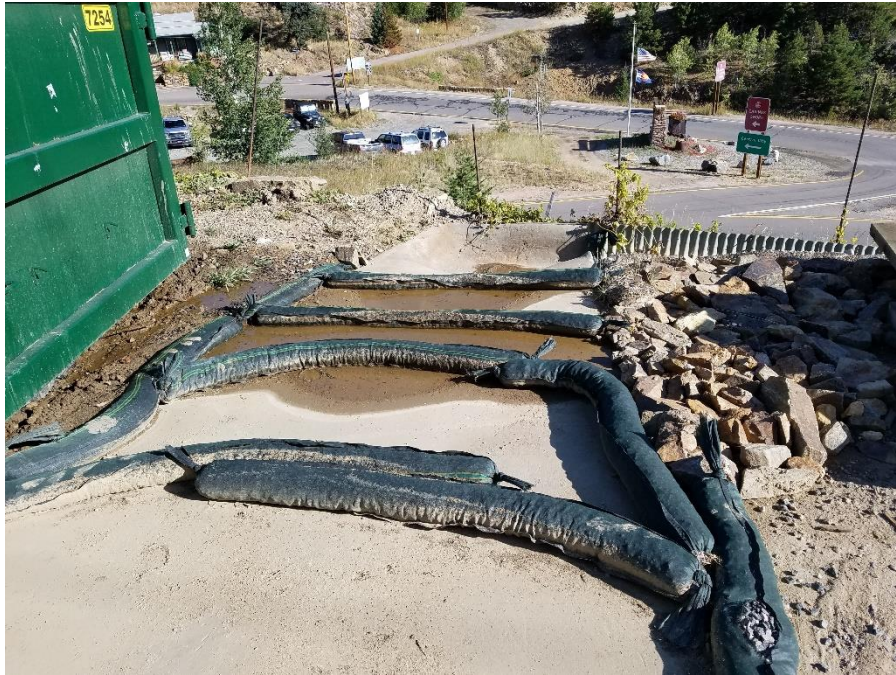
The Operator's Colorado Discharge Permit Outfall 002 reports to Outfall 003. Outfall 002 consists of a concrete basin with stone waddles in place creating several small catch basins. Outfall 002 discharges to an open corrugated metal channel that flows into small stone catch basins. Neither Outfall 002 nor 003 was discharging at the time of the inspection. The BMP's in place at these outfalls were in good repair and appeared functional. Water pumped from the mine is treated and discharged at Outfall 001.

Figure 1. Outfall 002

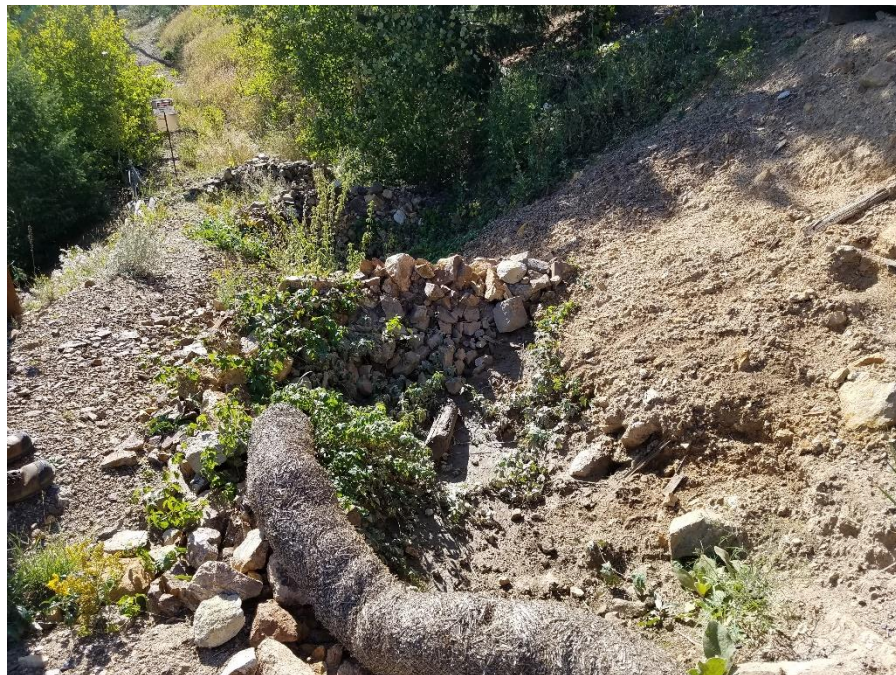
Figure 2. Catch basins above Outfall 003

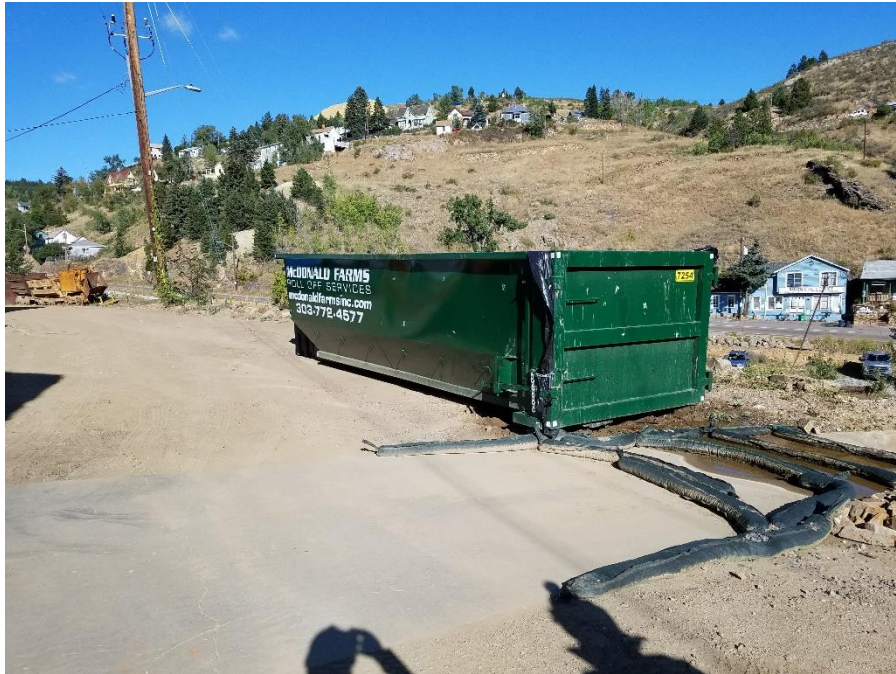
The sludge from the water treatment plant was placed in a large metal waste repository prepared for off-site transport.

Figure 3. Water treatment sludge disposal container.

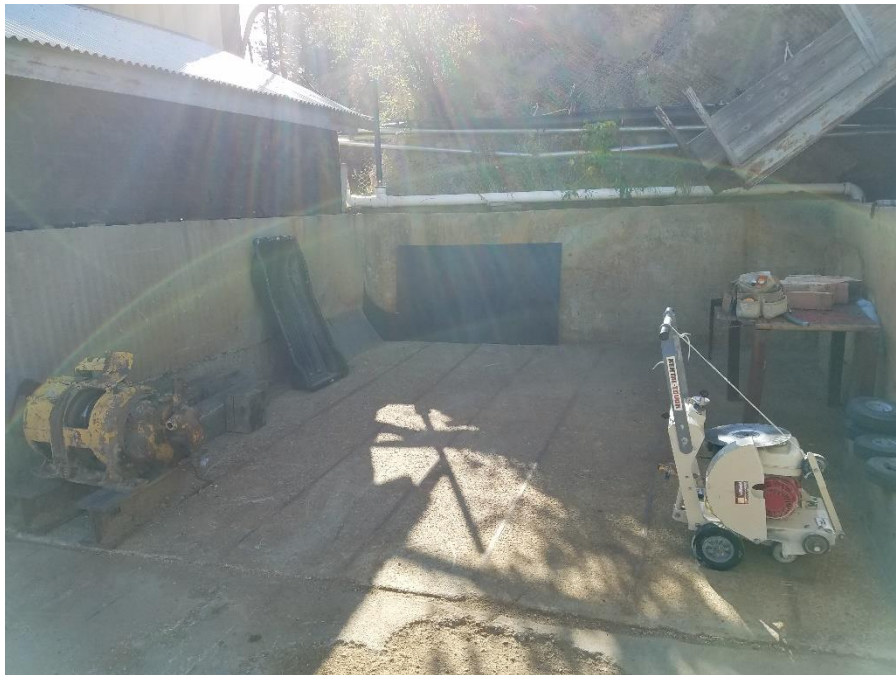
The ore bin was empty at the time of the inspection. According to Mr. Mason, they will be building an enclosed ore bin to shelter the ore from precipitation. Equipment and material were staged at the site for the construction of the enclosure.

Figure 4. Ore bin area.

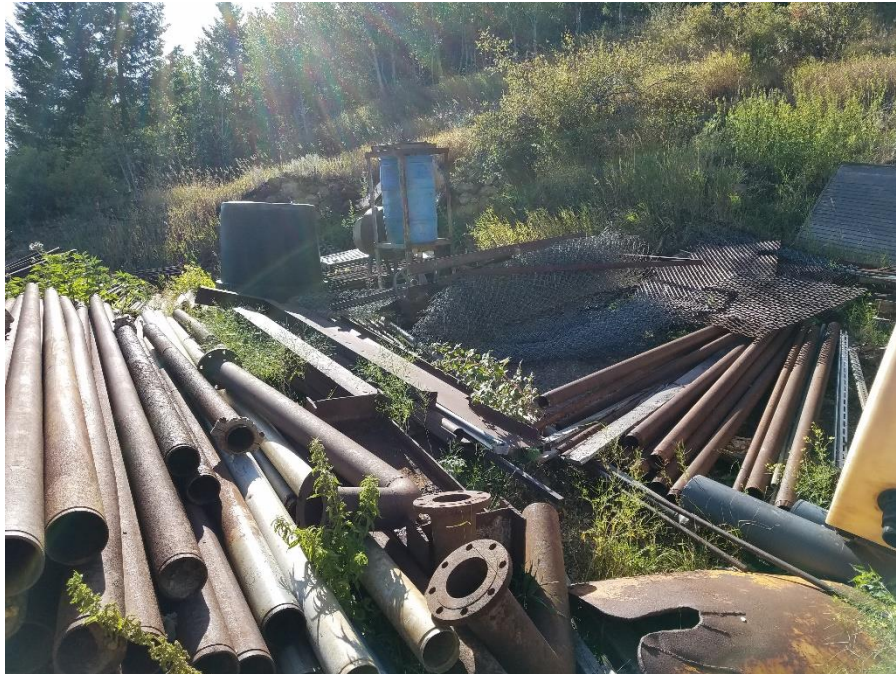
Figure 5. Excess materials storage area located at the south end of the site.

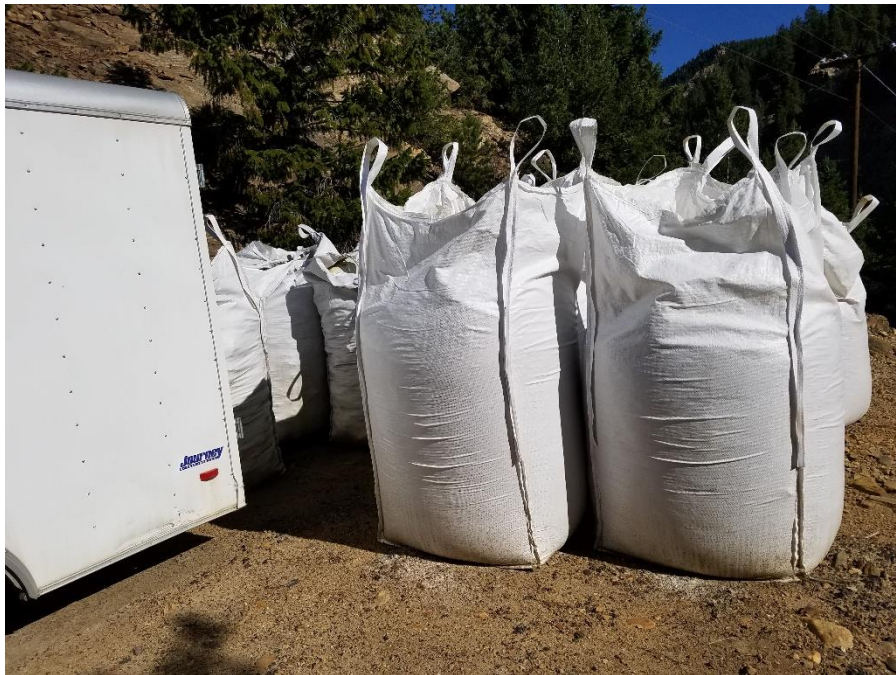
Figure 6. Ore stored on the north side of the Golden Gilpin Mill site.

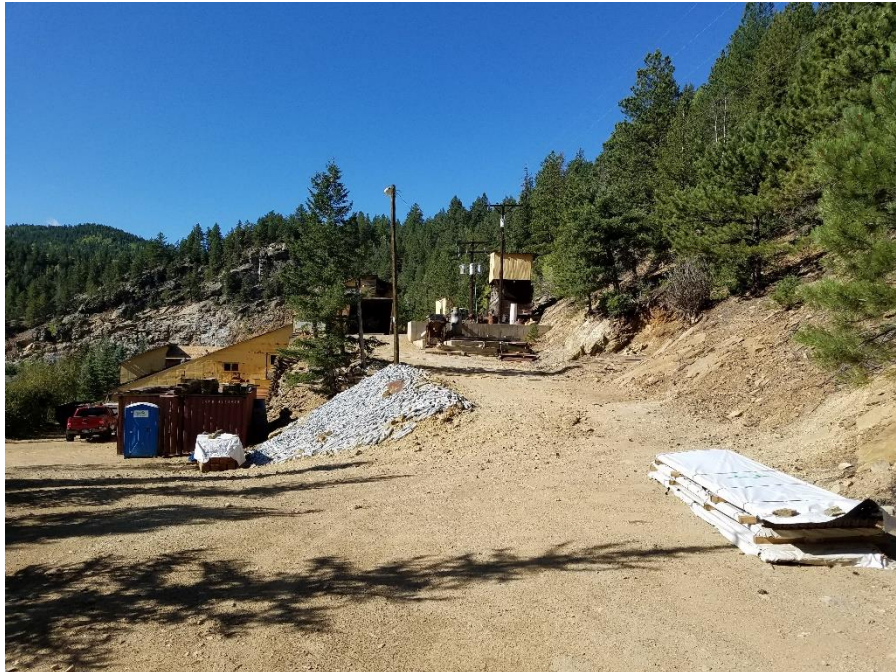
Figure 7. From the north side of the Golden Gilpin Mill site looking south.

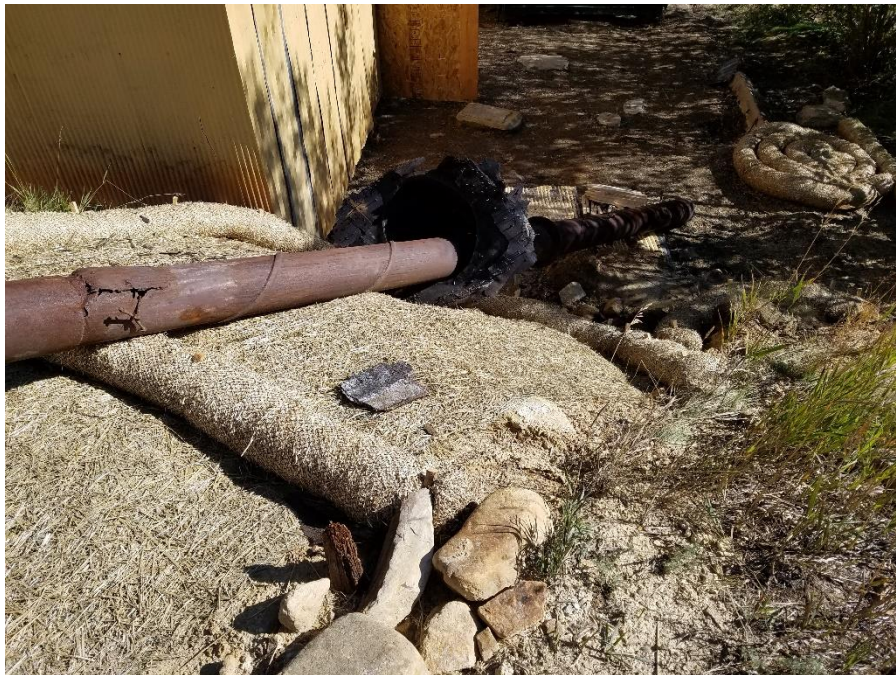
Figure 8. Northeast corner of the former tailing pond area, storm water controls installed where recent earthwork occurred.

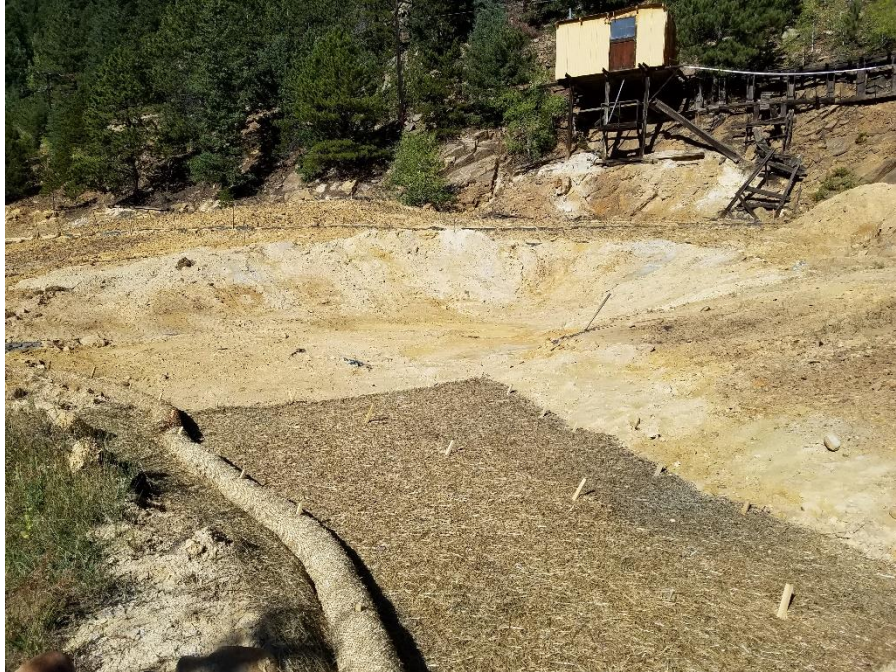
Figure 9. From the northeast corner of the former tailings pond area looking southwest.

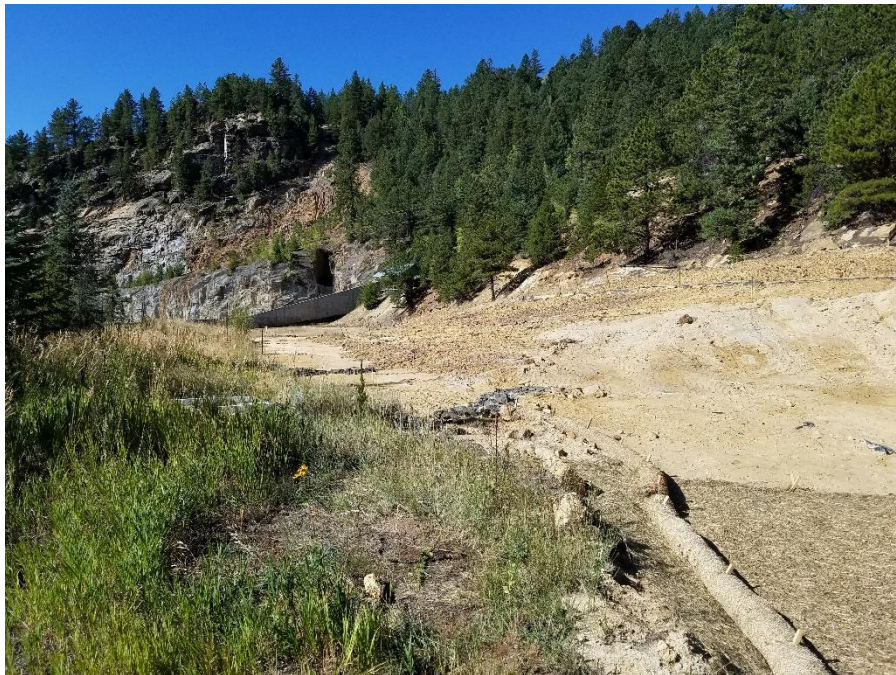
Figure 10. From the northeast corner of the former tailings pond area looking south.

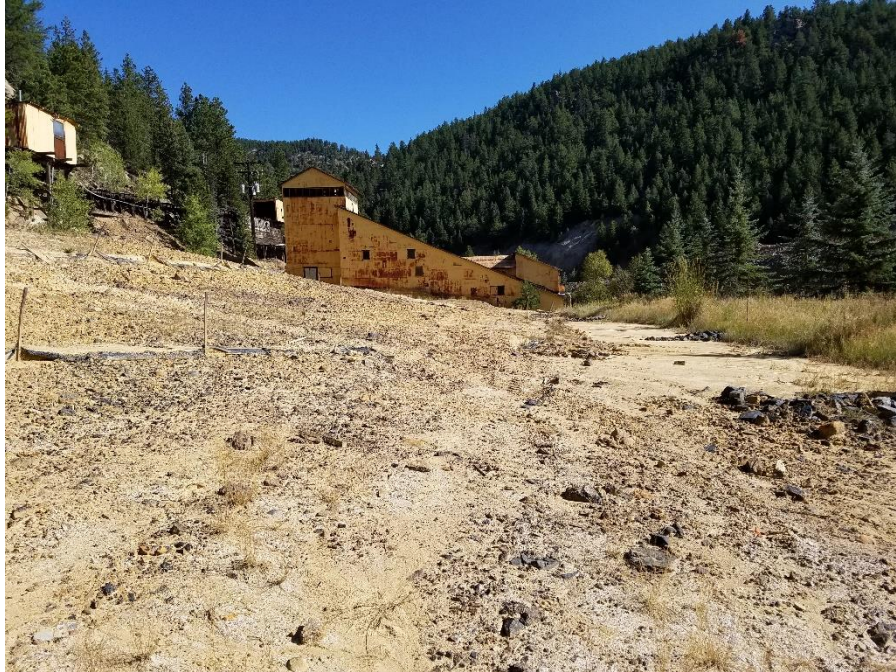
Figure 11. From the south end of the tailings pond area looking north.

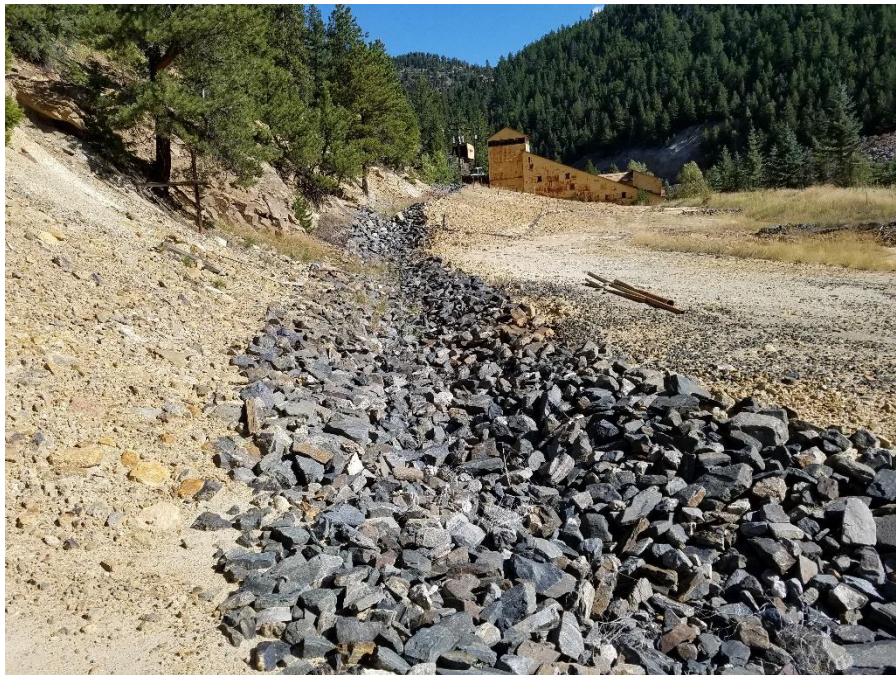
Figure 12. Run-on collection channel from the south end of the former tailings pond area looking north.
