MINERALS PROGRAM INSPECTION REPORT
PHONE: (303) 866-3567

MINE NAME: Western Slope Flagstone Quarry No. 2	MINE/PROSPECTING ID#: M-1996-076	MINERAL: Gravel	COUNTY: Mesa
INSPECTION TYPE: Monitoring	INSPECTOR(S): Amy C. Yeldell Lucas J. West	INSP. DATE: August 8, 2019	INSP. TIME: 08:10
OPERATOR: Rudolph Fontanari	OPERATOR REPRESENTATIVE:	TYPE OF OPERATION: 112c - Construction Regular Operation	
REASON FOR INSPECTION: High Priority	BOND CALCULATION TYPE: Complete	BOND AMOUNT HELD: \$88,251.00	
DATE OF COMPLAINT: NA	POST INSP. CONTACTS: None	JOINT INSP. AGENCY: None	
WEATHER: Clear	INSPECTOR'S SIGNATURE:

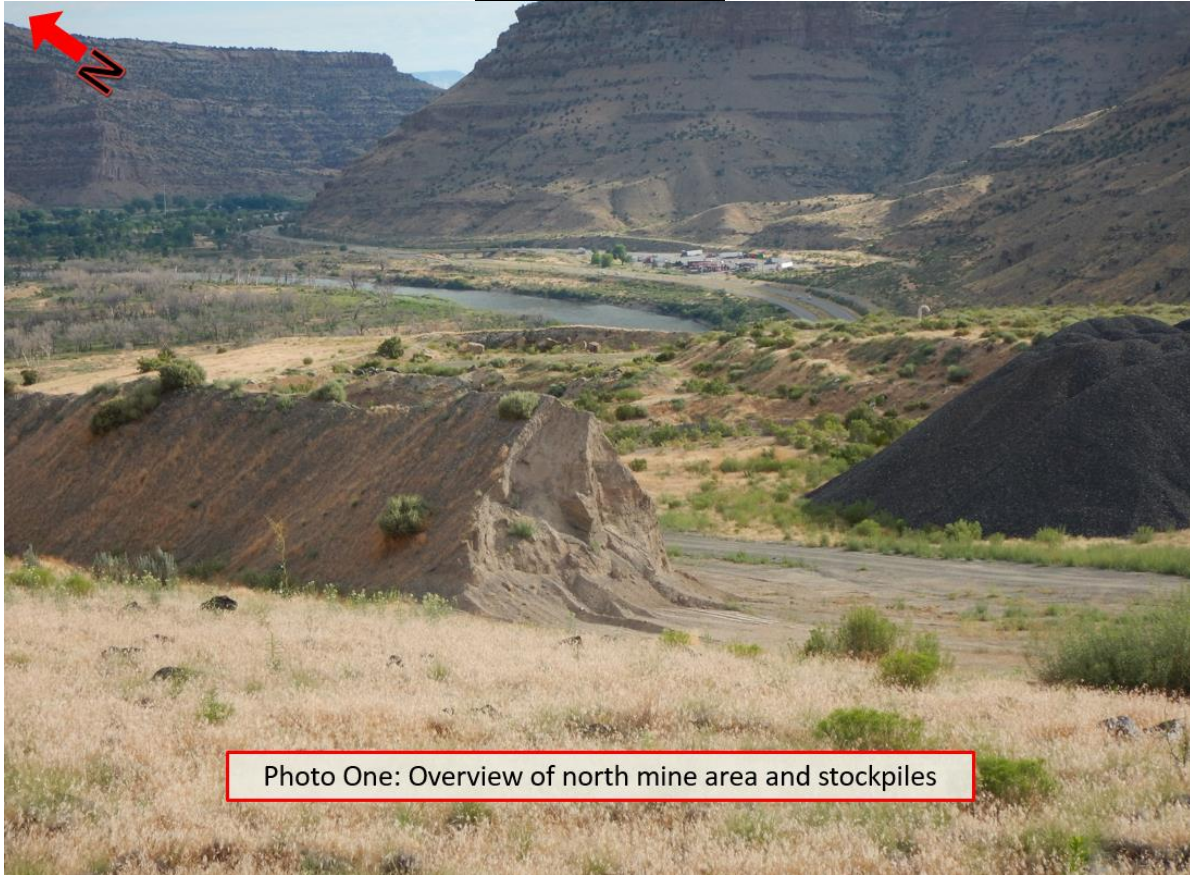
Staff took GPS data of stockpiles (railroad ballast and road base) in the north mine area. The Road base stored on the west side of the haul road is estimated to be 25 feet tall. The railroad ballast stored on the east side of the haul road is estimated to be 30-35 feet tall.

Photo One: Overview of north mine area and stockpiles

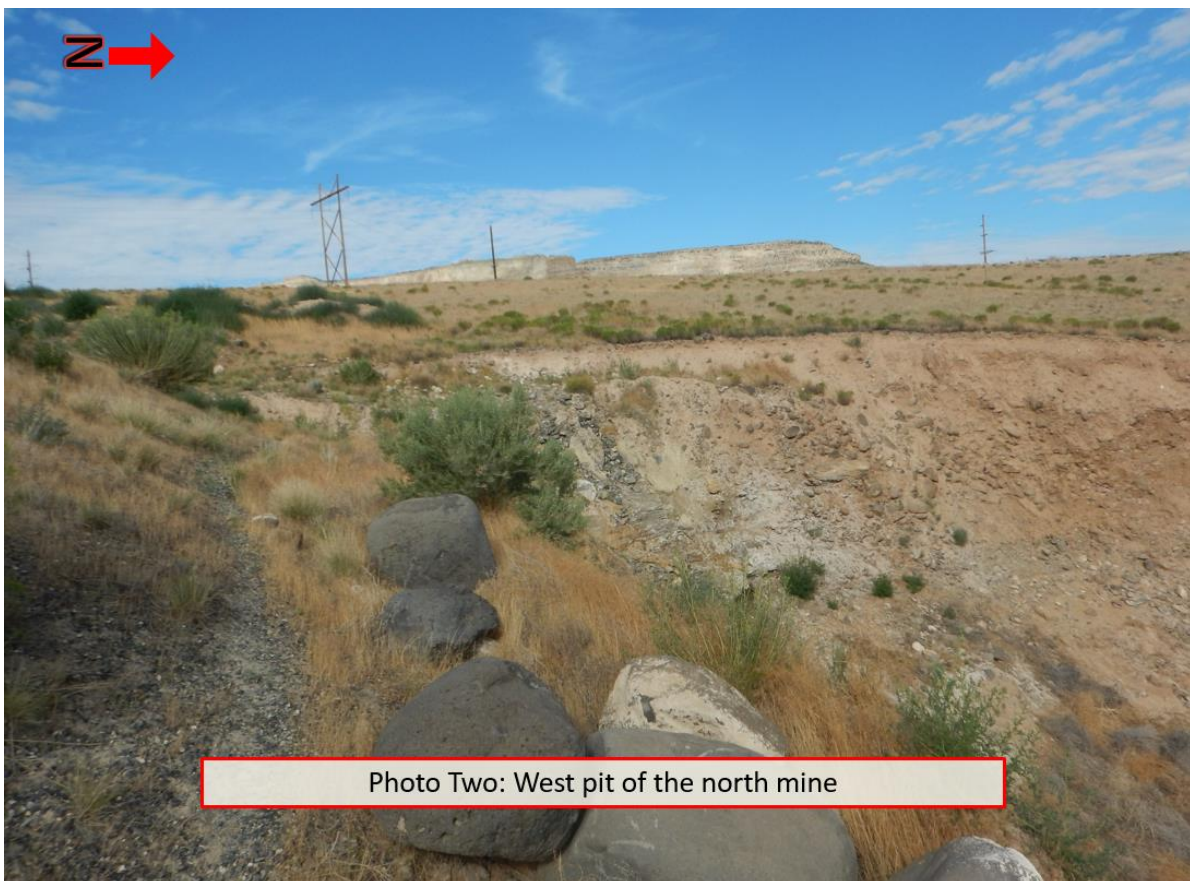
While walking around the stockpiles staff was able to see where water was seeping into the west pit/pond. Unlike previous flows, this water was not a surface flow running down the hillside; it was coming out of the rock layers in the southwest corner of the pit/pond. The pit/pond itself was mostly dry with a small amount of water in the southeast corner.

Photo Two: West pit of the north mine

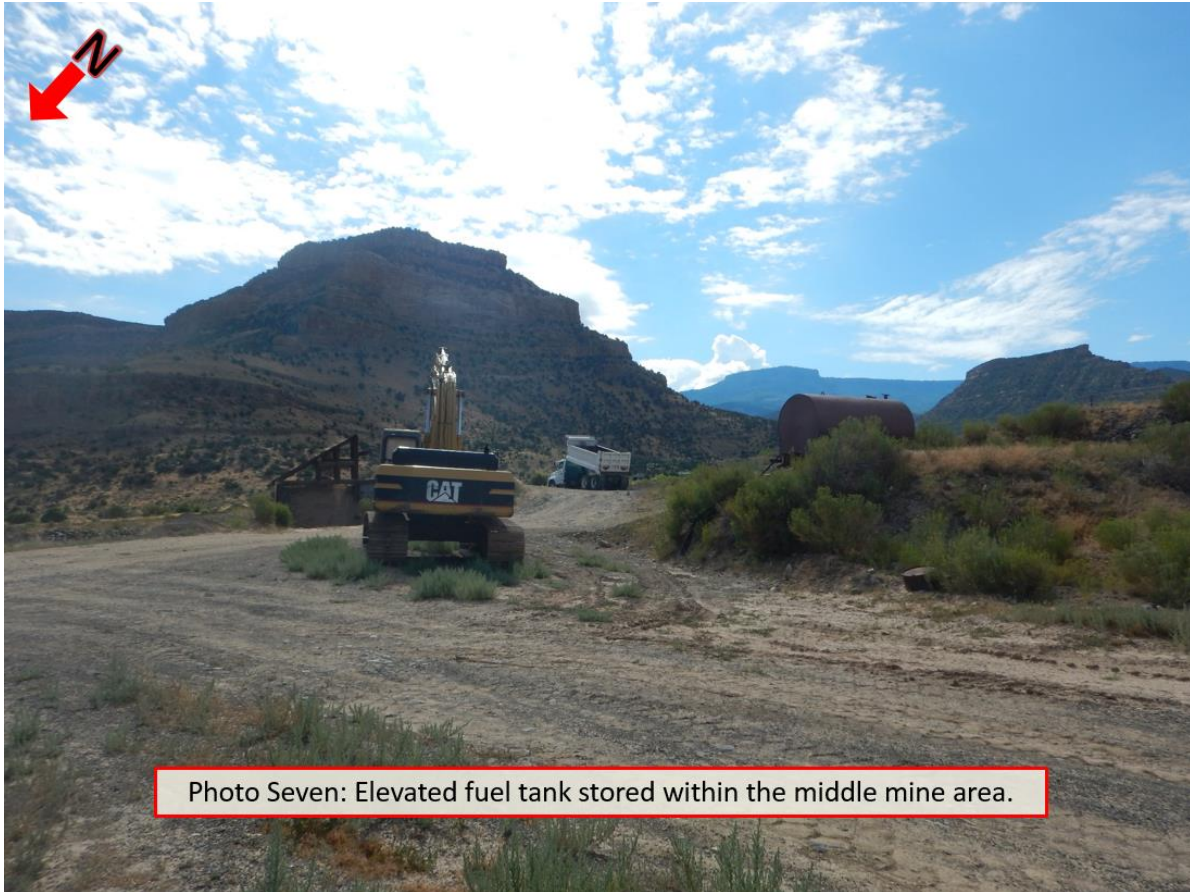
PROBLEM/POSSIBLE VIOLATION: Problem: The current mine plan needs to be updated and clarified pursuant to C.R.S. 34-32.5-112 (1)(c)(VI). The Mine Plan states that fuel will not be stored in the Middle Mine area and that all fuel will be delivered to the site. Currently fuel is being stored in Middle Mine area.

The south pit appears in a similar condition as compared to the inspection the previous year. A small scale and scale house remain on site. There is an elevated fuel tank on site as well as several other fuel type tanks stored on site. In previous inspections it was indicated that the elevated tank was empty and not in use. This tank appears to not be in secondary containment. In reviewing the permit, it explicitly states that fuel will not be stored in the Middle Mine area and that all fuel will be delivered to the site. On site fuel, storage will only

occur when the main operation moves to the North Mine area, all fuel will be stored in a secondary containment. Failure to follow the approved mine plan is cited as an inspection problem. All fuel tanks either need to be removed from site and fuel delivery be utilized or the mine plan needs to be revised in the form of a Technical Revision with the required \$216 revision fee to allow for fuel storage within the middle mine area and any tanks to remain on site to be stored within secondary containment.

Photo Seven: Elevated fuel tank stored within the middle mine area.

CORRECTIVE ACTIONS: 1) the Operator shall provide the Division documentation that all fuel tanks have been removed from site and utilize fuel delivery. OR 2) The Operator shall revised the mine plan in the form of a Technical Revision with the required \$216 revision fee to allow for fuel storage within the middle mine area and any tanks to remain on site to be stored within secondary containment by the corrective action date.

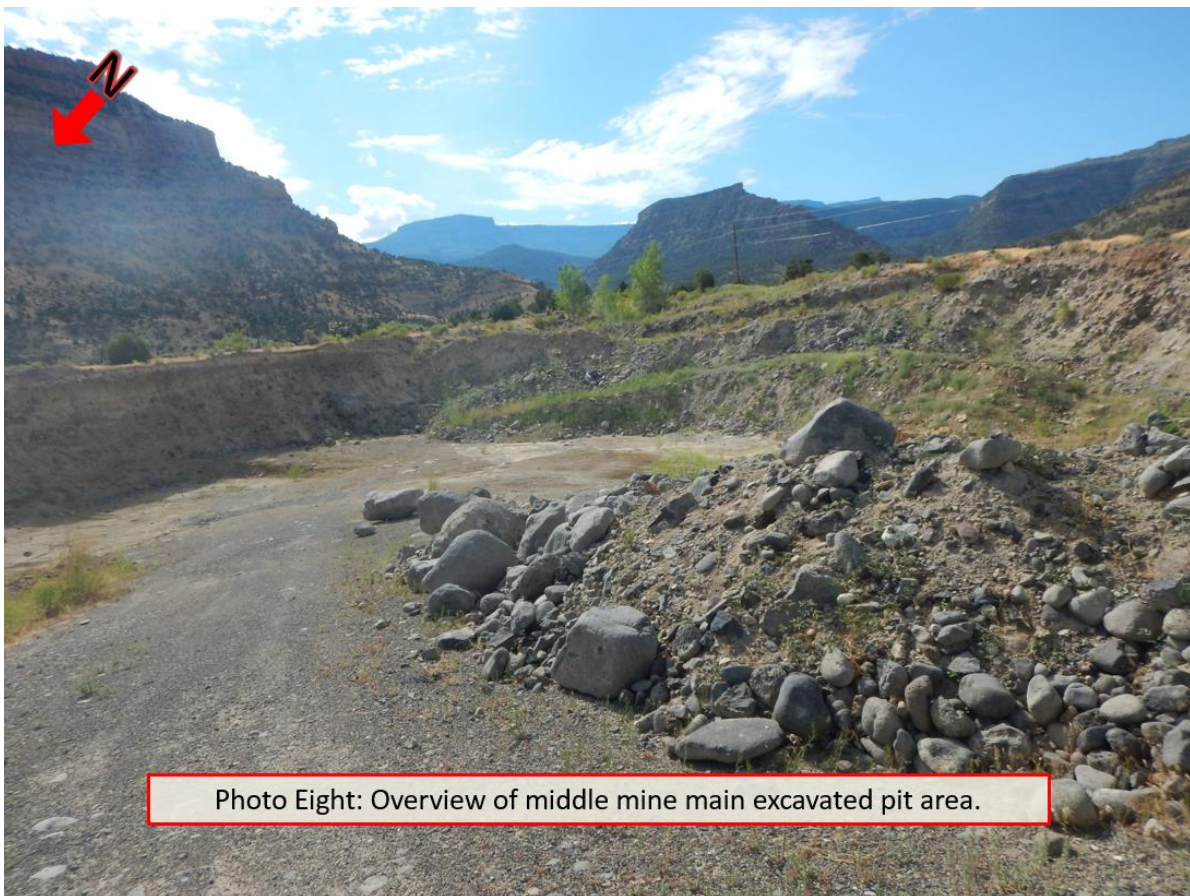
The southeast excavation is estimated to be 100 linear feet wide by 25 feet tall with near vertical slopes. The main southern pit is a bowl shape with an approximately 400 linear foot wide by 25 foot tall near vertical highwall. The overall excavated foot print is estimated to be two acre. A grizzly bar screen is placed atop another depression that is 15 feet high by 50 foot wide. Overburden is placed on the west end of the south pit and estimated to be 40 feet tall by 300 feet long. The flagstone stockpile areas is approximately 4 acres with dozens of 3 foot by 3 foot by 3-foot piles/pallets. In the stockpile area are additional screened boulders of various sizes that were mine from this site. The mine material stockpile takes up approximately 3 acres.

Photo Eight: Overview of middle mine main excavated pit area.

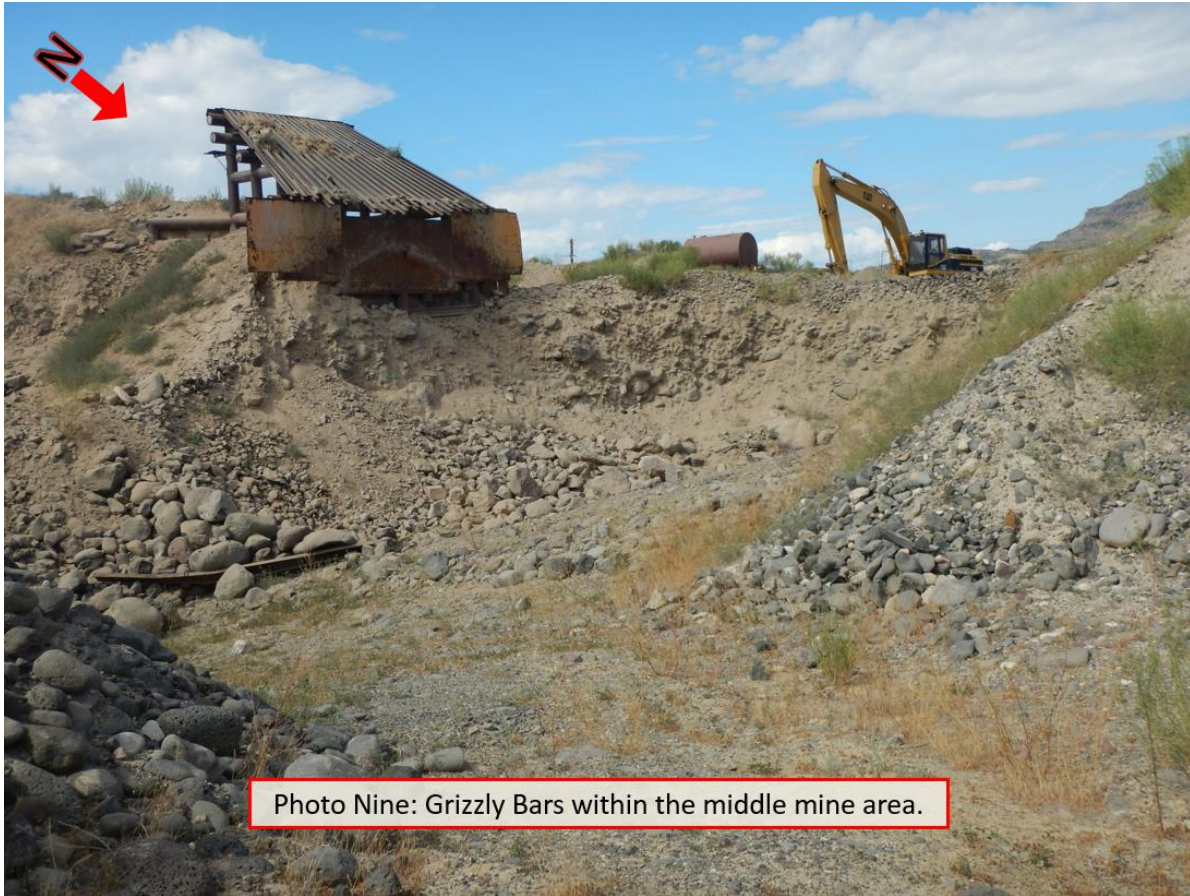
Photo Nine: Grizzly Bars within the middle mine area.
