MINERALS PROGRAM INSPECTION REPORT
PHONE: (303) 866-3567

MINE NAME: Nahcolite Project	MINE/PROSPECTING ID#: M-1983-194	MINERAL: Carbonates	COUNTY: Rio Blanco
INSPECTION TYPE: Monitoring	INSPECTOR(S): Amy C. Yeldell	INSP. DATE: August 13, 2019	INSP. TIME: 10:00
OPERATOR: Natural Soda LLC	OPERATOR REPRESENTATIVE: Kirk Daehling	TYPE OF OPERATION: 112d-3 - Designated Mining Operation	
REASON FOR INSPECTION: Normal I&E Program	BOND CALCULATION TYPE: None	BOND AMOUNT: \$7,521,565.00	
DATE OF COMPLAINT: NA	POST INSP. CONTACTS: None	JOINT INSP. AGENCY: U.S.BLM	
WEATHER: Clear	INSPECTOR'S SIGNATURE:

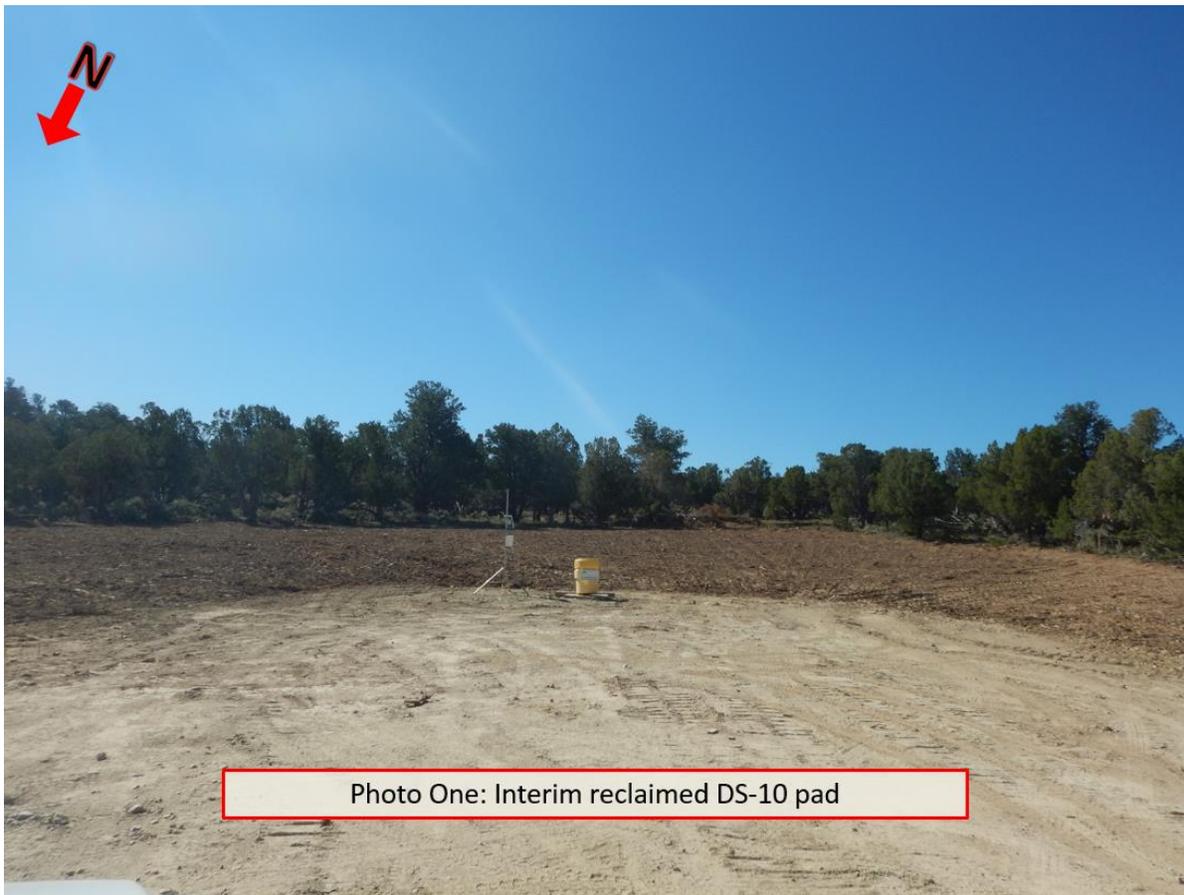
The DS-10 well pad has been interim reclaimed. The outsides of the pad have been graded and topsoil applied. Seeding will occur later this fall. Only a small working footprint around the wellhead remains disturbed.

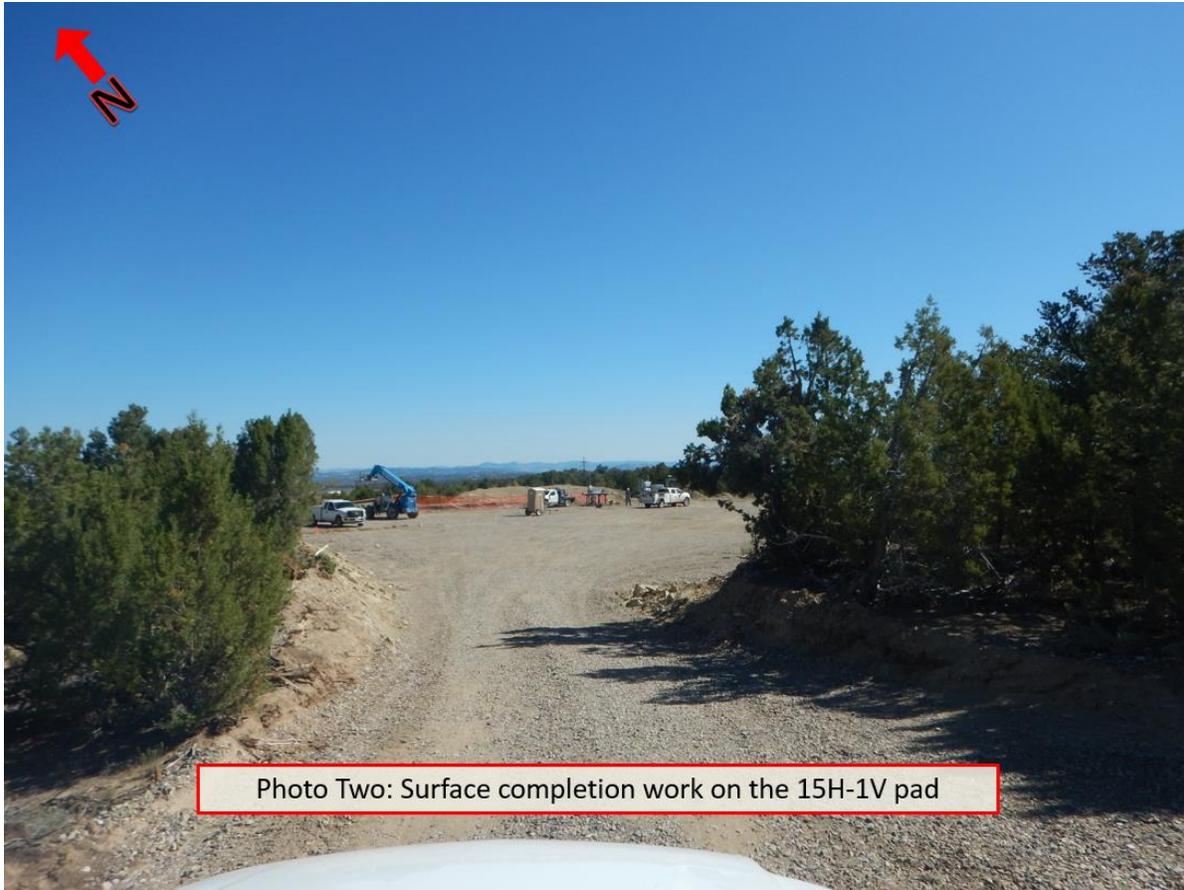
The 15H-IV well pad is still under construction. At the time of the inspection, they were working on surface completions - piping and electrical.

Photo Two: Surface completion work on the 15H-1V pad

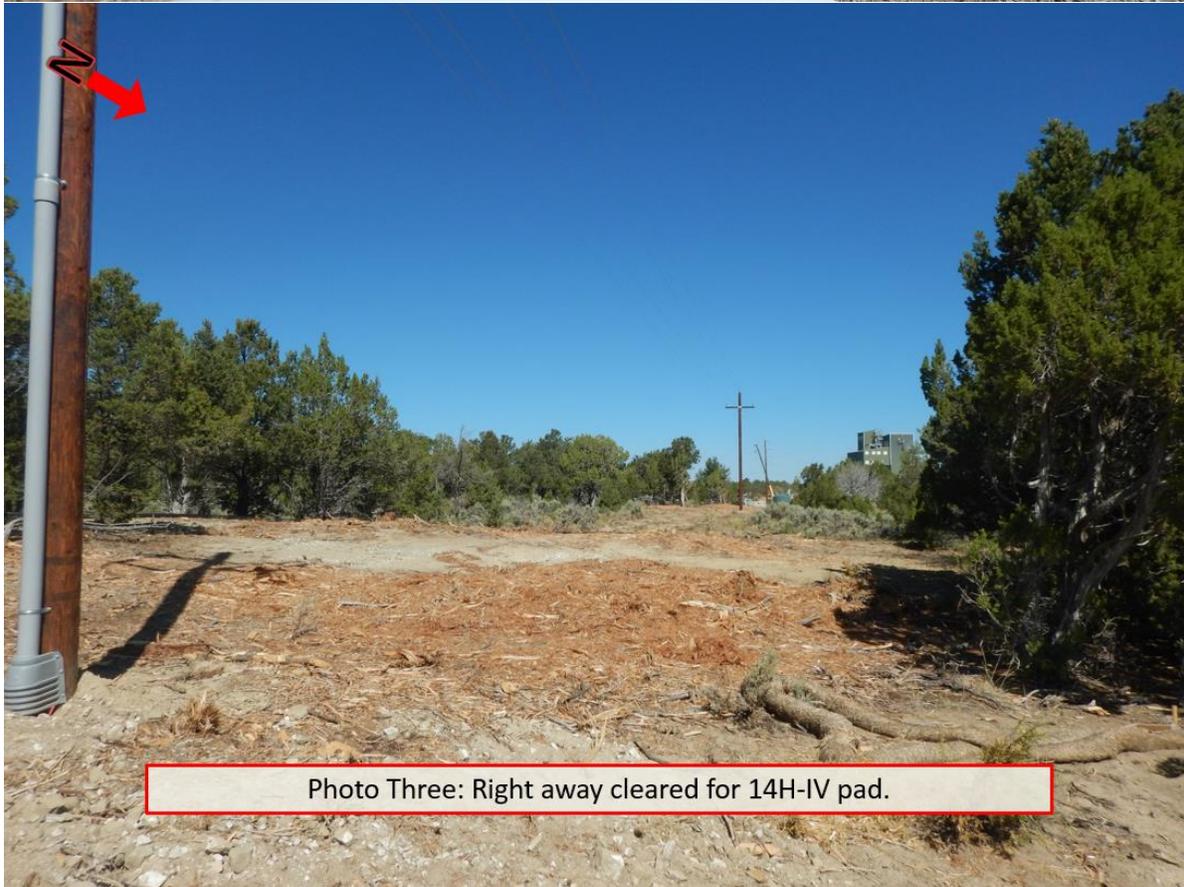
The 14H-IV well has been completed and is online. A new overhead electrical line was installed to supply the 14H-IV pad. The easement was cleared of any larger vegetation resulting in large mulch/wood chip piles. It was indicated that this reclamation is the utility company's responsibility.

Photo Three: Right away cleared for 14H-IV pad.

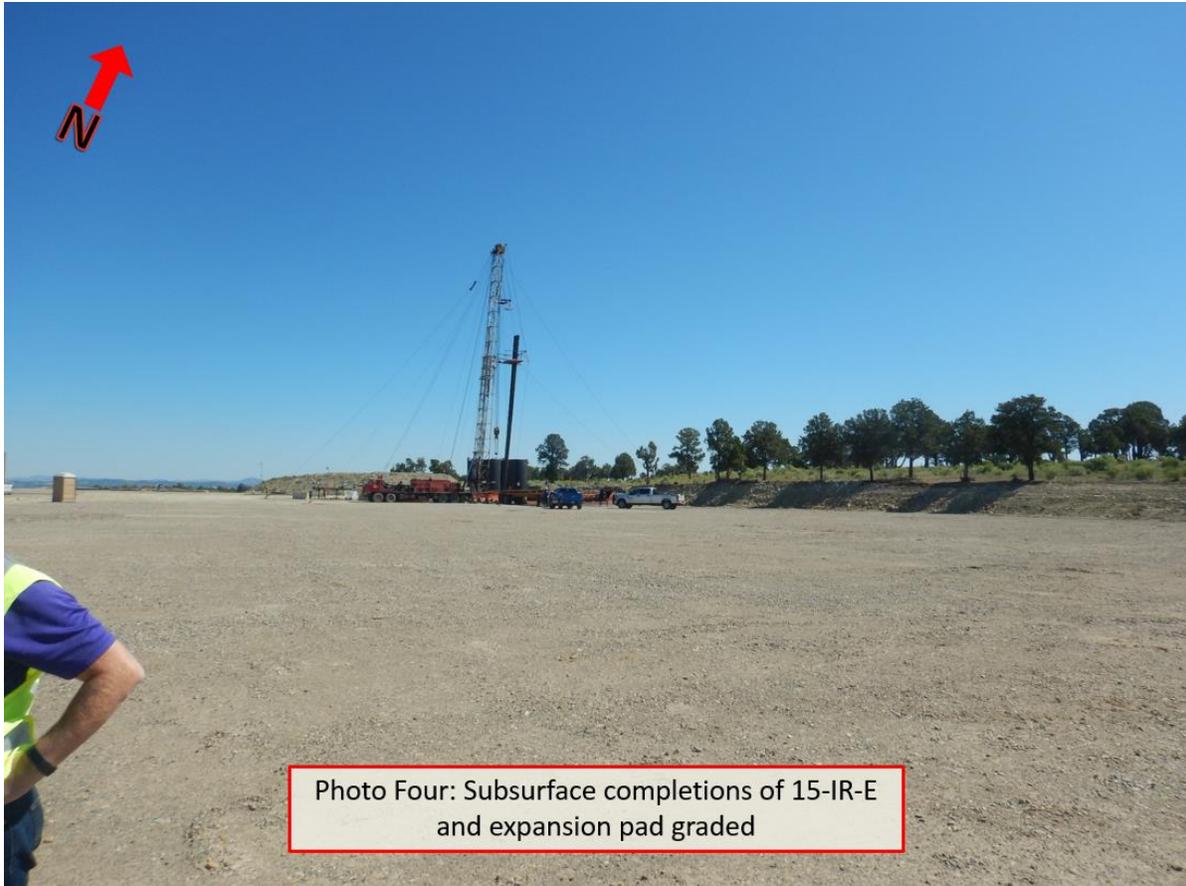
Well 15H-IR-E has been drilled. They encounter a bad cement job that required the well to be perforated and squeeze cement job.

Photo Four: Subsurface completions of 15-IR-E and expansion pad graded

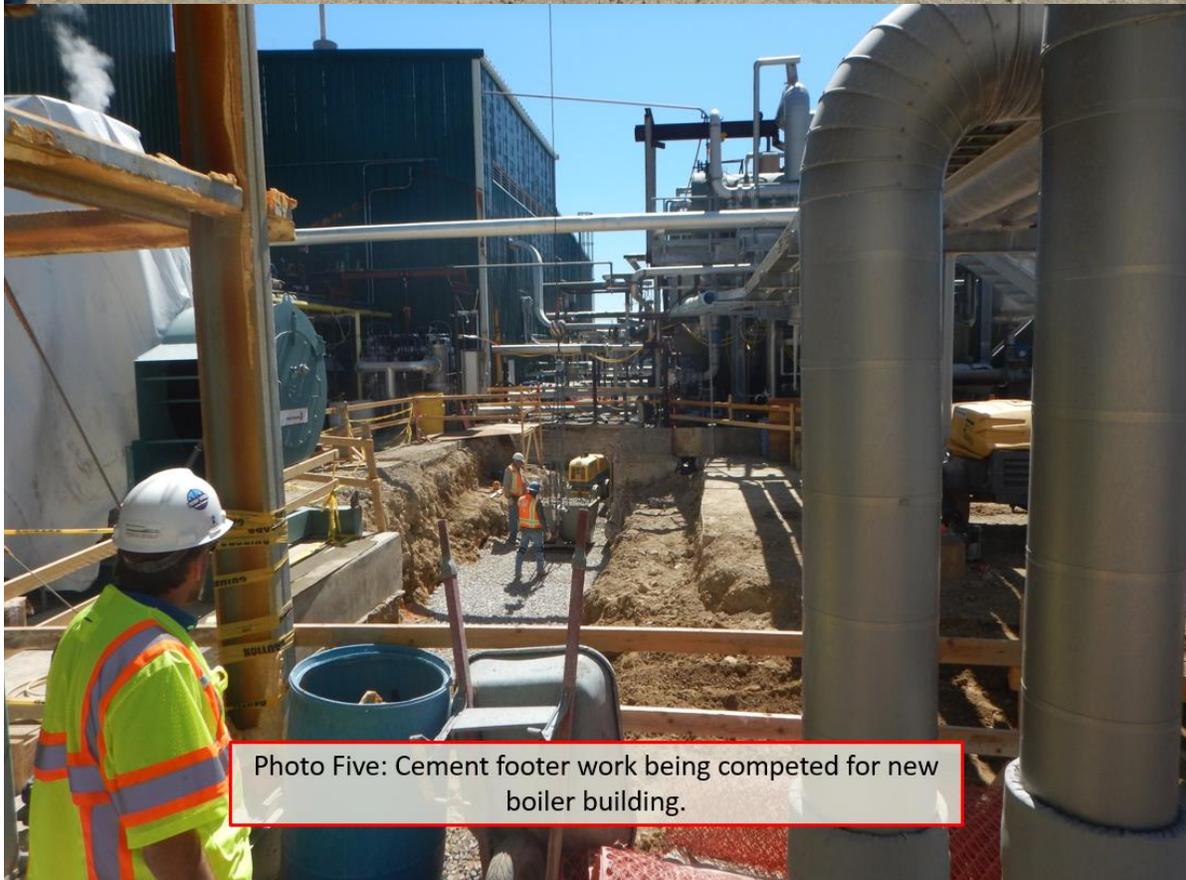
Progress continues on the boiler system switch out. The external building around Boiler #1 and 2 has been completely removed. The old boiler #1 remains functional while #2 has been removed. The new upgraded Boiler has also been installed but is not operational. The majority of work is currently focused on concrete operations.

Photo Five: Cement footer work being completed for new boiler building.
