Re: King I Mine, C-1981-035
Stoner Engineering: Quarterly Inspection: Refuse Pile
3rd Quarter 2019

Date: September 17, 2019

Re: King Coal I – Quarterly Waste Pile/Embankment Inspection

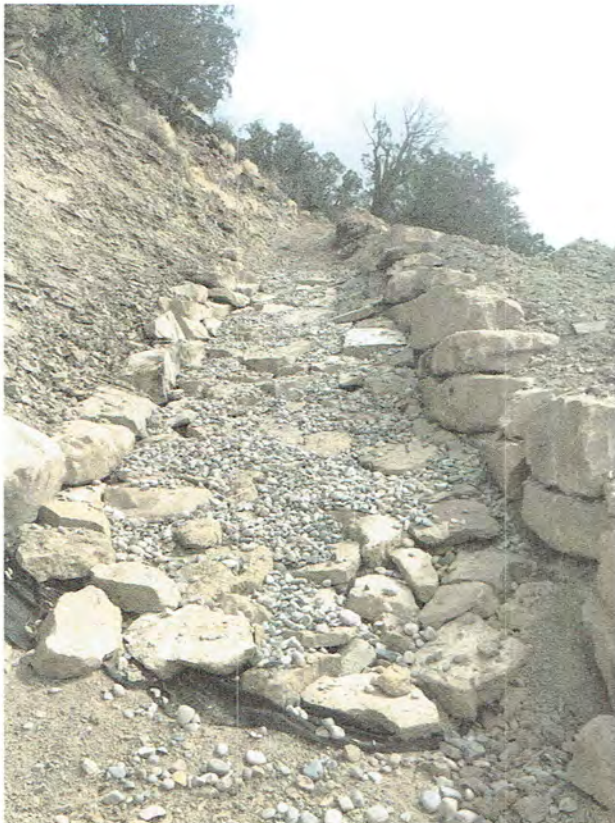
Pic. 2 – New riprap section of Reach 1 channel.

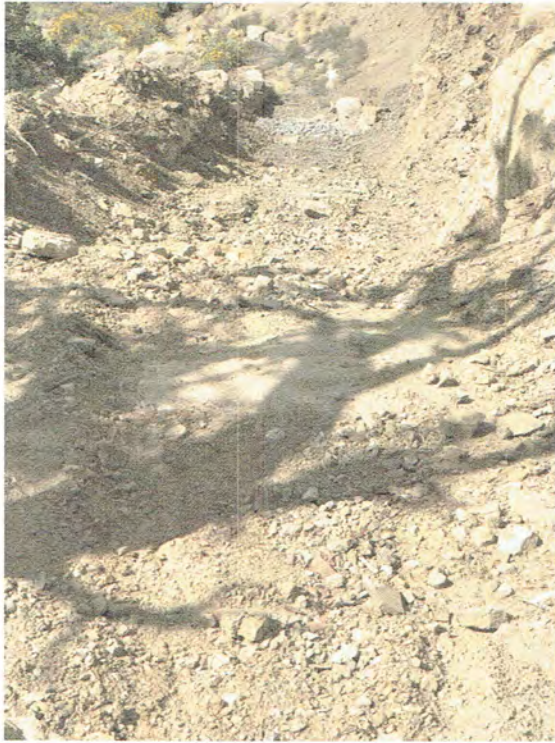
The south treated water ditch (Reach 10) was found to be in generally good condition with the exception of a section of the channel where the runoff has eroded the existing bank and is escaping the channel section. Runoff from the adjoining hillside has historically resulted in some erosion along the existing channel section but, the additional of channel flows has noticeably increased the erosion in a relatively short amount of time (see Pic. 1). This section of the channel should be repaired to prevent channel flows from escaping and increasing the natural erosion of the adjoining hill side. The upper portion of the clean water ditch (Reach 1) has been relocated to accommodate the placement of additional waste material. The lower section has been connected via a portion of riprap channel (see Pic. 2). The remainder of the channel section has been excavated and is awaiting the installation of a shot-crete channel to prevent erosion along the sloe (see Pic. 3).

Pic. 3 – Upper section Reach 1 channel awaiting shot-crete lining.

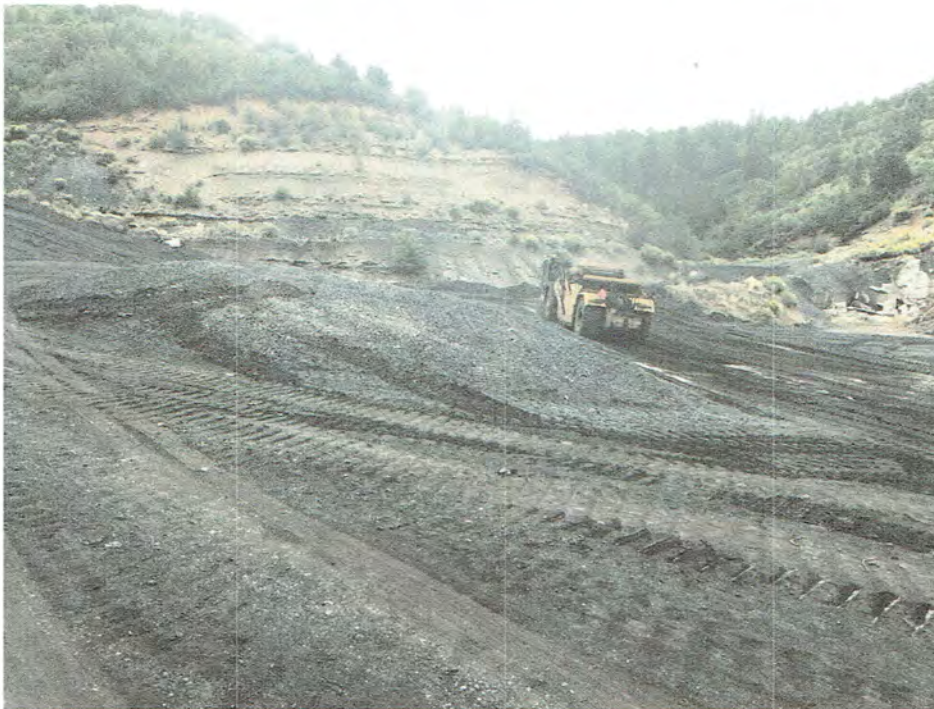
Waste material continues to be stockpiled at the base of the existing waste pile/embankment where it is collected and hauled to the top of the waste pile via excavator (see Pic. 4). The slope of the top of the existing pile is currently in excess of that defined in the Waste Bank Design produced by Don May, 1997. Specifically the cross slope from north to south across the top of the waste pile embankment. Now that the clear water ditch has been relocated up the hillside, waste material is being installed along the existing slope and the top of the existing pile should start to become more level with the placement of additional material.

Pic. 4 – Waste material at base of embankment/waste pile collected via excavator.

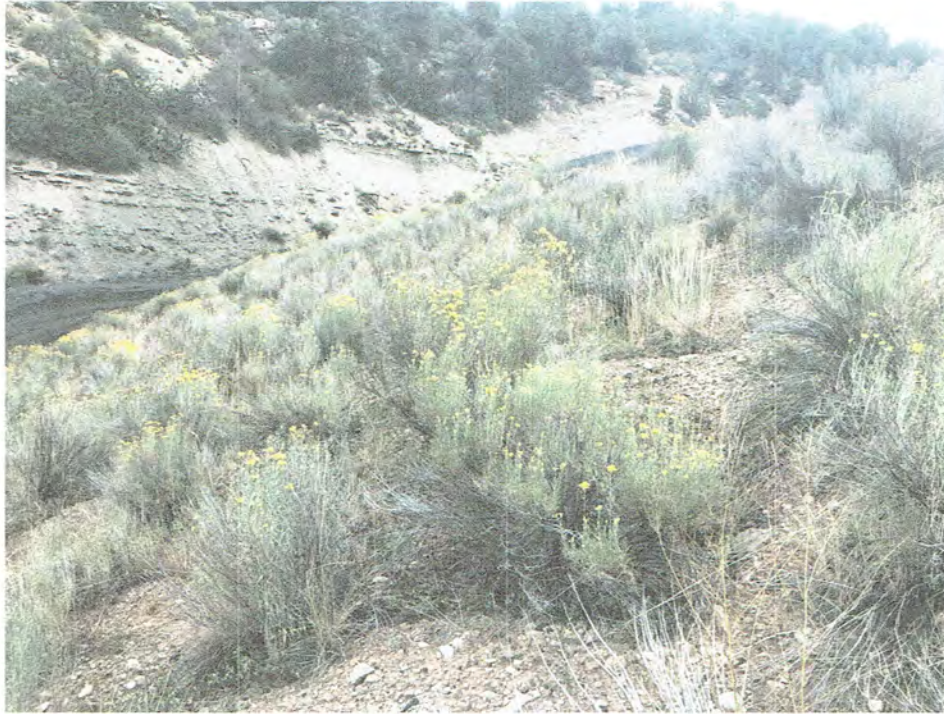
The face of the embankment appeared to be in good condition as there were no signs of excessive erosion, instability or weakness (see Pic. 5). The outlet of the under-drain at the base of the waste pile has been exposed.

Pic. 6 – Face of waste pile/embankment in good condition.
