Re: King I Mine, C-1981-035
Stoner Engineering: Quarterly Inspection: Water Quality Improvements
3rd Quarter 2019

Date: September 17, 2019

Re: King Coal I – Quarterly Water Quality Improvements Inspection

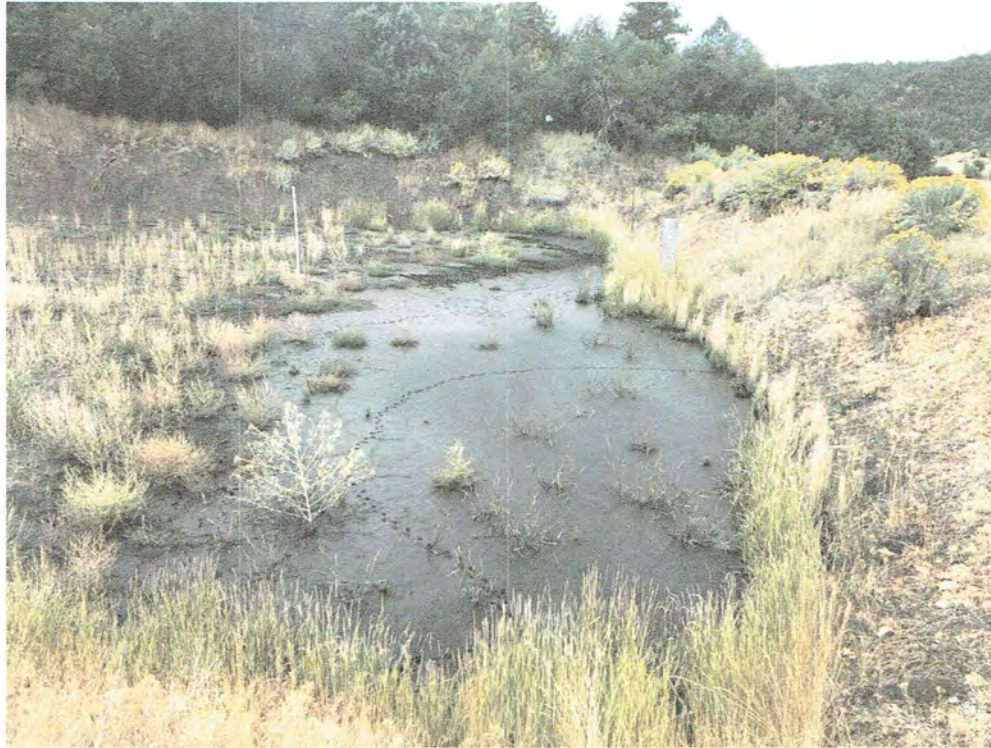
Both ponds were generally dry at the time of the inspection (see Pic. 1). The ponds both appeared to generally be in good condition and while there is additional sediment in the ponds, the sedimentation gages show the ponds are not yet it need of cleaning (see Pic. 2). The ponds should continue to be monitored after storm events to ensure that excess sediment does not reduce the required storage capacity available for storm water runoff.

Pic. 1 – West pond.

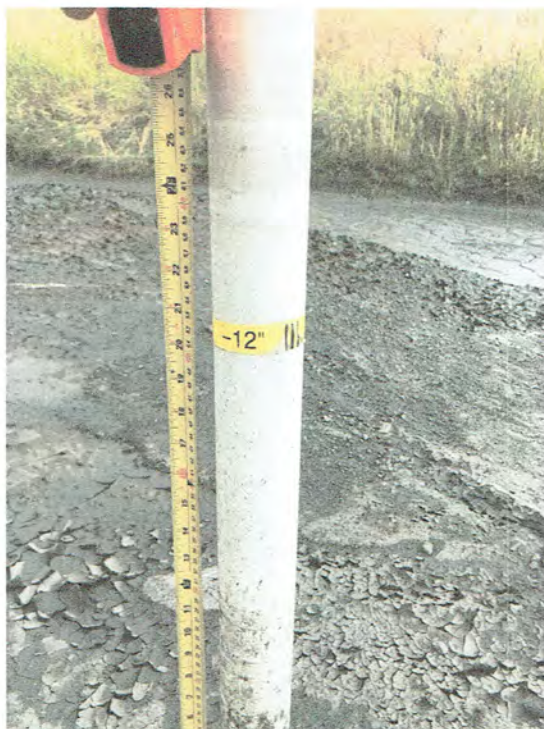
Pic. 2 – Sediment gage in east pond.

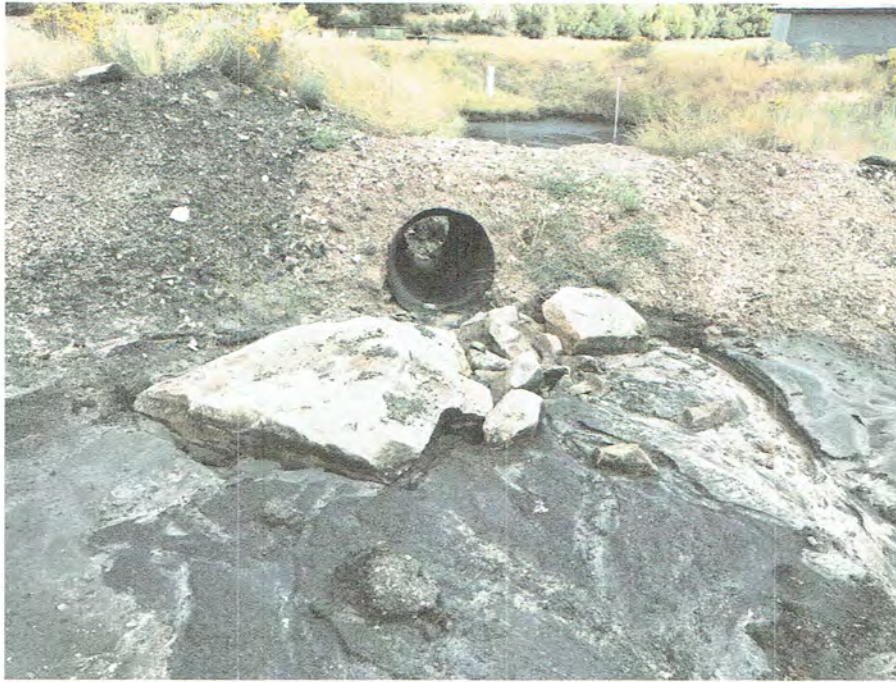
The sedimentation traps at the entrance to the site are in good condition and have been recently cleaned. There has been some riprap added at the pipe inlet/berming into the east pond (see Pic. 3). The work to Reach 1 is ongoing. The new clear water ditch has been connected to the existing portion of Reach 1. The steep section of channel connecting the upper and lower sections of Reach 1 has been excavated and is awaiting the placement of the shot-crete surfacing (see Pic. 4). There has been some sedimentation of the clear water ditch near the switchback due to recent storm runoff from the steep slopes to the north (see Pic. 5). There is a section of Reach 10 where runoff is escaping from the channel section and causing erosion along the side of the channel (see Pic. 6). While this runoff is still routed to the sediment ponds, it will result in excessive erosion to the existing hillside and should be repaired.

Pic. 3 – Riprap at pipe entrance to east pond.

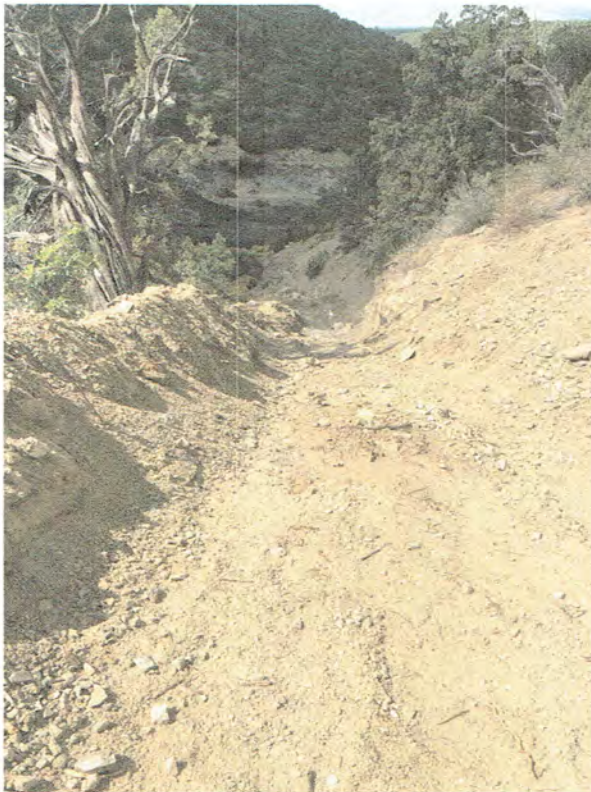
Pic. 4 – Channel section between upper and lower sections Reach 1.

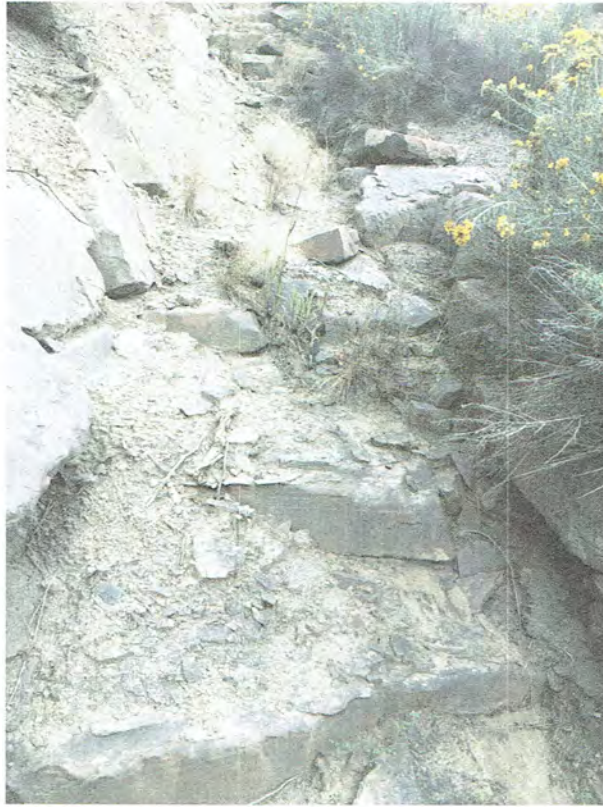
Pic. 5 – Reach 1 sediment near road switchback under steep slopes.

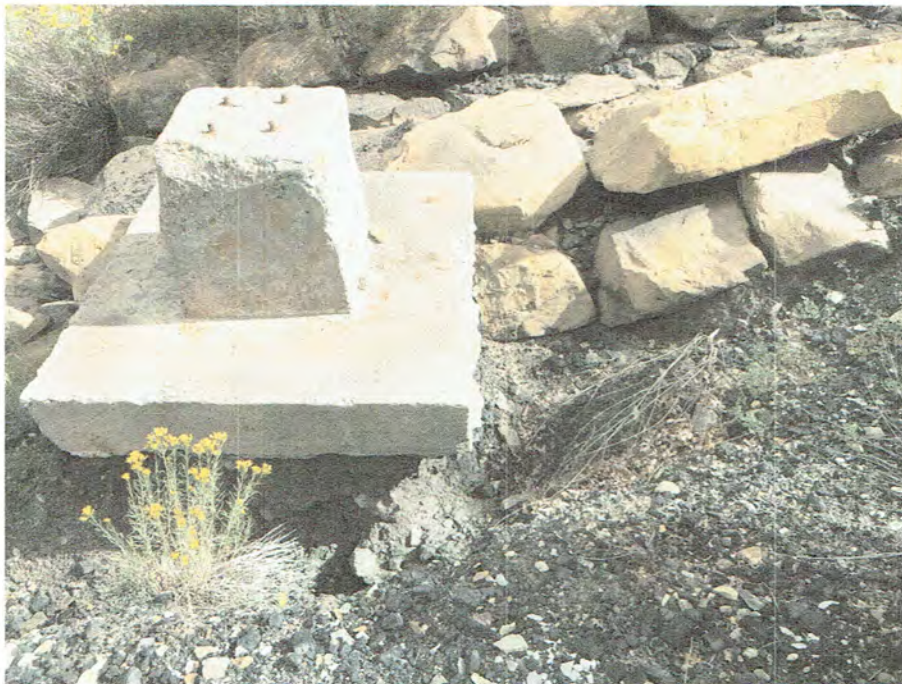
Pic. 6 – Reach 10 location where water is escaping existing channel section.
