**MINERALS PROGRAM INSPECTION REPORT**  
**PHONE: (303) 866-3567**

<b>MINE NAME:</b> Caldwell-Nesselhuf Pit No. 1	<b>MINE/PROSPECTING ID#:</b> M-1997-071	<b>MINERAL:</b> Sand and gravel	<b>COUNTY:</b> Crowley
<b>INSPECTION TYPE:</b> Preoperation Inspection	<b>INSPECTOR(S):</b> Patrick Lennberg	<b>INSP. DATE:</b> September 17, 2019	<b>INSP. TIME:</b> 11:00
<b>OPERATOR:</b> All-Rite Paving & Redi-Mix, Inc.	<b>OPERATOR REPRESENTATIVE:</b> Jodi Schreiber	<b>TYPE OF OPERATION:</b> 112c - Construction Regular Operation	
<b>REASON FOR INSPECTION:</b> Preoperation Inspection	<b>BOND CALCULATION TYPE:</b> None	<b>BOND AMOUNT:</b> \$36,000.00	
<b>DATE OF COMPLAINT:</b> NA	<b>POST INSP. CONTACTS:</b> None	<b>JOINT INSP. AGENCY:</b> None	
<b>WEATHER:</b> Clear	<b>INSPECTOR'S SIGNATURE:</b>

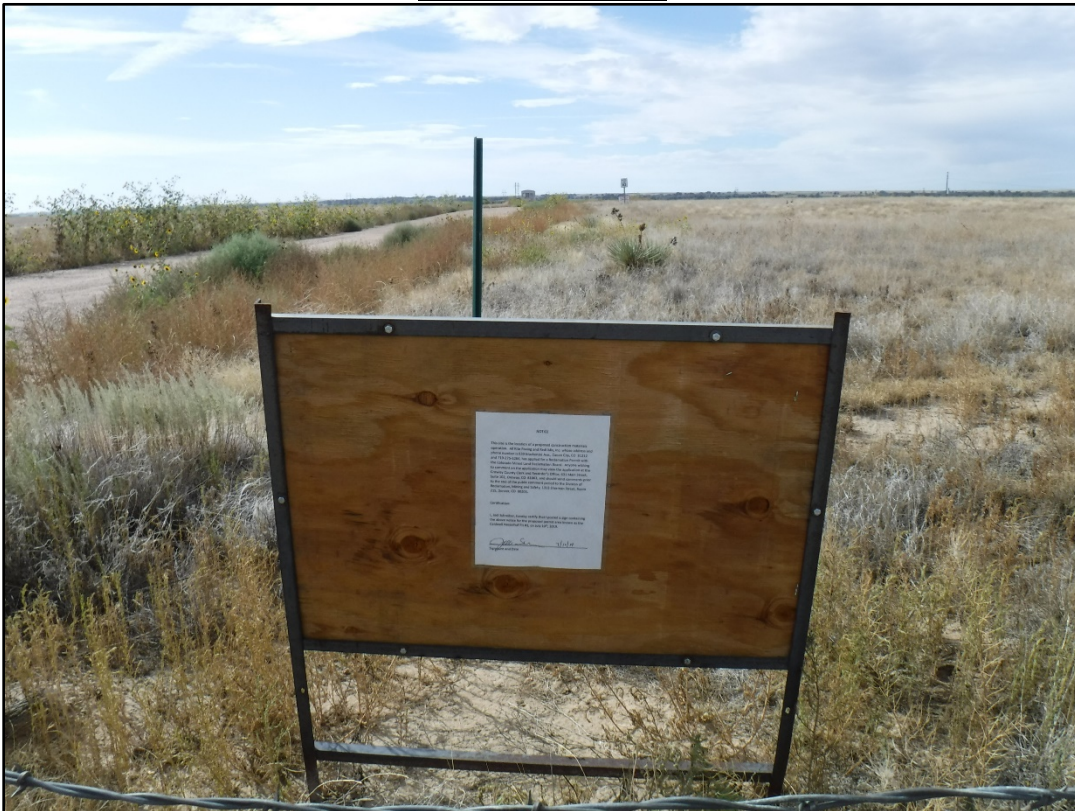
**Photo 1:** Application sign at entrance of mine

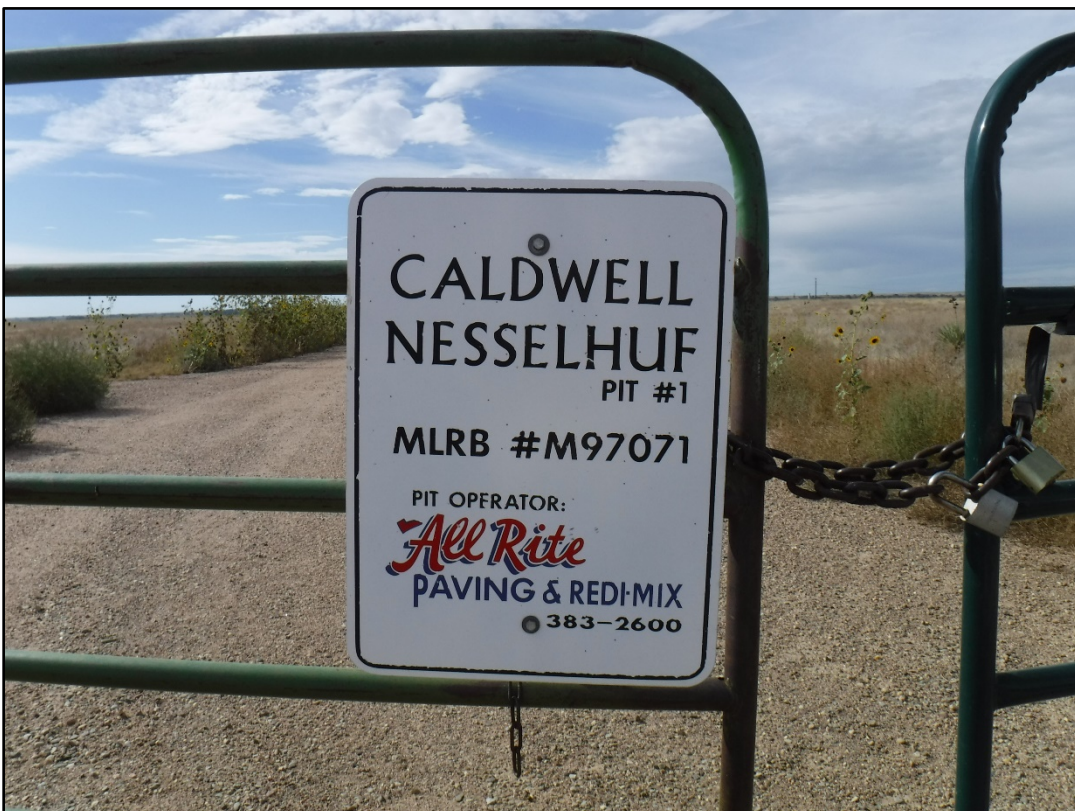
**Photo 2:** Mine sign at entrance

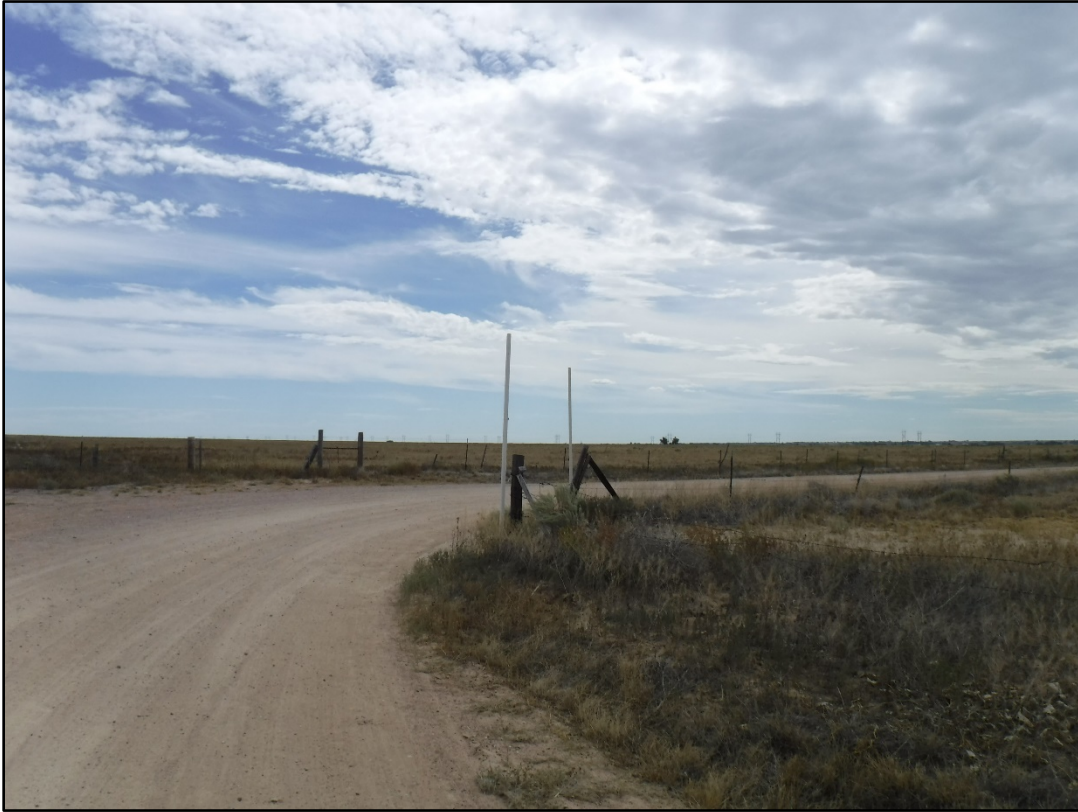
The site was not active at the time of inspection. It was noted that all high walls have been graded to 3H:1V or shallower, including the area around the power pole base. All mining affected lands have been brought to >75 feet of the Arkansas River. The proposed permit boundary markers were in place and consisted of 10 foot tall 2-inch PVC pipe.

**Photo 3:** Typical proposed permit boundary markers

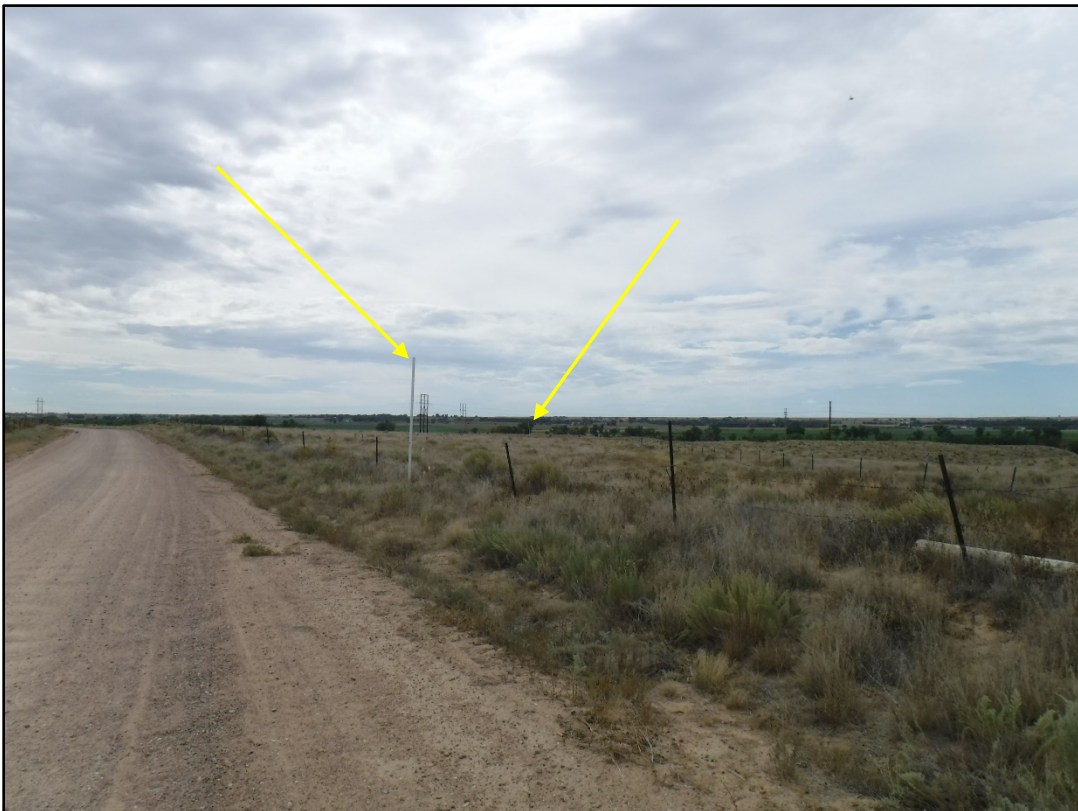
**Photo 4:** Typical proposed permit boundary markers (yellow arrows)

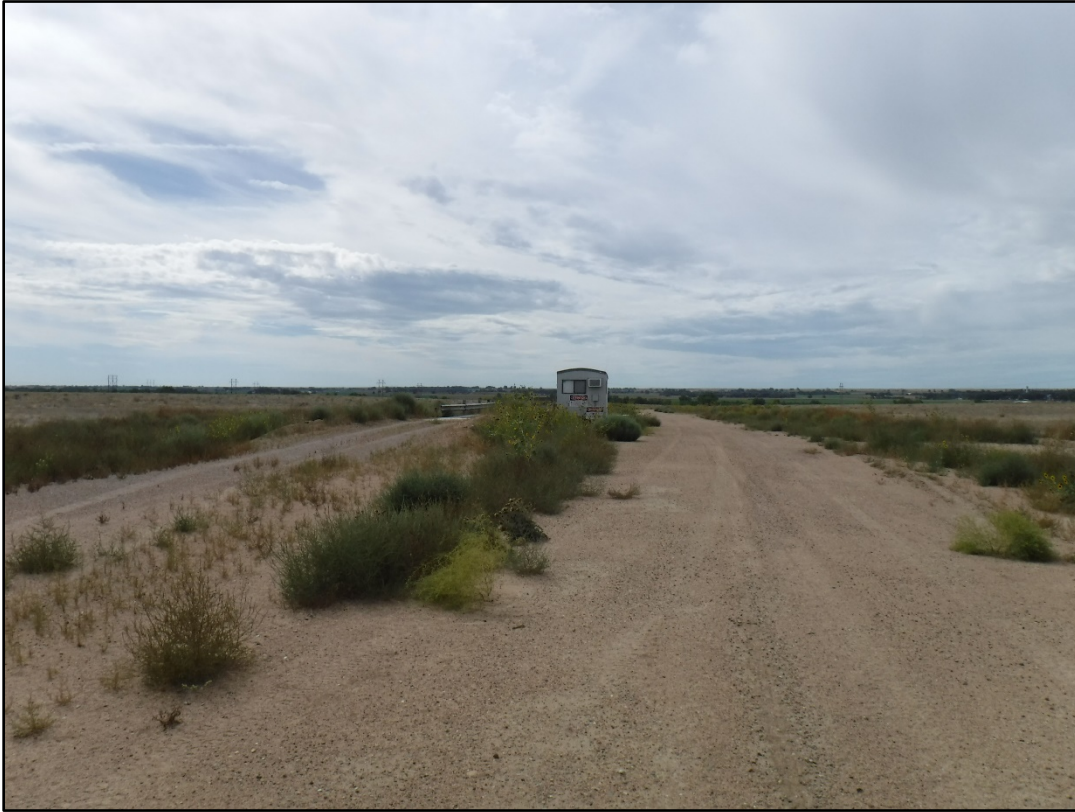
**Photo 5:** Portable scale and scale house near entrance to mine

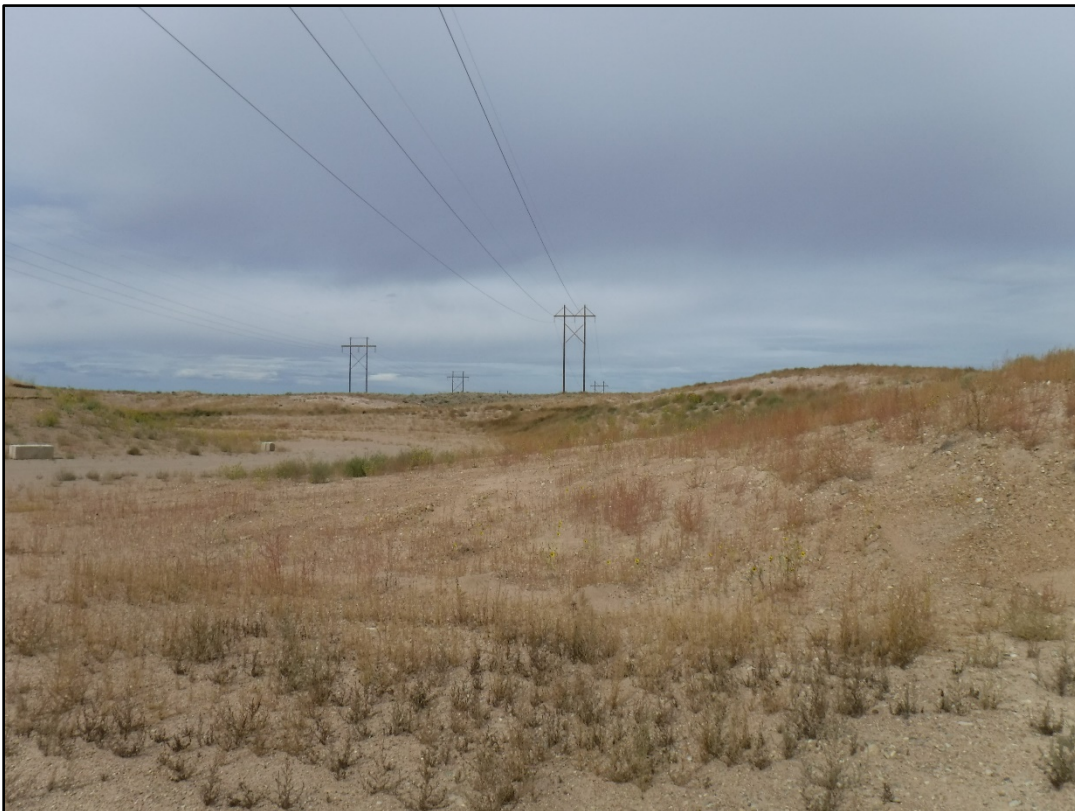
**Photo 6:** Graded high wall slopes to 3H:1V or less

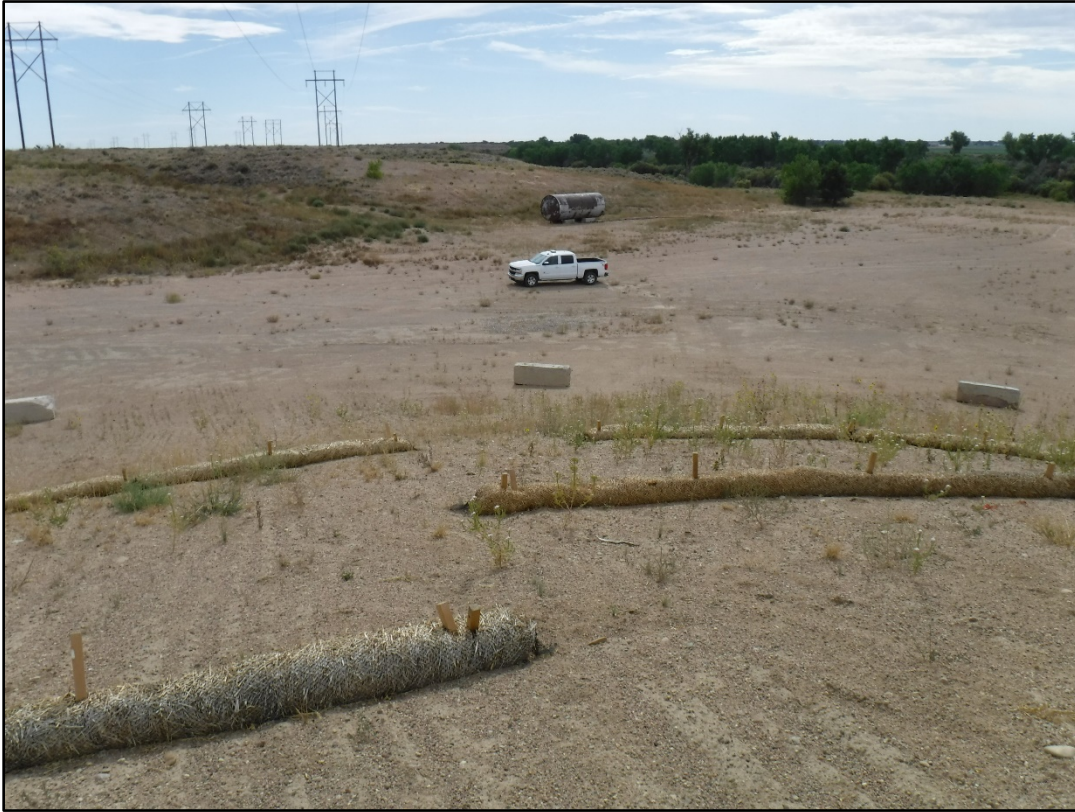
**Photo 7:** Graded slopes at base of power pole, note 2,000 gal AST center background

During the inspection it was discussed that the 2,000 gallon AST had to be identified on the Mining Plan map and narrative included in the Mining Plan that described how the AST was going to be used. Specifically, that during mining operations water obtained from a suitable source may be trucked in and off-loaded into the AST. The water then would be used as needed for dust suppression and washing of gravel during processing. Structure agreements are needed for the two wells along the river, both owned by the current landowner, and the fences along the eastern and western boundaries of the proposed permit.

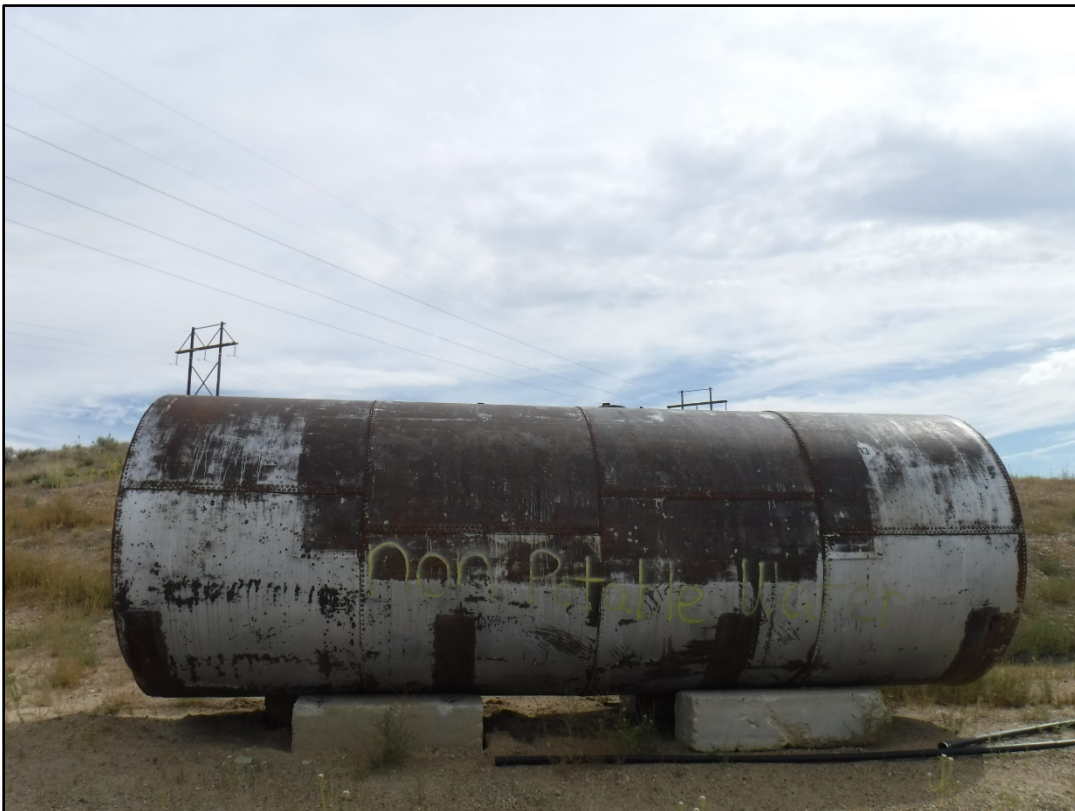
**Photo 8:** AST 2,000 gallon estimate capacity

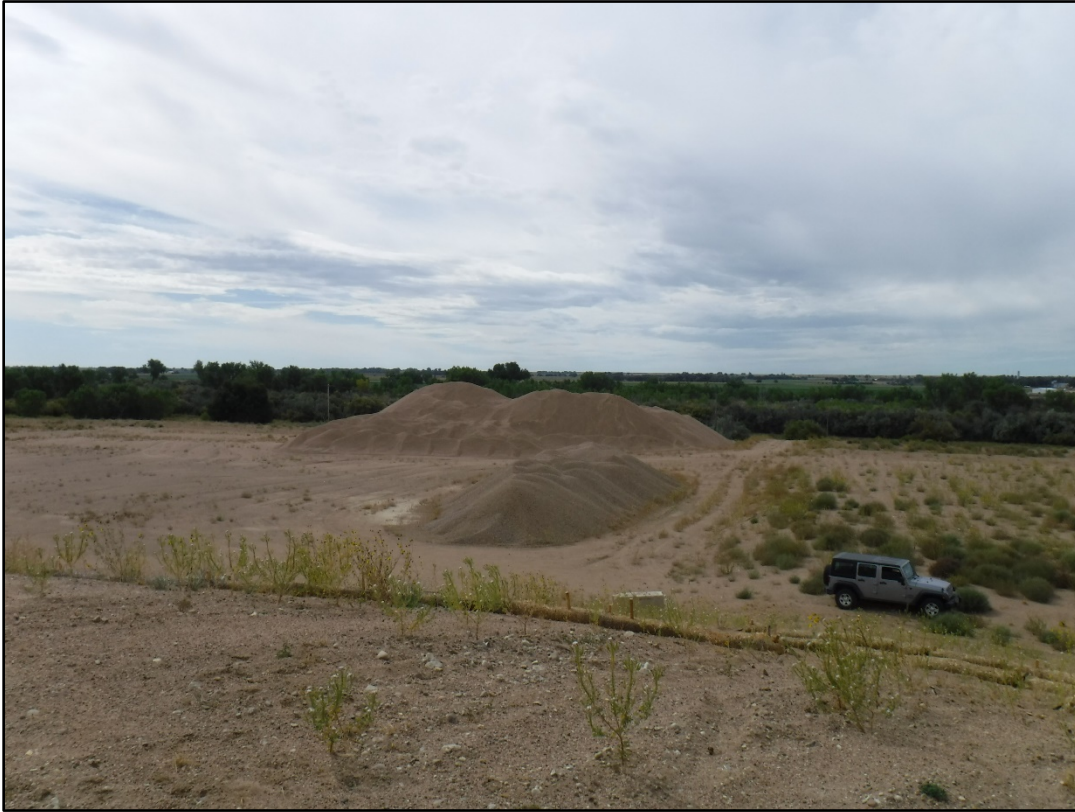
**Photo 9:** Stockpiles still remaining at the site

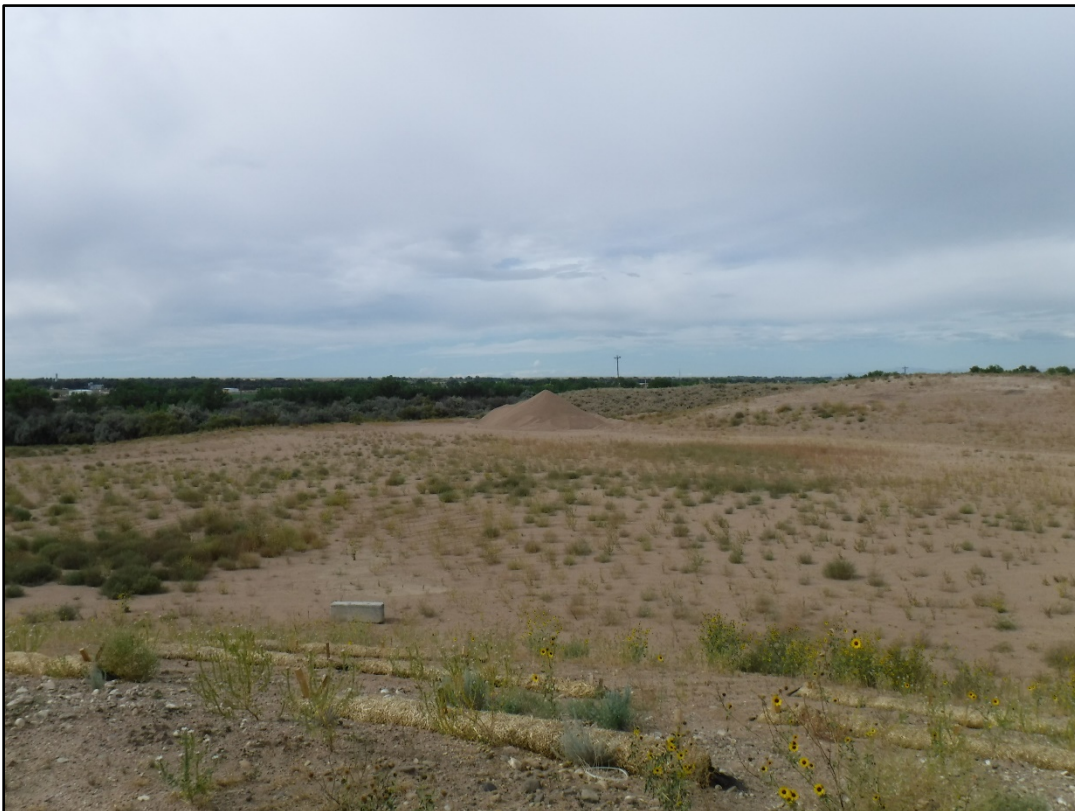
**Photo 10:** Lone stockpile near the southwestern corner of current permit boundary
