MINERALS PROGRAM INSPECTION REPORT

MINE NAME: Cresson Project	MINE/PROSPECTING ID#: M-1980-244	MINERAL: Gold	COUNTY: Teller
INSPECTION TYPE: Aerial Inspection	INSPECTOR(S): Timothy A. Cazier	INSP. DATE: June 13, 2019	INSP. TIME: 13:37
OPERATOR: Cripple Creek & Victor Gold Mining Company	OPERATOR REPRESENTATIVE: None	TYPE OF OPERATION: 112d-3 - Designated Mining Operation	
REASON FOR INSPECTION: Normal I&E Program	BOND CALCULATION TYPE: None	BOND AMOUNT: \$209,491,188.00	
DATE OF COMPLAINT: NA	POST INSP. CONTACTS: None	JOINT INSP. AGENCY: None	
WEATHER: Cloudy	INSPECTOR'S SIGNATURE:

This was an aerial photo inspection of the Cresson Project conducted by Tim Cazier of the Colorado Division of Reclamation, Mining and Safety (Division) based on aerial photographs taken by the Division. No operator was present during the inspection. The site is a 112d-3 gold mine located between Cripple Creek and Victor in Teller County.

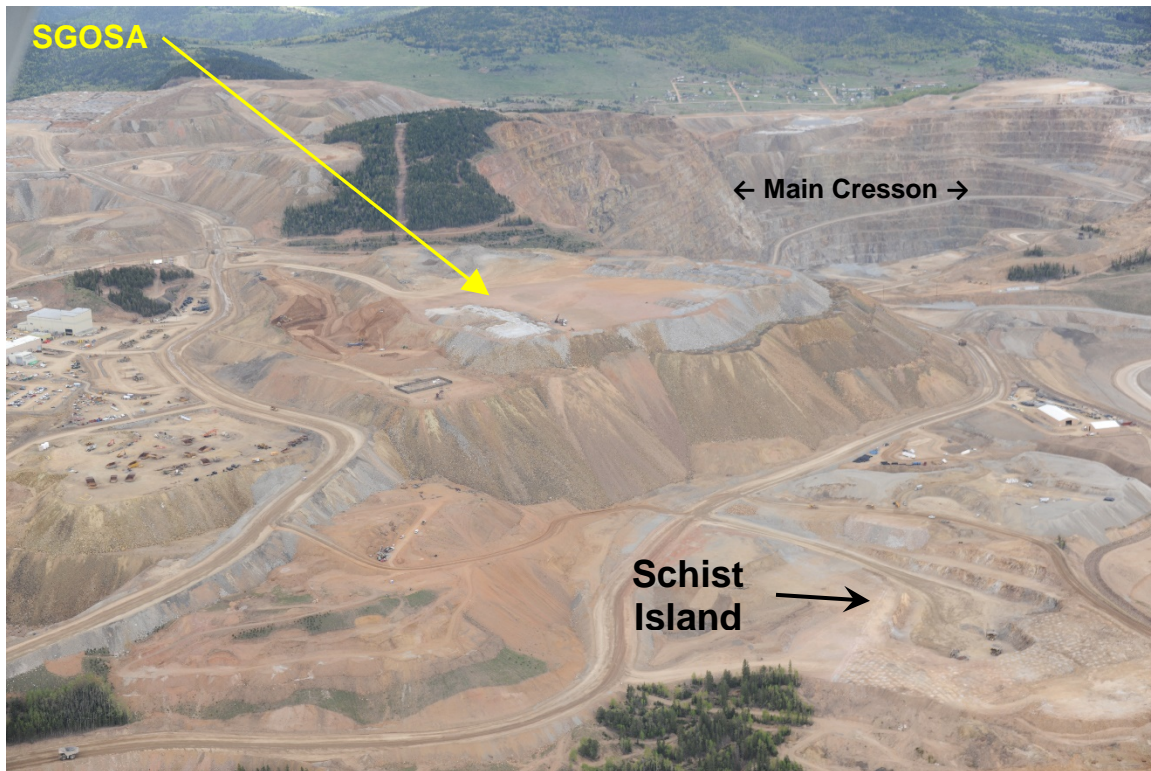
Photo 1. North Cresson pit – Schist Island Pit (Looking SE).

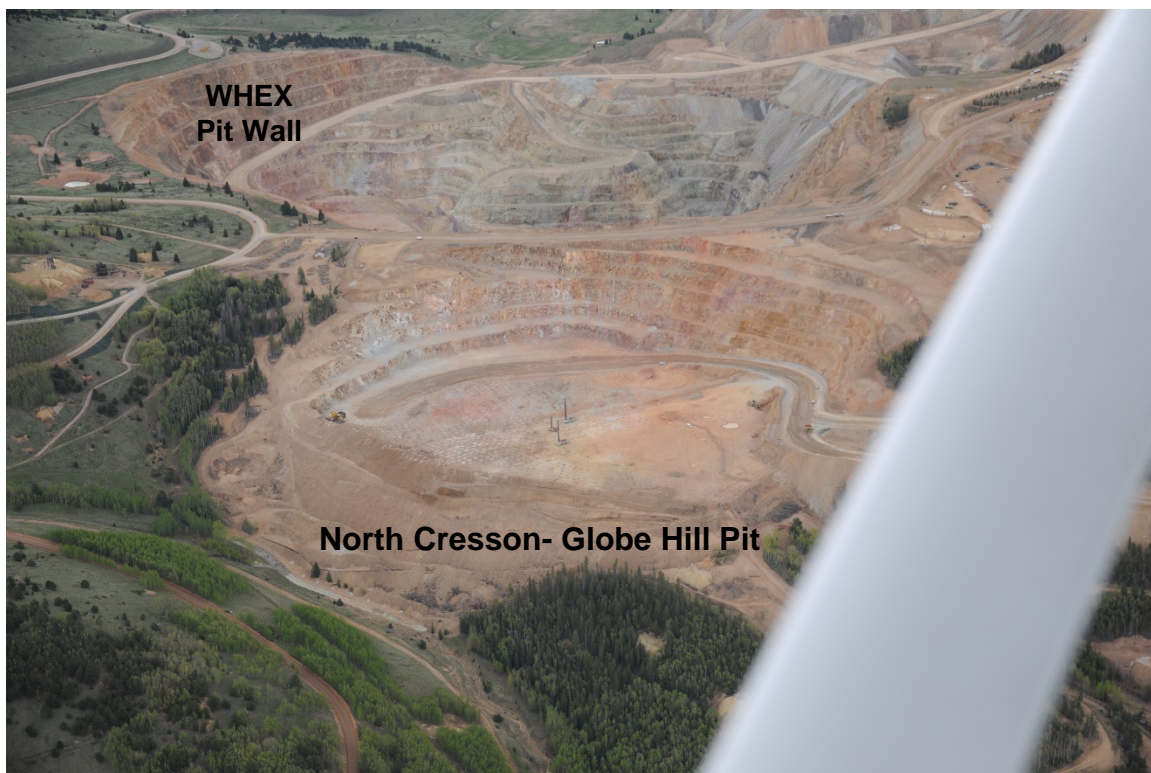
Photo 2. North Cresson (looking ENE).

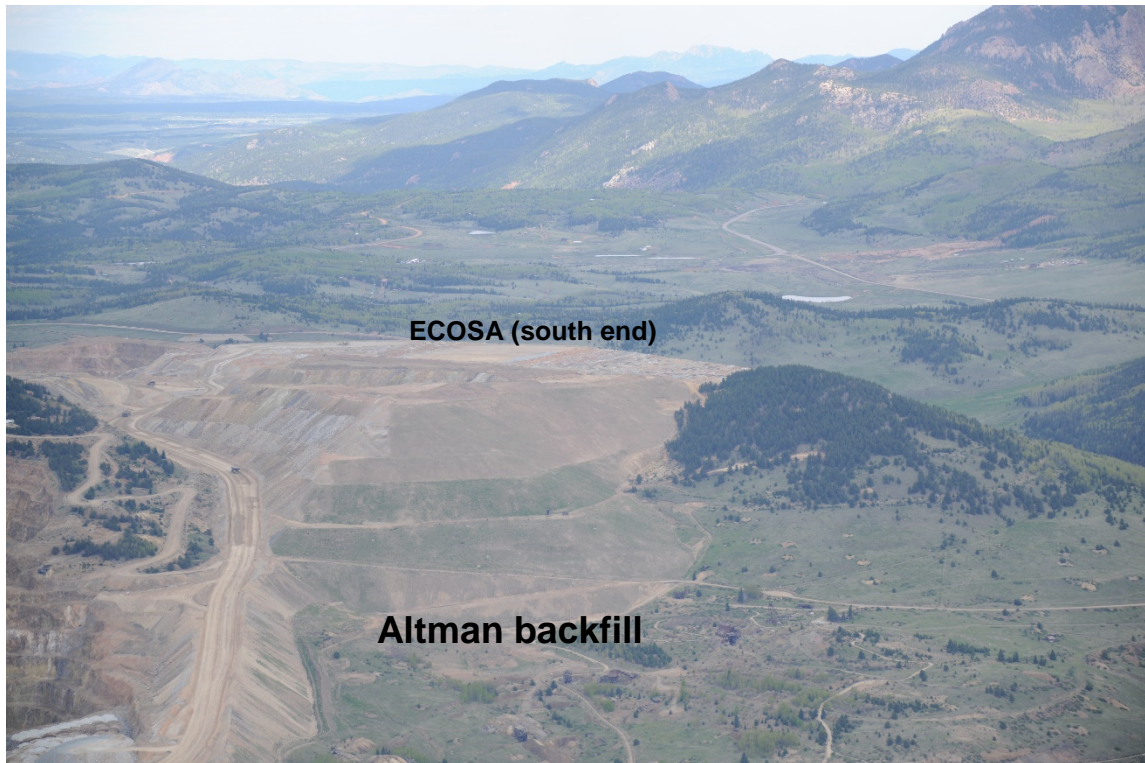
Photo 3. East Cresson OSA, south end (looking north).

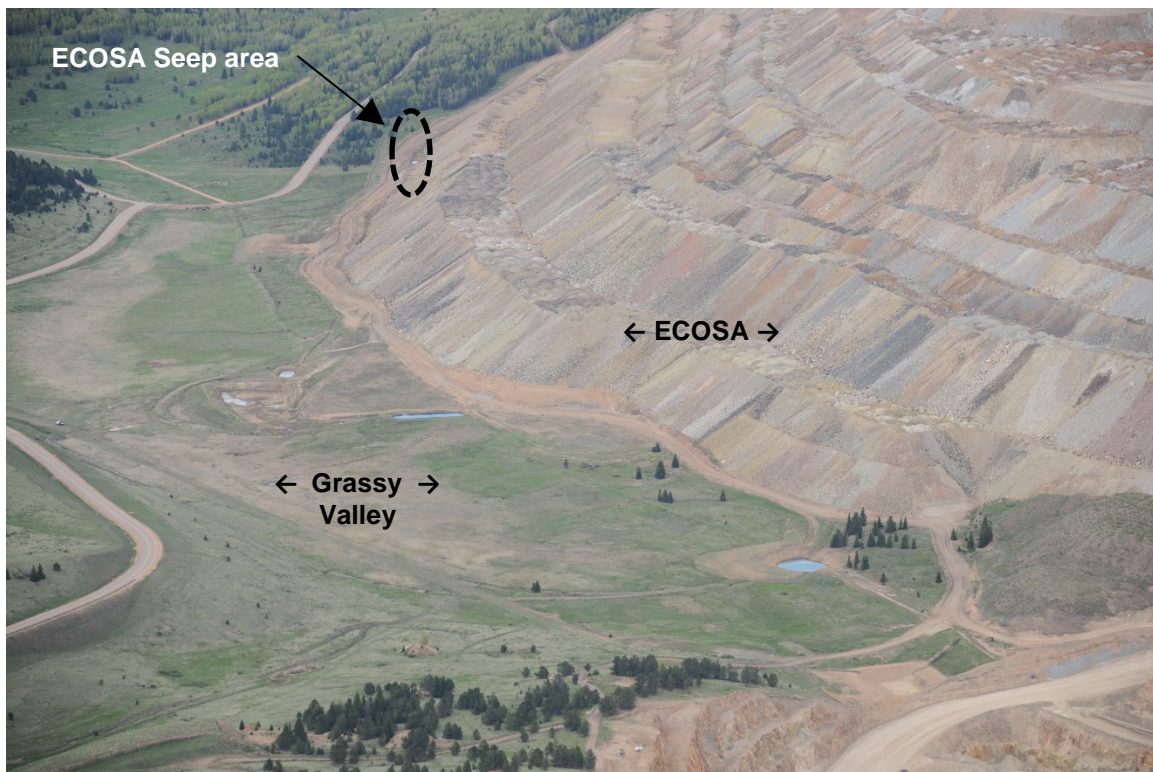
Photo 4. East Cresson OSA Toe, south end (looking SE).

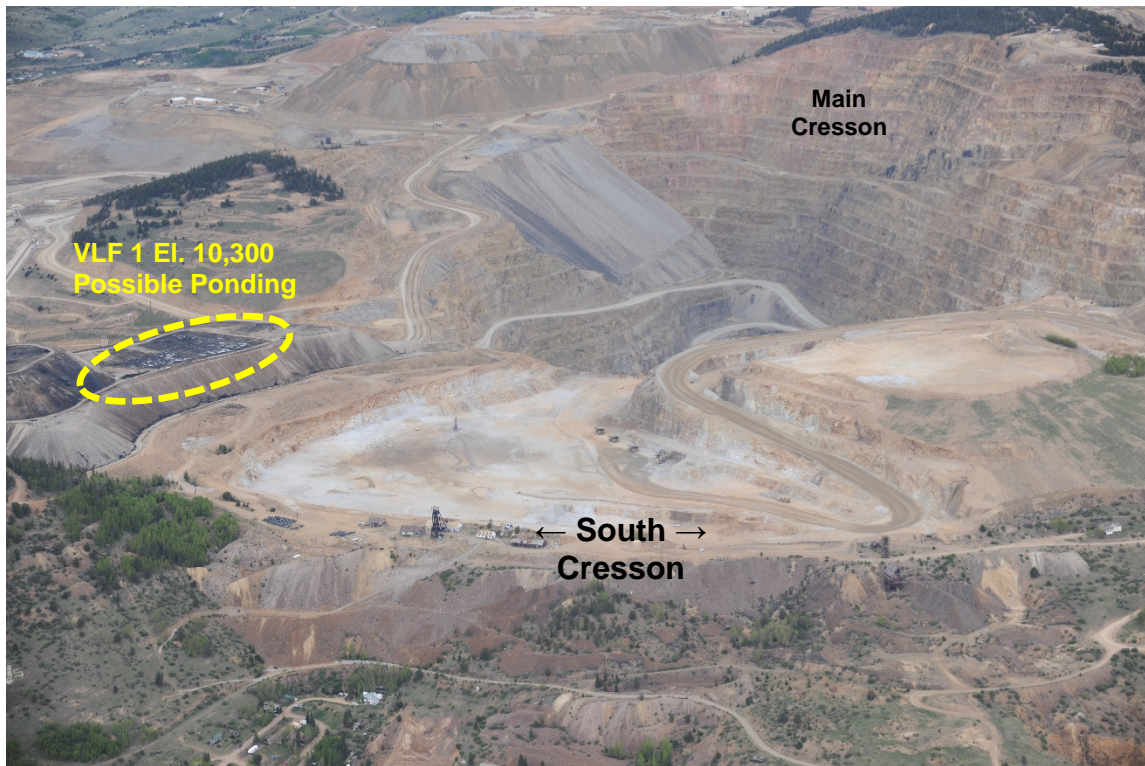
* Possible process solution ponding at multiple locations on VLF 1. The Division ground checked this potential problem on June 24, 2019.

Photo 5. South Cresson Pit (looking north, note possible ponding on VLF 1).

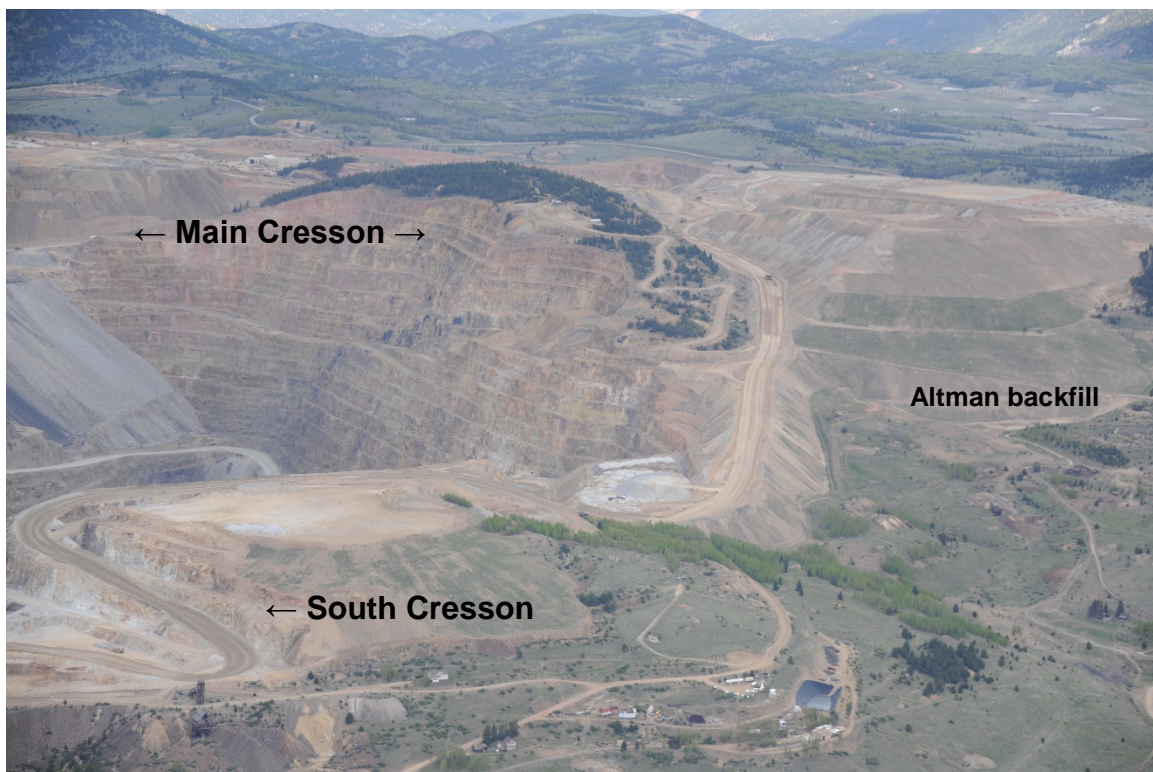
Photo 6. Main Cresson Pit (looking north)

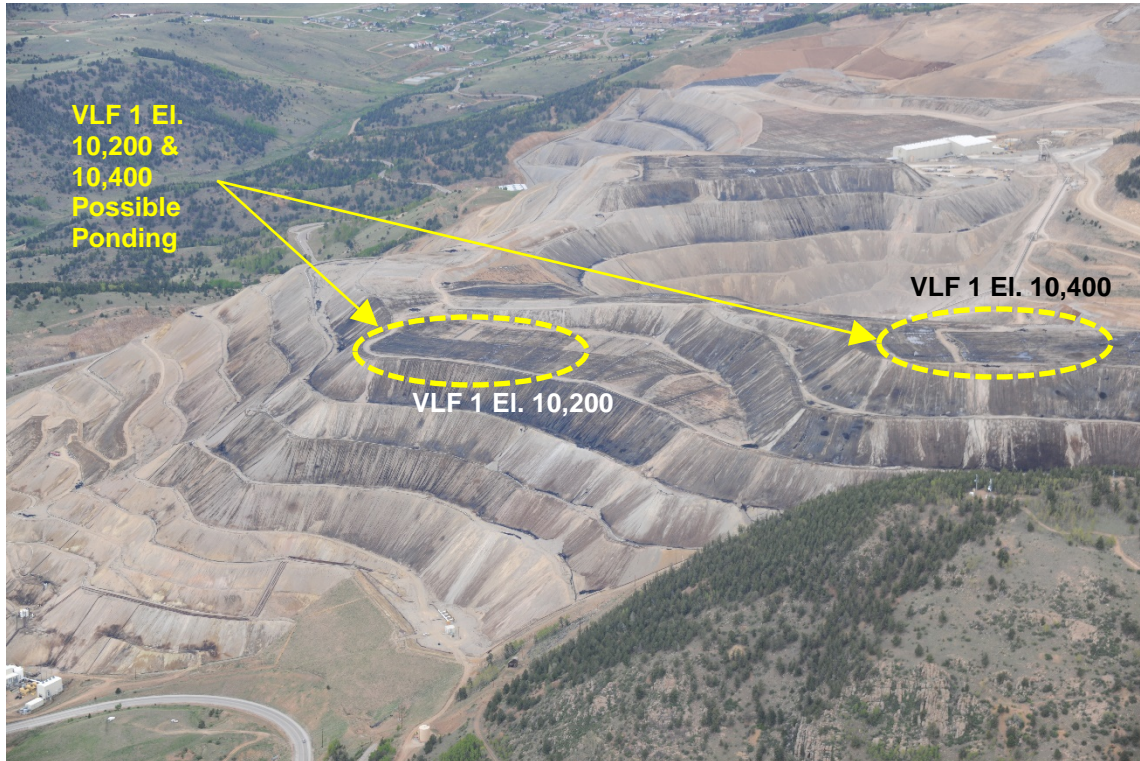
Photo 7. VLF 1/Arequa Gulch VLF (looking NNW); Note possible ponding on VLF 1.

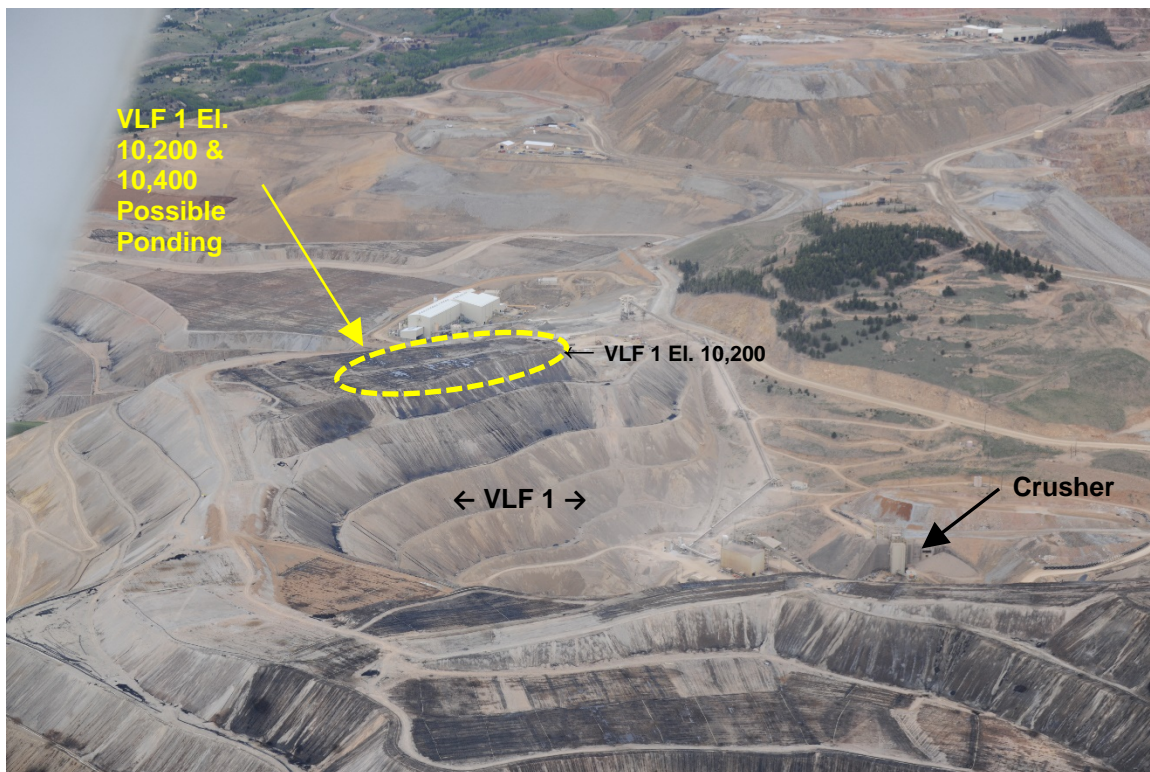
Photo 8. VLF 1/Arequa Gulch VLF (looking north) ; Note possible ponding on VLF 1.

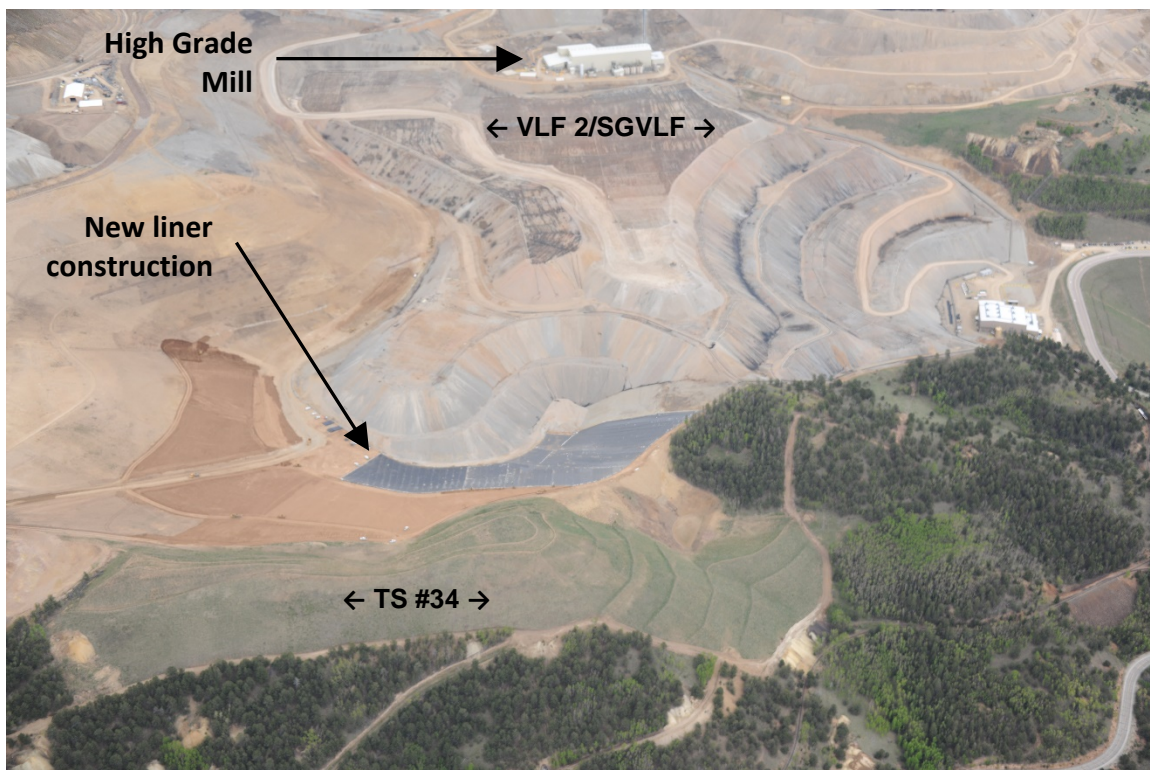
Photo 10	Squaw Gulch VLF (VLF 2)	Looking SE	Topsoil Stockpile #34 in foreground; Mill beyond (<i>note VLF 2 liner construction beyond TS #34</i>).
Photo 11	Site Overview	Looking SE	<i>Note VLF 2 liner construction beyond TS #34</i>
<u>Acronyms:</u>		PSSA – Pregnant Solution Storage Area	
ADR – Adsorption/desorption Recovery		OSA – overburden storage area	
PSES – Process Solution Enhancement System		VLF – valley leach facility

Photo 10. VLF 2/Squaw Gulch VLF (looking SE) .

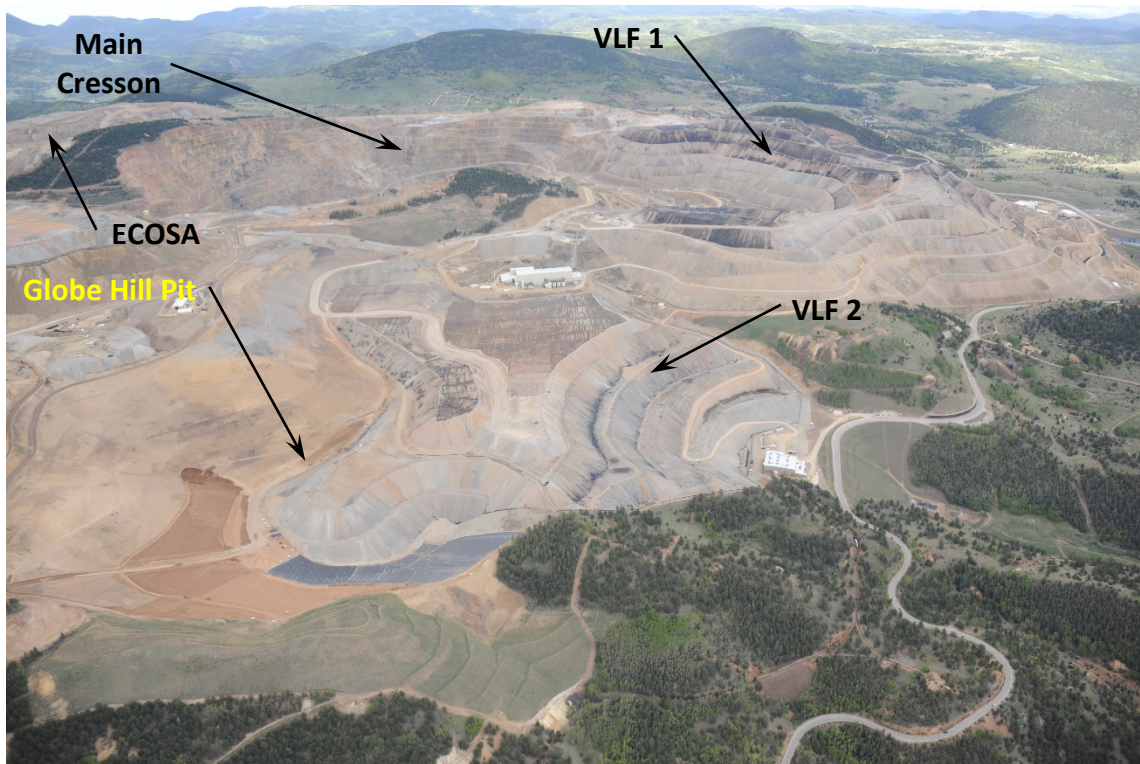
Photo 11. Site Overview (Looking SE).
