**COLORADO**Division of Reclamation,
Mining and Safety

MINERALS PROGRAM INSPECTION REPORT**PHONE: (303) 866-3567**

MINE NAME: Peters Pit	MINE/PROSPECTING ID#: M-1991-078	MINERAL: Gravel	COUNTY: Crowley
INSPECTION TYPE: Monitoring	INSPECTOR(S): Patrick Lennberg	INSP. DATE: September 17, 2019	INSP. TIME: 13:00
OPERATOR: Kiowa County	OPERATOR REPRESENTATIVE: Rick Spady	TYPE OF OPERATION: 112c - Construction Regular Operation

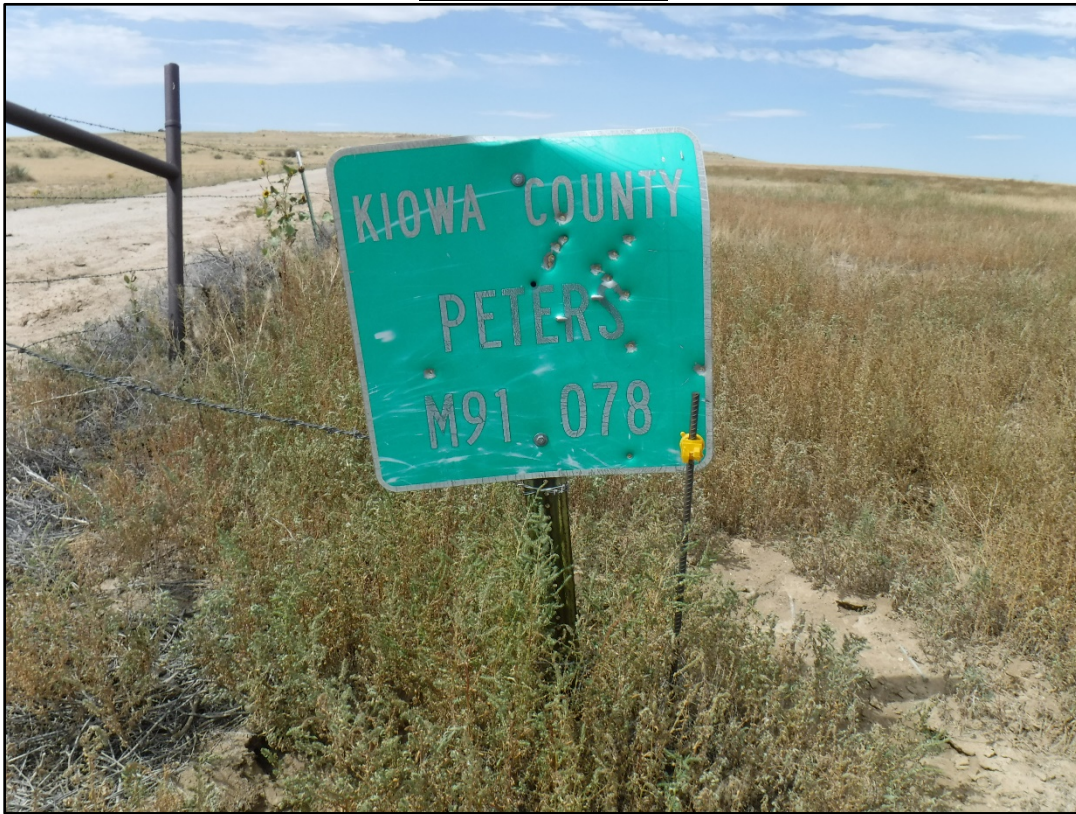
The Peters Pit is a 112c operation permitted for 21.49 acres to mine sand and gravel for use in county road construction and maintenance. The maximum allowed disturbed area at any time is 21.49 acres. The site is located approximately 10.5 miles northeast of Sugar City, Colorado in Crowley County. The site can be accessed from the east off of County Lane 31. The approved post-mining land use is rangeland. A mine sign was observed as required by Rule 3.1.12.

Photo 1: Mine sign at entrance off of County Road 31

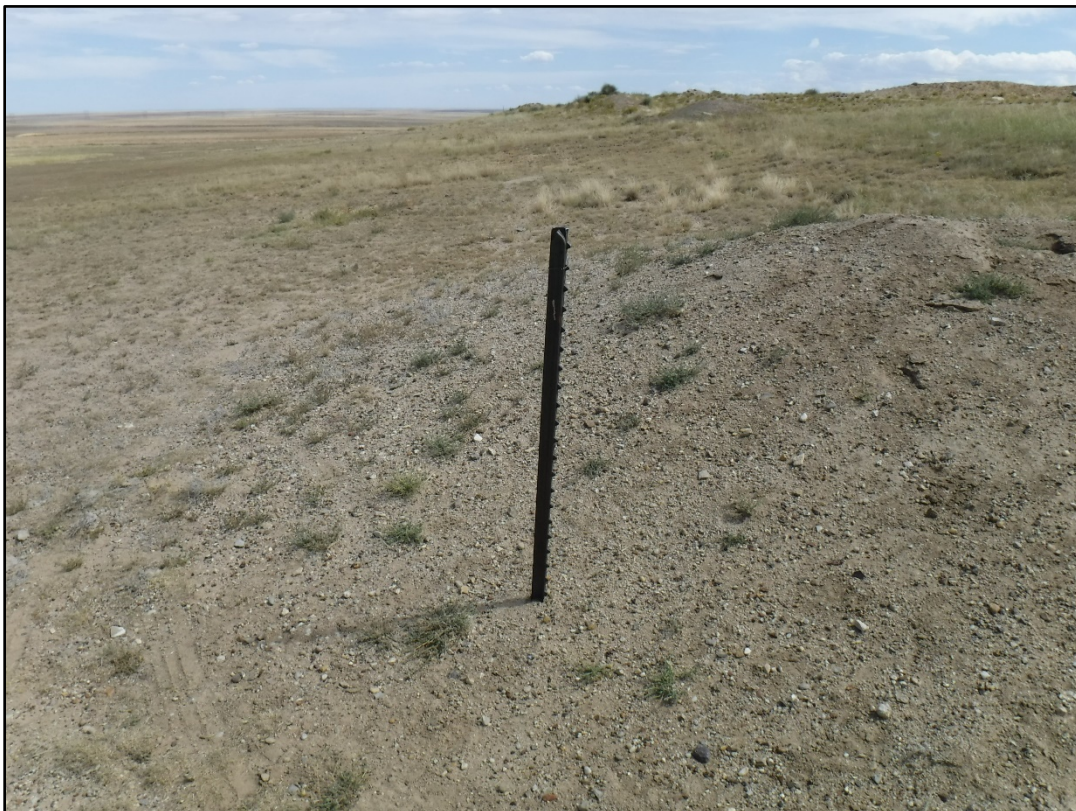
The Division was able to GPS all permit boundary markers. All areas affected by mining are within the permit boundaries.

Photo 2: Typical permit boundary marker

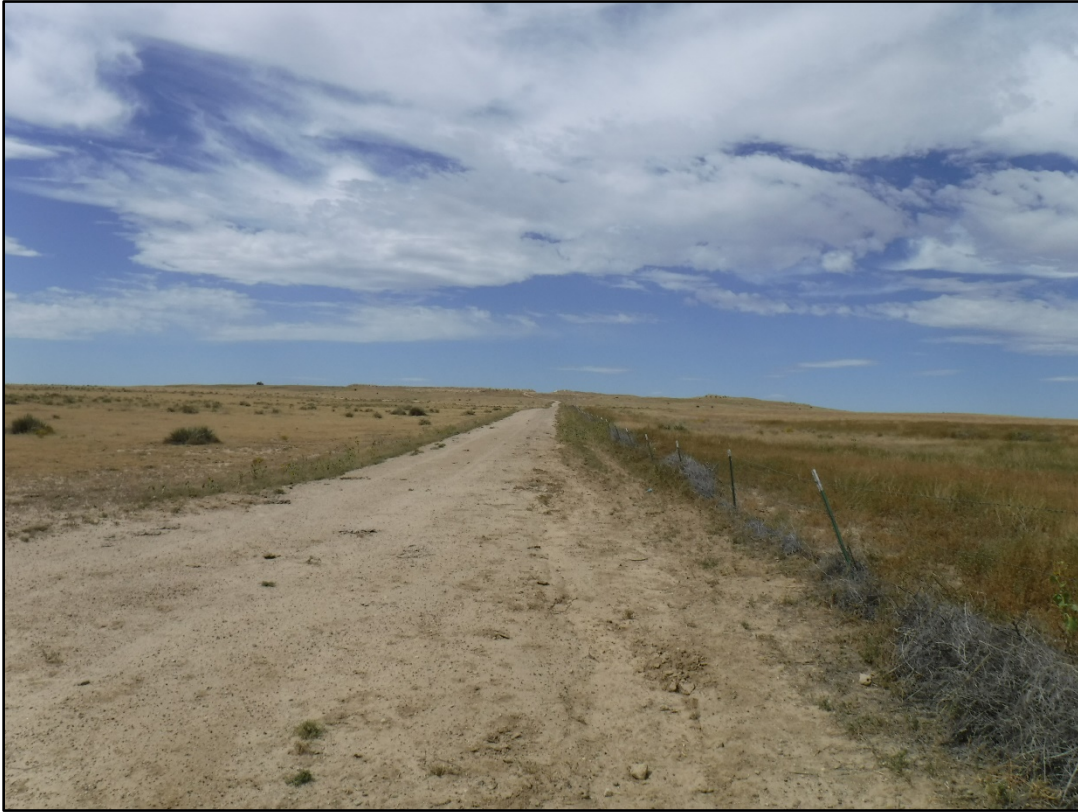
Photo 3: Haul road leading from County Road to pit area

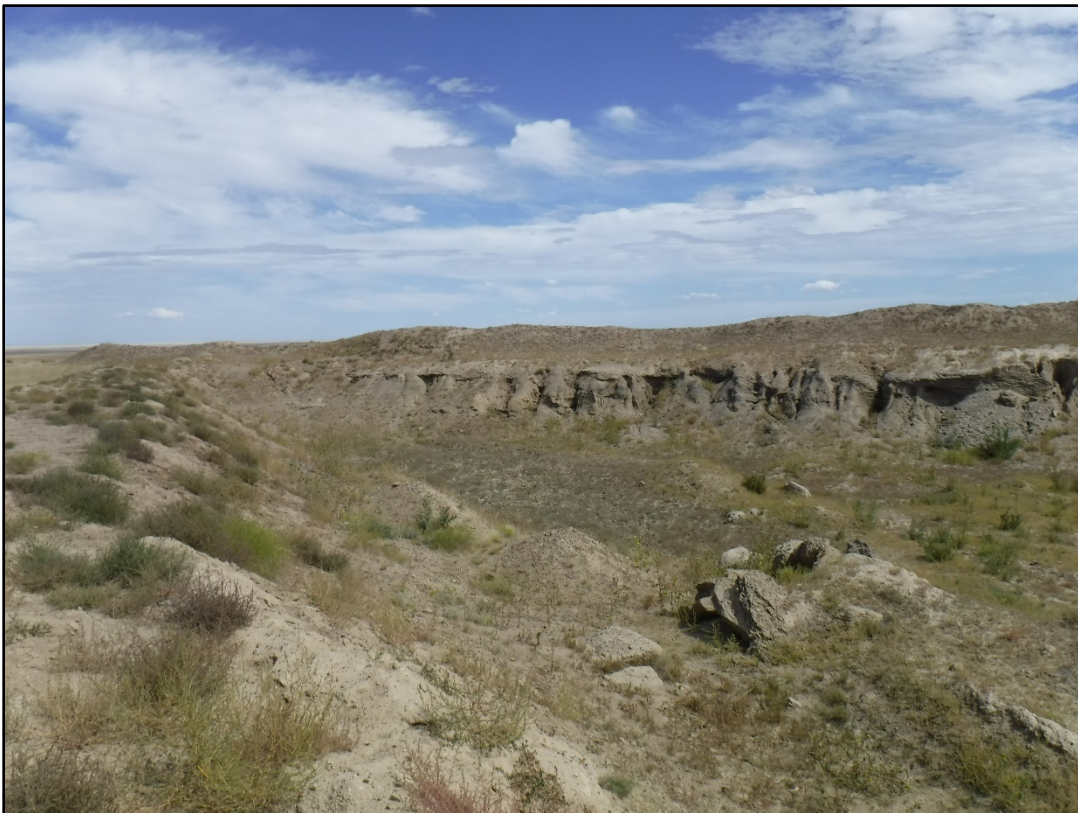
The site was not active at the time of the inspection, however they were in the process of mobilizing a dozer to the site to begin mining operations. Mr. Spady stated that the pit usually is worked in October of every year unless the county sees significant flooding. The active pit is approximately 15-20 feet in depth. The mined walls have slope gradients ranging from approximately 1H:1V to 3H:1V. The pit appeared to be stable with no erosion problems observed. A few material stockpiles were scattered around the pit area.

Photo 4: Pit area in the northern area of permit

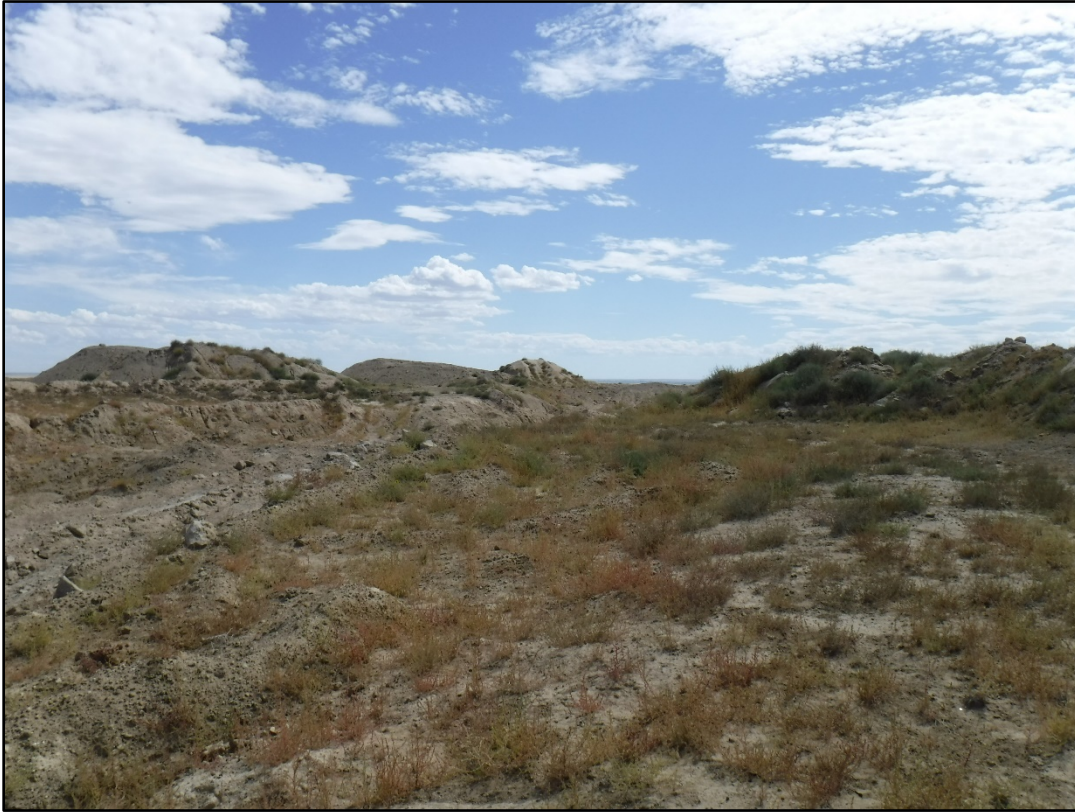
Topsoil has been stripped, and is stored in berms along the perimeter of the pit area. The topsoil stockpiles appeared to be stable with some vegetative cover. Additional topsoil and overburden is stored in the eastern portion of the permit area which was mined first and has been partially reclaimed. According to Mr. Spady, the operation has difficulty with a thick layer of sandstone that varies in depth and thickness across the site. Where the operation is able to break through the sandstone the pit is deeper.

Photo 5: Topsoil stockpile center right of picture and product stockpiles center left of picture

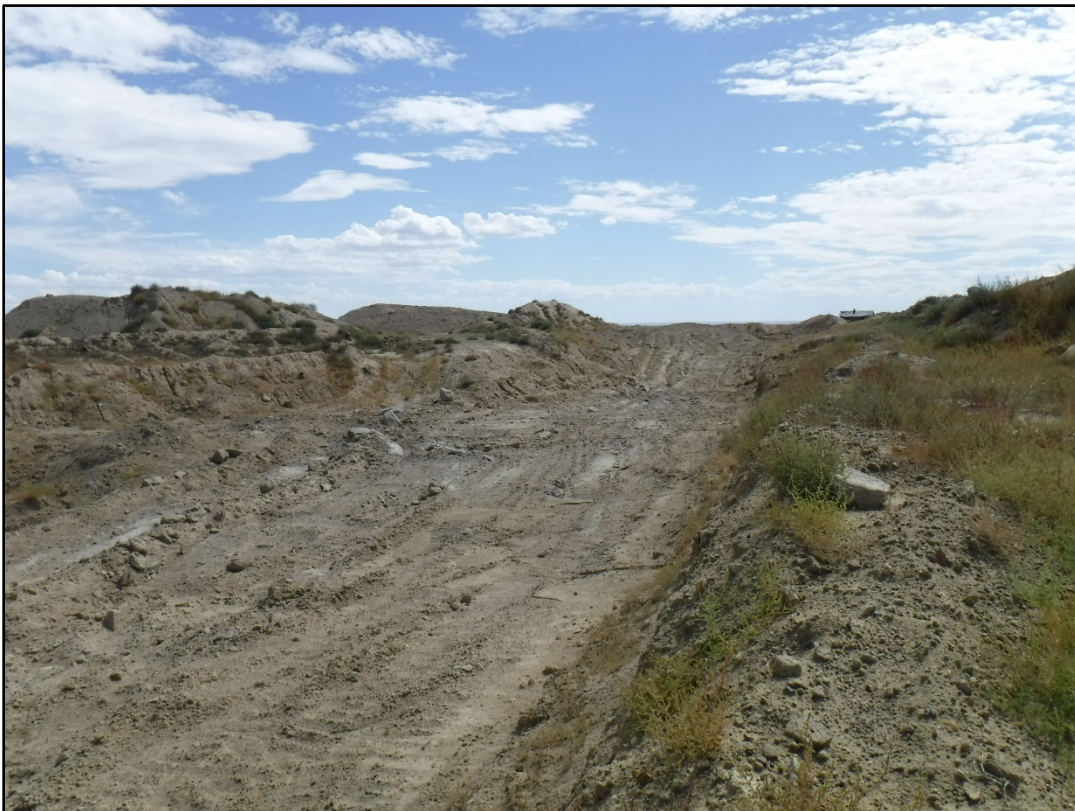
Photo 6: Recent area of activity where a dozer was ripping the sandstone layer

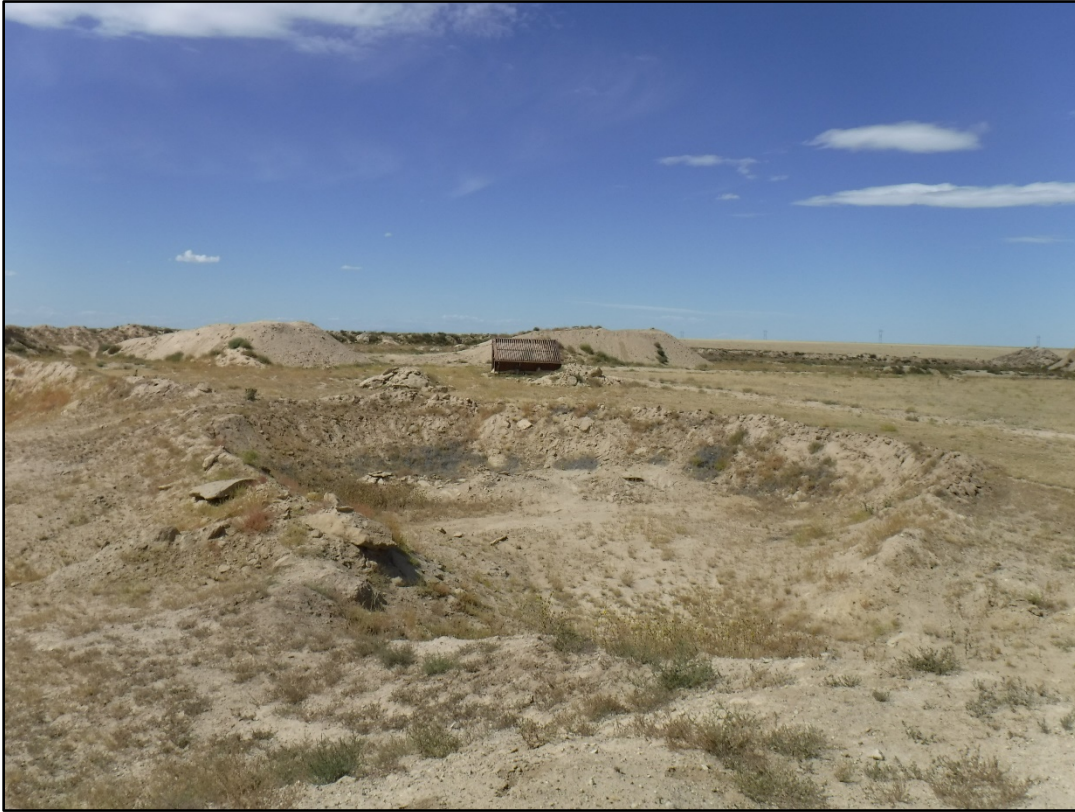
Photo 7: Shallow excavation area where the sandstone prevented deeper excavating

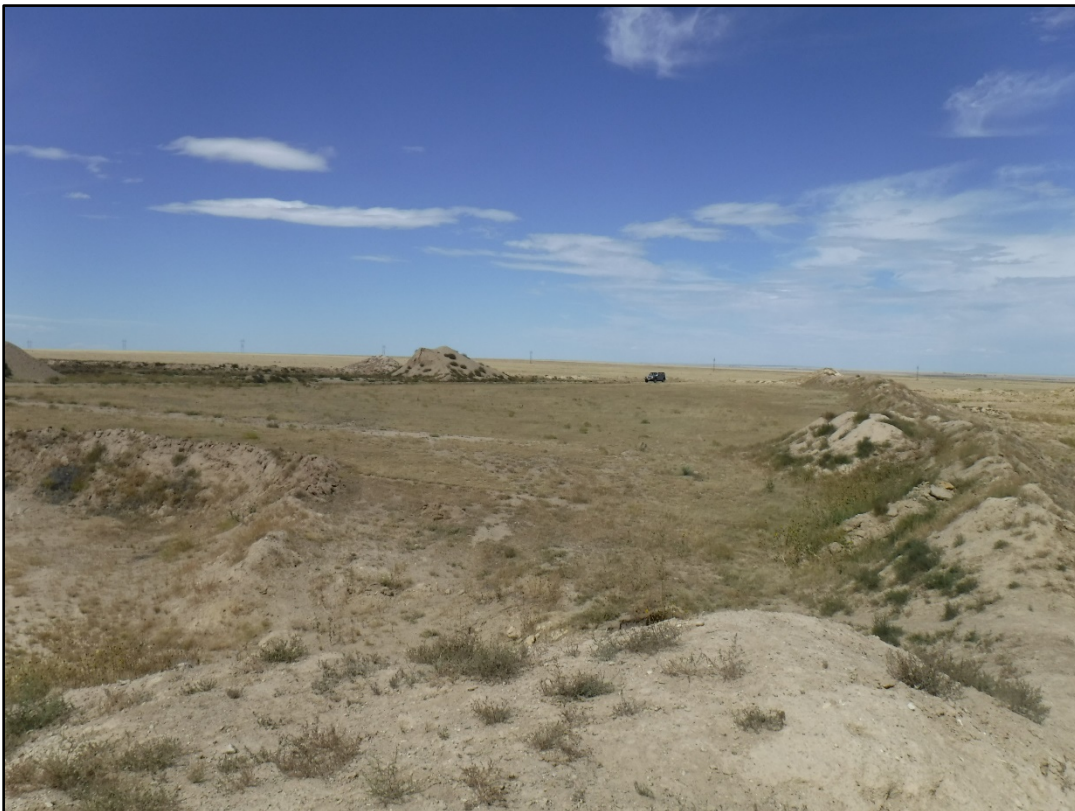
Photo 8: Looking northwest across the central portion of the permit at areas to be mined
