Division of Reclamation,
Mining and Safety

MINERALS PROGRAM INSPECTION REPORT

MINE NAME: Detroit City Mine	MINE/PROSPECTING ID#: M-2017-003	MINERAL: Gemstones	COUNTY: Park
INSPECTION TYPE: Monitoring	INSPECTOR(S): Elliott R. Russell	INSP. DATE: August 29, 2019	INSP. TIME: 09:15
OPERATOR: Colorado Calumet Co., Inc.	OPERATOR REPRESENTATIVE: Graham Sutton	TYPE OF OPERATION: 110(1) - Hard Rock Limited Impact

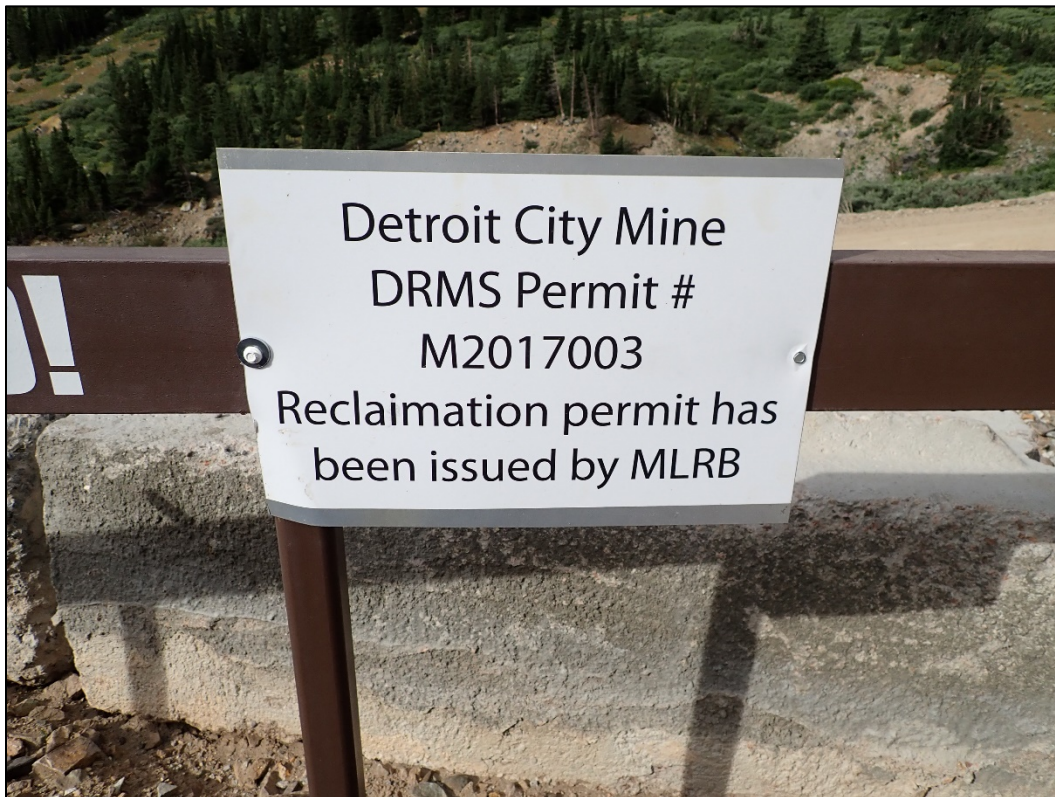
Signs and Markers: The mine identification sign was posted at the entrance of the mine site. The sign will need to include the name of the Operator in accordance with Rule 3.1.12(1). The boundary of the permit was delineated by tall rebar stakes with red plastic caps. It appeared several of the markers were not in place, however this is not cited as a compliance problem at this time as the corrective action regarding the off-site disturbance will be to expand the permit boundary whereas new markers in new locations will be required in accordance with Rule 3.1.12(2).

Photo 1. Mine identification sign; looking west.

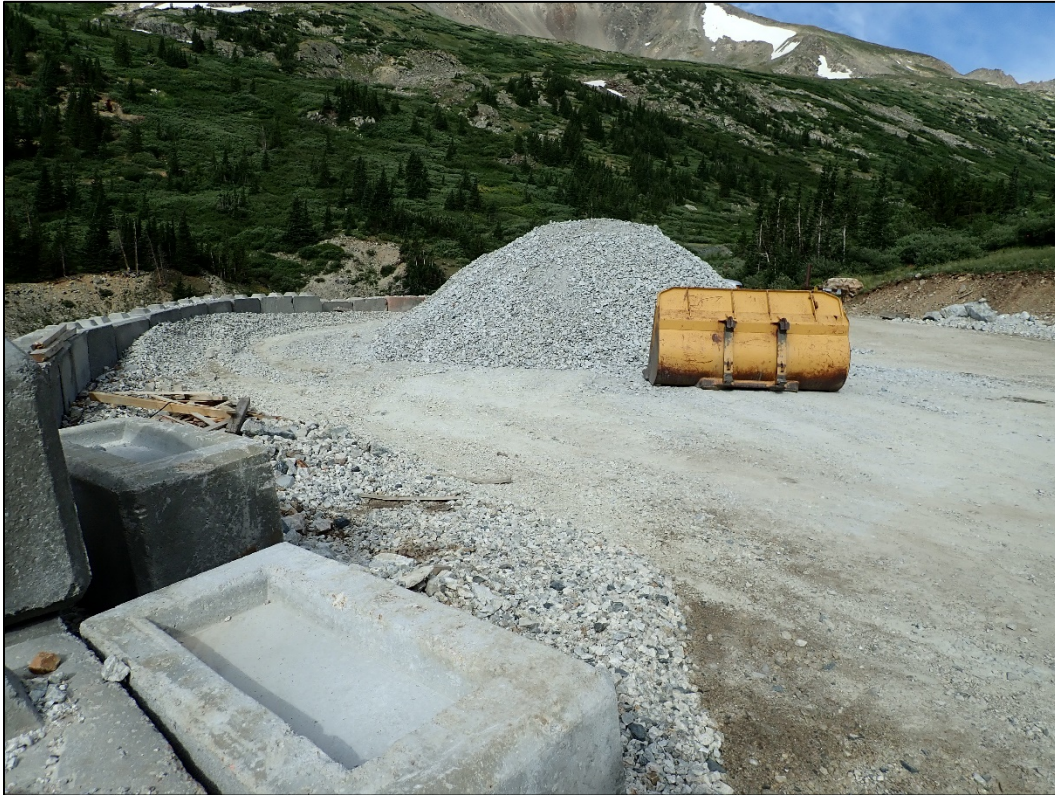
Photo 2. Working pad area located near the site entrance; looking west.

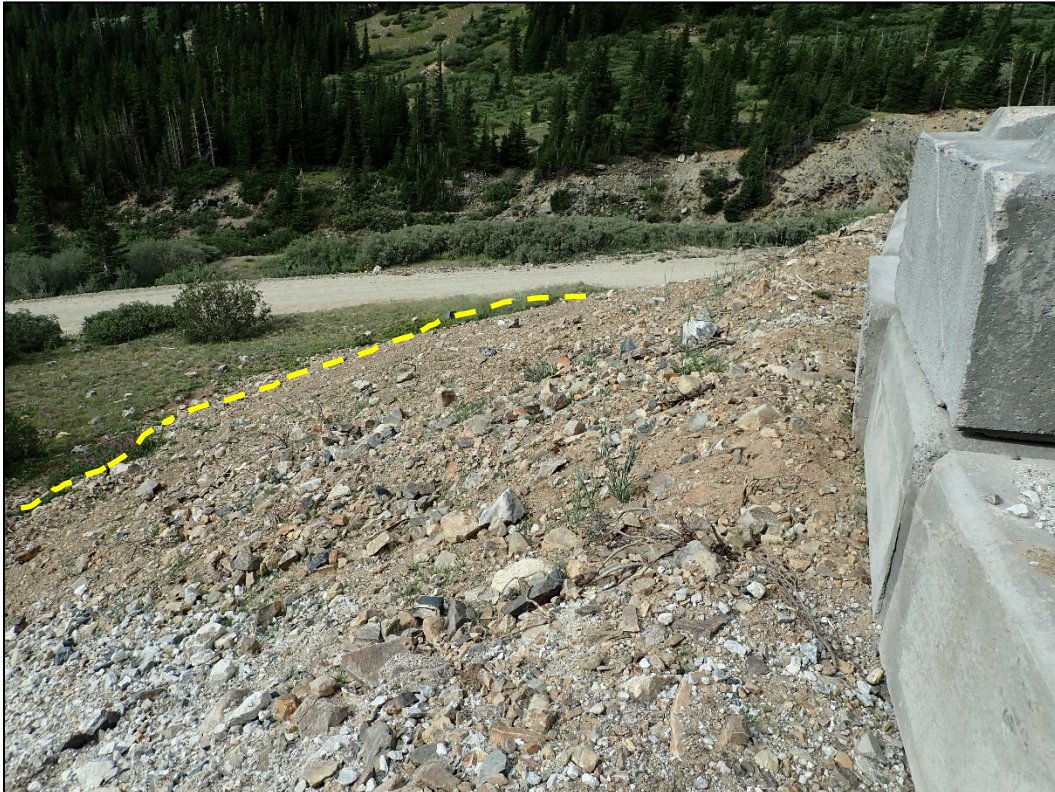
COMPLIANCE PROBLEM #4: The out-slope of the of the waste rock dump is awaiting for vegetation establishment, however there are no temporary measures in place to protect the slope from erosion which could result in off-site sedimentation. This is a problem pursuant to C.R.S. 34-32-116(7)(i).

Sediment Control: The Division inspected the working pad constructed near the entrance to the site. The out-sloping face of this pad has been recently seeded. While this area is awaiting vegetation to establish, there is a potential for erosion and sedimentation of off-site lands. This has been cited as Compliance Problem #4, requiring the Operator to establish temporary erosion control measures. This area is shown in **Photographs 3-5** with a suggested silt-fence alignment depicted by the yellow-dashed line.

Photo 3. Out-slope of the working pad area where BMPs are needed; looking west.

CORRECTIVE ACTIONS: The operator shall implement erosion control measures on the waste rock dump and provide photo documentation to the Division by the corrective action due date.

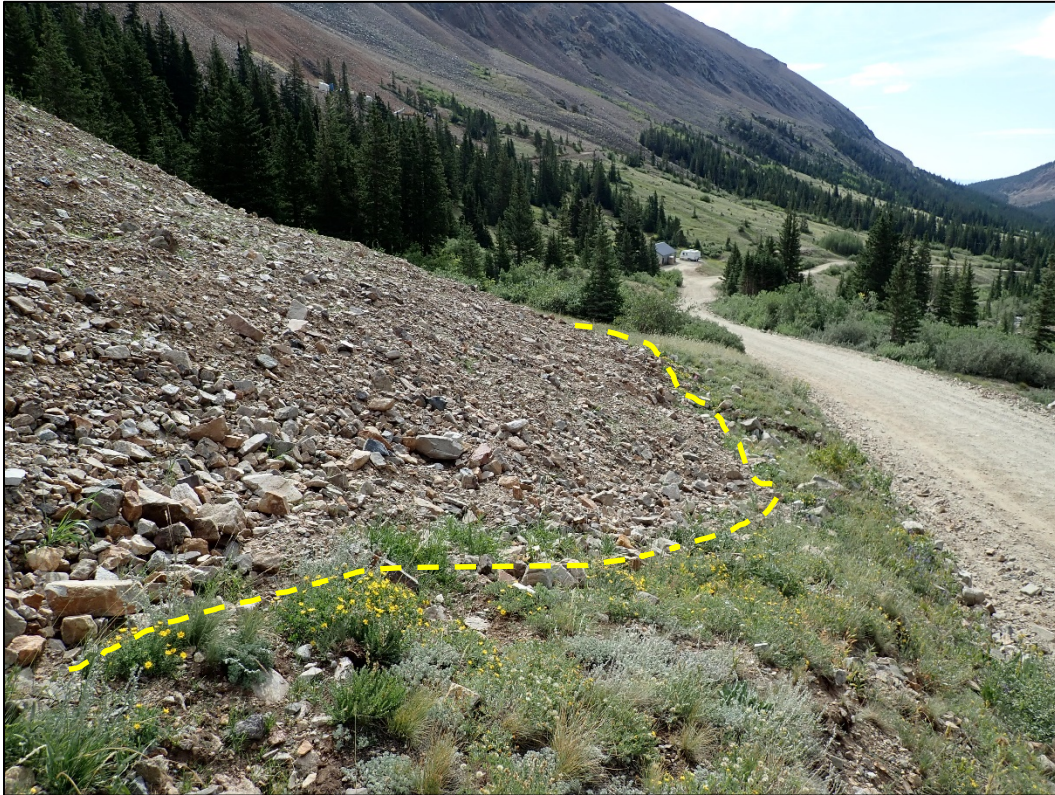
Photo 4. Out-slope of the working pad area where BMPs are needed; looking southeast.

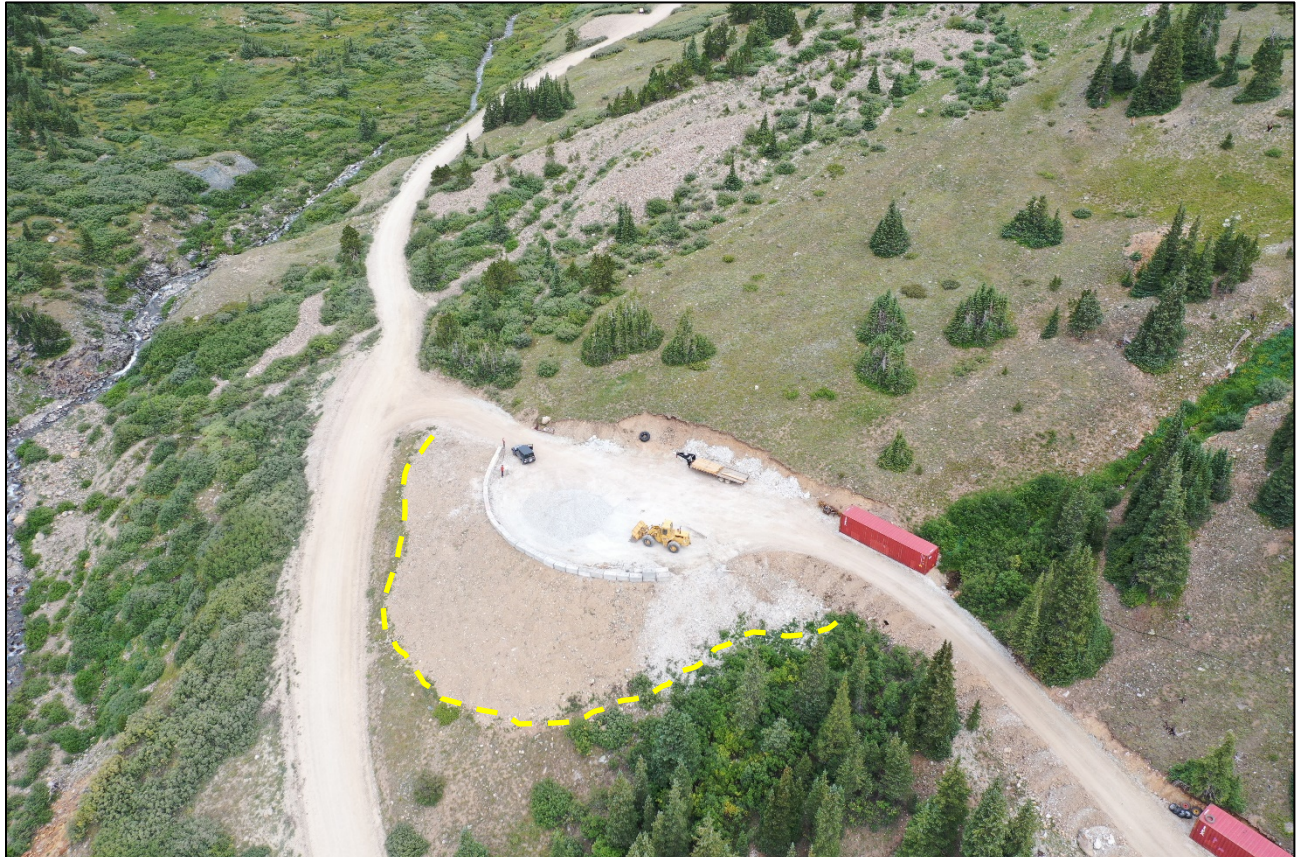
Photo 5. Overview of the working pad area near the entrance to the site; looking northeast.

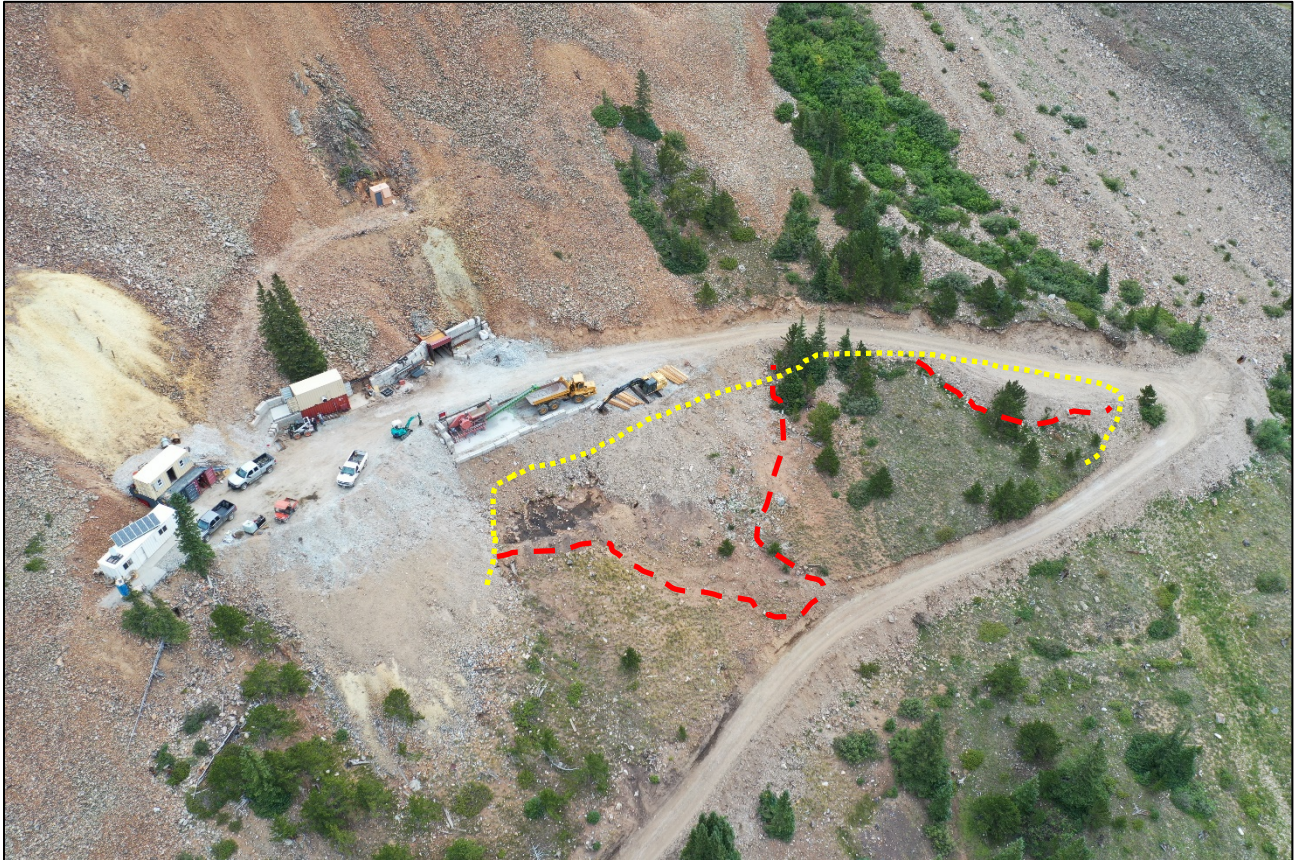
POSSIBLE VIOLATION: Land has been affected by the mining operation outside of the approved permit boundary. This is a possible violation of C.R.S. 34-32-116(7)(h) for failure to protect areas outside of the affected land from slides or damages occurring during the mining operation.

Off-site Damage: The Operator depicted two disturbed areas on the 2018-2019 Annual Report Map (attached) outside of the permit boundary and labeled it as "2018 Activity: Turnaround Pad." During the inspection the Division observed these areas, which matched the area depicted on the annual report map. The larger of the two areas is near the portal where the crusher is located and the haul truck is parked. The smaller area is near the switch-back along the haul road. Both areas appear to have been created to allow more room for the mining operation. The larger off-site disturbance also contains a stormwater sump at the toe of the disturbance. The

Photo 6. Overview of the mine site with permit boundary (yellow dotted line) and off-site disturbance area (red dashed line) approximated; looking east.

CORRECTIVE ACTIONS: This possible violation will require a hearing before the Mined Land Reclamation Board scheduled for the October 23-24, 2019 Board meeting. The schedule and other details for the MLRB hearing will be provided under a separate document to be sent via certified mail to the Operator.

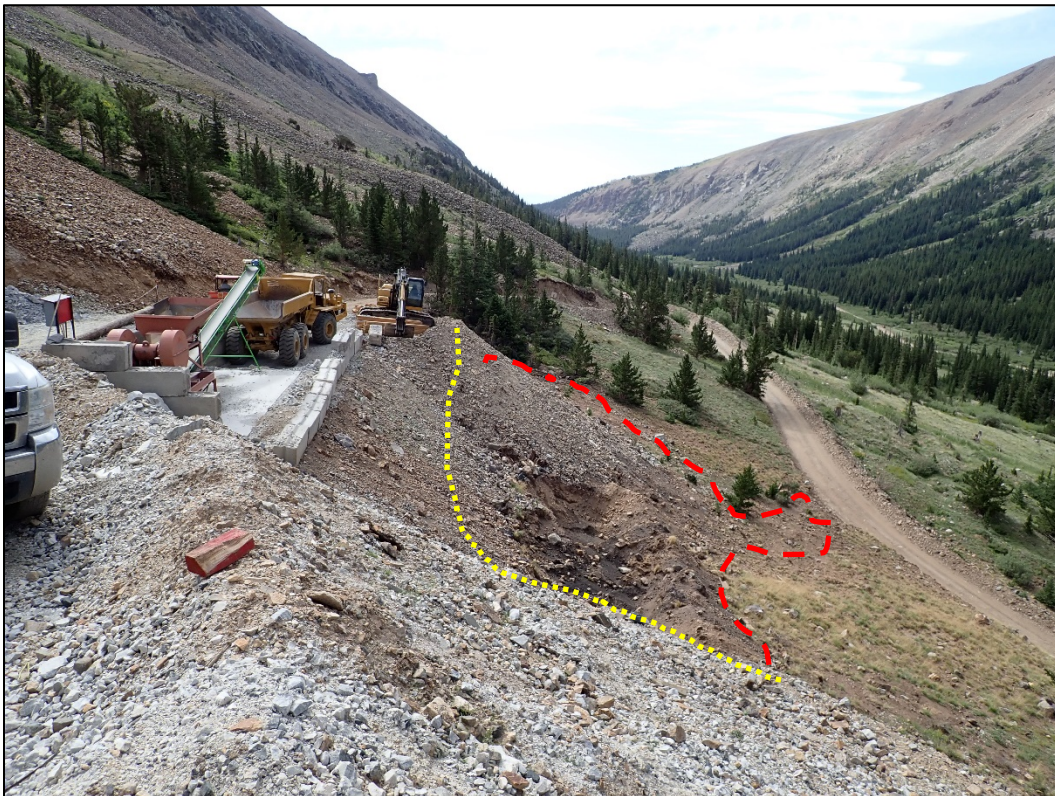
Photo 7. Off-site area near portal; looking southeast.

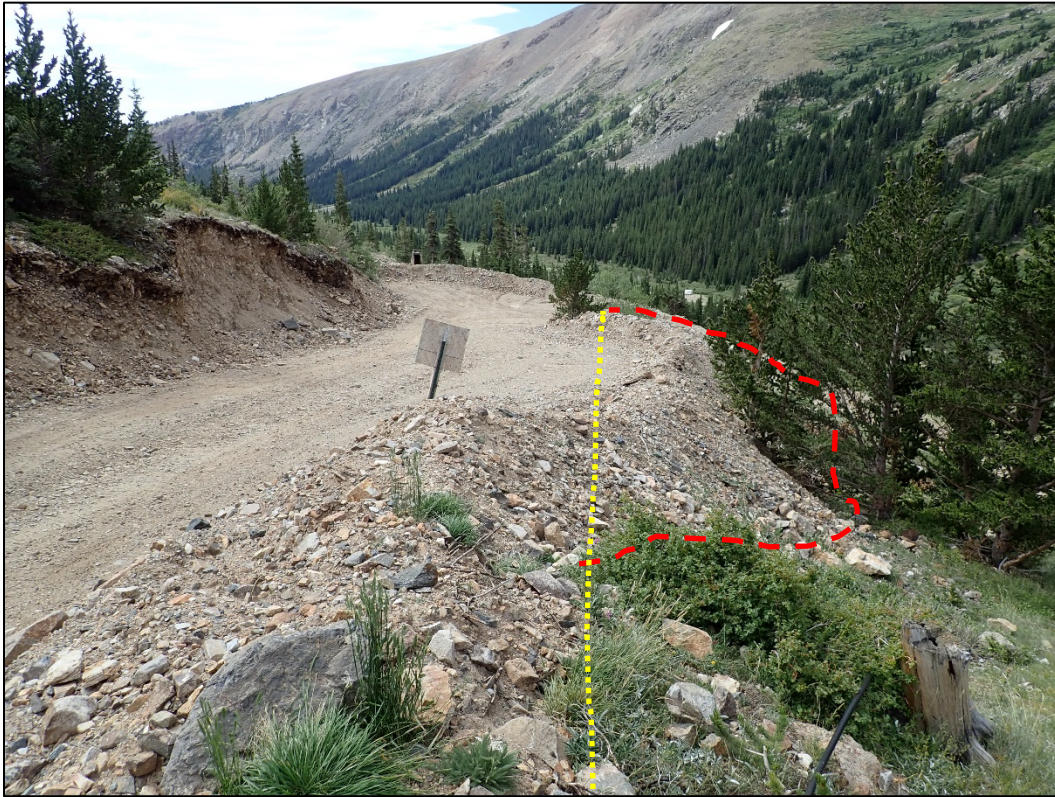
Photo 8. Off-site area near the switchback; looking south.
