MINERALS PROGRAM INSPECTION REPORT
PHONE: (303) 866-3567

MINE NAME: Everitt Pit	MINE/PROSPECTING ID#: M-2004-037	MINERAL: Gravel	COUNTY: Phillips
INSPECTION TYPE: Monitoring	INSPECTOR(S): Brock F. Bowles	INSP. DATE: August 29, 2019	INSP. TIME: 11:00
OPERATOR: John M. Everitt	OPERATOR REPRESENTATIVE: John Everitt	TYPE OF OPERATION: 110c - Construction Limited Impact	
REASON FOR INSPECTION: Normal I&E Program	BOND CALCULATION TYPE: Complete Bond	BOND AMOUNT: \$14,900.00	
DATE OF COMPLAINT: NA	POST INSP. CONTACTS: None	JOINT INSP. AGENCY: None	
WEATHER: Clear	INSPECTOR'S SIGNATURE:

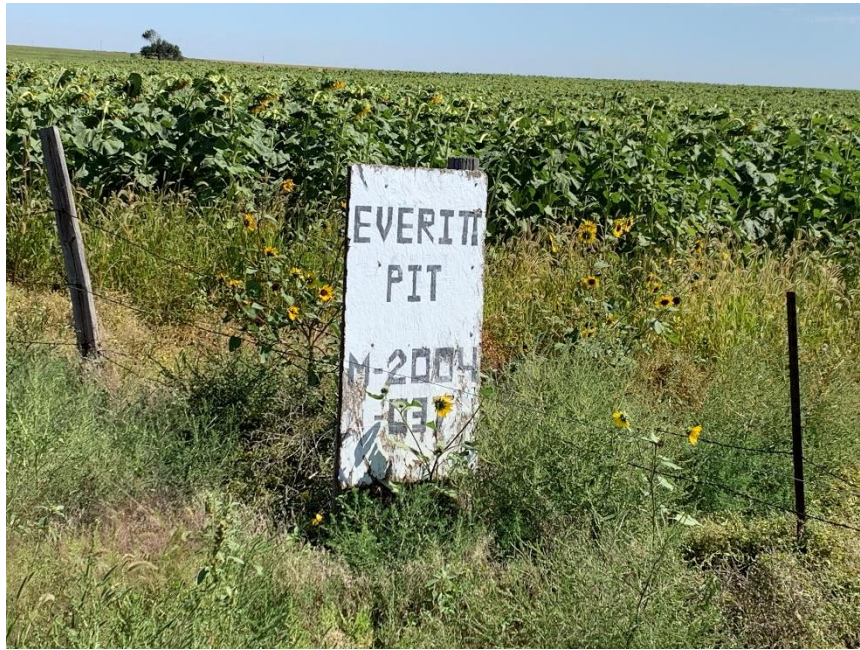
The permit identification sign was in place at the mine entrance and legible. The permit boundary markers were in place and visible. No mining activity was being conducted and no equipment was on site.

Mine entrance sign along County Road 16

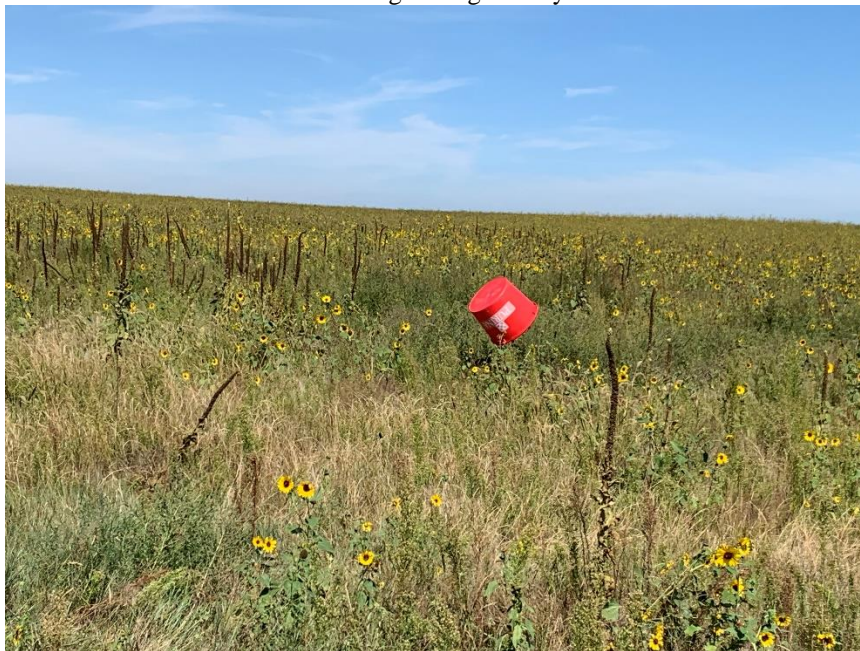
Permit boundary marker on northeast corner

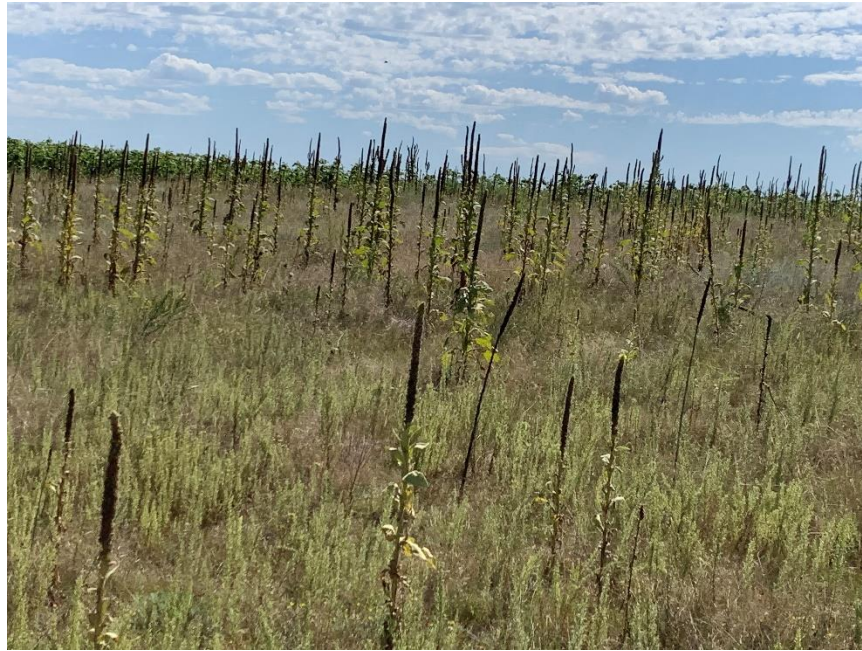
The pit area had a large stand of common mullein. Mullein is a Colorado Dept. of Ag List C species and is on the Phillips County list of species that needs to be controlled. For more information and to develop a plan to treat the mullein, please contact the Phillips County Weed and Pest District Manager.

Mullein plants that need to be controlled
