MINERALS PROGRAM INSPECTION REPORT
PHONE: (303) 866-3567

MINE NAME: Borrow Area C	MINE/PROSPECTING ID#: M-1981-086	MINERAL: Sand and gravel	COUNTY: Grand
INSPECTION TYPE: Monitoring	INSPECTOR(S): Peter S. Hays	INSP. DATE: September 17, 2019	INSP. TIME: 10:00
OPERATOR: N Colo Water Conservancy Dist.	OPERATOR REPRESENTATIVE: Craig Friar	TYPE OF OPERATION: 112c - Construction Regular Operation

September 17, 2019 Inspection Map

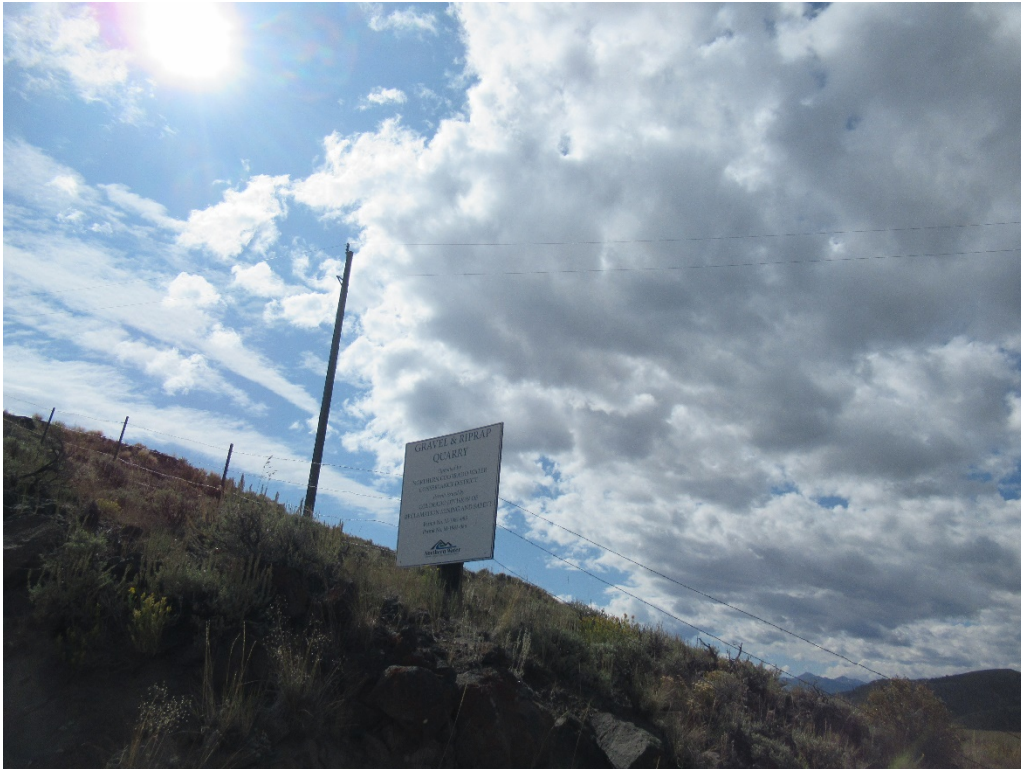
Borrow Area C mine sign

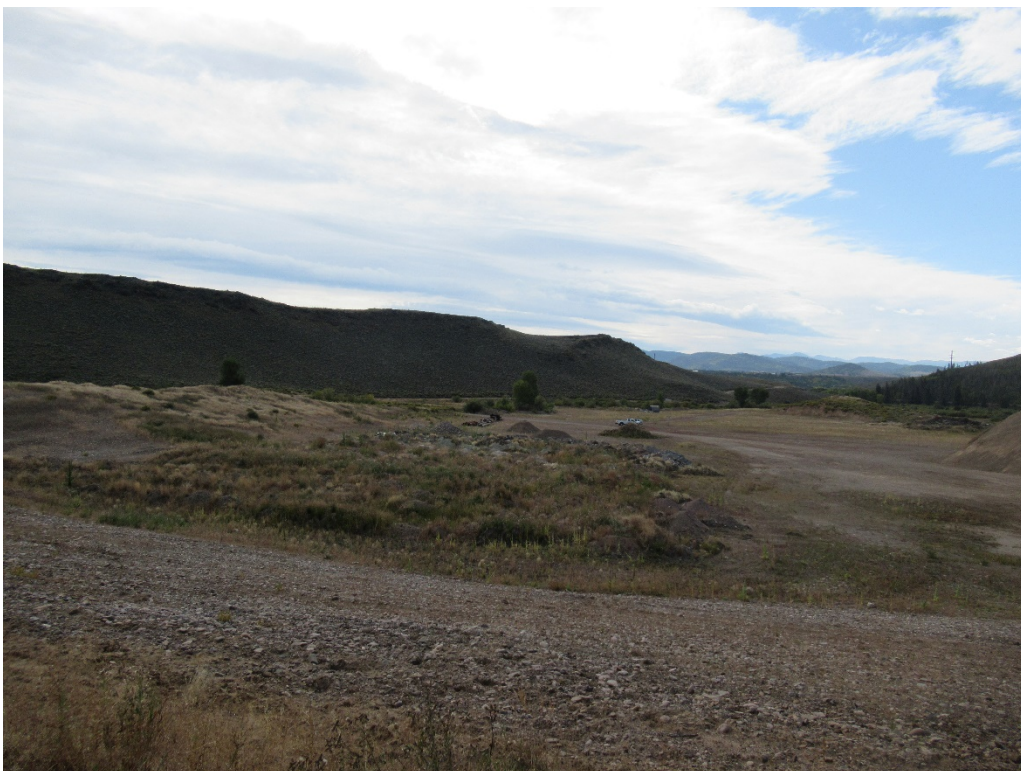
View of the site (imported material stockpiles) from the north highwall looking southeast

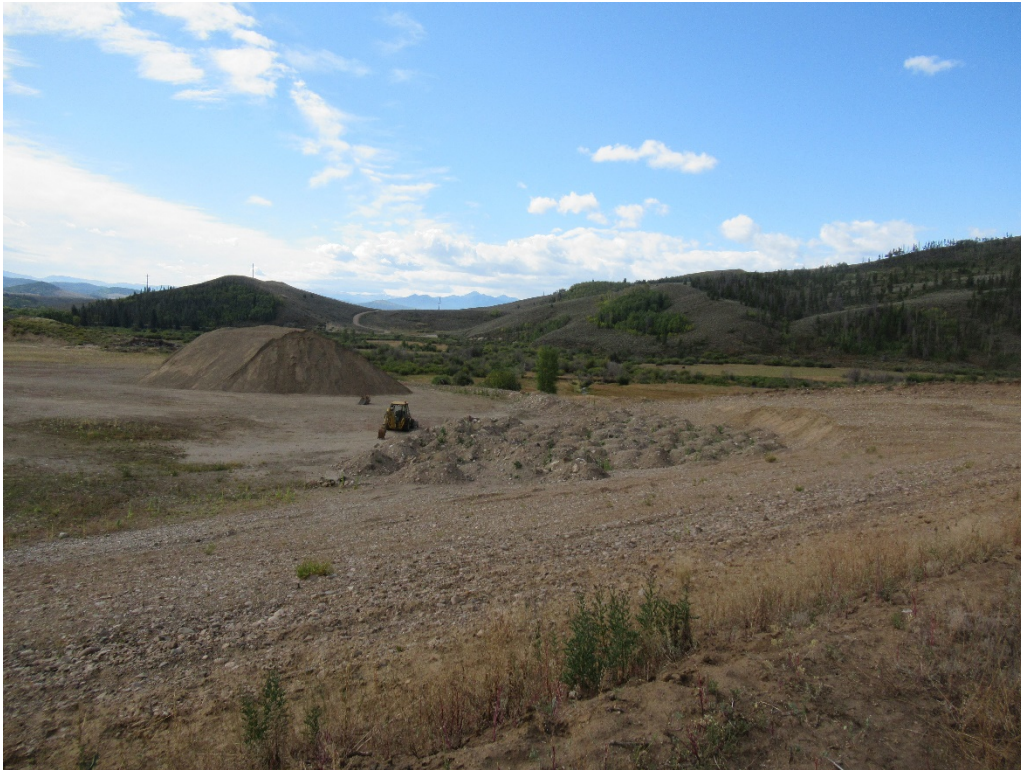
View of the site (road base and imported material stockpiles) from the north highwall looking southwest

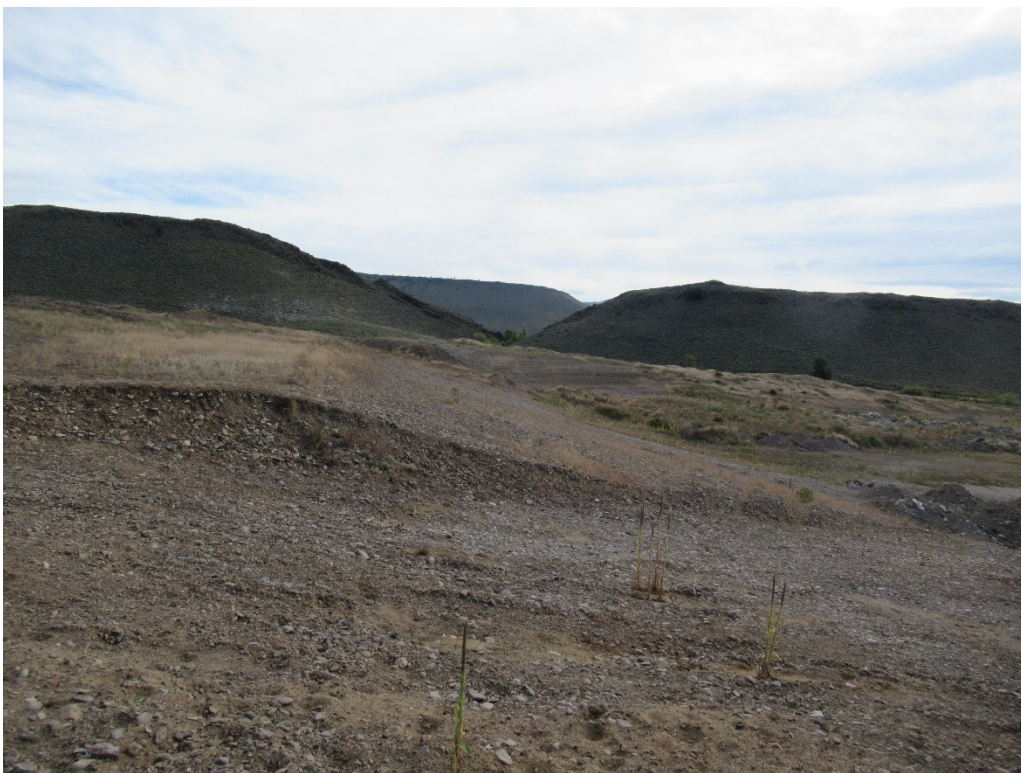
View of the temporarily sloped highwall from the west end looking east

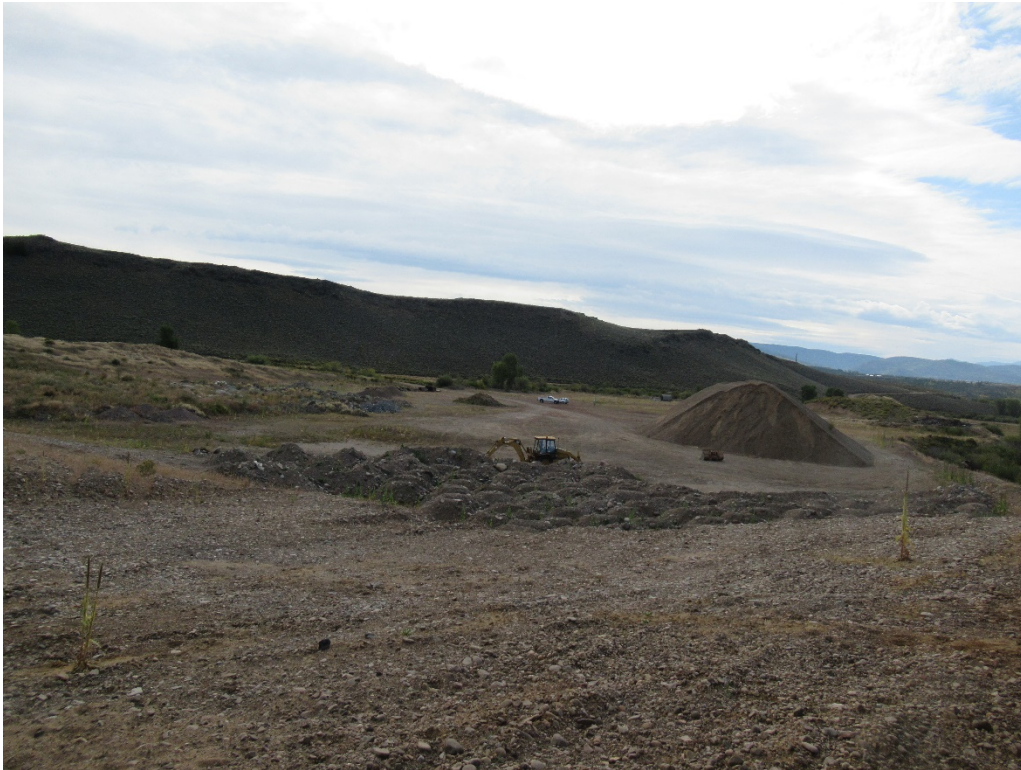
View of the site from the west end of the highwall looking southeast

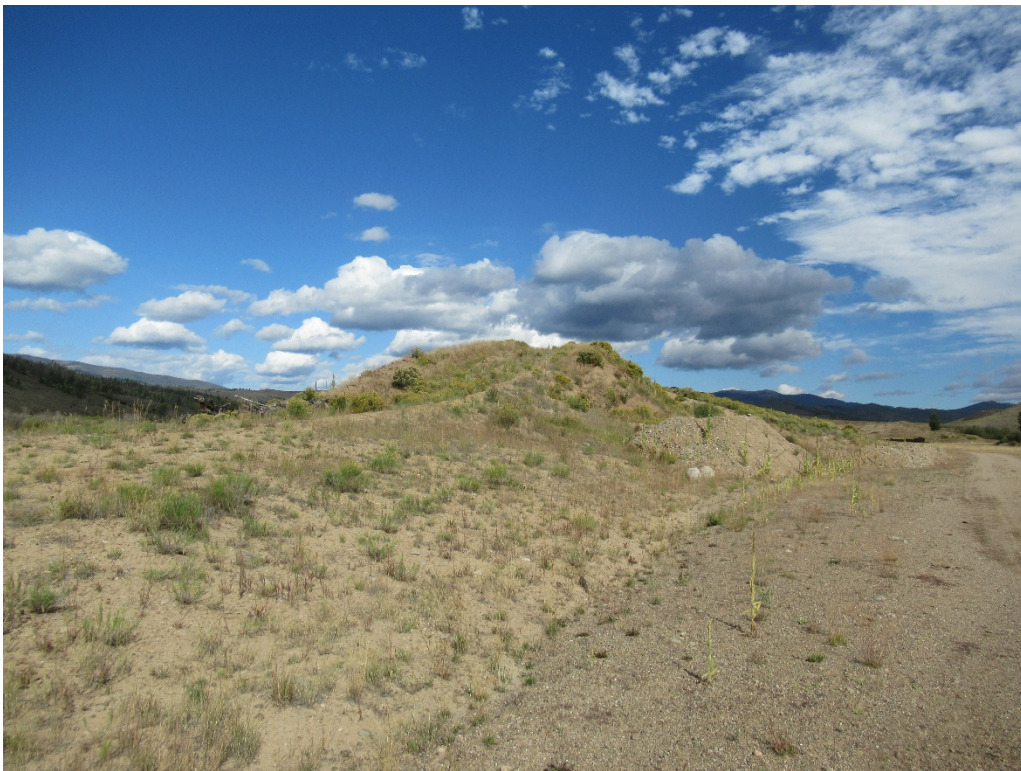
View of the topsoil and overburden stockpiles

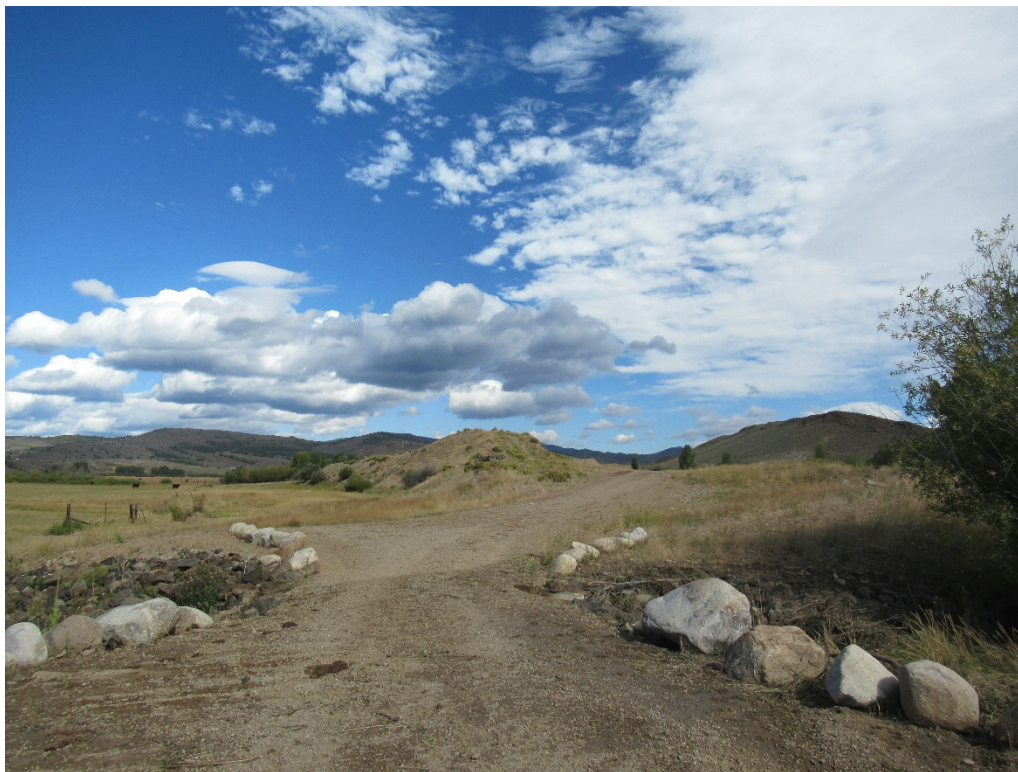
View of the site from the south access road looking north
