MINERALS PROGRAM INSPECTION REPORT
PHONE: (303) 866-3567

| MINE NAME: Henderson Mine | MINE/PROSPECTING ID#: M-1977-342 | MINERAL: Molybdenum | COUNTY: Clear Creek, Grand |
| INSPECTION TYPE: Monitoring | INSPECTOR(S): Peter S. Hays | INSP. DATE: September 18, 2019 | INSP. TIME: 09:00 |

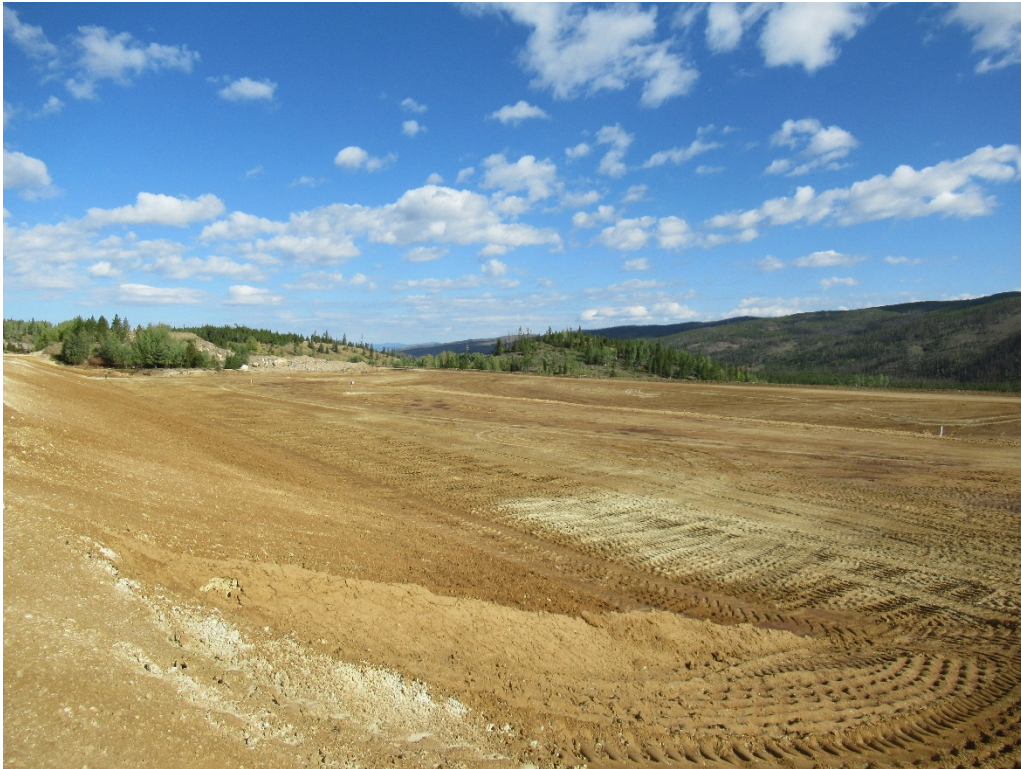
The 3-Dam Buttress – Stage 1 project approved under TR-29 by the Division on April 4, 2018 is complete. All buttress material is placed and instrumentation including two (2) piezometers and two (2) inclinometers were installed. The surface of the buttress was sprayed with Coherex to prevent wind erosion. The Operator will survey the buttress and produce as-built drawings as required by Rule 7.3.1. The design for Phase 2 of the buttress project is expected to occur over the winter with construction of the Phase 2 occurring next summer.

View of the complete 3-Dam buttress – Phase 1 from the southwest corner of the buttress looking northwest

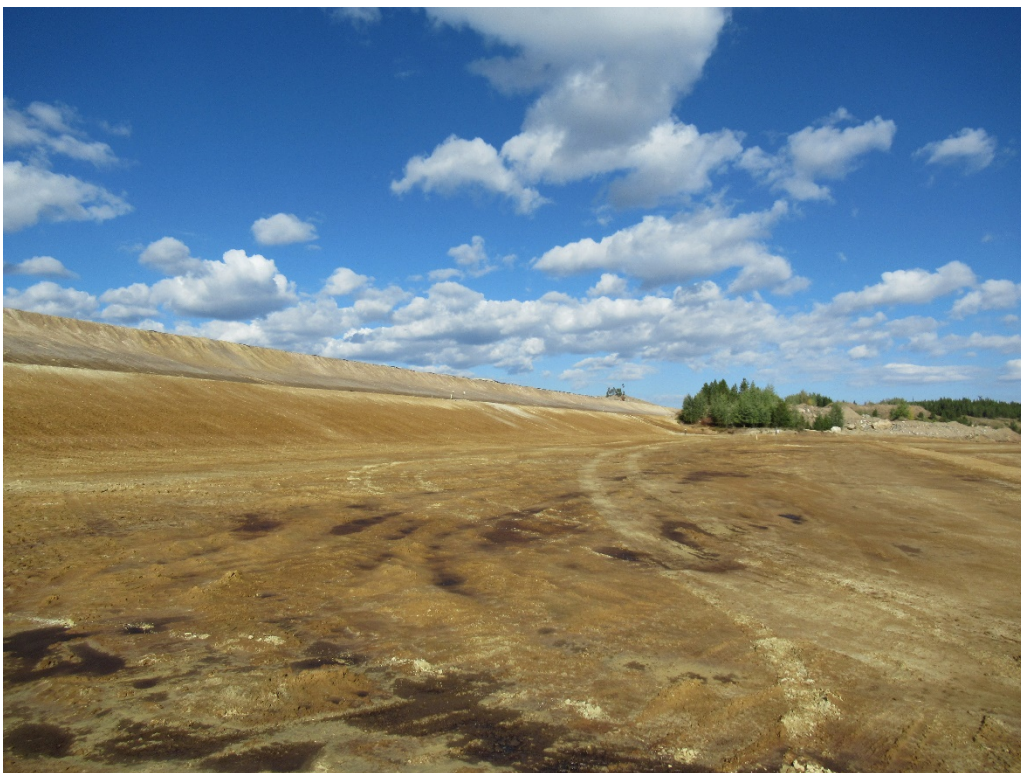
View of the complete 3-Dam buttress – Phase 1 from the southeast corner of the buttress looking northeast

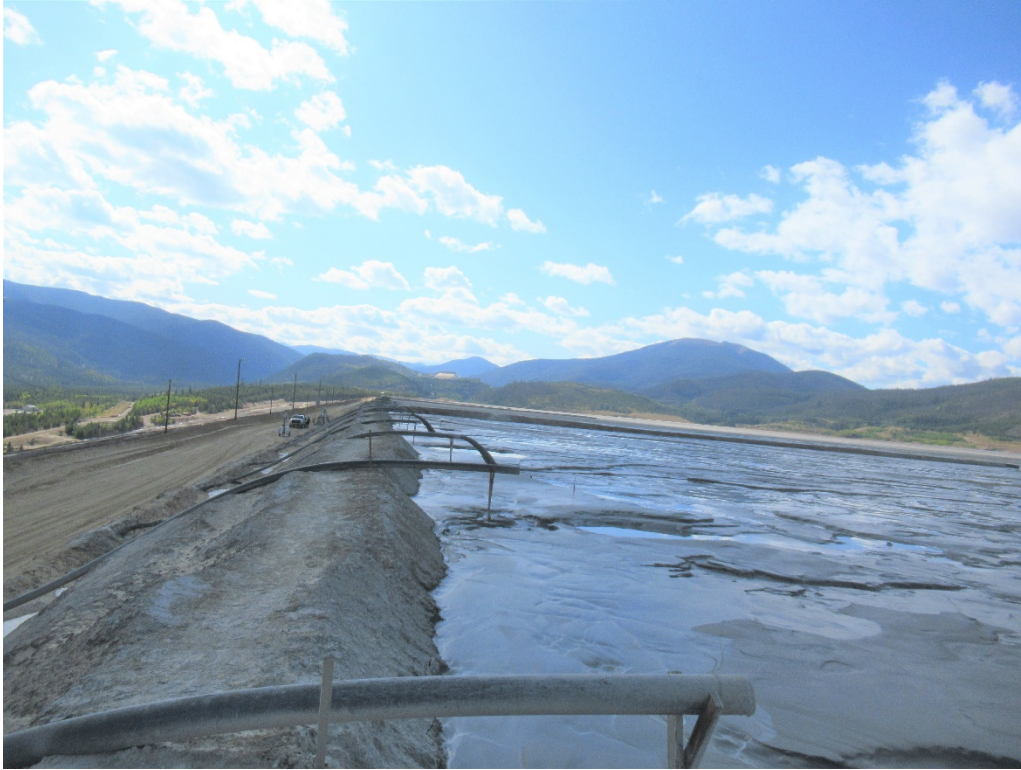
Tailings deposition via spigot in the 3-Dam cells is scheduled for later this year and will consist of one deposition. Tailings deposition via spigot in the 1-Dam cells is progressing from south to north. Tailings deposition was observed in cells 6 and 7 during the inspection. Cells 8 and 9 were prepared for deposition and were observed during the inspection.

View of tailing deposition in 1-Dam Cell 6 looking south

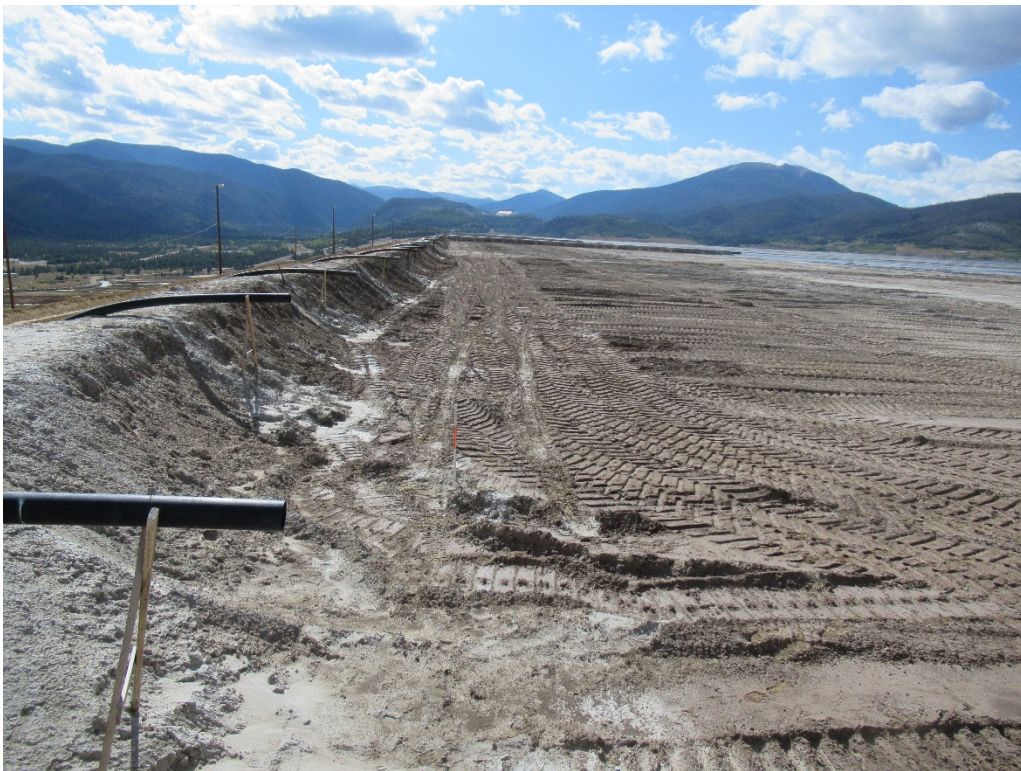
View of prepared 1-Dam Cell 8 looking south

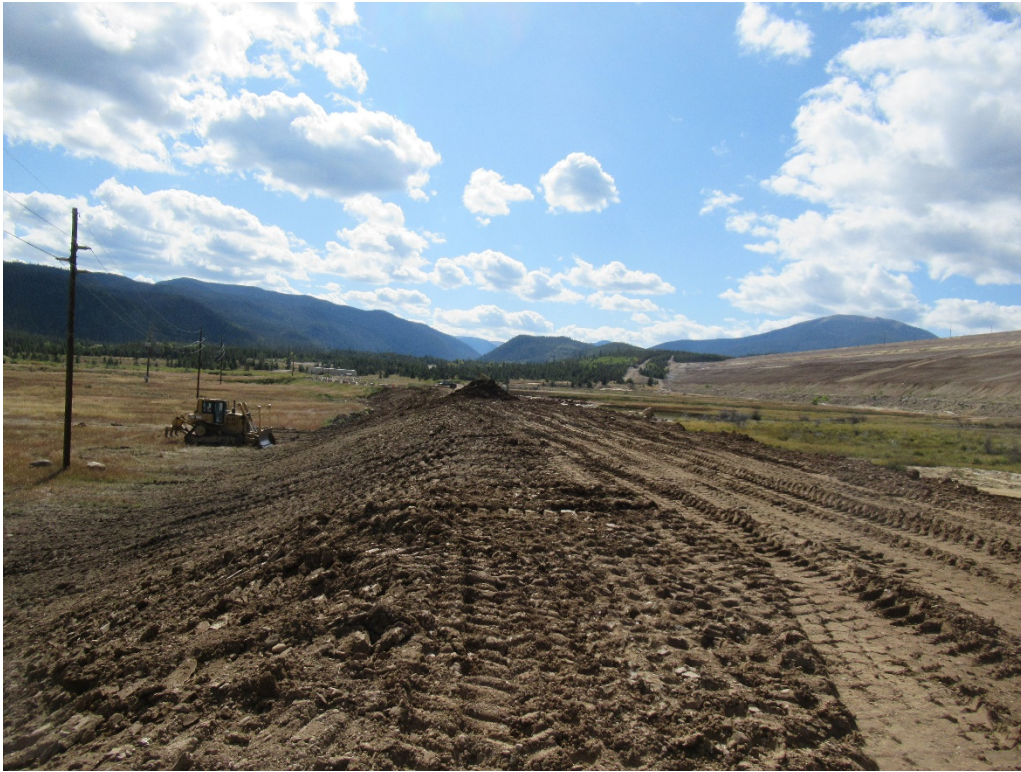
The 1-Dam Seep Water Collection and Return System Improvements project approved under TR-30 by the Division on November 1, 2018 was observed during the inspection. The culvert extensions, gate operation electronics raises and installing new communications cabling for the gate controls were completed last year. Material was being placed on the north portion of the road before the junction with the north feeder channel access road. The material was delivered by haul truck, graded with a tracked dozer and compacted with a sheepsfoot compactor. The backfill material will be covered by eight (8) inches of road base to construct the road surface. The northern portion of the seep road will accommodate 2-way traffic with the remainder of the seep road south of the north feeder channel accommodating 1-way traffic.

View of fill material on the southern portion of the 1-Dam seep road

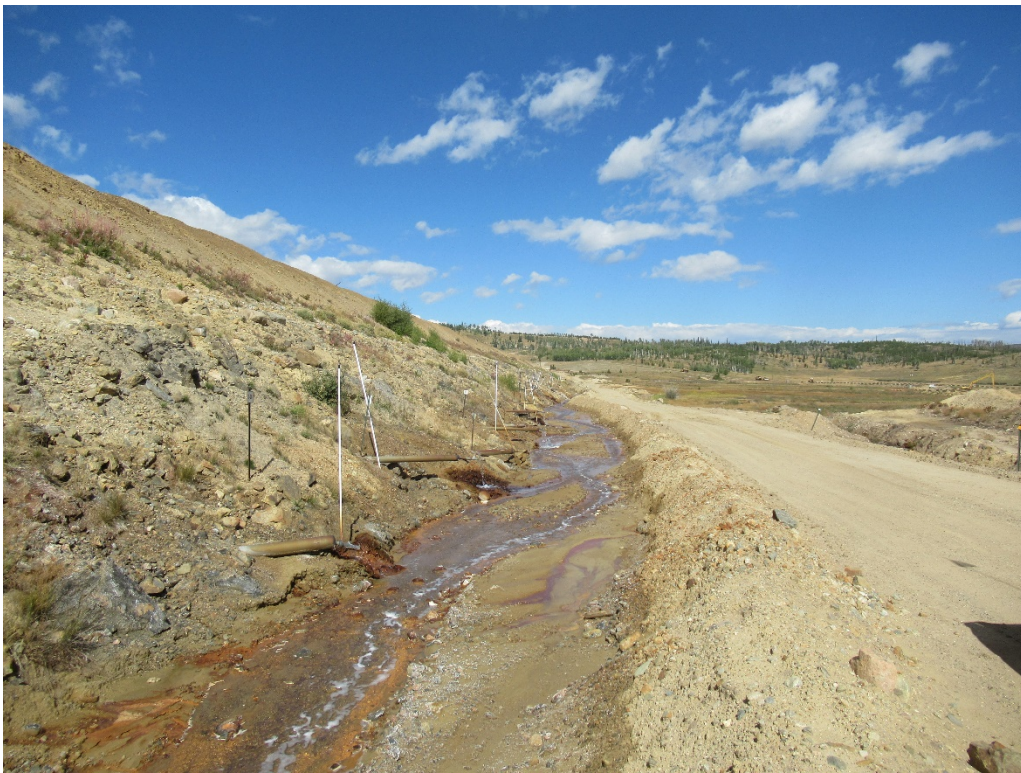
Henderson stated three (3) additional horizontal drains would be installed this year. The foundation drains under the impoundments were discussed and several of the active drains were observed during the inspection.

View of 1-Dam horizontal drains looking north

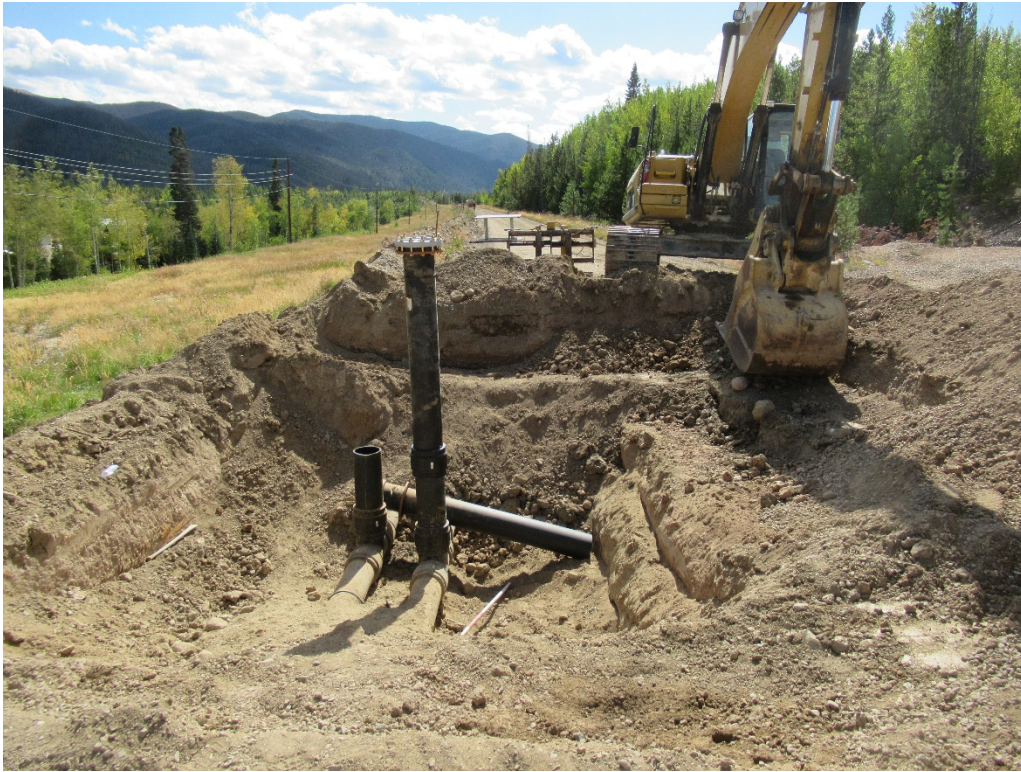
The 3-Dam Seepwater Return Line Clean-out Port project approved under TR-31 by the Division on July 10, 2019 was observed during the inspection. The 3-Dam Seepwater pipelines consist of two (2) 10 inch diameter HDPE lines, one (1) primary and one (1) backup. The project was on-going during the inspection. The project was delayed due to the amount of sediment in the line requiring additional flushing and cleaning of the lines than anticipated by the Operator. All six (6) of the new ports were plumbed into the existing lines with molded tees. The fusing of the southernmost riser for the primary line was observed during the inspection. The Operator stated the primary line would be pressure tested soon. The fusing of the risers for the backup line will follow and the excavations will be backfilled once the pressure tests are complete. Bollards will be installed adjacent to the clean-out port for protection.

View of the north 3-Dam Seepwater additional clean-out port

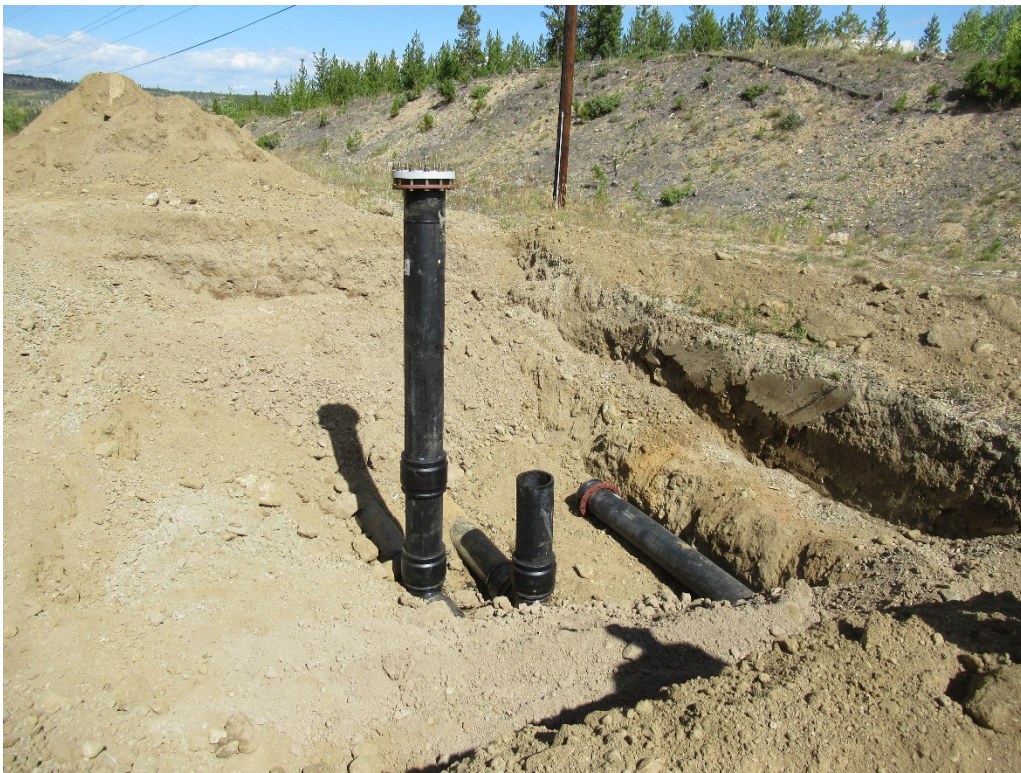
View of the middle 3-Dam Seepwater additional clean-out port

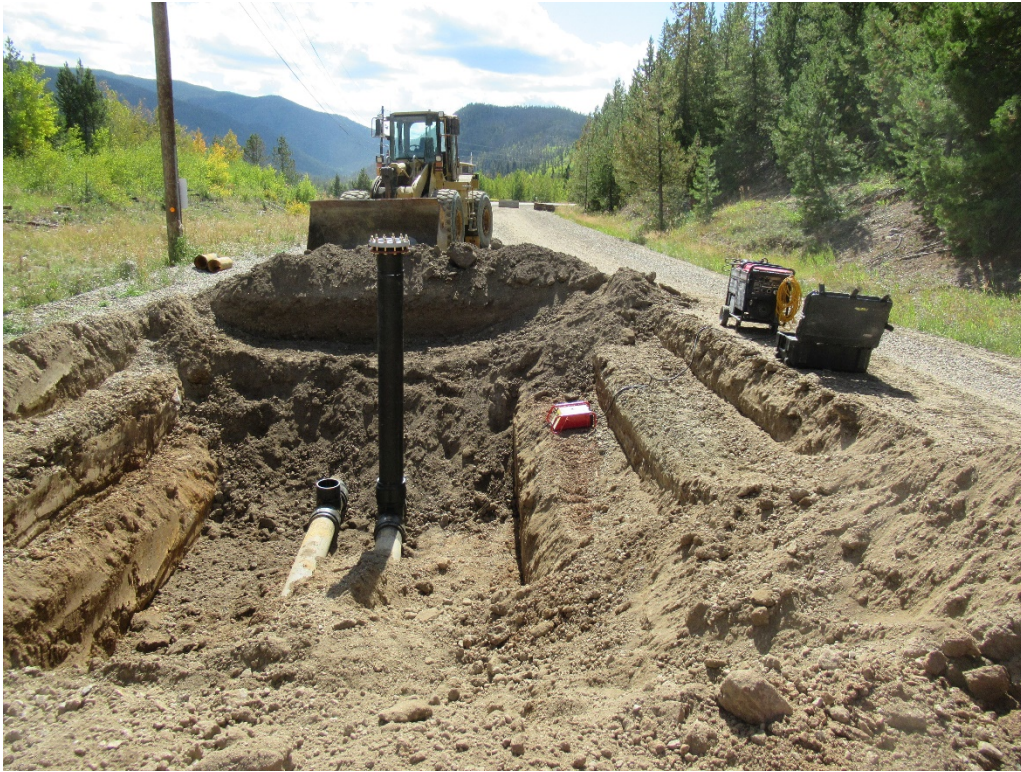
View of the south 3-Dam Seepwater additional clean-out port
