MINERALS PROGRAM INSPECTION REPORT
PHONE: (303) 866-3567

MINE NAME: C-LP-21 Mine	MINE/PROSPECTING ID#: M-1977-305	MINERAL: Uranium and vanadium	COUNTY: Montrose
INSPECTION TYPE: Monitoring	INSPECTOR(S): Dustin M. Czaplá	INSP. DATE: September 12, 2019	INSP. TIME: 11:30
OPERATOR: Cotter Corporation	OPERATOR REPRESENTATIVE: Scott Pottorfs	TYPE OF OPERATION: 112d-1 - Designated Mining Operation	
REASON FOR INSPECTION: Normal I&E Program	BOND CALCULATION TYPE: IT.Bondcalculationtype.CD.Desc	BOND AMOUNT: \$100.00	
DATE OF COMPLAINT: NA	POST INSP. CONTACTS: None	JOINT INSP. AGENCY: None	
WEATHER: Clear	INSPECTOR'S SIGNATURE:

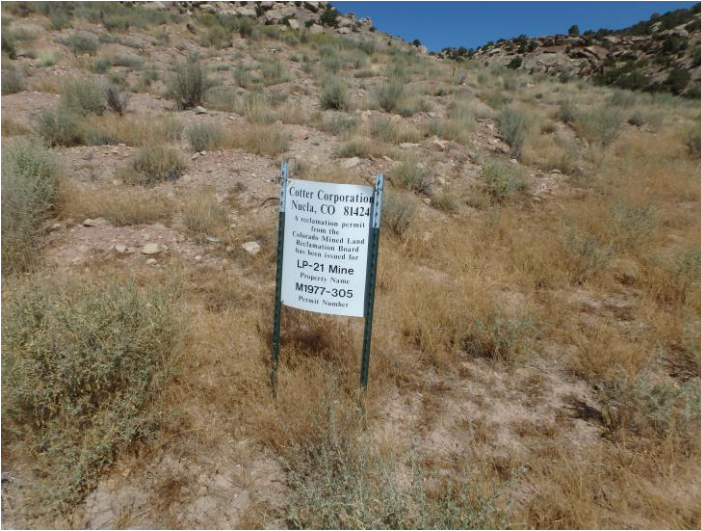
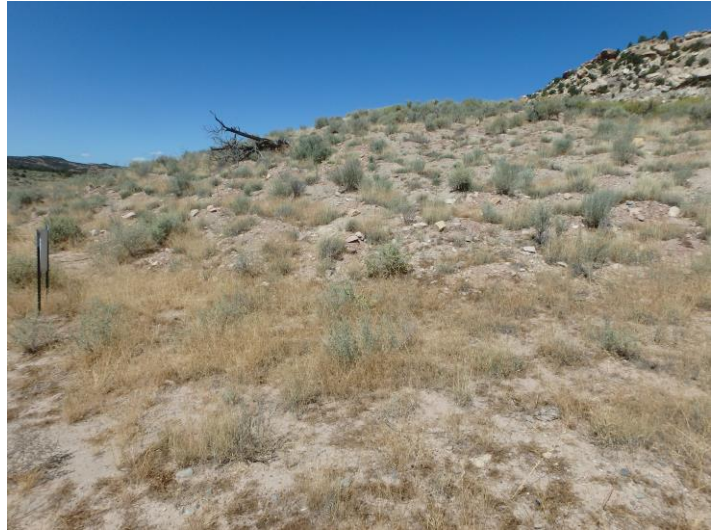
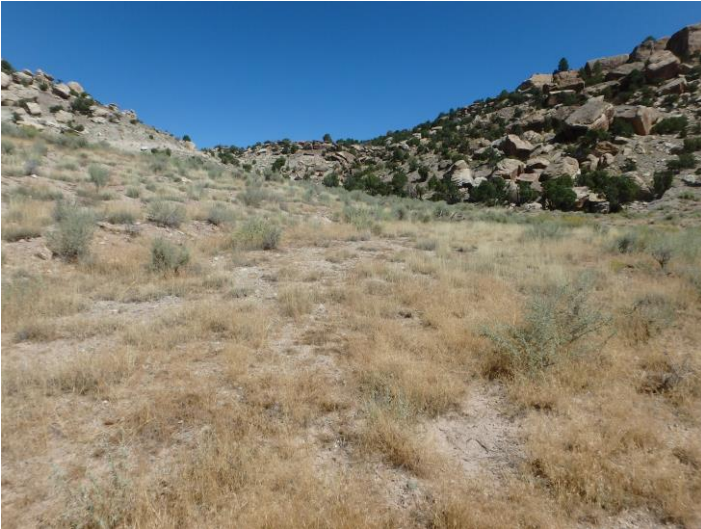
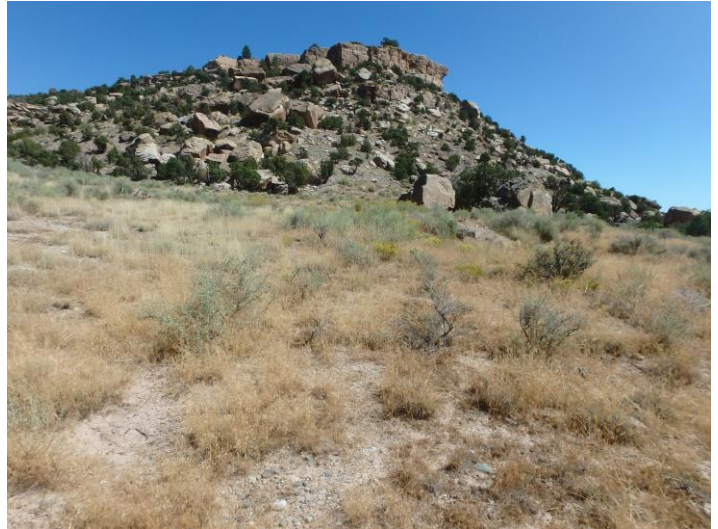
According to the operator's annual reports, final reclamation was completed at this site in February, 2003. All reclaimed slopes appeared stable and vegetation is well established over the reclaimed areas.
