MINERALS PROGRAM INSPECTION REPORT PHONE: (303) 866-3567

MINE NAME:	MINE/PI	ROSPECTING ID#:	MINERAL:	COUNTY:	
C-JD-8	M-1984-0	014	Uranium and vanadiu	Montrose	
INSPECTION TYPE:	INSPEC	TOR(S):	INSP. DATE:	INSP. TIME:	
Monitoring	Dustin M	. Czapla	September 12, 2019	15:00	
OPERATOR:	OPERAT	TOR REPRESENTATIVE:	TYPE OF OPERATION:		
Cotter Corporation	Scott Pott	corfs	112d-1 - Designated Mining Operation		
REASON FOR INSPECTION:	BOND C	ALCULATION TYPE:	BOND AMOUNT:		
Normal I&E Program	None		\$69,950.00		
DATE OF COMPLAINT:	POST IN	SP. CONTACTS:	JOINT INSP. AGENCY:		
NA	None		None		
WEATHER:	INSPECTOR'S SIGNATURE:		SIGNATURE DATE:		
Clear	the		September 26, 2019

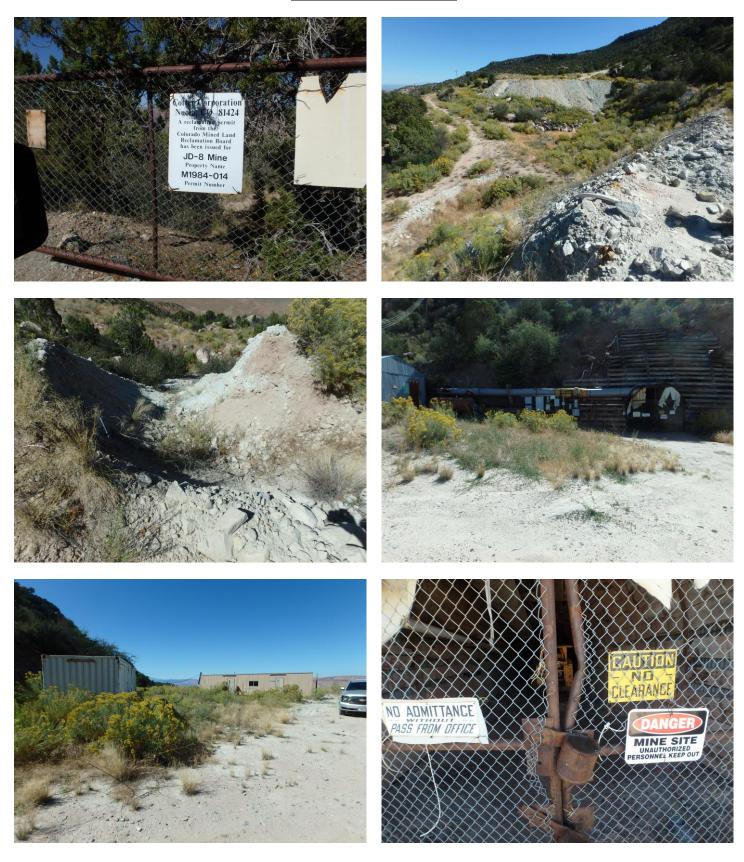
An office building, compressor shed and ventilation system are located on the main mine bench. Unused mining equipment and empty fuel tank have been removed from the site. Stormwater control structures appeared maintained and functional. No problems or violations were noted during this inspection.
