**COLORADO**Division of Reclamation,
Mining and Safety

MINERALS PROGRAM INSPECTION REPORT**PHONE: (303) 866-3567**

MINE NAME: CM-25 Mine	MINE/PROSPECTING ID#: M-1977-307	MINERAL: Uranium and vanadium	COUNTY: Montrose
INSPECTION TYPE: Monitoring	INSPECTOR(S): Dustin M. Czapla	INSP. DATE: September 12, 2019	INSP. TIME: 11:40
OPERATOR: Cotter Corporation	OPERATOR REPRESENTATIVE: Scott Pottorfs	TYPE OF OPERATION: 110d - Designated Limited Impact

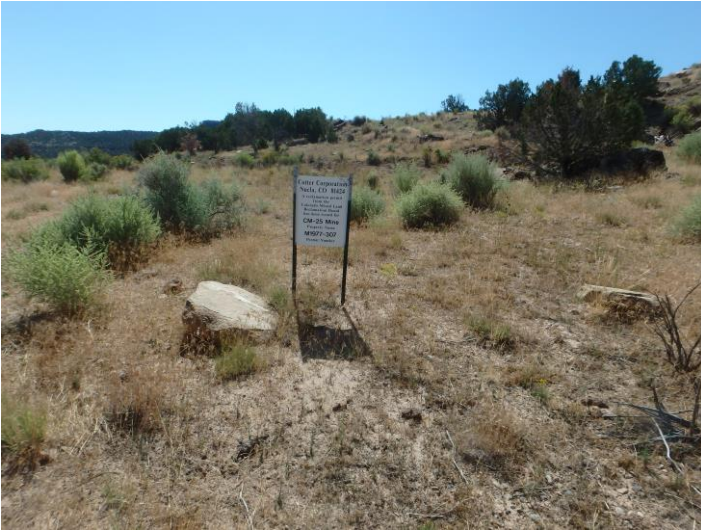
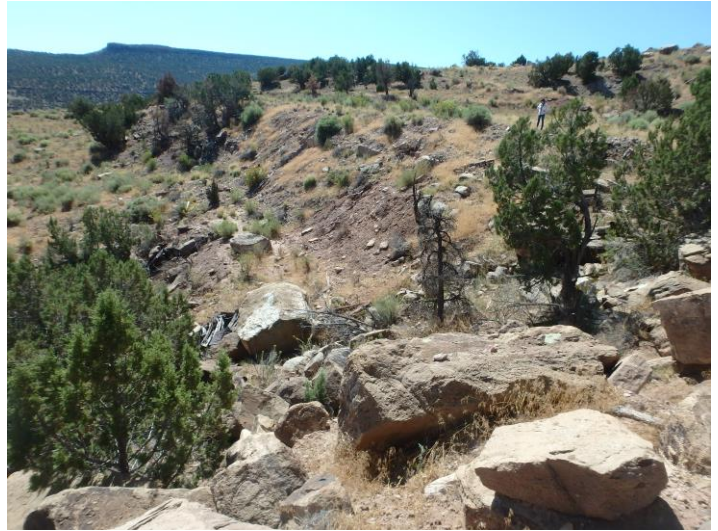
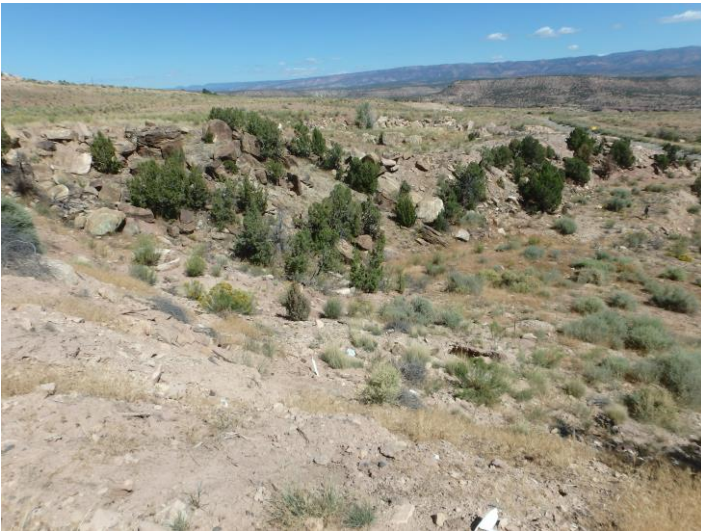
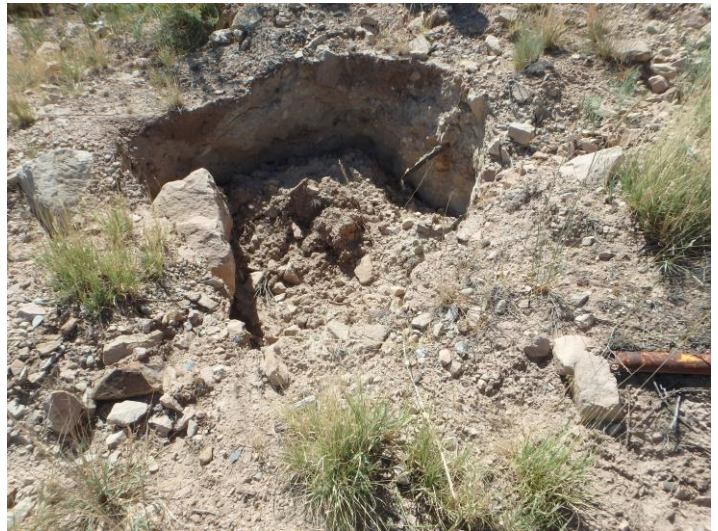
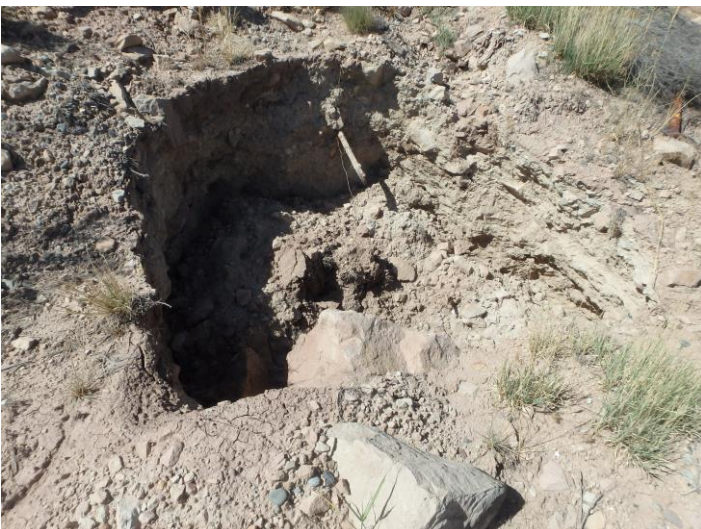
According to the operator's annual reports, final reclamation was completed at this site in February, 2003. This inspection found that a small amount of subsidence has occurred at the portal area. The operator was instructed to backfill and regrade the subsidence area. All other reclaimed slopes appeared stable and vegetation is well established over the reclaimed areas.

INSPECTION TOPIC: Subsidence**PROBLEM/POSSIBLE VIOLATION:** Problem: Subsidence has occurred at the portal area.**CORRECTIVE ACTIONS:** Backfill and regrade the portal area to blend with the surrounding topography.**CORRECTIVE ACTION DUE DATE:** 11/01/19
