MINERALS PROGRAM INSPECTION REPORT

MINE NAME: SM-18 Mine	MINE/PROSPECTING ID#: M-1978-116	MINERAL: Uranium and vanadium	COUNTY: Montrose
INSPECTION TYPE: Monitoring	INSPECTOR(S): Dustin M. Czapla	INSP. DATE: September 12, 2019	INSP. TIME: 11:00
OPERATOR: Cotter Corporation	OPERATOR REPRESENTATIVE: Scott Pottorfs	TYPE OF OPERATION: 112d-1 - Designated Mining Operation

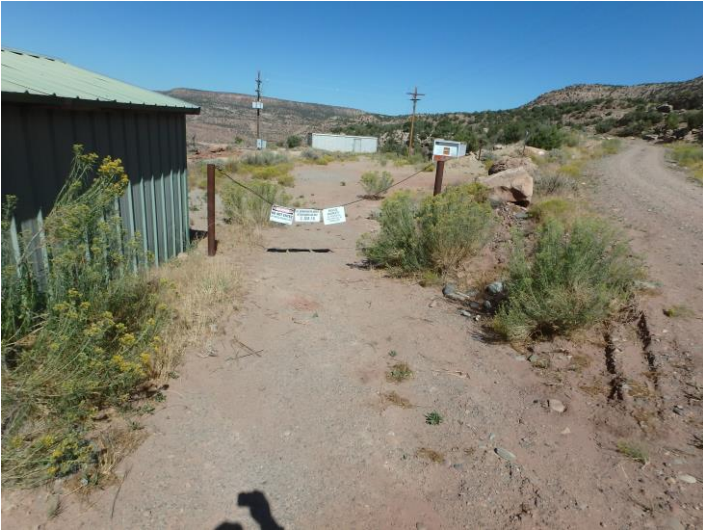
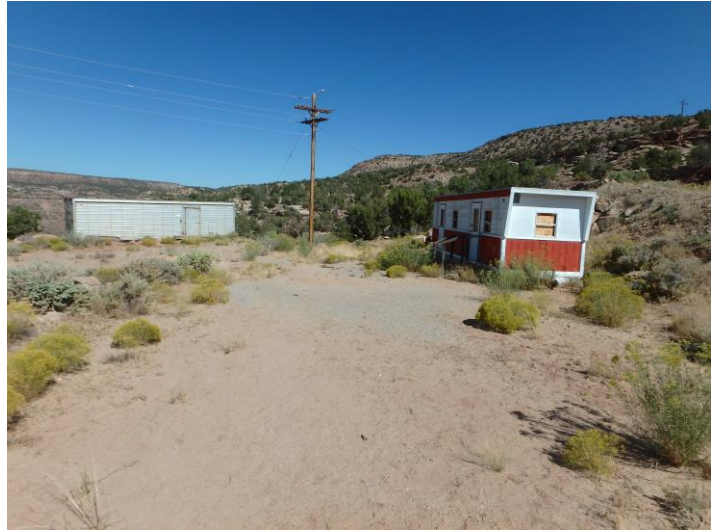
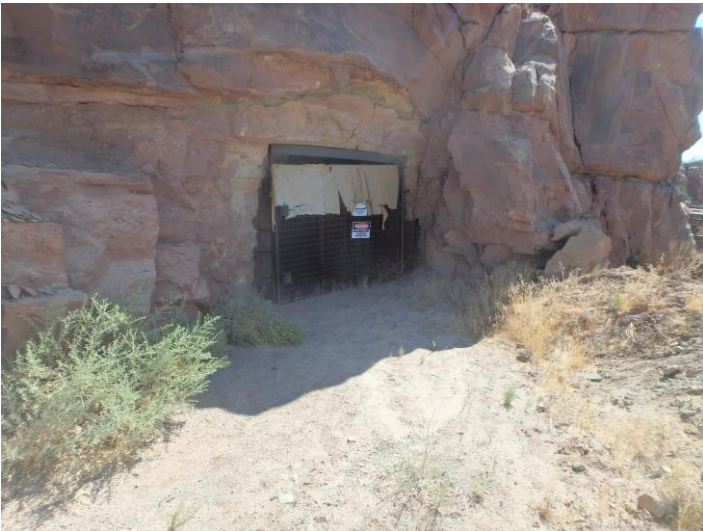
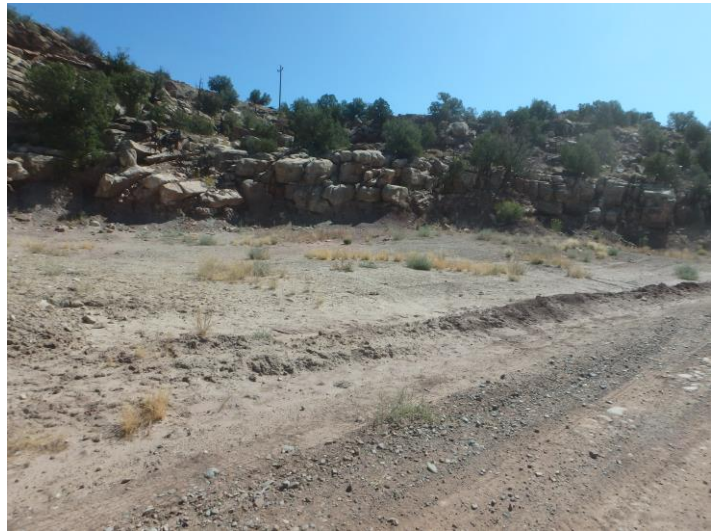
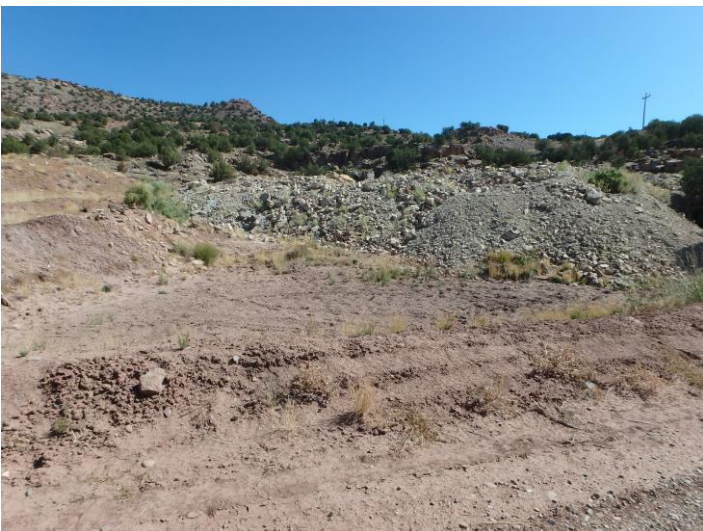
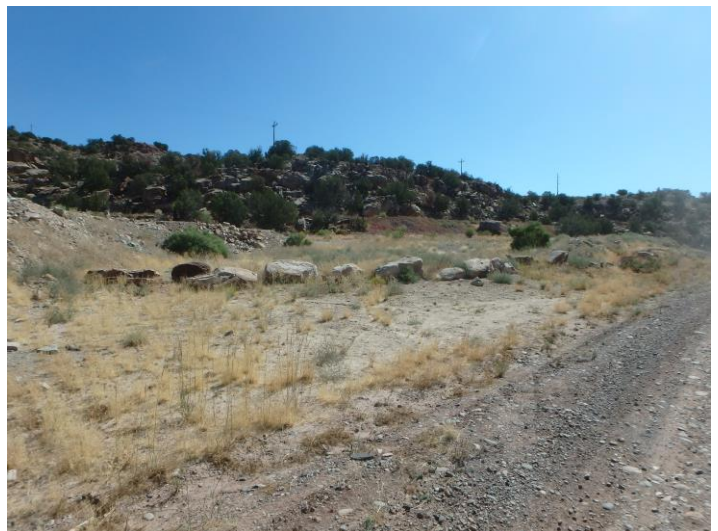
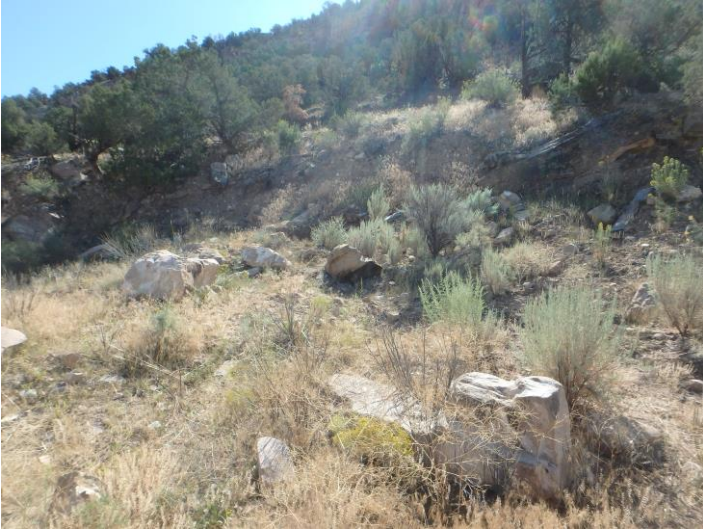
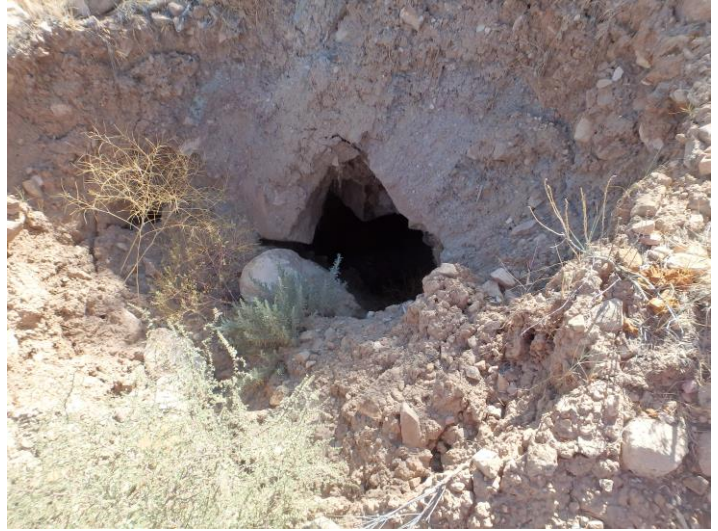
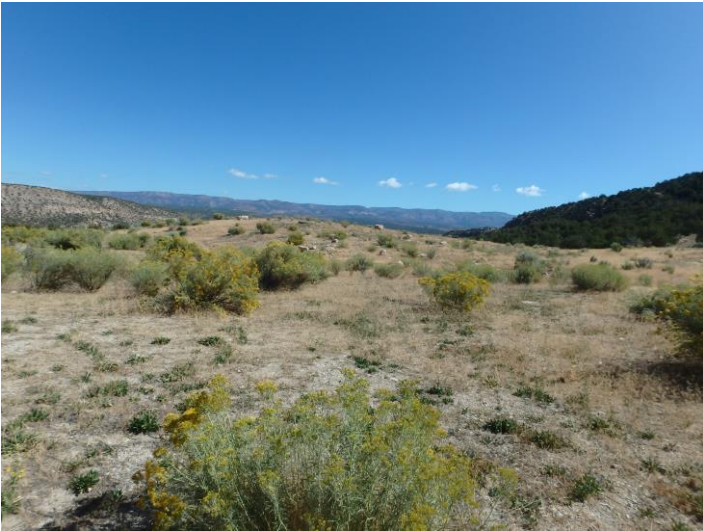
PROBLEM/POSSIBLE VIOLATION: Problem: Subsidence has occurred at the portal area on the north side of Spring Camp Mesa.

The north portion of the affected area, on the north side of Spring Camp Mesa, consists of the old reclaimed portal and mine area. Subsidence has occurred at the portal area. The operator was instructed to backfill and regrade the subsidence area. A steel building is located in this area. The building appears in good repair. Vegetation is well established over the reclaimed waste rock pile.

CORRECTIVE ACTIONS: Backfill and regrade the portal area to safeguard and blend with the surrounding topography.
